SAFETY INVESTIGATION AGENCY

FINAL REPORT
ON THE ACCIDENT INVESTIGATION OF AIRCRAFT
PIPISTREL PANTHERA
S5-MTR

10 September 2019
AT PORTOROŽ AIRPORT - LJPZ

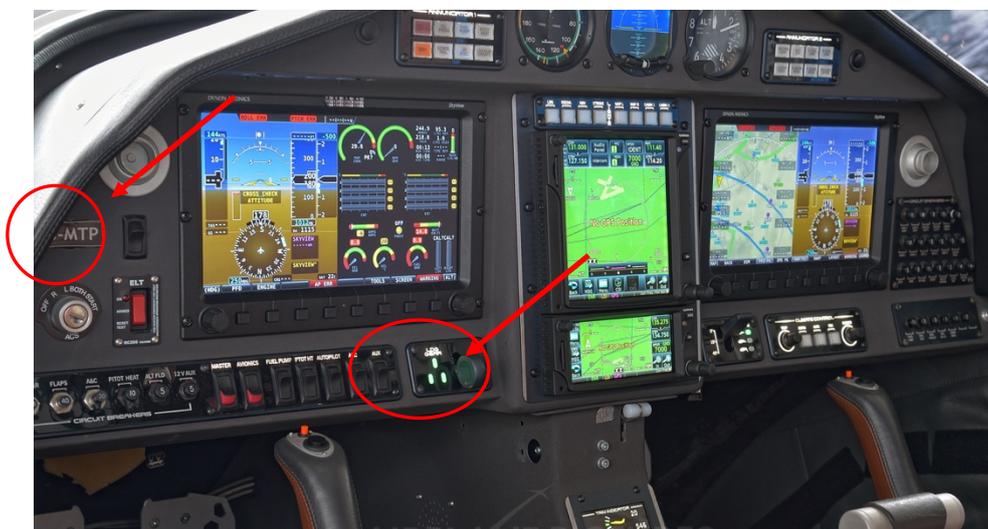
Image 2: Position of the LDG selector switch on Panthera registered S5-MTP

3. When examining and analyzing switch positions and indication signaling for landing gear in the design phase, the design organization of the first of three existing Panthera aircraft (reg. S5-MTP) determined that the position of the switch, which is manufactured in the form of a wheel shaped lever in the lower part of the instrument panel as shown in Image 2 is not safe. The pilot explained that, for the aircraft involved in the accident, the designer planned the switch location in the upper part of the instrument panel because of the possibility of accidental activation of the switch with the right leg of the left seated pilot (Image 3) if switch was positioned in the lower part of the instrument panel. The Commission noticed that the Landing gear selector switch on the instrument panel of the aircraft involved in the accident is identical to the Flap selector switch located at the same height and in the immediate vicinity - approximately 10 cm from the Landing gear selector switch. Switches are in close proximity and are designed to control the configuration of the aircraft, which represents the risk of confusion and possibility of misunderstanding their actual function. UP and DOWN positions of the Landing gear

selector switch mounted on the airplane involved in the accident, are far more difficult to detect than the positions of the Landing gear selections of the switch position installed in the first Panthera aircraft (Image 2) where the lever is wheel shaped.

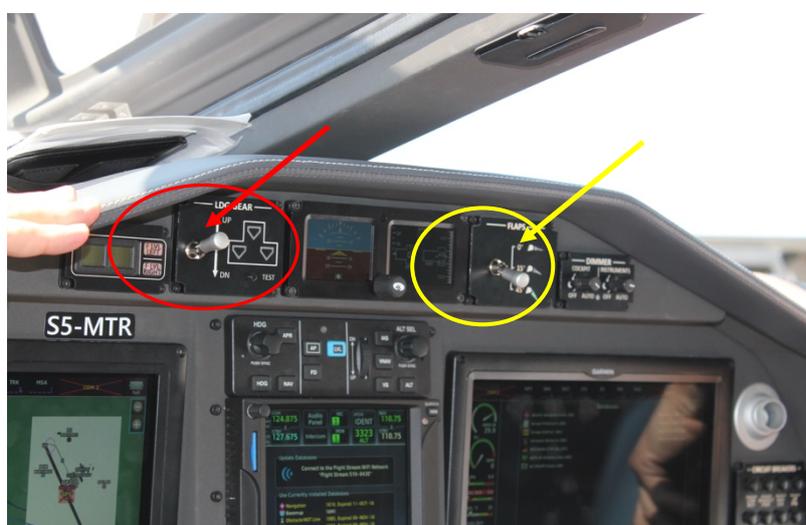
Image 3: Position of the LDG selector switch (red circle) on the accident aircraft Panthera registered S5-MTR

11. The comment made by the pilot about the malfunctioning of the light signaling during the landing gear selection in approach is subject to further analysis under the responsibility of the aircraft designer and manufacturer. The aircraft designer has designated the position of the landing gear control lever, which is identical to and adjacent to the flap position control switch. Identical switches in the immediate vicinity on the instrument panel in the cockpit of the aircraft pose the risk that they may be mistaken during landing configuration checks. Given the relatively small distance between the UP and DOWN positions, the position of the Landing gear selector switch is very difficult to identify when viewed from the pilot's seat. Such an arrangement of the Landing gear selector switch and the Flap control switch on the instrument panel of the aircraft involved in the accident, poses a risk of switch confusion. The consequences of incorrect and untimely use of the Landing gear selector switch can be significantly more dangerous than the consequences of incorrect use of the flap switch.

The manufacturer and designer of the airplane should perform additional analyzes and comparisons of positions and shape of the Landing gear selector switch in comparison with airplanes of a similar category with retractable landing gear and ensure that the Panthera Landing gear selector switch is replaced with a lever of a suitable shape and size not equal to the Flap control switch. Switches should be shaped in accordance with the practices of designers for the manufacture of such class of aircraft, which according to the Commission, shows all the characteristics of a complex aircraft.

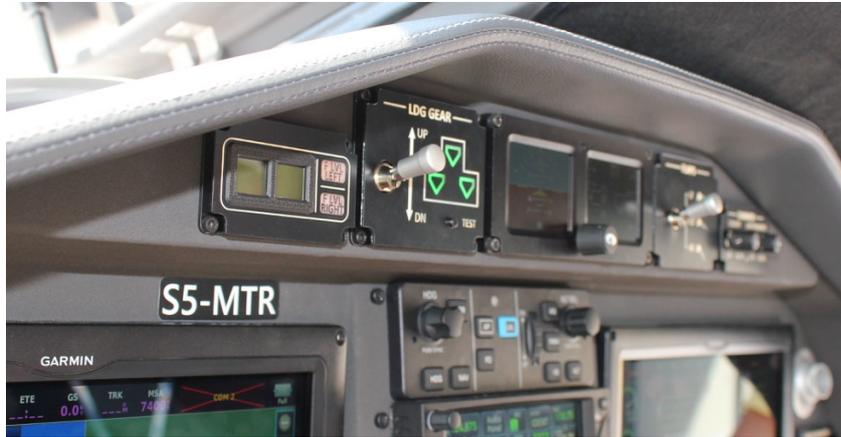
Image 4: LDG selector switch position and light signaling after landing gear emergency extension

4. Upon inspection of the airplane and the landing gear, it was found that the indication of the extended landing gear (three green indication lights) during switch UP position is only possible when the emergency landing gear extension procedure is performed (without moving the landing gear selector switch for normal lowering of the landing gear) and the landing gear

comes into the final extended position (Image 4). Position of switches and the cabin state showed, that pilot did not perform emergency gear extension.

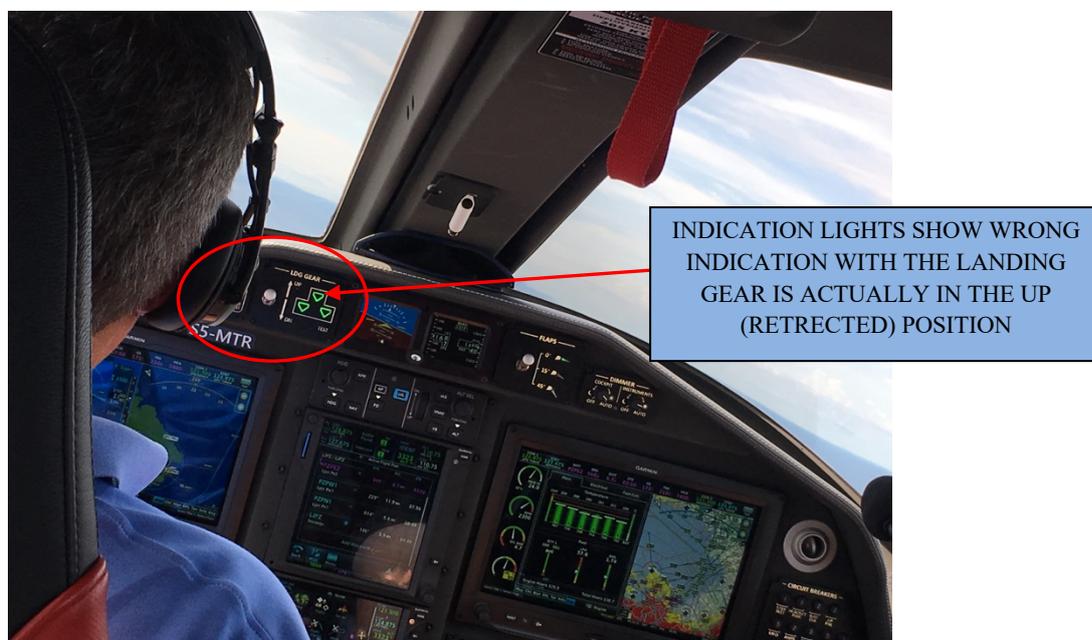
Image 6: Photography taken by the rear passenger a few minutes before the accident

In the follow-up of the investigation, the pilot responded to the draft report and provided photographs taken during the flight by a passenger sitting in the passenger seat at the rear of the airplane during the event. The analysis of the photography shows that during the flight, the landing gear indication lights **were green** when the Landing gear selector switch was in the UP position (Image 6).

This indication of the Landing gear indication lights is identical to that of the emergency landing gear extension (without moving the Landing gear selector switch to DOWN position) as described in point 4 of this report (Image 4).

10. Following the tests performed by the airplane designer, the causes for the pilot's assertion that the indication of "3 green" indication lights before landing indicated that the landing gear was in the extended position were not identified or confirmed. The landing gear selector switch selected to UP position always resulted in the landing gear retracted position.

Designer during internal technical investigation did not reveal a reason for false indication of retractable landing gear position. Designer stated that one of possible reasons could be the interruption of data bus CAN, which could be a result of data bus loss of connection (poor connection) or software error. Conclusion has been made that loss of CAN connection, does

not influence function of system configuration management. As a precaution measure, for possible loss of connection on CAN data bus, the airplane designer will issue a Technical bulletin for airplanes with serial numbers PX1520002, PX1520003 and PX1520005, including instructions for wiring system (indicating position of landing gear) modification, bypassing CAN data bus (direct connection to aircraft retractable landing gear indication).

The airplane designer should analyze the Landing gear warning system and, if possible, install an additional audio warning indication to reduce the risk of landing with landing gear retracted in the future.

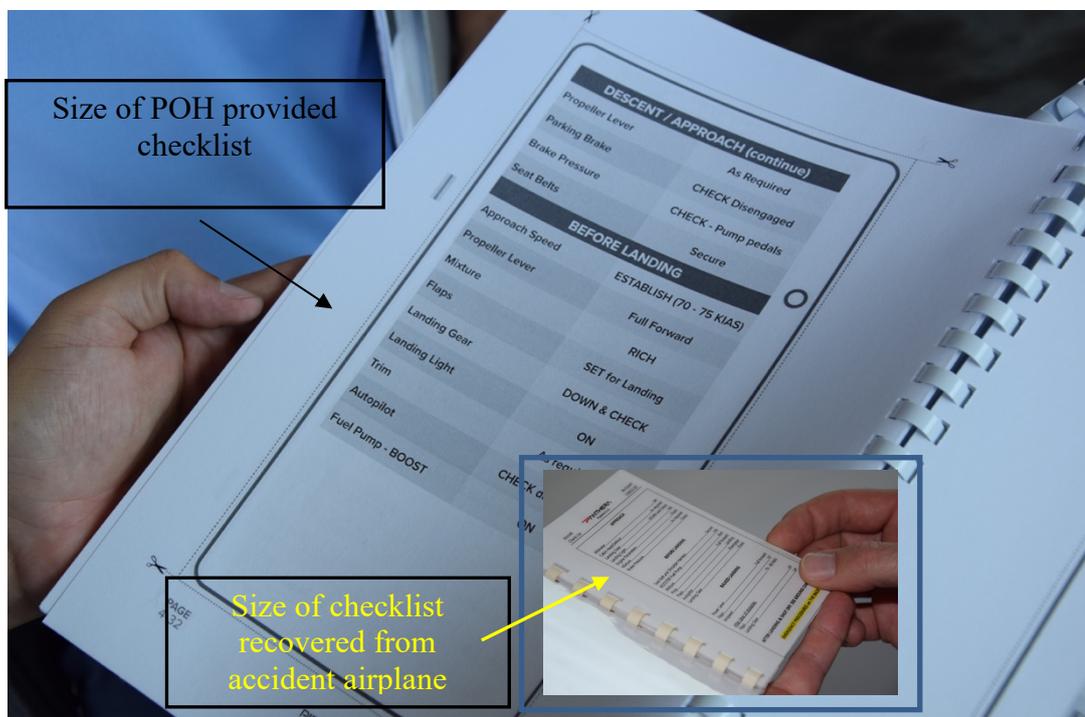
Image7. Checklist size comparison

It was concluded that pilot did not use Pilot Operating Handbook checklists but other unknown origin checklist (probably early version during aircraft design), which did not include all items included in current revision of Pilot Operating Handbook (only DESCENT/APPROACH and BEFORE LANDING procedures were analyzed in details). Pilot's checklist was printed in small size (small fonts) which would be hardly readable by a pilot limited with VNL (defective near vision) or this would require too much of his attention during flight.

Unsuitable shape and size of checklists or missing items therein (according to POH), could have contributed to the accident.

Slovenian CAA should include a topic on the Correct use of checklists in general aviation in this year's safety promotion activities.

Issue of CAA Safety circular on Size and shape of checklists and their compliance with Aircraft Flight Manuals is recommended and shall be evaluated during safety promotion activities.

Fonts that are too small in self-made checklists can take too much pilot's attention (head down), contributes to negligence (jumping over checklist items and procedures) and diminishes overall situational awareness.
