FINAL REPORT

ON THE INVESTIGATION OF THE AIRCRAFT ACCIDENT

INVOLVING THE AIRCRAFT PIPER PA-34-200T, SENECA II,

REGISTRATION S5-DGL, ON 26 OCTOBER 2012

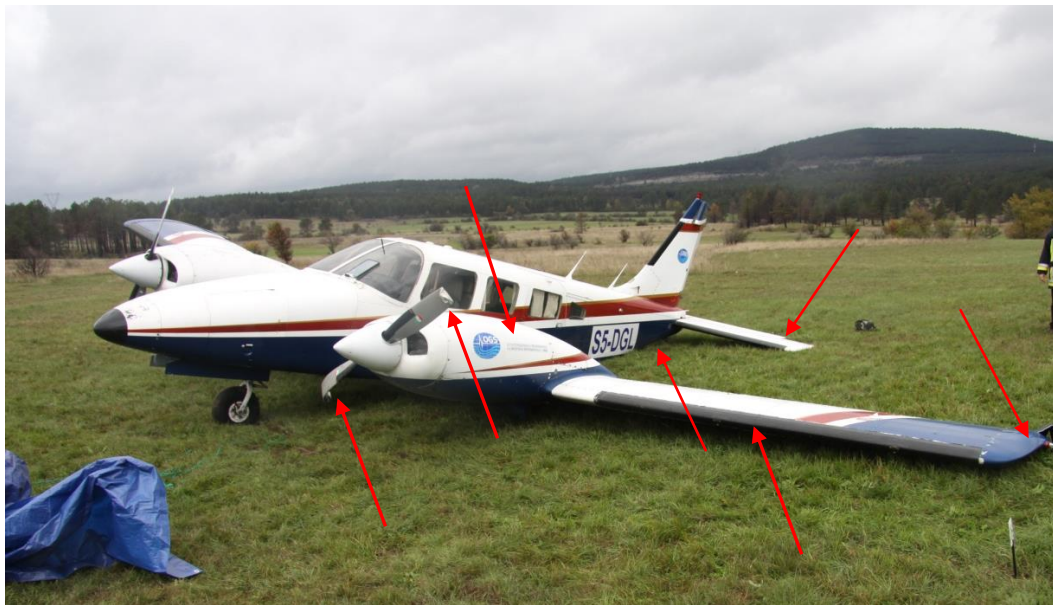
The support fittings of the left landing gear leg were damaged during landing and braking of the aircraft. Consequently, the plane glided along the grass surface with the top of the left wing outside the edge of the runway. The left engine propeller hit the asphalt runway several times. The left landing gear wheel sank under the flap of the left wing. The lower surface of the left wing was thus damaged and deformed. During the runway excursion, the lower part of the tail surfaces, left height control and fuselage were damaged. There was visible deformation of the shell – nacelle – on the inner side of both motors.

Figure 1 Aircraft at the stopping point after the runway excursion - damages

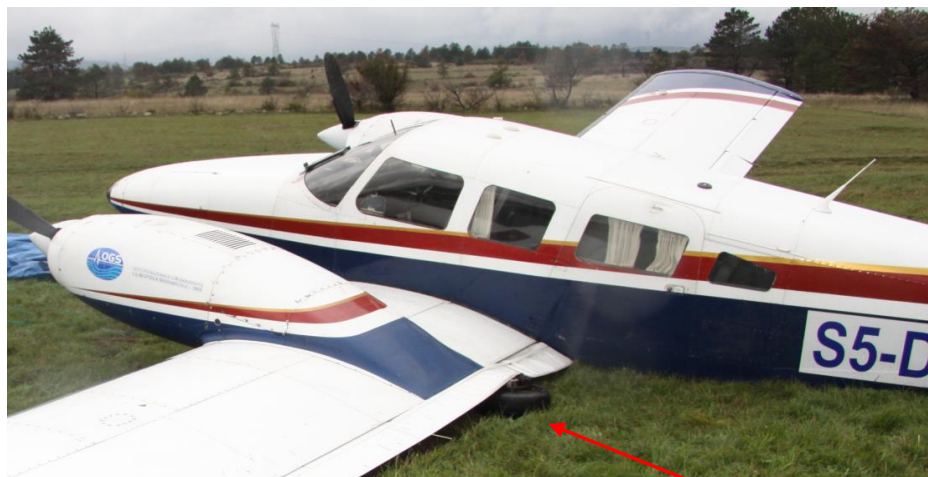
Structural damage to the left landing gear leg and left wing, damage to both tires, damage to the lower part of the fuselage. The two-bladed left engine propeller hit the asphalt runway several times causing the left engine to stop. There have been visible deformation of the shell at the wing junction and deformation of the left and right engine shell (nacelle).

Figure 2 Damage to aircraft

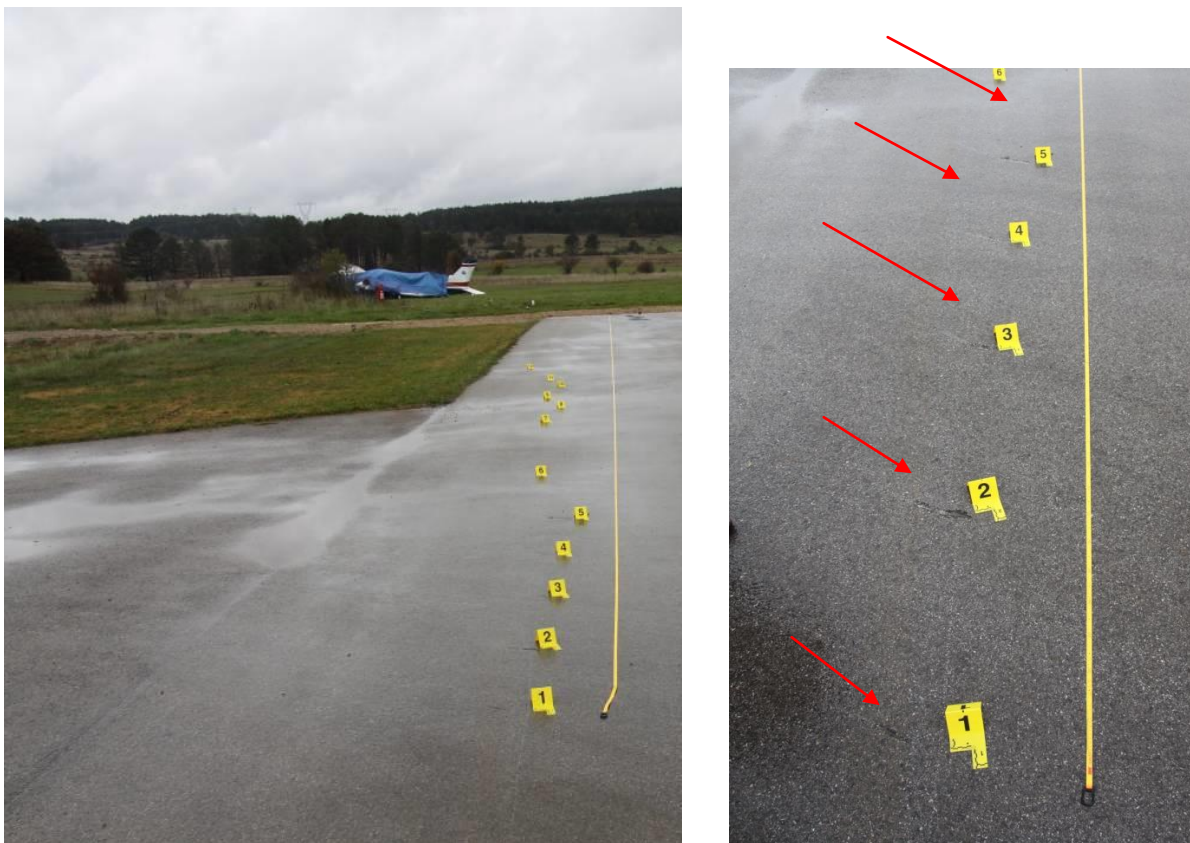
When the left engine propeller hit the asphalt runway, minor superficial damage was caused to the surface asphalt layer. There was no other damage.

Figures 3 and 4 Damage to the surface asphalt layer

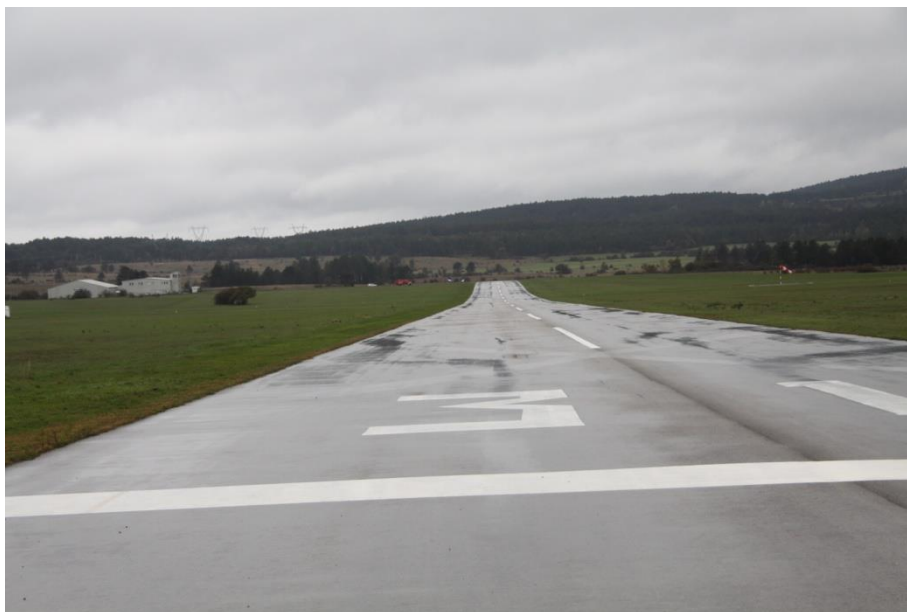
Figure 6 Asphalt RWY 13-31 the day after the event (photo in the direction of the aircraft landing)

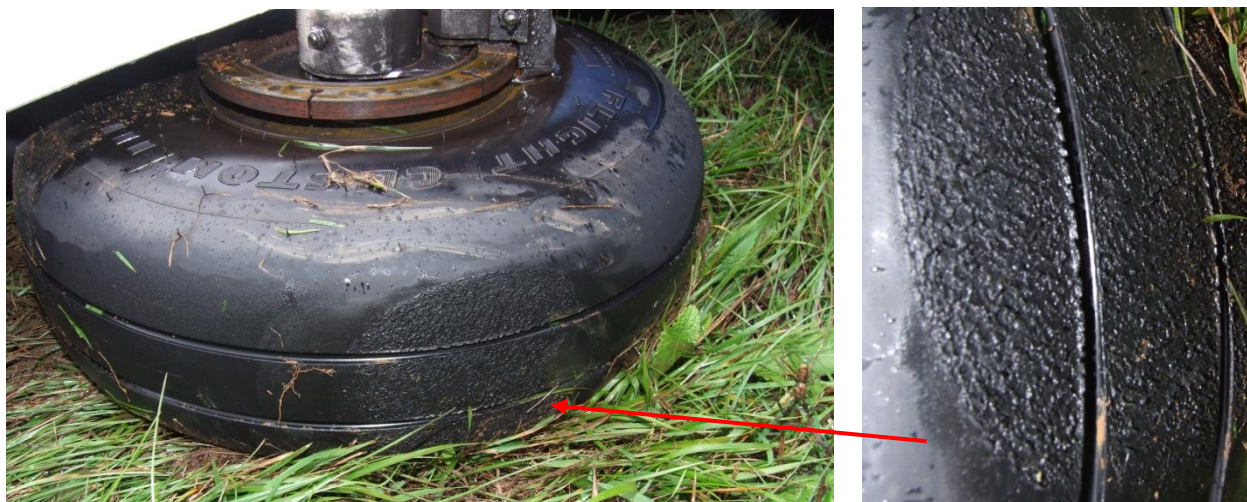
Figure 10 Aquaplaning marks on the left LG leg tire

The tire marks on both wheels show the multiple aquaplaning effect. The attempt of braking and maintaining the direction most likely led to strong vibrations and strongly unsymmetrical braking of the aircraft, causing the support fitting to fracture. The skeletal analysis revealed damage to the shock absorber on the two landing gear legs. The shock absorbers two pistons are bent in the axial direction forward-rearward. The mentioned deformation occurred as a result of unsymmetrical braking.

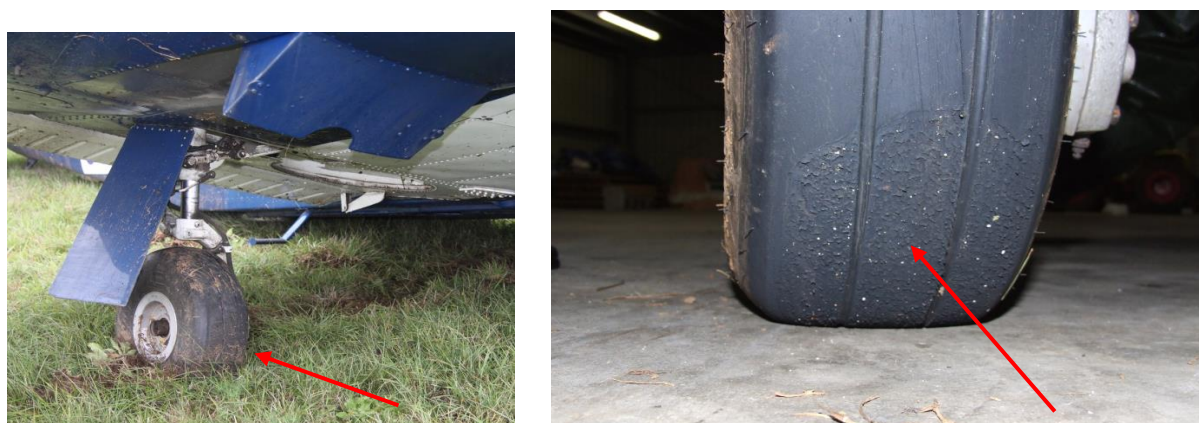
Figure 11 Aquaplaning marks on the right LG leg tire

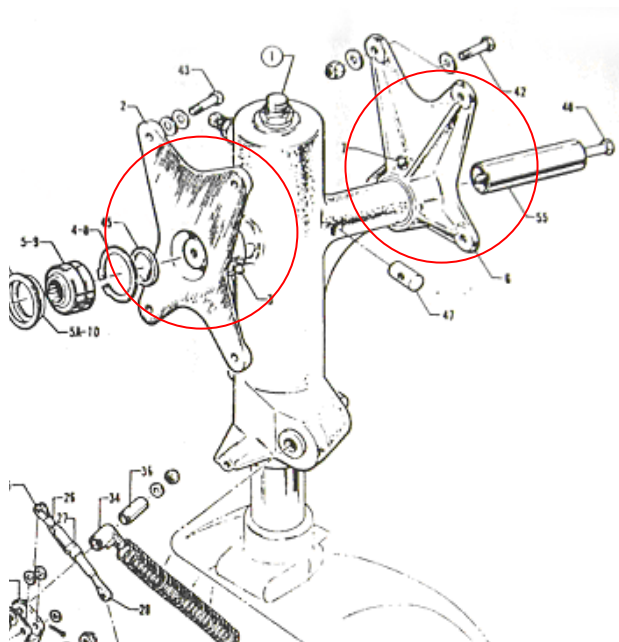
Figure 12

The investigation failed to reveal any damage or failure of parts or hydro installations or micro switches on the landing gear, which would result in unlocking of the left landing gear leg. Failure of the main support fitting (Trunion) was caused due to visible damage to one of the two fixed support fittings in the form of a butterfly - Figure 12.

Sudden overload and fracture of the left landing gear leg support fitting as a result of braking during landing and the occurrence of aquaplaning.

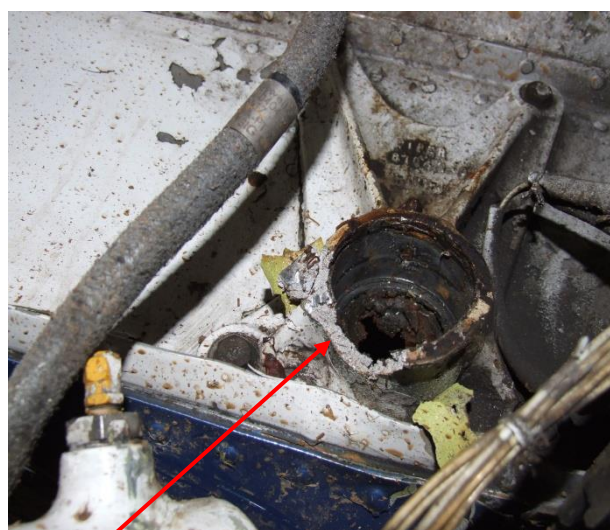
Figure 13

The investigation of the Trunion support fittings included an additional investigation of the material, which was performed by an approved institution for the investigation of metal structures. The left landing gear leg shock absorber was investigated. The findings of the left landing gear leg investigations are given in the Institute's Report no. P29381 of 10 January 2014. Due to the discovered deformation of the shock absorber, the right landing gear leg was dismantled and an investigation was performed - measurement of the deformation of the right landing gear leg shock absorber. The measured value of the bent left and right piston is 2.48 mm and 2.83 mm, respectively.

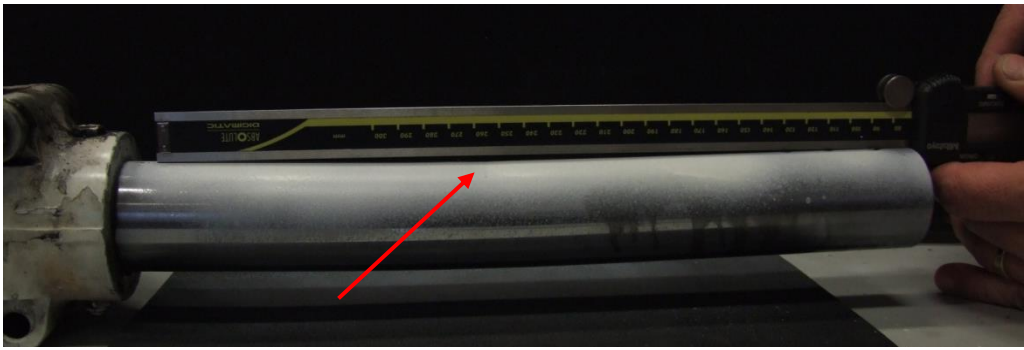
Figure 14 Bent piston of the right LDG leg shock absorber

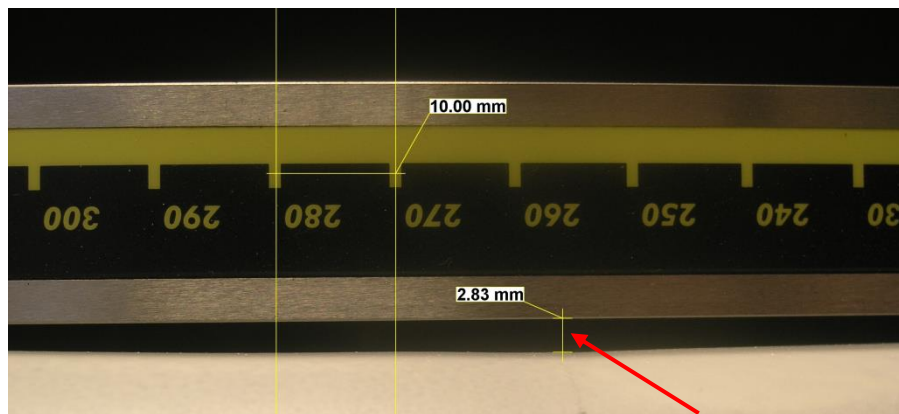
Figure 15 Measured value of the deviation of the right LDG leg shock absorber

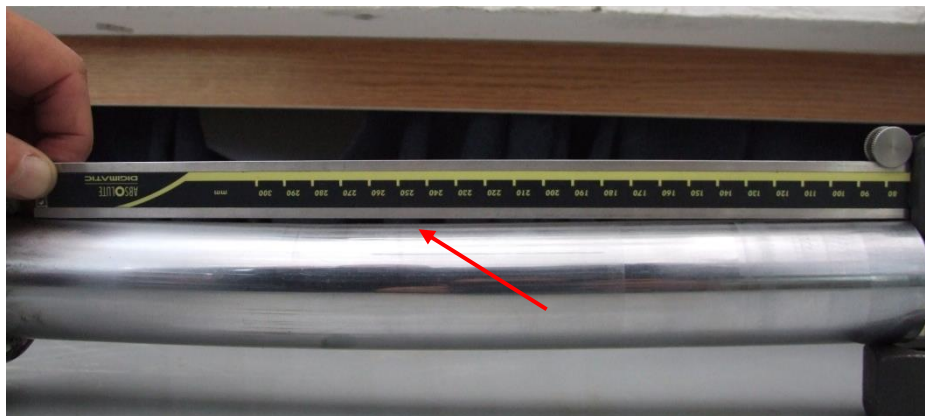
Figure 16 Bent piston of the left LDG leg shock absorber

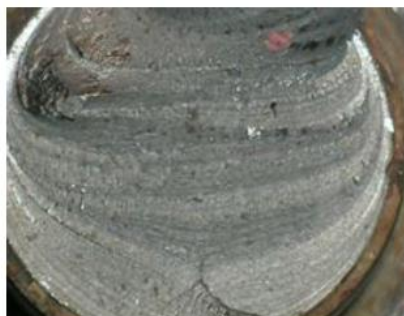
To našo ugotovitev utemeljujemo z dejstvom, da na sami prelomni površini nismo zasledili tako imenovanih linij počitka iz katerih bi lahko zaključili, da gre v tem primeru za utrujenostni lom (slika 9), ampak je bil glavni vzrok za zlom že prej omenjena nenadna preobremenitev nosilca.

Slika 9. Značilne linije utrujanja pri utrujenostnem lomu
