**FINAL REPORT**

**ON THE INVESTIGATION OF AN AIR ACCIDENT**

**INVOLVING THE ROBIN DR 400/180 AIRCRAFT WITH**

**REGISTRATION NUMBER S5-DKL 14 SEPTEMBER 2014 AT**

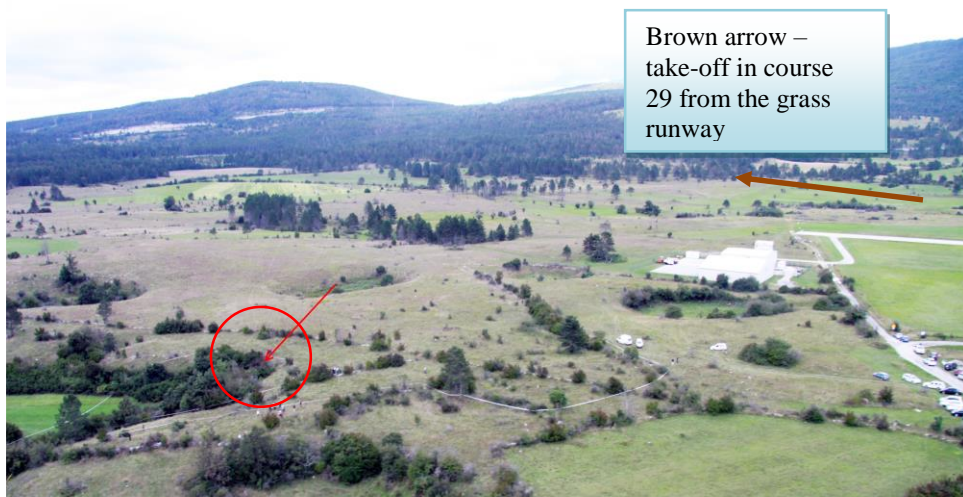
Figure 1 2: The red arrow indicates the location of the accident

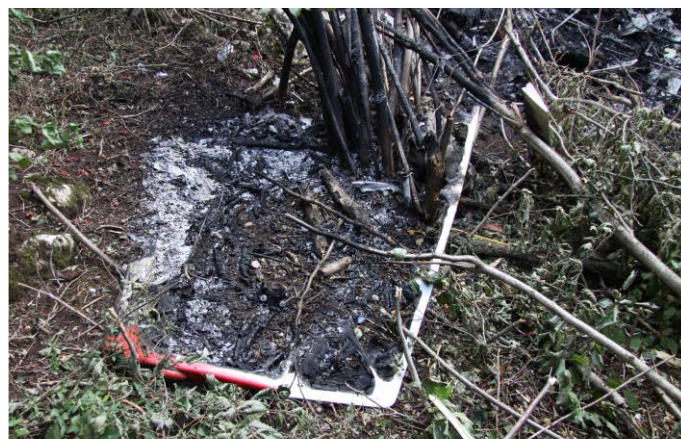
Upon collision with the terrain, the structure of which was essentially wooden, the aircraft caught fire and was completely destroyed in the fire. At the scene of the accident, mainly the metal components of the aircraft's landing gear, the engine with the drive shaft and the propeller, the cabin structure, parts of the burnt electrical installation equipment, and metal parts of the command controls were visually recognisable.

Figure 1 3: The location of the wreckage of the left wing at the scene of the accident

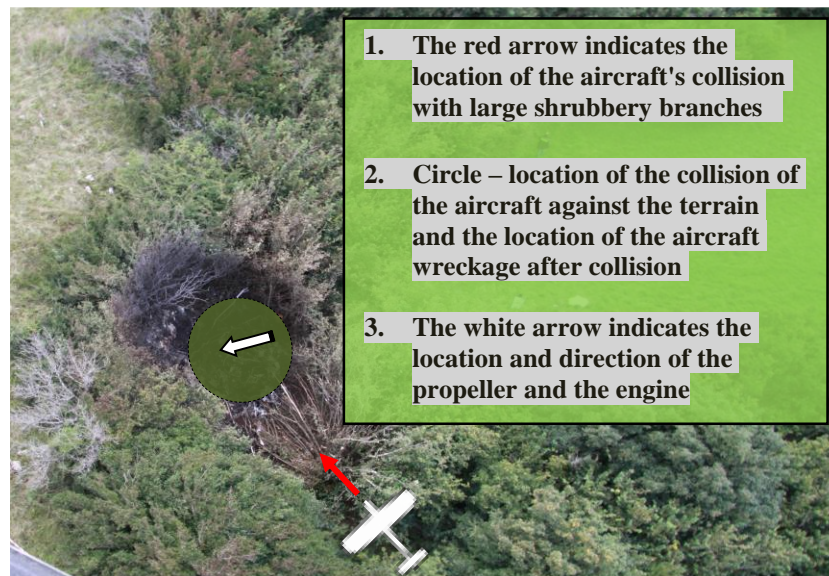
*Figure 1 4: A helicopter image of the scene of the accident – crash direction*

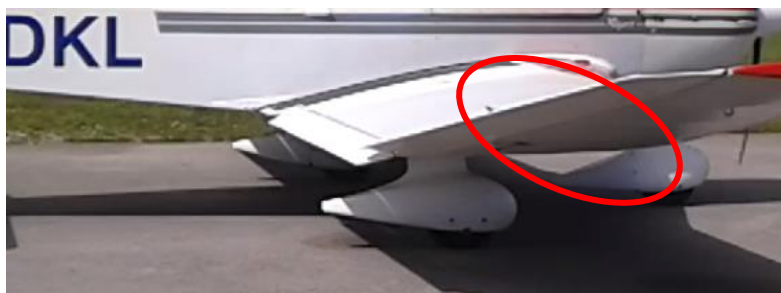
1. The engine ignition was without any peculiarities. The pilot and the passengers were properly fastened in.
2. The flaps were set to level 1 – take-off position.

*Figure 1 17: Aircraft flap setting*

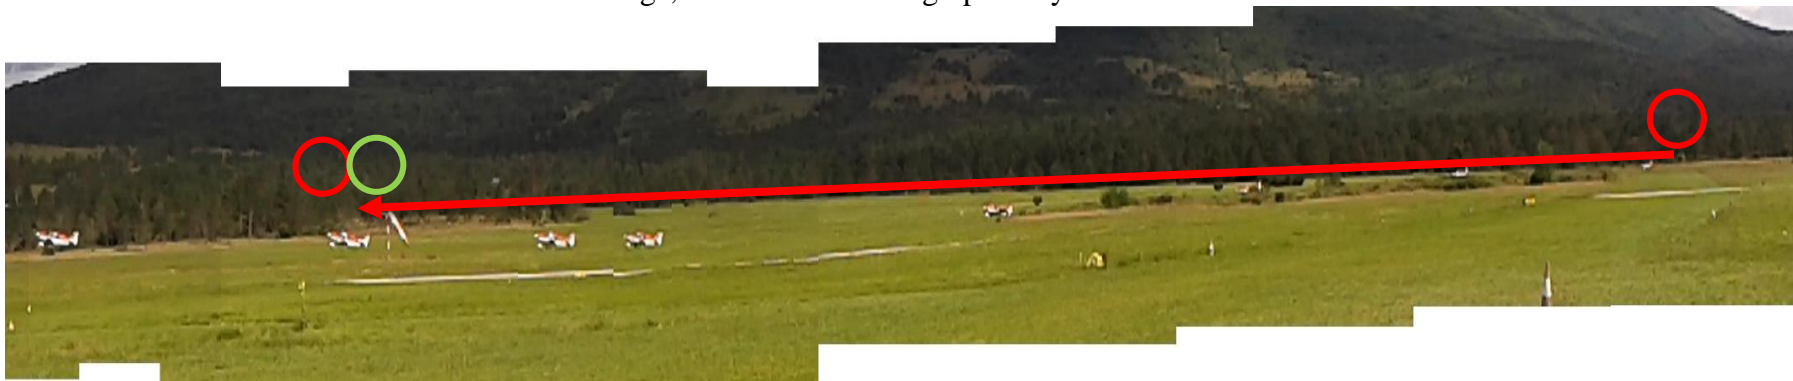
*Figure 1 18: Aircraft take-off run*

The figure shows the take-off run of the aircraft: the distance from the beginning of the run until the moment of take-off is indicated with a red arrow.

The green circle indicates a mild headwind and the suitable runway selection. On the basis of this data, the calculation of take-off performance was carried out below.

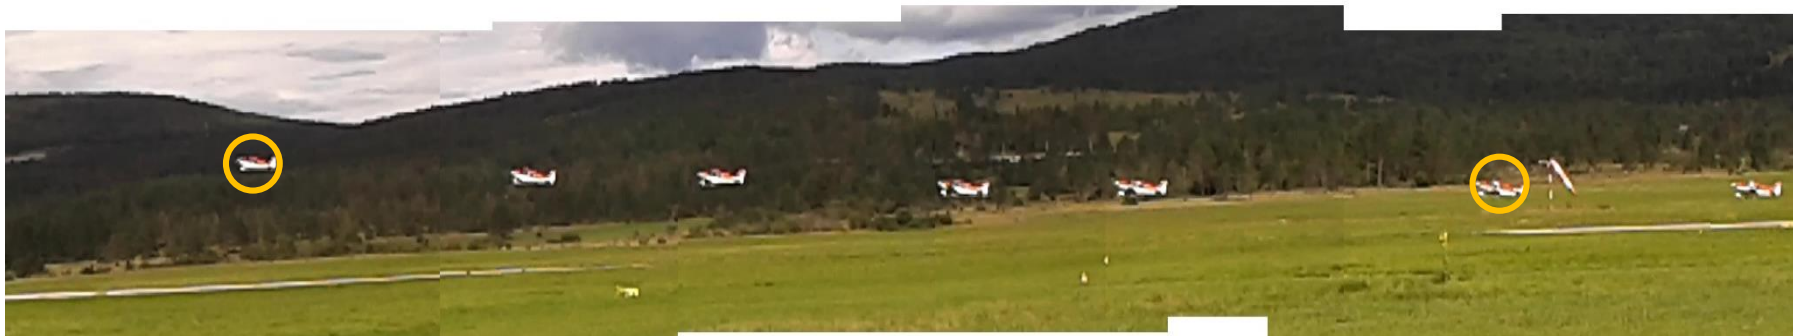
*Figure 1 19: Aircraft climb*

The figure shows the aircraft climb in the direction of the runway prior to the first turn. The TO took place without any noticeable issues or deviations from standard practices.

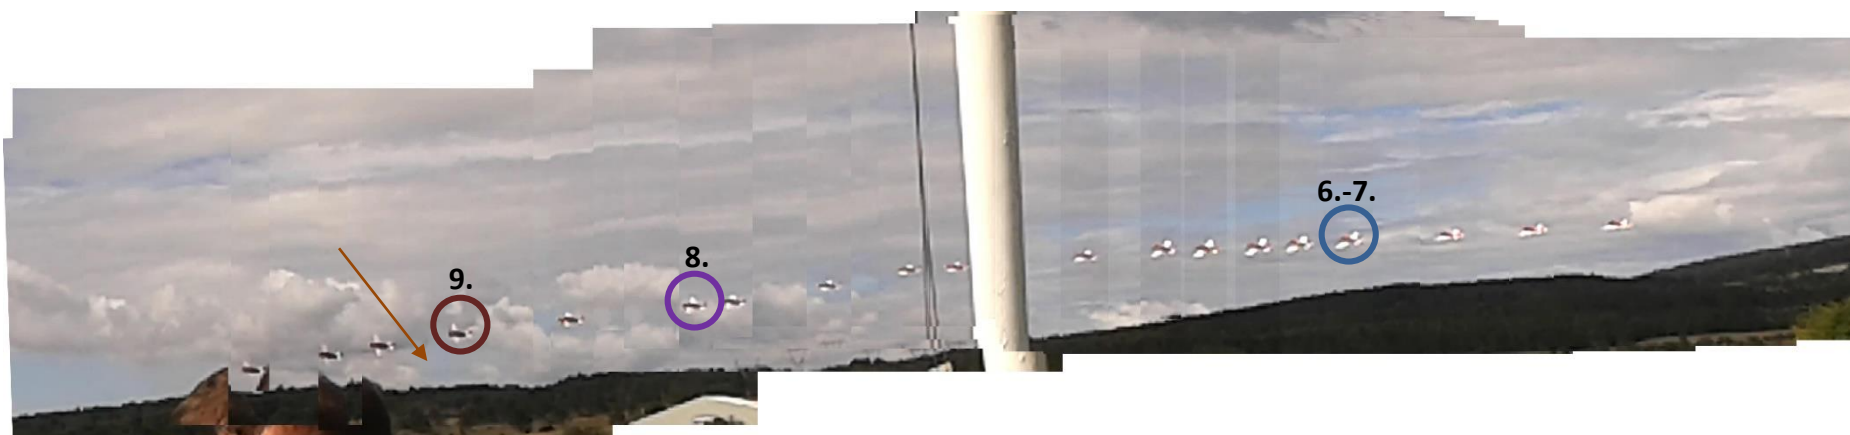
Figure 1 20: Display of events following the TO

The acceleration begins as the aircraft turns into the crosswind run (blue). In this phase, the aircraft is not gaining altitude; at first, the bank is only slight. The aircraft bank then increased (purple) and, as a result, approached the point of stalling. The last marker (brown) indicates the position, in which the aircraft continued to increase the bank and begins to lose altitude due to stall.

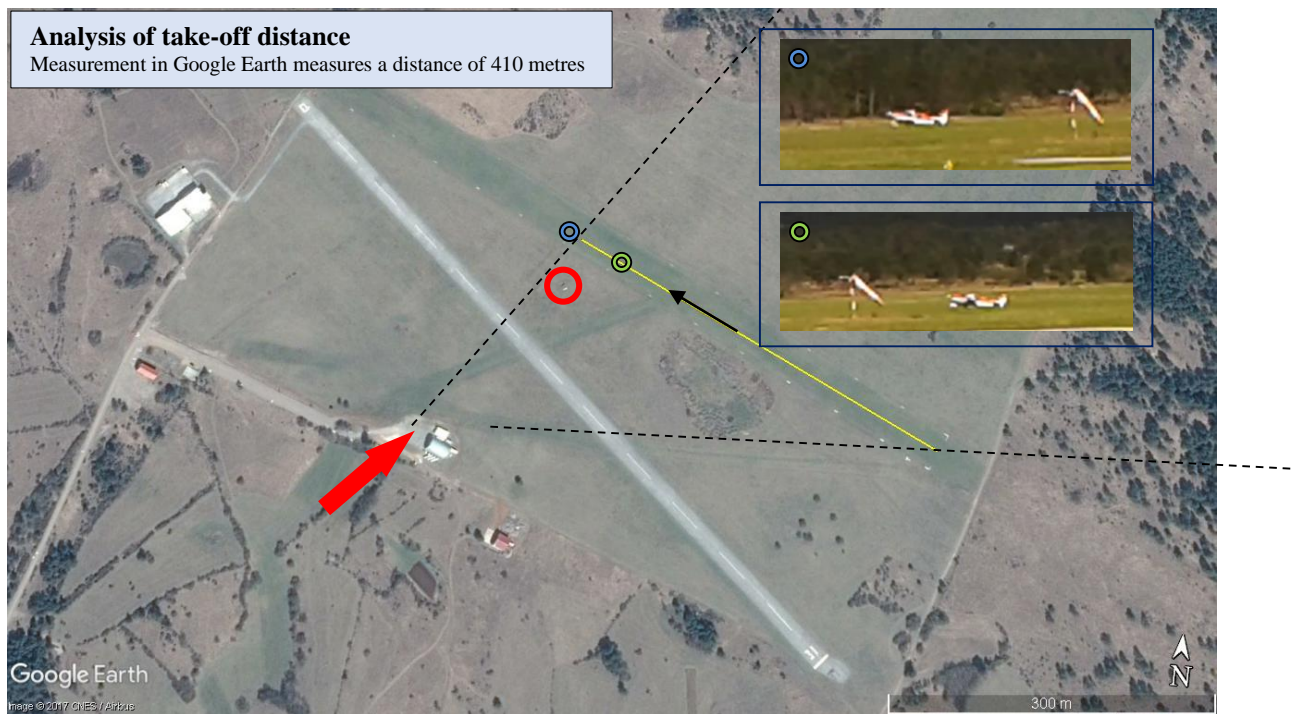
Figure 1 21: Graphic display of the calculation of the aircraft's take-off distance

The red arrow indicates the location of the observer – recorder. The red circle indicates a windsock, which is clearly seen in the recording. The black dashed lines indicate the visible line from the beginning of the take-off run until take-off. The green and blue circles indicate the position of the aircraft in the take-off phase from the location of the observer.

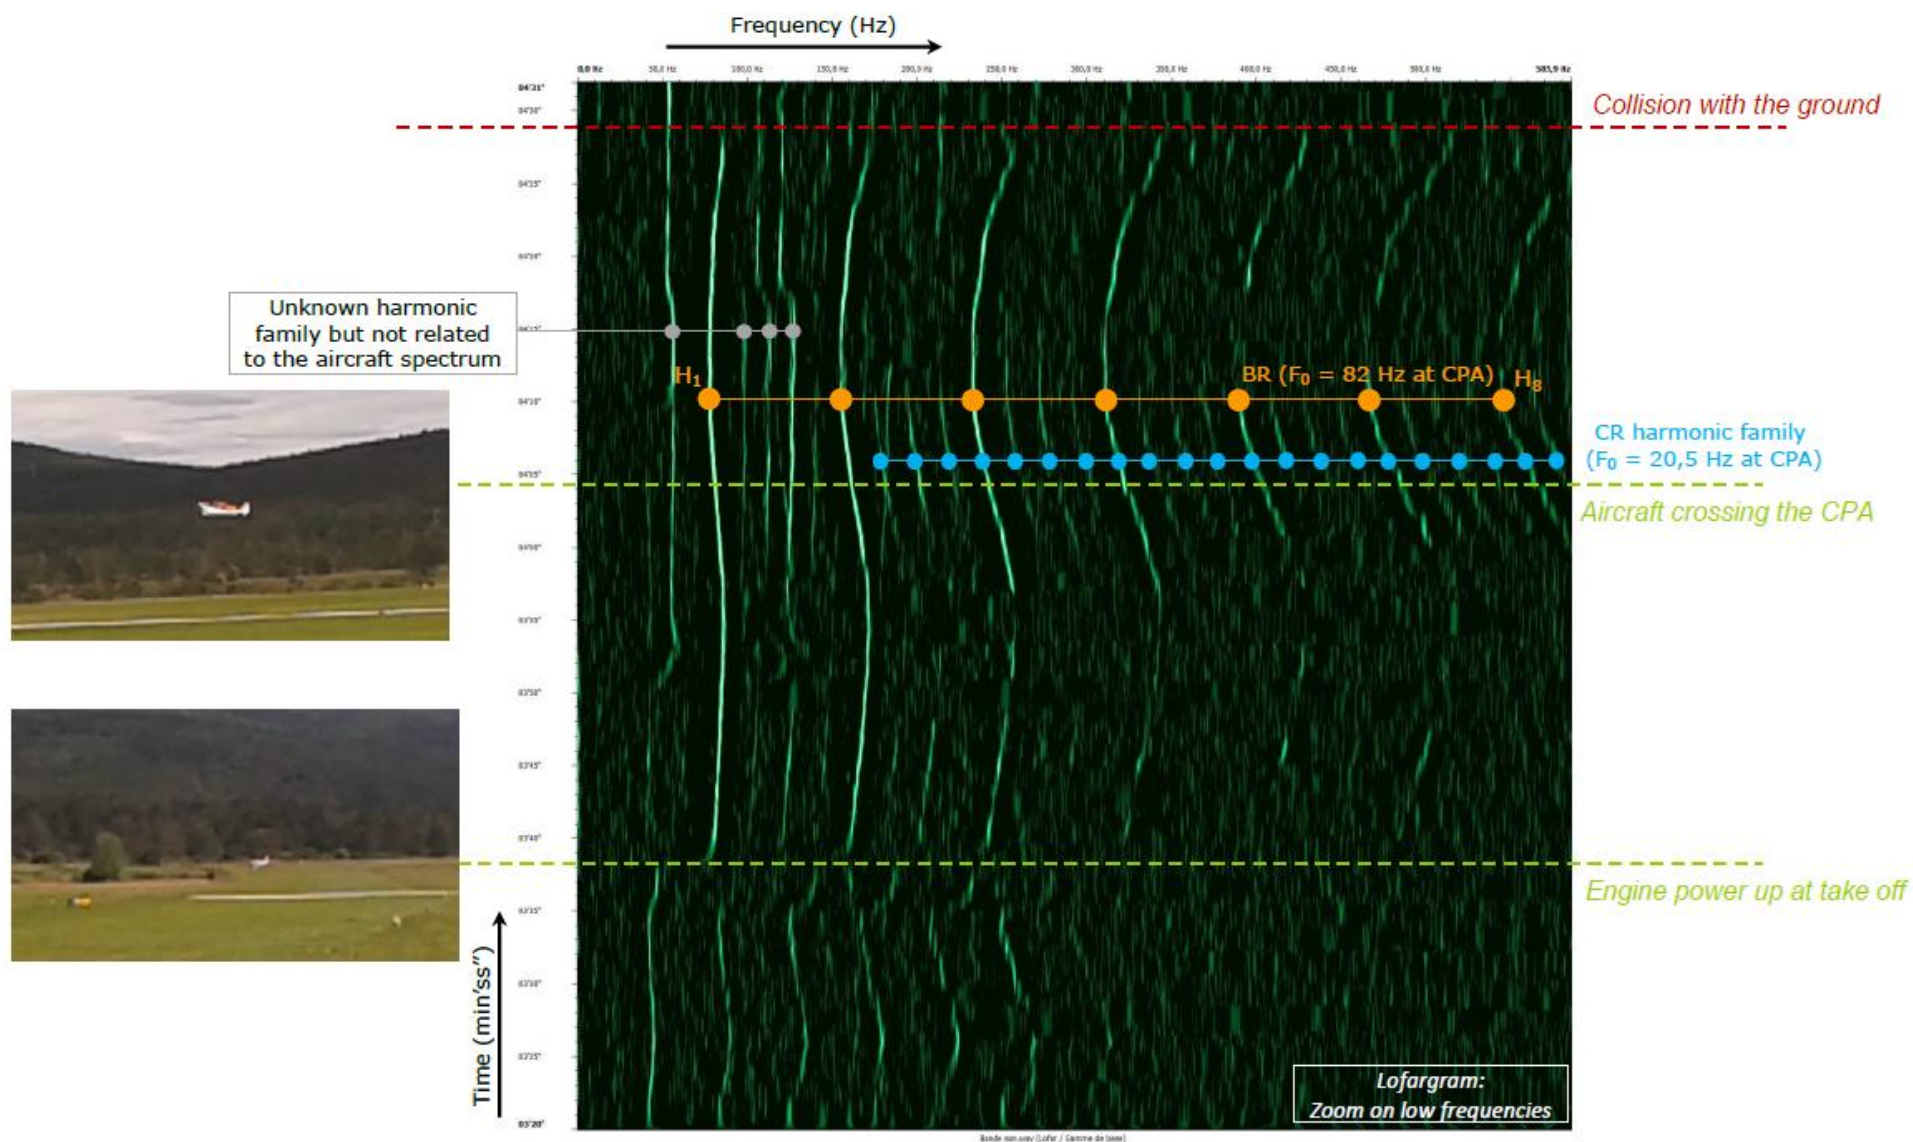
## Appendix: Spectrum view (Lofargram) – Last minute of the video (audio soundtrack)

Those acoustic signatures at take-off were consistent with the spectrum usually observed on that family of aircraft. The spectral lines associated with those acoustic signatures did not show any anomalies and were continuous until the collision with the ground.

The propulsion system condition appeared to be nominal from the beginning until the end of the flight.
