MINISTRY OF INFRASTRUCTURE

SAFETY INVESTIGATION AGENCY

FINAL REPORT
ON
ACCIDENT INVESTIGATION OF
PIPER PA28R-201
OE-DYM
near Mengeš,
3rd December 2015

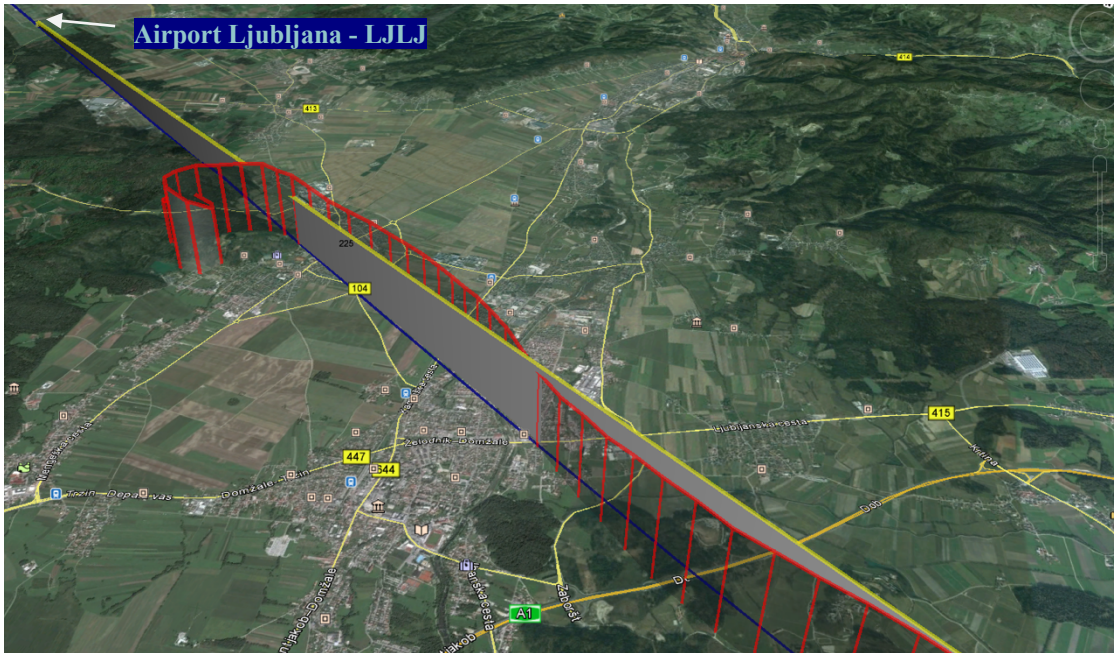
The pilot reported several times in communication with the air traffic controller, about 8 nautical miles to threshold, that he had a problem. At 6:50 p.m., the aircraft disappeared from the radar screen. The search and rescue process has been immediately initiated by Slovenian air traffic control. Hours later, Police and Administration of the Republic of Slovenia for civil protection and disaster relief representatives reported that the wreckage of the plane had been found on a forested slope about 4,3 nautical miles from the runway threshold. Upon crashing, the pilot lost his life. Accident also resulted with a death of a dog, which was found on the crash site. The dog was carried in the cabin of the aircraft.

Image 1: The yellow line represents the ILS approach, while the red line represents the actual flight path

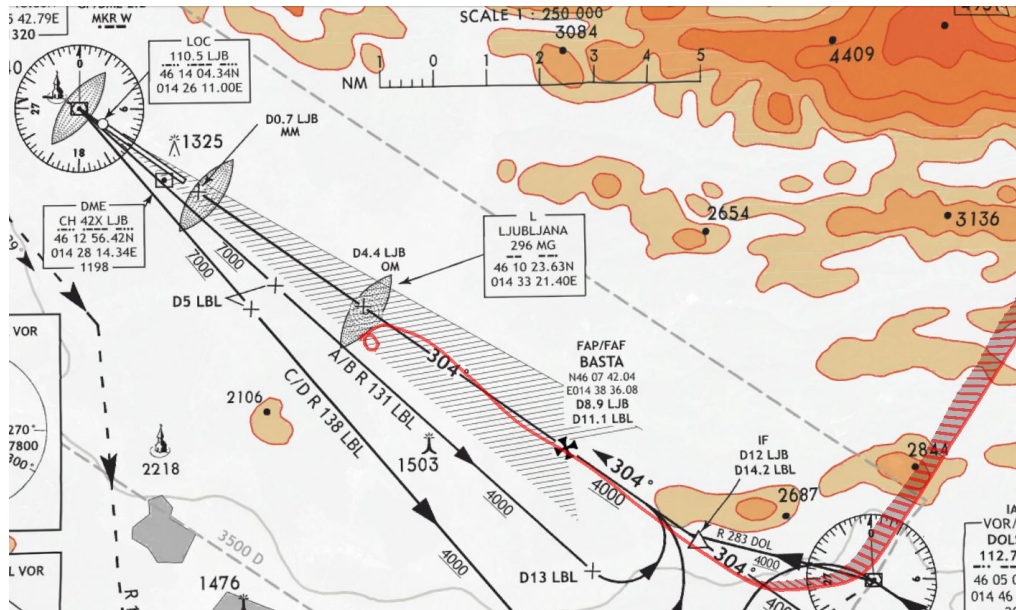
Image 2: Red line represents the actual flight path of the aircraft

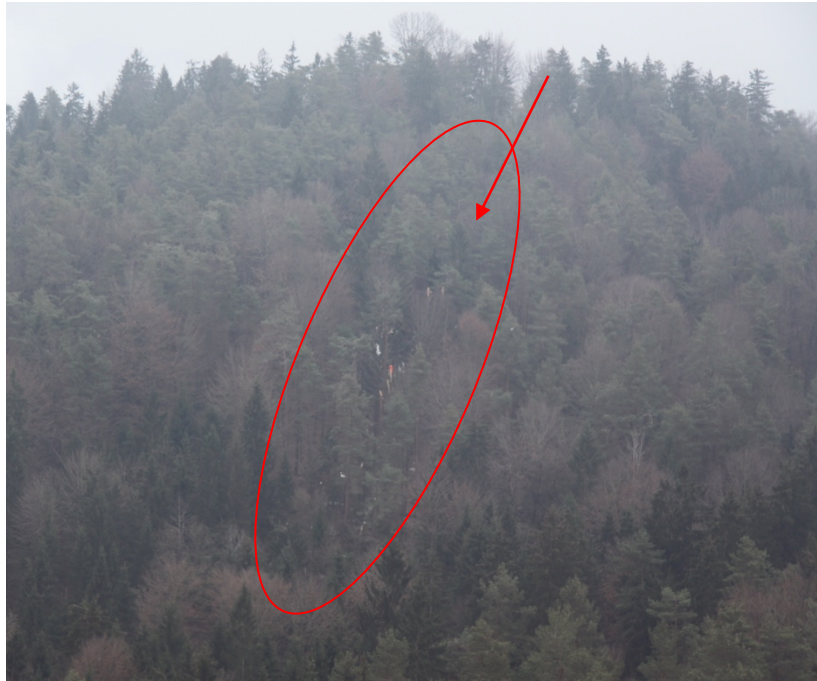
The plane separated into smaller pieces in the direction of movement, from the top of the hill towards the valley. In the crash, the plane first impacted with left wing, which collided with a

tree. Due to force of the collision, the left wing was torn off from the fuselage and came to rest on the ground together with the landing gear wheel, which was in an extended and locked position. Some parts of the airplane remained on tree canopies. The aircraft cabin, fuselage and tail surfaces were crushed to unrecognizable shape. A wider range of wreckage contained instrument panel not containing any instruments. Identification of instruments of the instrument panel and their readouts (flight data and engine performance) was not possible. At the far lower point of the crash trajectory was the engine along with the propeller.

Image 3: Crash trajectory line was downslope and 120 m long

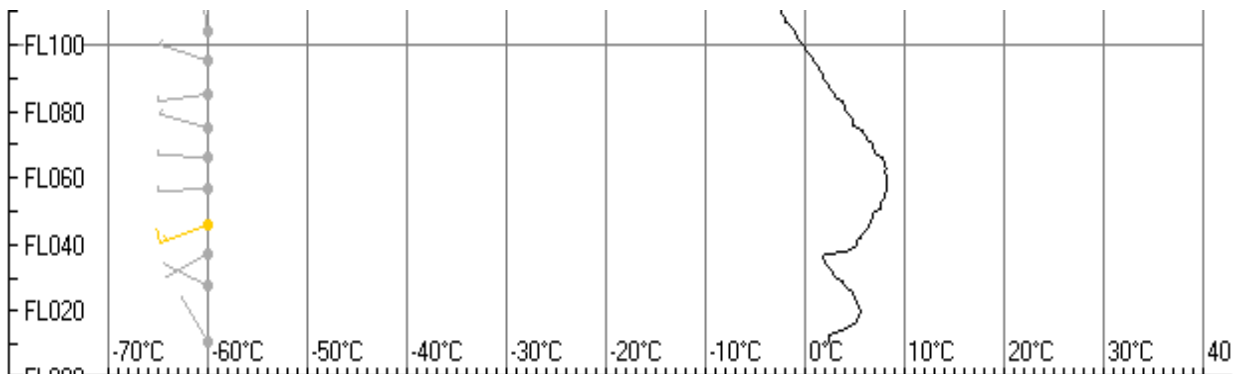
Over Slovenia the temperature was above 0°C in the lower part of the atmosphere. The temperature dropped below 0°C at altitudes above 10000 feet, below this altitude the temperatures were positive (Image 4). There were no conditions for the formation of icing on the structural parts of the airplane as temperatures were positive below 10000 feet and there was no visible moisture above 10000 feet.

Image 4: Temperature profile above LJJ at 18:46 LT

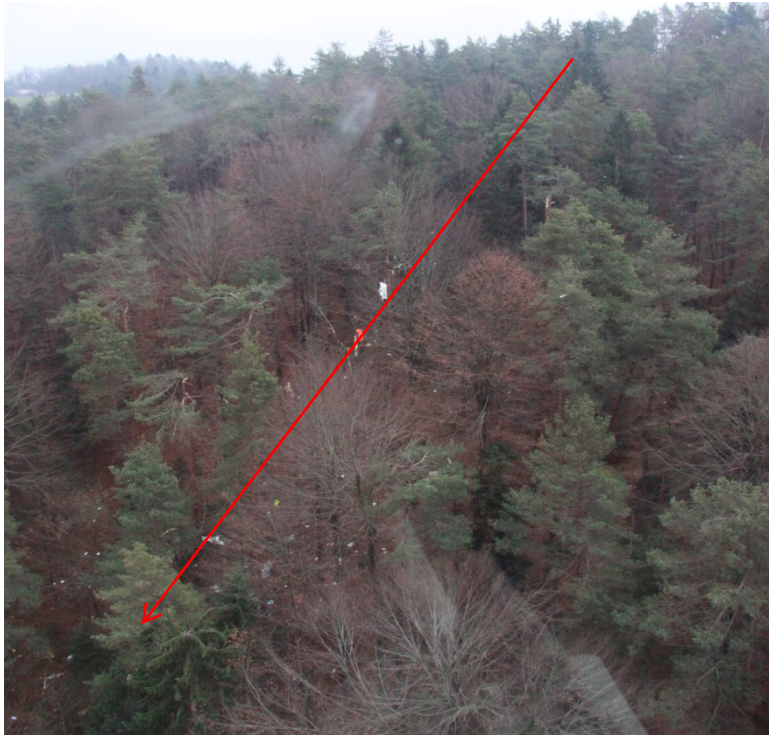
Image 5: The crash site captured from a helicopter. Red line marks the trajectory of impact.

The investigation process, in cooperation with Police representatives, began the next day. The site of the accident was documented from the air by a Police helicopter. During the investigation, logistic assistance in clearing the parts of the wreckage from the tree canopies and in the wider forest area was provided by firefighters and Mountain Rescue Association members.

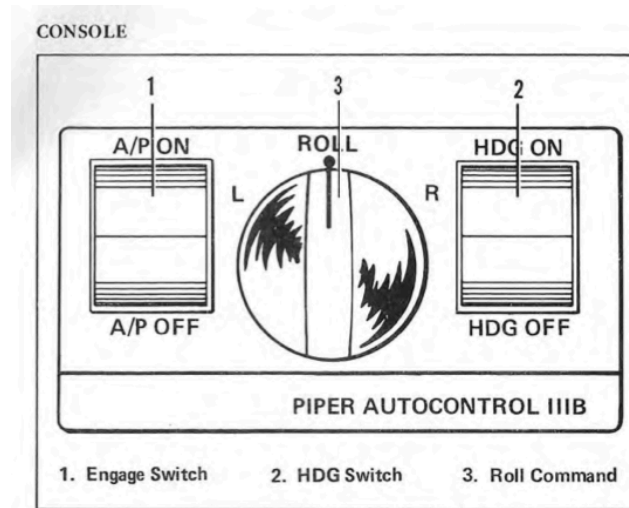
Umage 6 Autoppilot control switches

Basic modes of the autopilot directional control are ROLL and HDG. ROLL switch controls the execution of left or right turn by turning switch no. 3 (Image 6), when the autopilot is ON (A/P ON) – switch 1 (Image 6). The ROLL switch returns to neutral position when released. HDG mode enables flight in 5 sub-modes. Sub-modes also utilize selected radio navigation receiver being NAV1 or NAV2 and OBS selection of selected navigational receiver.

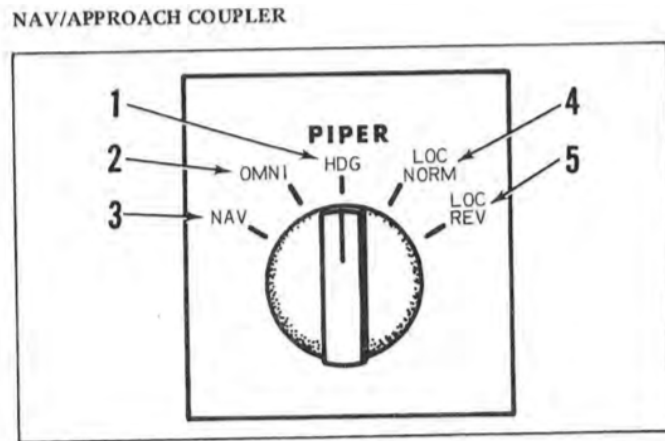
Image 7 Selector of autopilot sub-modes

When the aircraft is on final vector to intercept the ILS, OBS is set to localizer course, heading bug is turned towards ILS course, then we switch sub-mode from position 1 to position 4 - LOC

NORM (Image 7) and autopilot intercepts and maintains the localizer (including correction for wind effect).
