MINISTRY OF INFRASTRUCTURE

SAFETY INVESTIGATION AUTHORITY

FINAL REPORT

TL-2000 STING S4

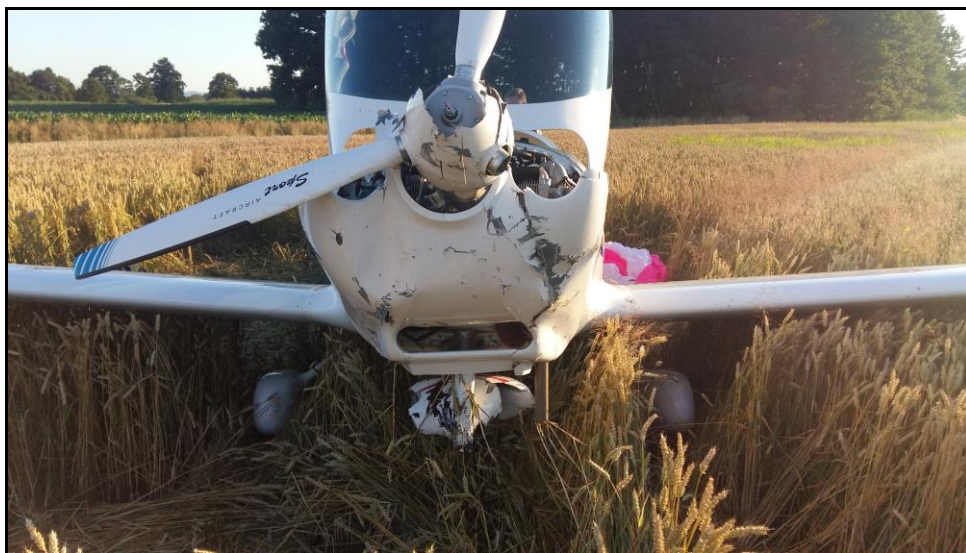
Figure 1: Aircraft position at the scene

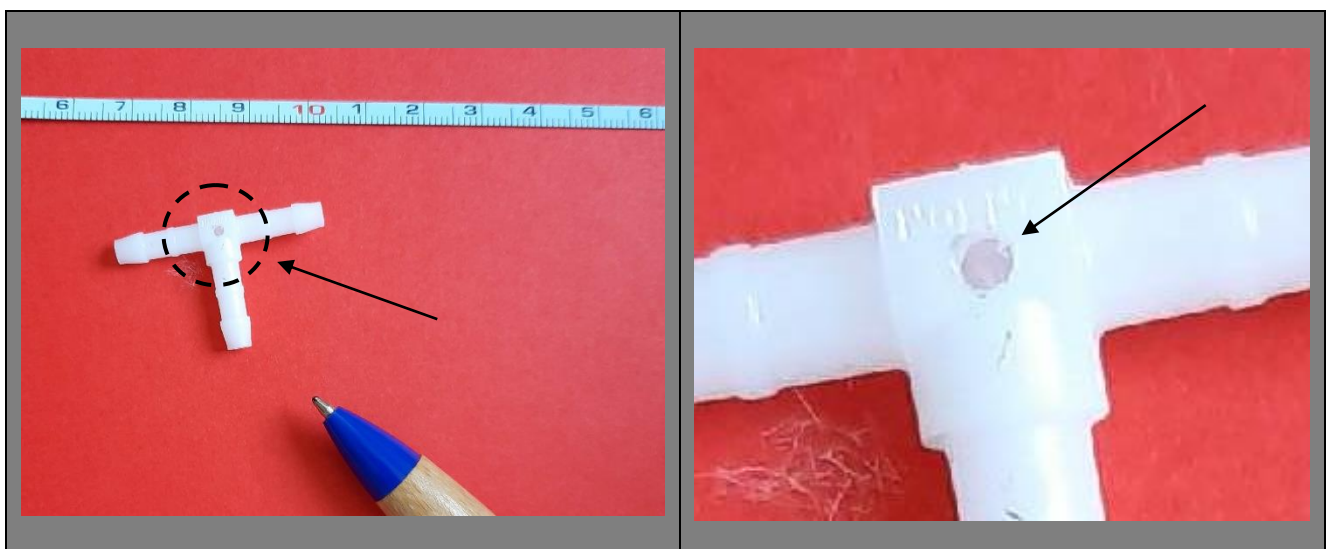
An examination of the PVC connections revealed a leak that was not caused by the accident. The leak in the static system installation was found on the »T« connector which connects the Air Data Computer, the Static Ports and the line leading to the cockpit instrument panel. The »T« connector is located behind the cockpit on the inside of the right side of the fuselage. The »T« connector's drilled hole was approximately 1.5 mm in diameter. Over the drilled hole, insulating tape was wrapped.

Figure 3: Leakage location at the "T" connector

6. A pitot static system inspection revealed a deficiency in the form of excessive leakage in the static line of the barometric indication system, resulting in the barometric mechanical and electronic altitude, speed, and vertical speed indicators error. The leak in the static system installation was found on the »T« connector that connects the Air Data Computer, the static ports and the line leading to the instrument panel;

Following the removal of the leak source, a re-test of the aircraft's pitot static system tightness was carried out. Following a successful leak test, barometric instruments and electronic multifunction devices were tested and calibrated. The test was completed successfully. The instruments resumed normal operation after the static line leak issue was resolved. The installation of both pneumatic channels was adequate in terms of tightness. The test results are included in Final report Appendices.

The aircraft manufacturer (TL Ultralight) should review Aircraft Maintenance Manual pitot static testing procedure on ground.

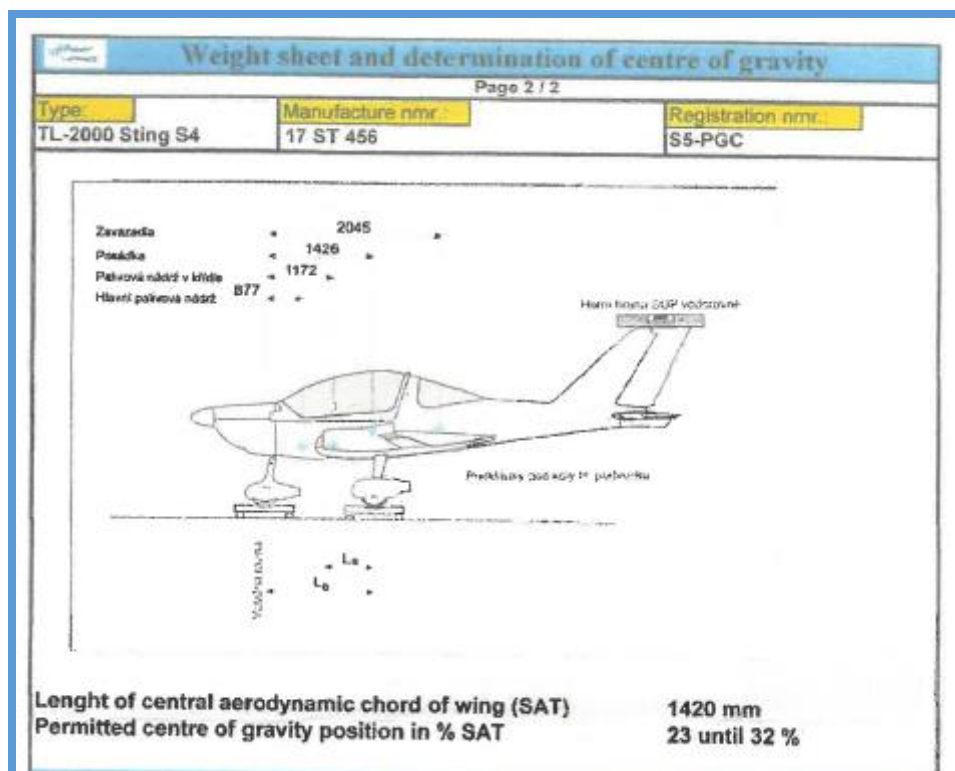
Figure 4: Data from measurements performed by the manufacturer

The position of the center of gravity of an empty aircraft can be calculated based on the weighing of the empty aircraft and the documents issued. The center of gravity is obtained at 28% MAC.

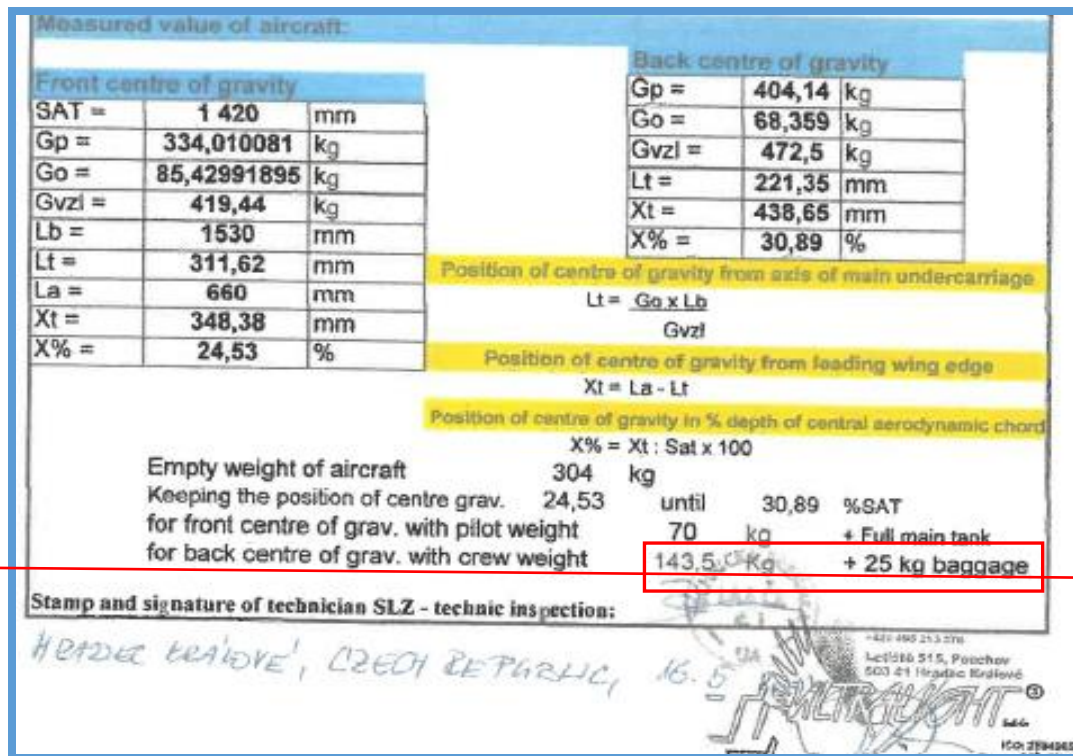
Figure 5: Data from the manufacturer's report on the performed weight measurement

The maximum crew weight of 143.5 kg and 25 kg of baggage determine the aft limit position of the center of gravity (as specified by the manufacturer in the weighing report – Figure 5). The given report makes it difficult to conclude whether fuel is already included in this mass, because adding all the masses results in a mass greater than 472.5 kg, i.e. greater than the maximum allowed.
