**AIR, MARITIME AND RAILWAY ACCIDENT AND INCIDENT
INVESTIGATION UNIT**

Number: 37200-2/2022/35

FINAL REPORT
ON THE ACCIDENT INVESTIGATION
Of the Jonker JS MD-3 Rapture glider,
reg. marks D-KXBL,
in Hudi kot, Ribnica na Pohorju,
February 26, 2022

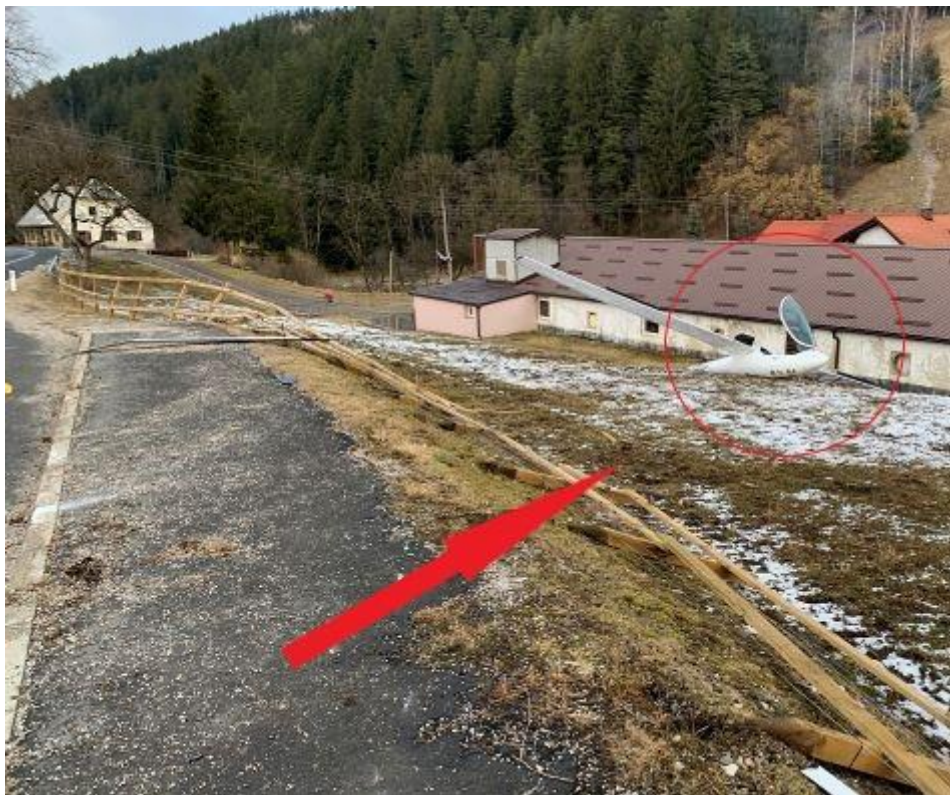
Figure 1: Landing direction and position of the aircraft at the accident site

Aircraft and equipment: The tail of the aircraft was broken off, and the fuselage and the wing were damaged.

On February 26, 2022, the pilot flew a single-seat glider equipped with an auxiliary jet engine in an aircraft sled from Moškanjci Airport with the aim of maintaining his flight qualifications in the category of flying gliders. Due to the northerly and north-easterly winds, the weather conditions in north-eastern and north-western Slovenia were favourable for sailing that day. After a few hours of sailing in the area of north-western Slovenia and the Carnic Alps in Austria and reaching an altitude of around 3,000 metres, the pilot returned to his home airport on the previously planned route. In the gliding area between Radlje ob Dravi and Ribnica na Pohorju, the pilot assessed that the altitude and weather conditions (without thermal lift or sufficient slope updraft) did not ensure a safe return to the departure airport, so he decided to gain altitude by starting the engine's JET (jet), which did not work after two starting attempts. Then, at approximately 4:15 p.m. local time (LT), the pilot decided to make an emergency landing outside the airport, which is a normal emergency procedure in the glider category. During the landing on the chosen terrain, which was icy and covered with snow, the aircraft skidded, hit the ground, and the tail structure of the aircraft broke. The aircraft skidded across the local road, knocked over a wooden fence, and stopped just short of the building (Figure 1). After landing, the pilot left the aircraft uninjured and called for help.

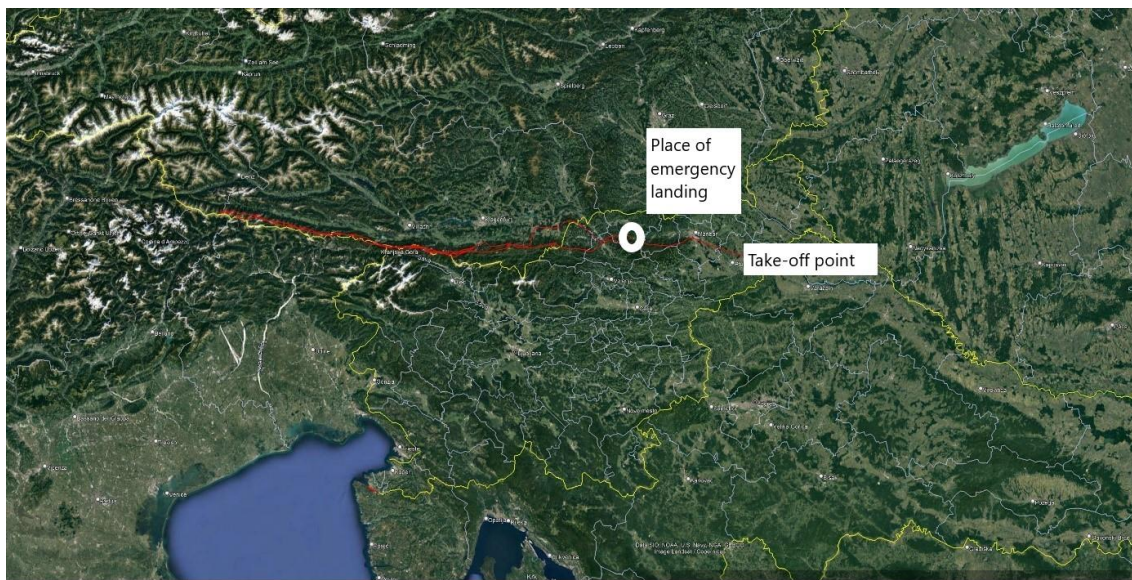
Figure 5: Display of flight route with departure from Moškanjci Airport and return journey

From the analysis of the data obtained from the recording device of the manufacturer LXnav, the trajectory of the flight after departure from Moškanjci airport to the southern crossing of Lienz in Austria and back along the border with the Republic of Austria, part of the flight east of Obertilliach and then towards Slovenj Gradec, at a linear distance of about 500 km in both directions (Figure 5).

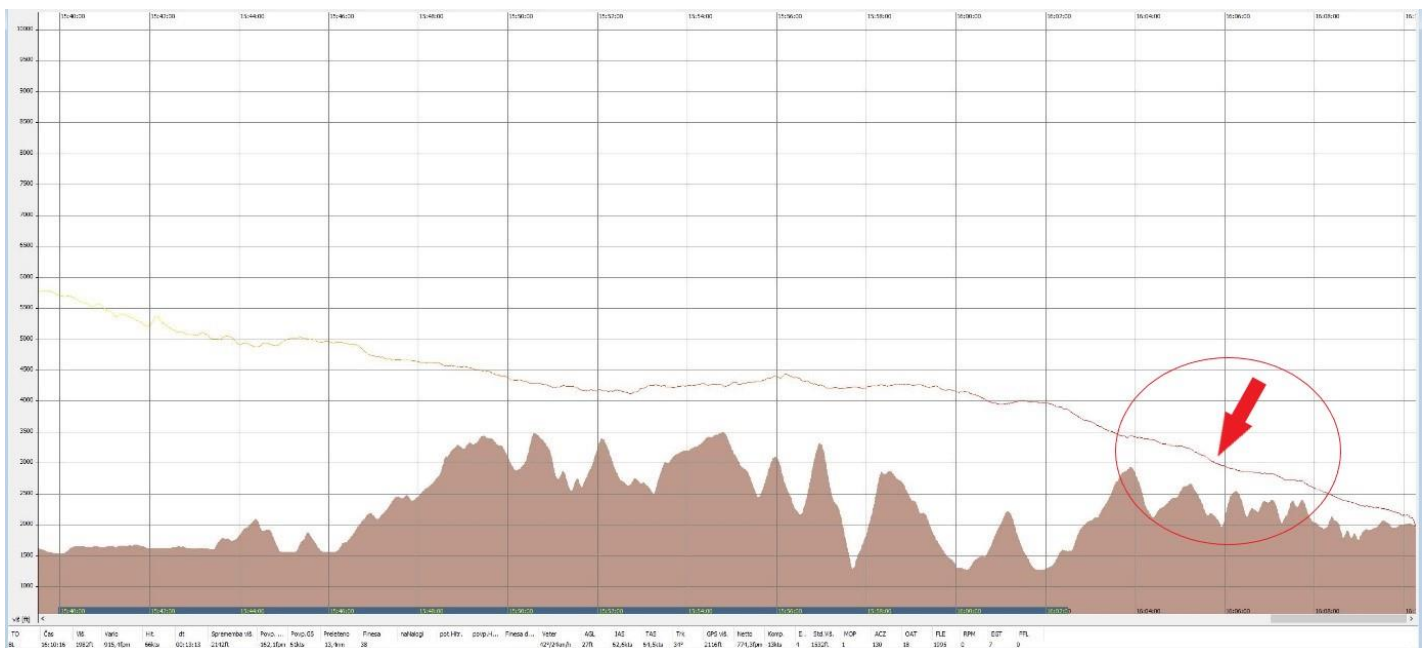
Figure 7: Display of the flight route by time and altitude, depending on the terrain configuration

The data from the LXnav recorder also shows that the aircraft continuously lost altitude from 16:02 (Figure 7) until about 16:10, when the altitude over the terrain was so low that the pilot decided to make an off-airport landing or an emergency landing after unsuccessful attempts to start the engine.

Although a jet engine has very little additional drag when retracted, the pilot must ensure sufficient altitude to land on suitable terrain before attempting to start the engine in flight.
