# FINAL REPORT

ON THE INVESTIGATION OF THE AIRCRAFT

UL motor aircraft TL Ultralight STREAM,

reg. mark OK-XUA 62,

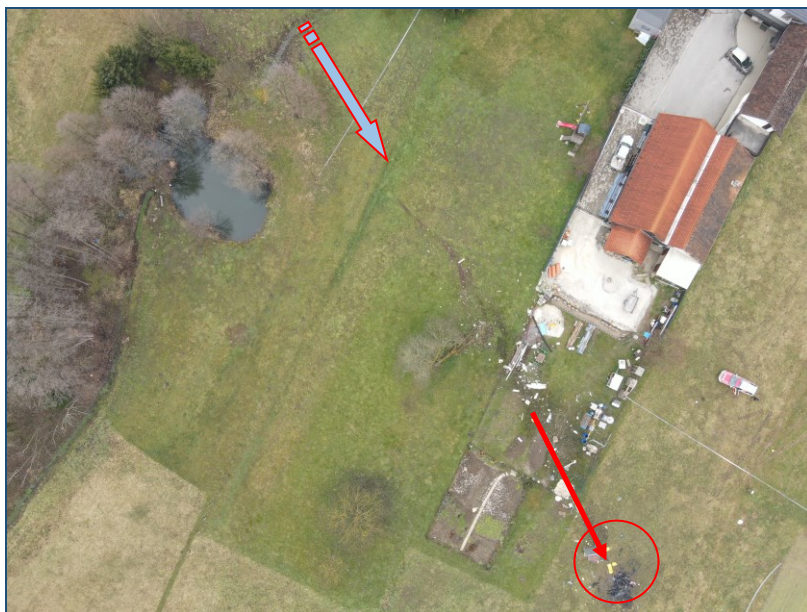
On the day of the accident, at 16:11 local time, the pilot took off from the Prečna - LJNM airport and arrived in the area of Šentjernej in a scheduled flight. Upon arriving above his hometown, he began performing manoeuvres with sharp turns at a height that was mostly below 300 m above the terrain. He made sharp turns in a very narrow radius between 150 and 700 m. The pilot flew the plane in concentrated circles in a densely populated part of the city by flying over groups of houses north of the settlement of Mihovica and infrastructure facilities and residential houses in the immediate vicinity of the Šentjernej racecourse. At approximately 16:50 local time, the pilot was making a left turn from a heading of approximately 080° west to a heading of 270° when he abruptly reversed course to a sharp right bank of over 60°, losing altitude during the turn. The pilot then slowly reduced the pitch of the aircraft to ground level when the aircraft, in a slight right bank of approximately 10°, collided with the grassy terrain of the yard in the immediate vicinity of residential houses in the village of Dobravica in the municipality of Šentjernej. The aircraft caught fire when it hit the ground violently. The pilot lost his life when he hit the terrain.

**Figure 1: The scene of the accident - the direction of the flight and the place where the plane crashed**

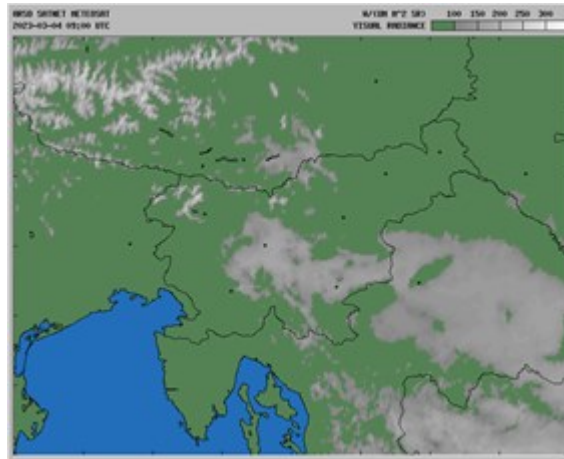
Figure 2: Satellite image of cloud cover at 10:00

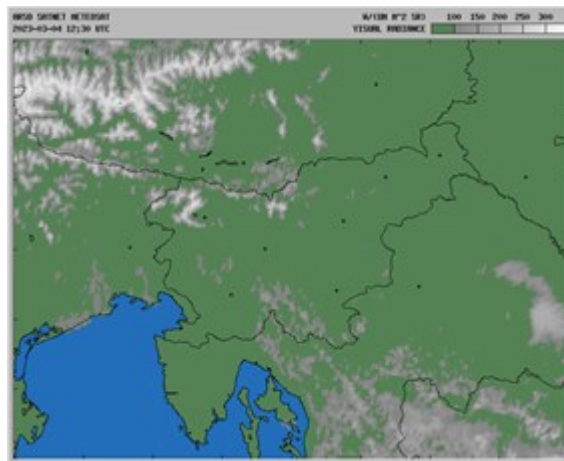
Figure 3: Satellite image of cloud cover at 13:30

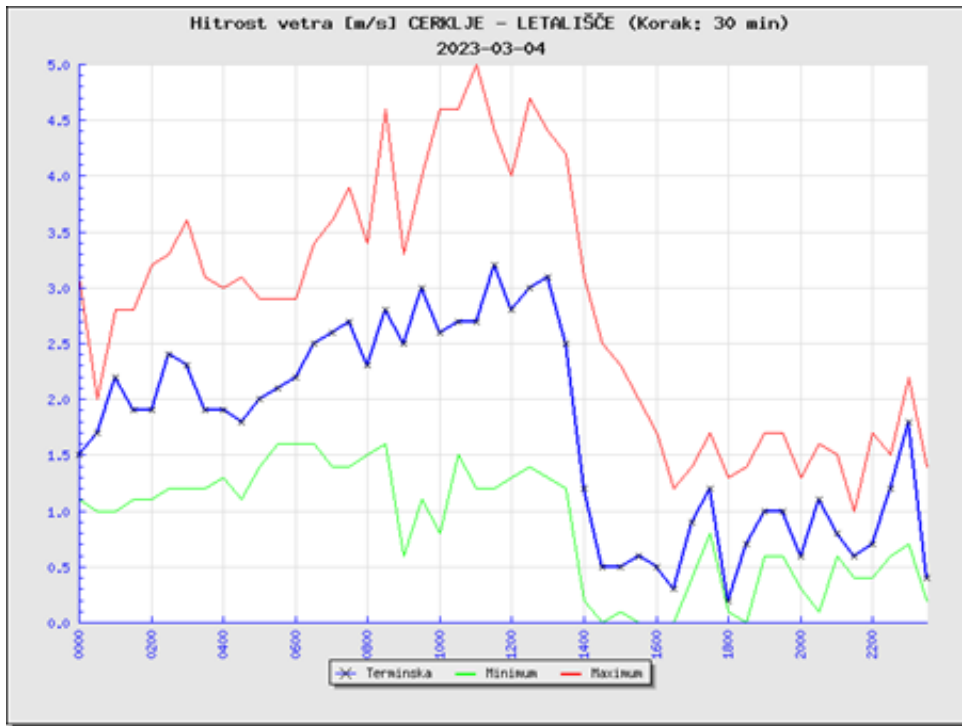
The weather was clear. Visibility was above 30 km. During the day, a westerly wind blew in southeastern Slovenia with a speed of around 6 knots and gusts of up to 9 knots, but the wind stopped at 4 pm, and at 4:50 pm, it blew with a speed of up to 2 knots and gusts of up to 3 knots. The temperature at 16:50 was 10 °C and the relative humidity was 45%. No warning for dangerous meteorological phenomena was issued for the area of southeastern Slovenia. The forecast clearly predicted mostly clear weather without dangerous meteorological phenomena.

Figure 4: Wind speed at Cerklje ob Krki Airport

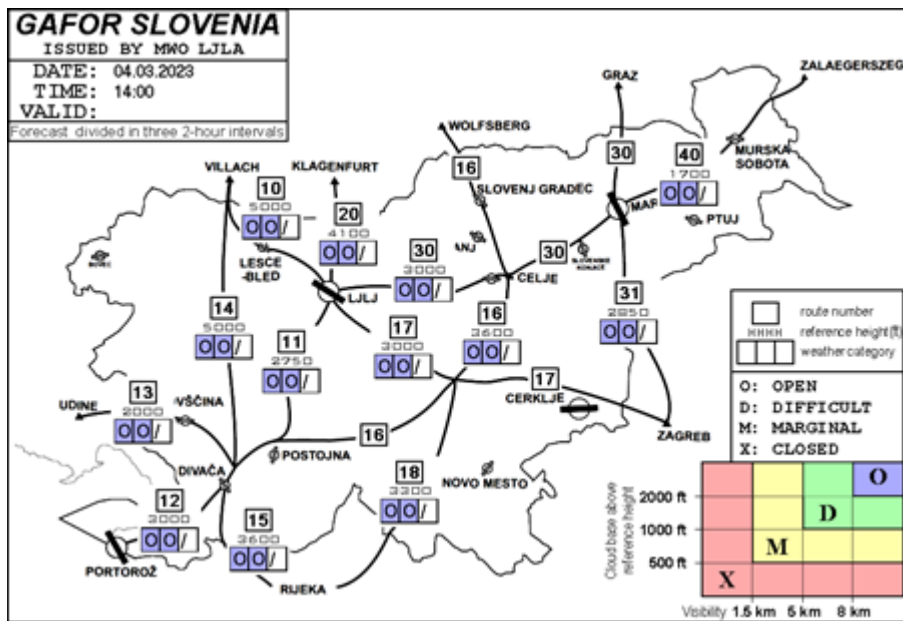
Figure 5: GAFOR forecast

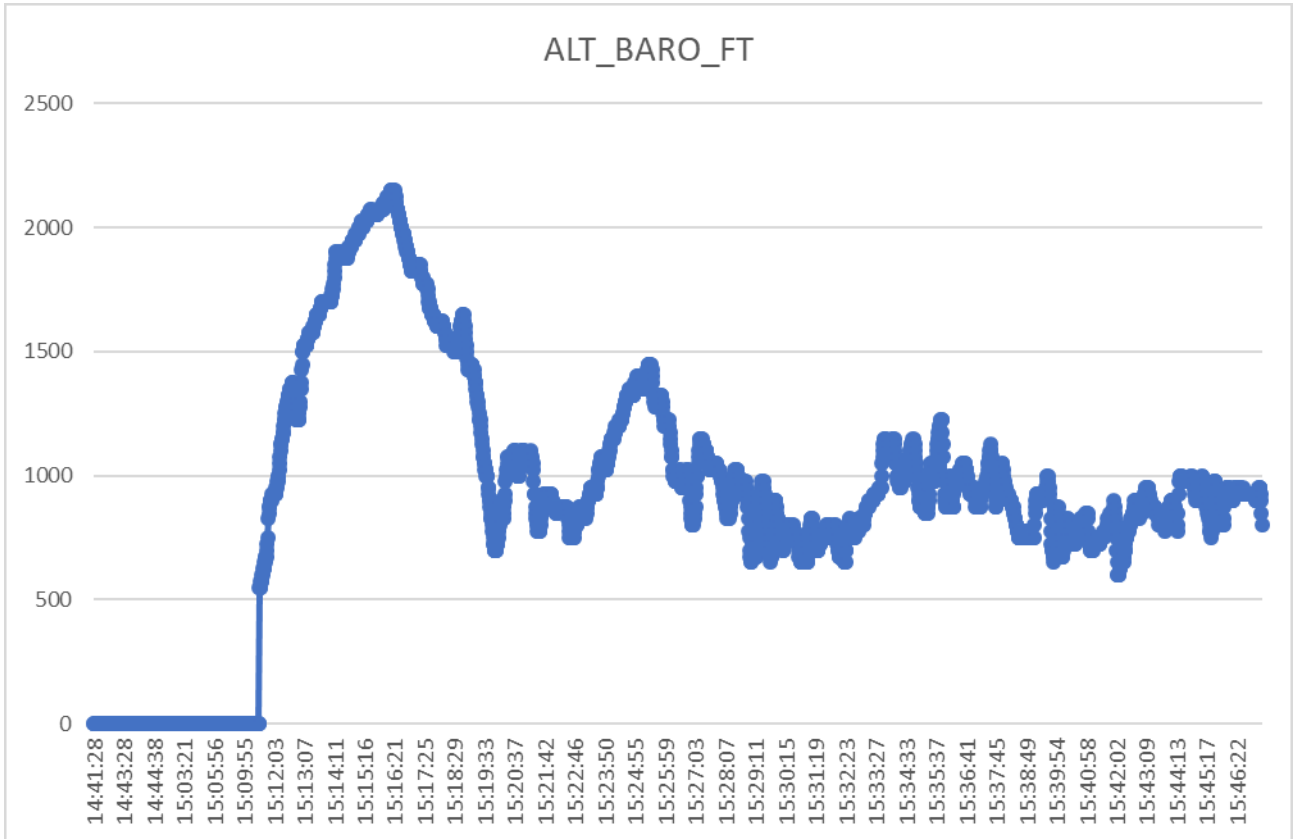
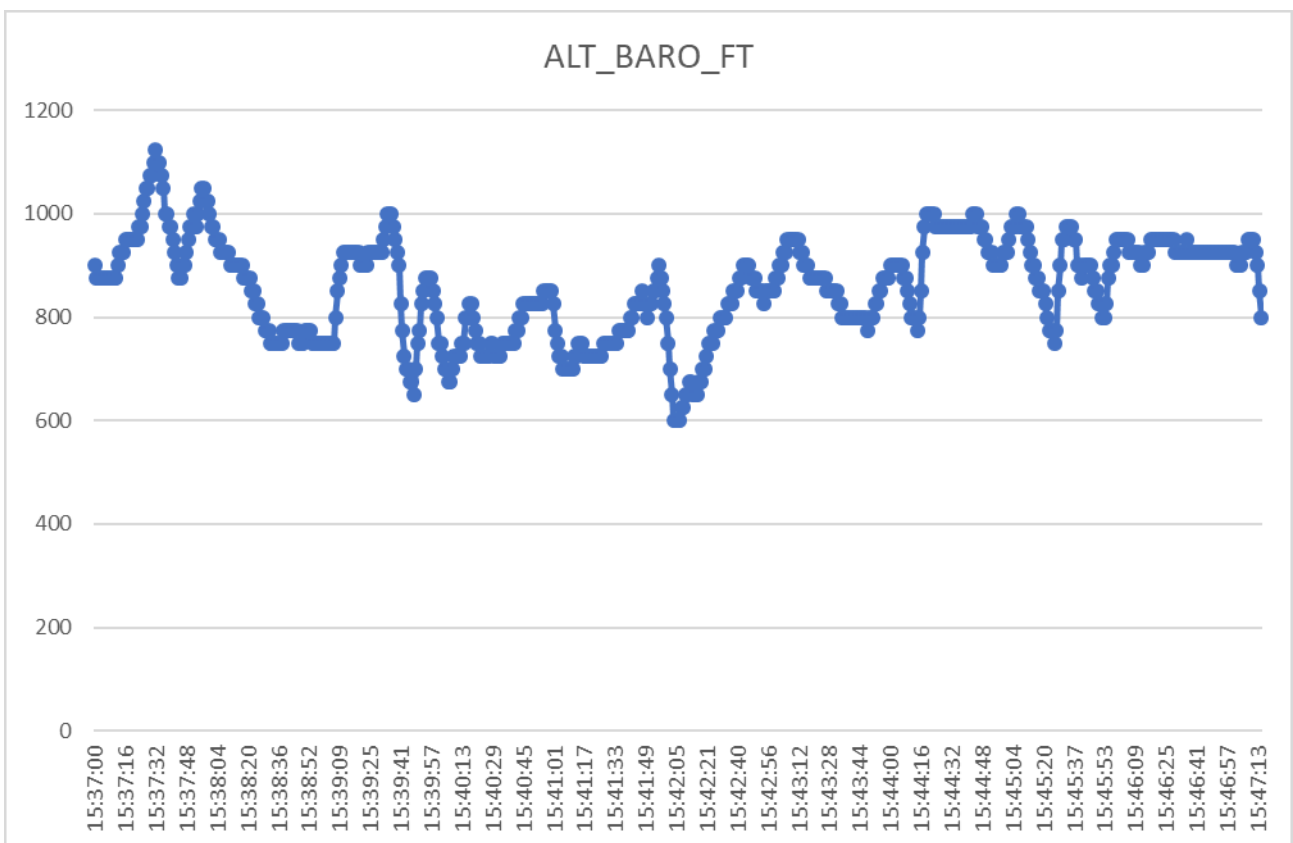
## 6.1 Altitude

After analysing the ATC radar images, a height calculation (true altitude) was made at the lower point of the manoeuvre before the crash. The calculation is made taking into account the fact that the air pressure at the time of the event was 1015 hPa. From this, it follows that the height of the flight in the manoeuvre before the crash was 810 ft, or 246 m (according to QNH). During the calculation, there was no significant difference between the detected and the corrected value (the correction takes into account the difference between pressure and air temperature at the time of the accident, which was close to the standard ISA model). Deviations due to the tolerance of the radar response system are negligible in this case. The ground speed of the aircraft during the manoeuvre was approximately 110 kn (200 km/h). If we take into account the altitude of the terrain at the place of the event, which is about 190 m, it follows that the height of the flight before the introduction into the right turn was just under 60 m (according to QFE). At the time of the incident, the pilot was flying significantly below the minimum permitted flight height, which according to aviation regulations is 300 m above the terrain.

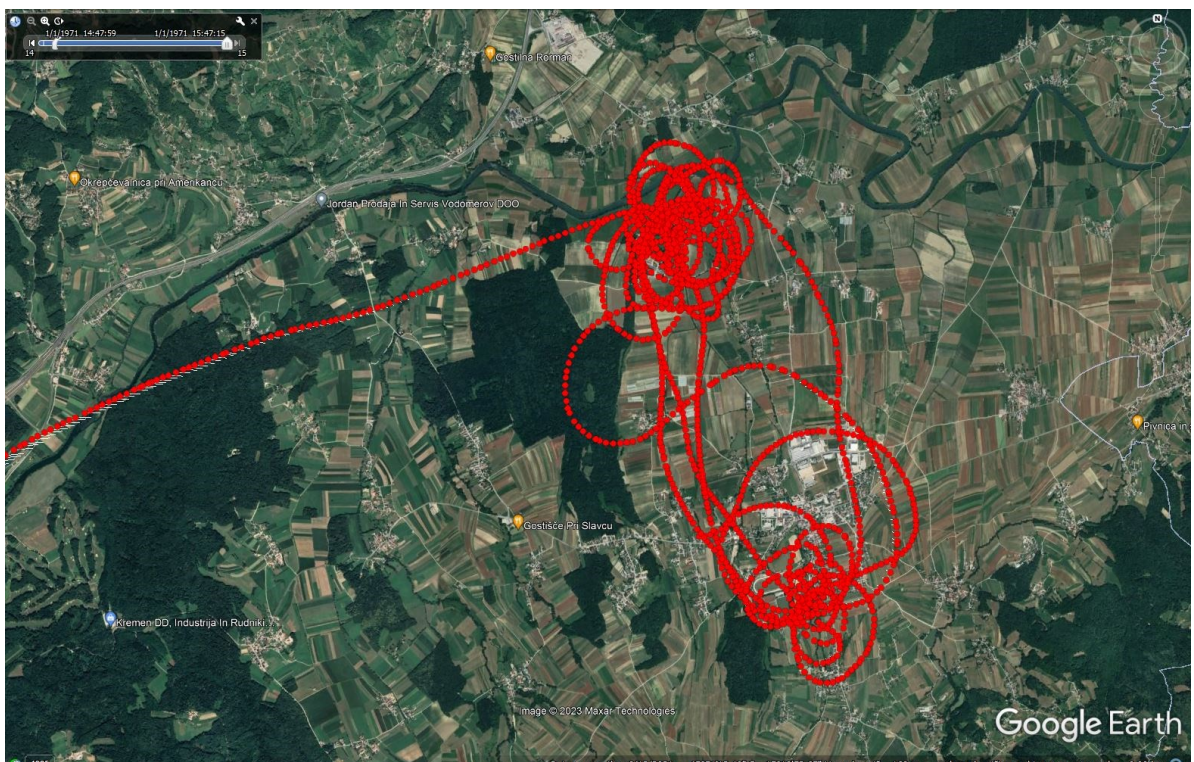
### 6.4 Flying in the area of Šentjernej

When performing the manoeuvre, the pilot, from the left turn, which he performed at a height of approximately 60 m above the terrain, introduced the aircraft into a right turn. When changing pitch from left to right, a sharp turn obscured the visual contact with the terrain he had on the left wing side. It did not provide sufficient G loading in the manoeuvre to maintain such a critical flight altitude. Continuing the manoeuvre, the pilot reduced pitch while losing altitude so that the first collision of the aircraft with the terrain was with the top of the right wing and the lower part of the fuselage. In the crash line, the aircraft impacted the terrain with a descent angle of about 3° and a right bank of up to 10°.
