# FINAL REPORT

## ON THE INVESTIGATION OF A SERIOUS INCIDENT

Involving aircraft Cessna U206F,  
registration S5-DOT,  
at Šentvid pri Stični Airfield,  
on 11 May 2024

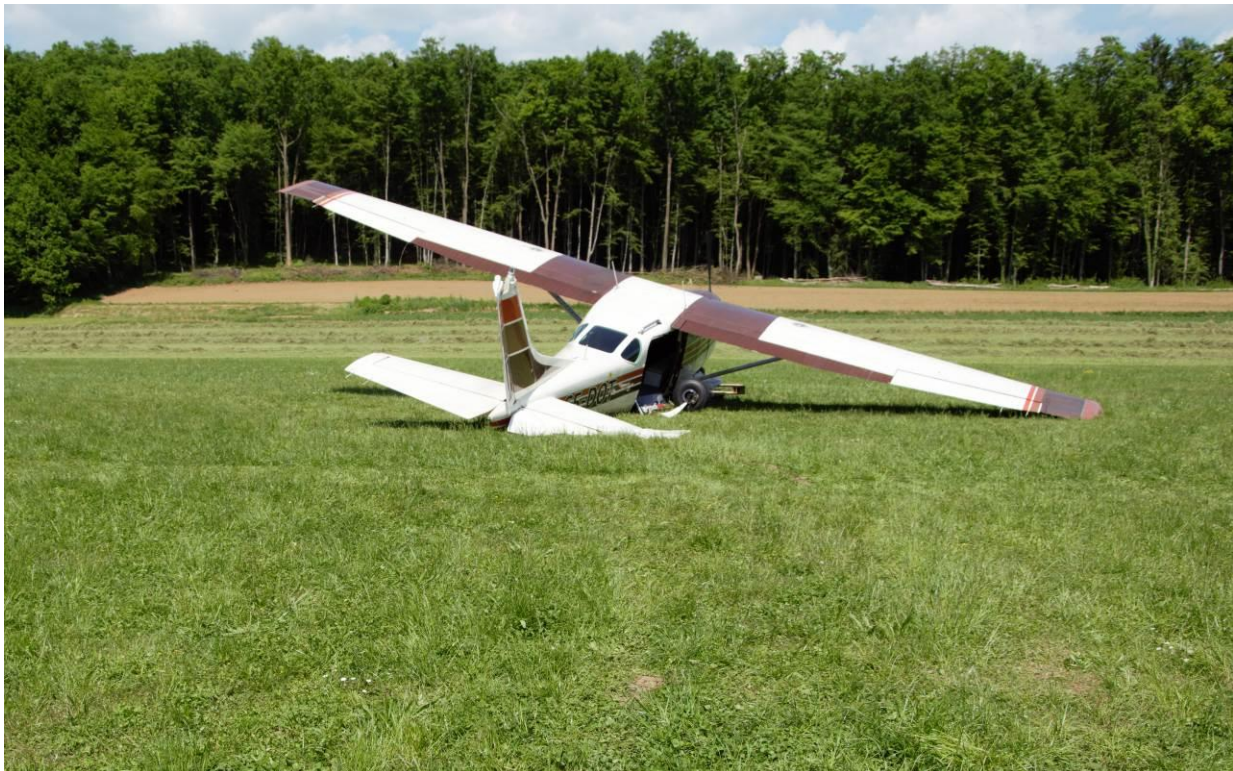
**Figure 1: Aircraft position following the failure of the right main gear spring leg**

While taxiing on the grass surface, the right main landing gear spring strut (hereinafter referred to as the "spring leg") suddenly failed. As a result, the aircraft tilted to the right and the edge of the right wing scraped along the grass surface. Simultaneously, the aircraft tilted backward onto the tail, leading to deformation of the right horizontal stabilizer.

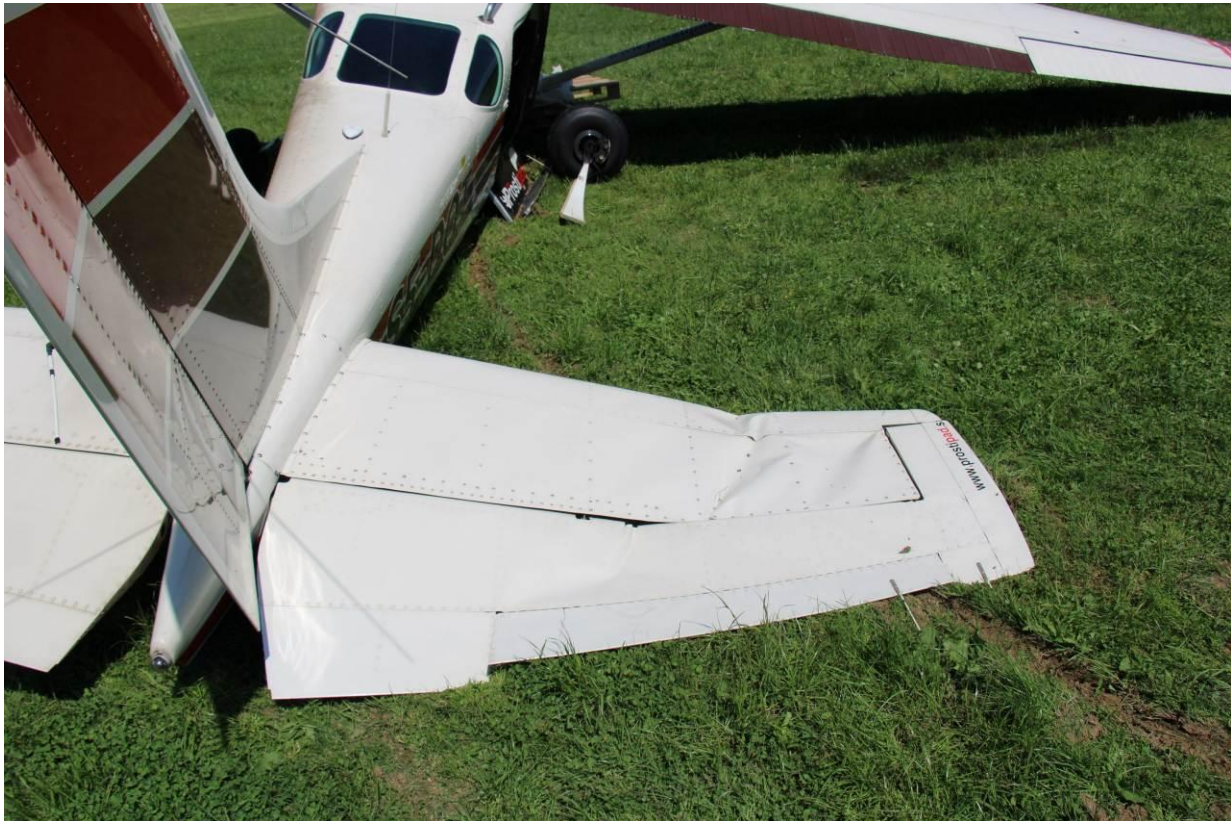
**Figure 2: Aircraft damage**

The aircraft sustained a fracture of the right spring leg, and damage to the lower fuselage, the right wing, and the right horizontal stabilizer.

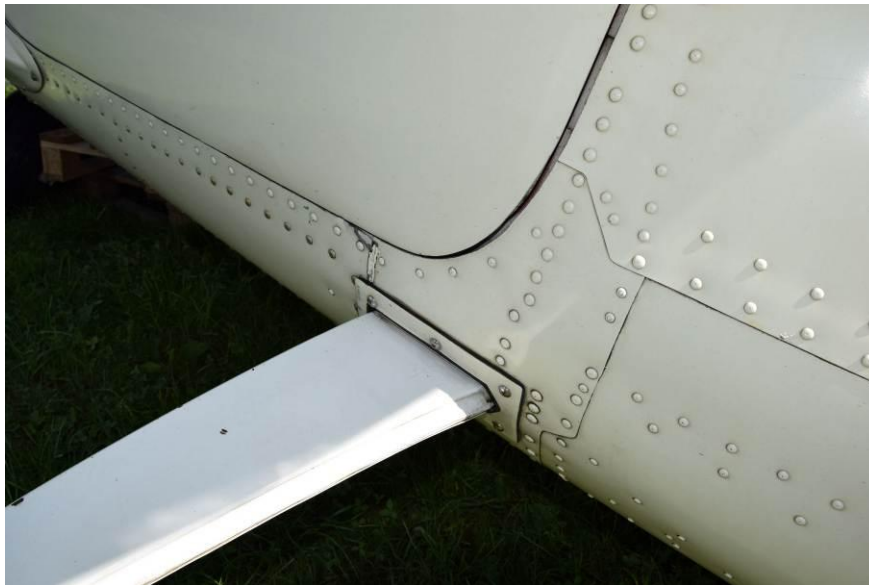
**Figure 6: Spring leg entry point into the fuselage**

The failure occurred at the point where the spring leg enters the fuselage opening (Figure 6). After the failure, part of the leg remained inside the fuselage (Figure 7), while the section connected to the wheel was found lying on the grass (Figure 8).

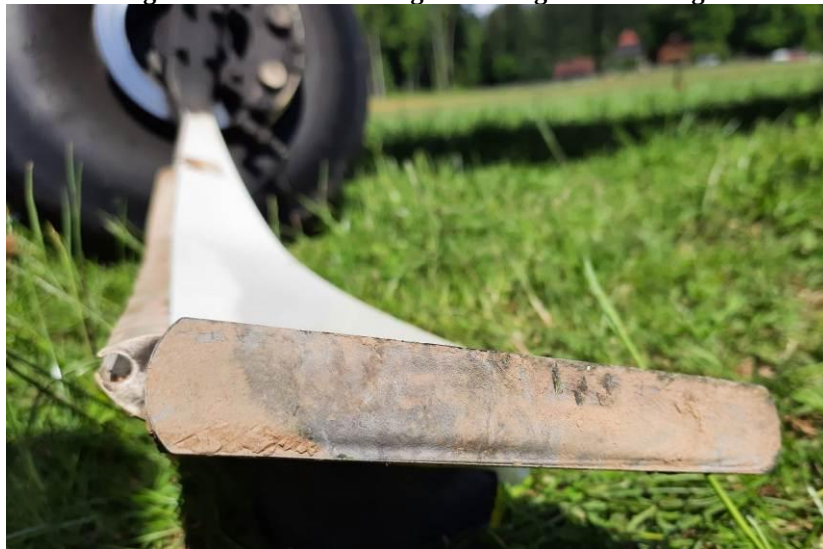
**Figure 8: Detached spring leg section found on the grass**

The final fracture occurred suddenly (brittle failure), with fracture paths clearly indicated in Figure 8.

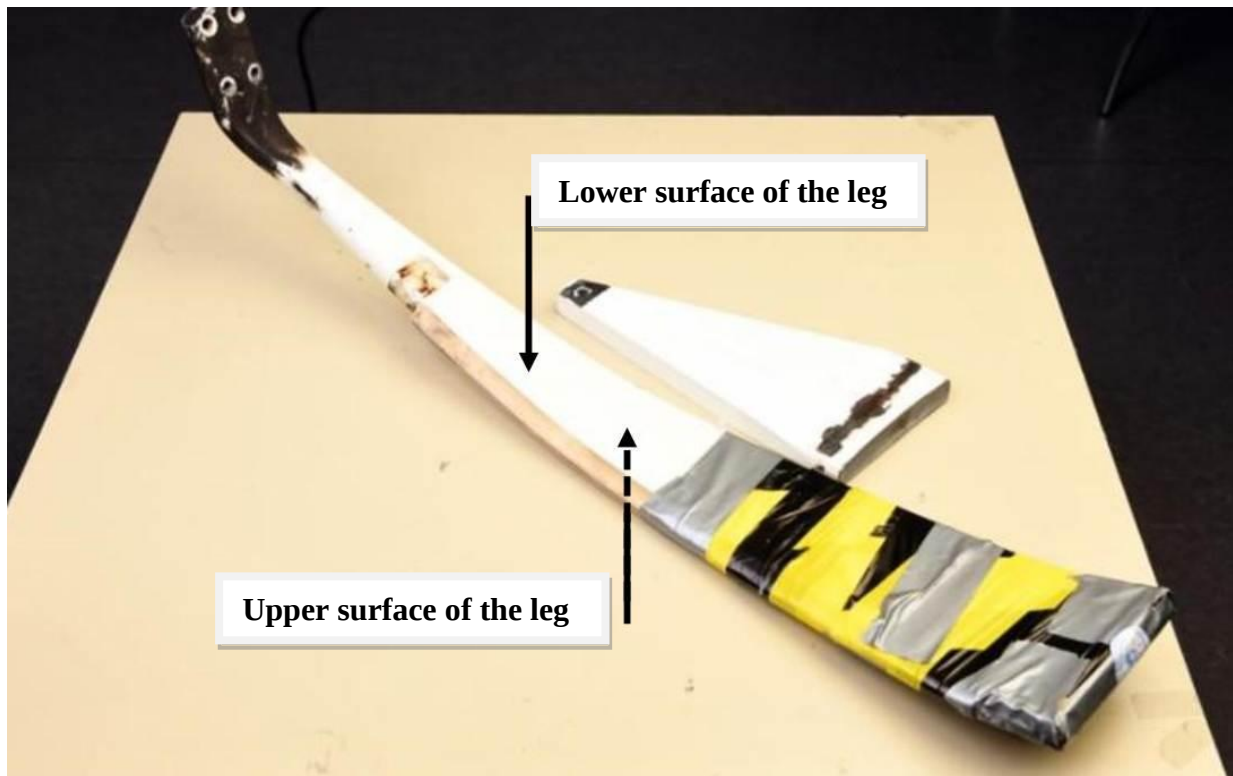
Figure 9: Spring leg prior to examination at ZAG

The fracture originated on the underside of the spring leg at position 3 (channel), shown in the left sketch in Figure 9. This area is subject to tensile loading during taxiing, take-off, and landing. The crack was fatigue-induced, with the origin being a corrosion pit approximately 0.3 mm deep and 2 mm long. The fatigue crack propagated to a depth of 2.5 mm and a length of 5 mm, with visible fatigue striations ("beach marks").

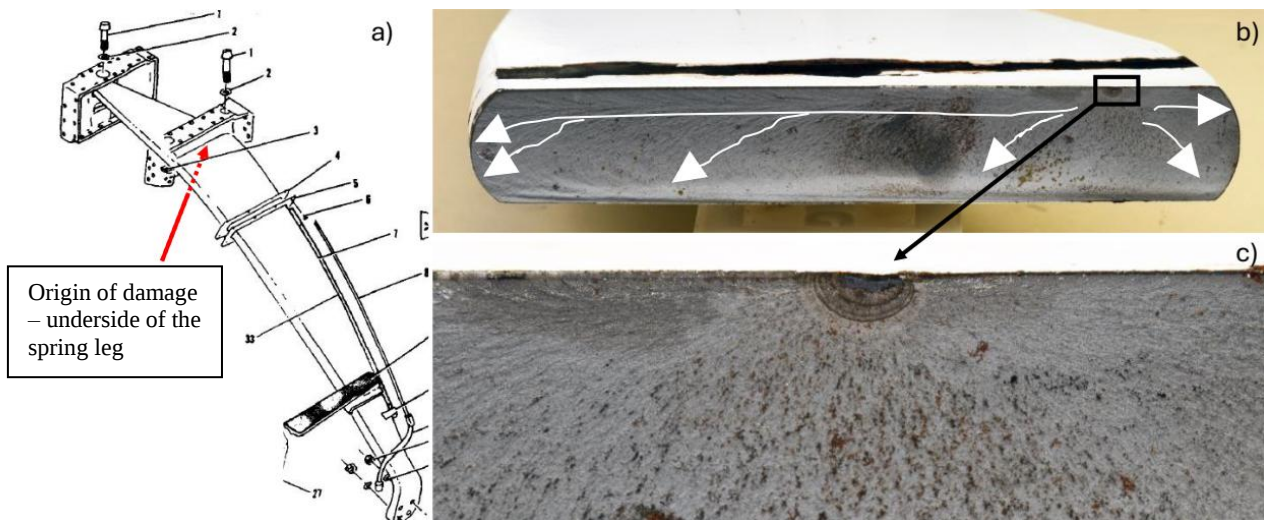
The origin of the crack was located on the underside of the spring leg, as shown in Figure 11b (adapted from *Cessna SERVICE MANUAL 1969 thru 1976, MODEL 206 T206 SERIES, Section 5 – Landing Gear and Brakes*). The fracture surface was visually examined to determine the precise initiation point of the crack. The crack began at the location marked with a black rectangle in Figure 10b, and propagated in the directions indicated by the white arrows on the same figure. The origin was a corrosion pit on the lower surface of the spring leg, with

characteristic beach marks ("concentric arcs") visible in the magnified detail in Figure 10c. The size of the initiation area was approximately 5 mm in diameter.

**Figure 10: Crack origin on the underside of the spring leg (a), initiation near surface damage caused by contact with a channel (b), and magnified view of crack initiation zone (c)**

In the examined spring leg, the pit at the crack origin was approximately 0.3 mm deep, far exceeding the protective shot peened depth, thus critically compromising the component's integrity.

Sudden failure (fracture) of the right spring landing gear leg due to fatigue originating from a pre-existing corrosion pit.

- **Immediately perform a visual inspection of the landing gear to detect signs of corrosion, cracking, or other defects.**
- **Repeat such inspections every 50 flight hours or during every scheduled aircraft inspection.**
- **If corrosion is detected, determine the extent of the damage and replace all corroded, cracked, or otherwise compromised spring leg components that exceed the manufacturer's specified limits.**
- **For aircraft where damage remains within acceptable manufacturer limits, operators should apply all prescribed preventive measures for corrosion protection of the landing gear.**

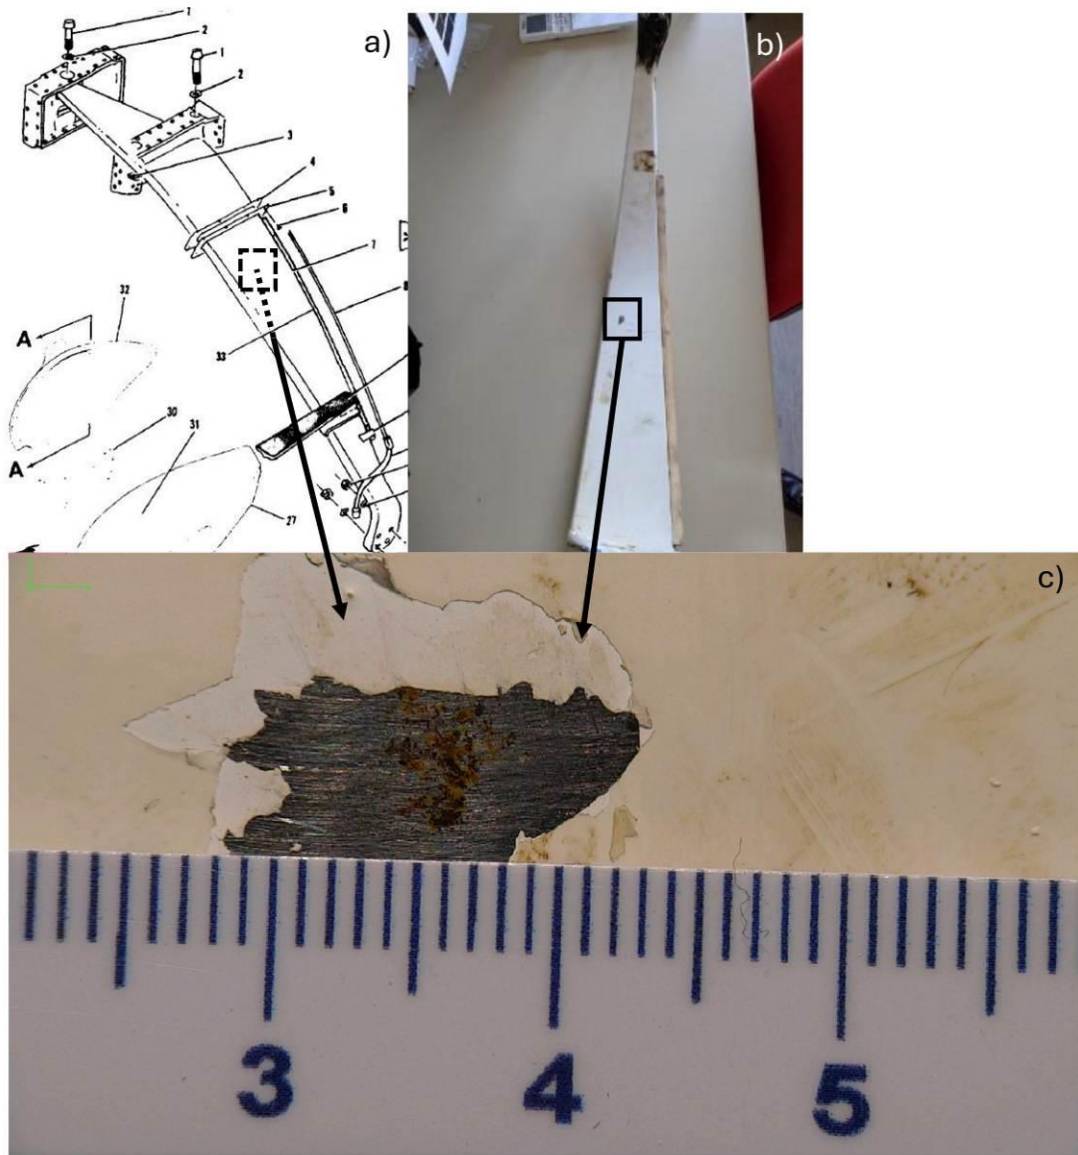
The spring leg's external surfaces were protected with a white anticorrosive coating. In some areas, the coating was missing or flaking, likely due to mechanical abrasion from contact with other elements. Poor adhesion was observed in some areas. After removing the poorly adhered coating, surface corrosion was found underneath (Figure 11). The steel had been ground manually in these areas—grinding marks were visible.

**Figure 11: Corroded surface beneath poorly adhered coating on the underside of the spring leg (a and b – coating damage location, c – corrosion detail)**

The surface coating consists of four layers with a total thickness of approximately 90 micrometers. The coating was machine-applied. Areas with delaminated coating were identified, mainly due to mechanical abrasion and corrosion.
