FINAL REPORT

ON THE INVESTIGATION OF THE AIRCRAFT

Cessna 172,

reg. mark S5-DLM,

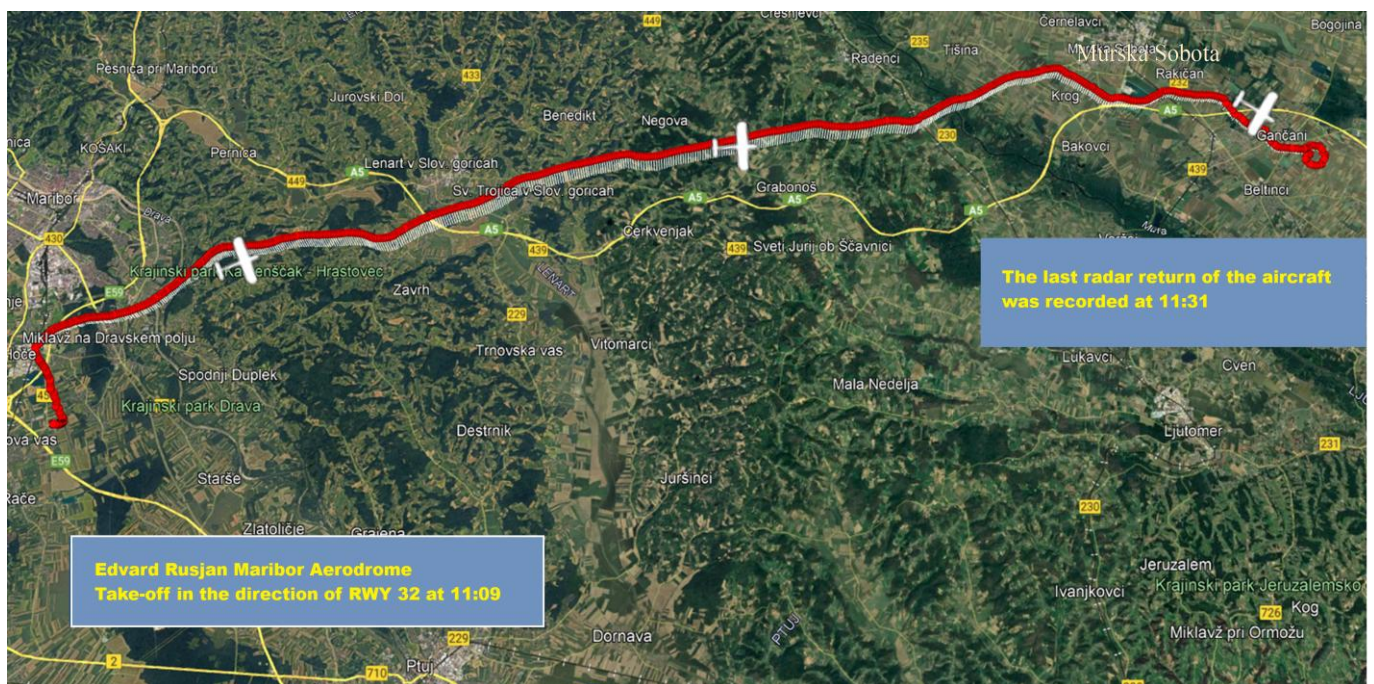
During the continuation of the flight, the aircraft continuously decreased its altitude, such that between the settlements of Gančani and Lipovci it was flying straight and level at an altitude of 1,400 feet (426 m) QNH (the terrain elevation in this area is 560 feet or 170 m). After passing the settlement of Gančani, the pilot initiated a right turn. During the right turn manoeuvre, the aircraft continued to descend and impacted terrain approximately 950 m southeast of the settlement of Gančani. Upon impact with the terrain, all three occupants of the aircraft lost their lives.

Figure 1: Radar recording of the entire flight trajectory

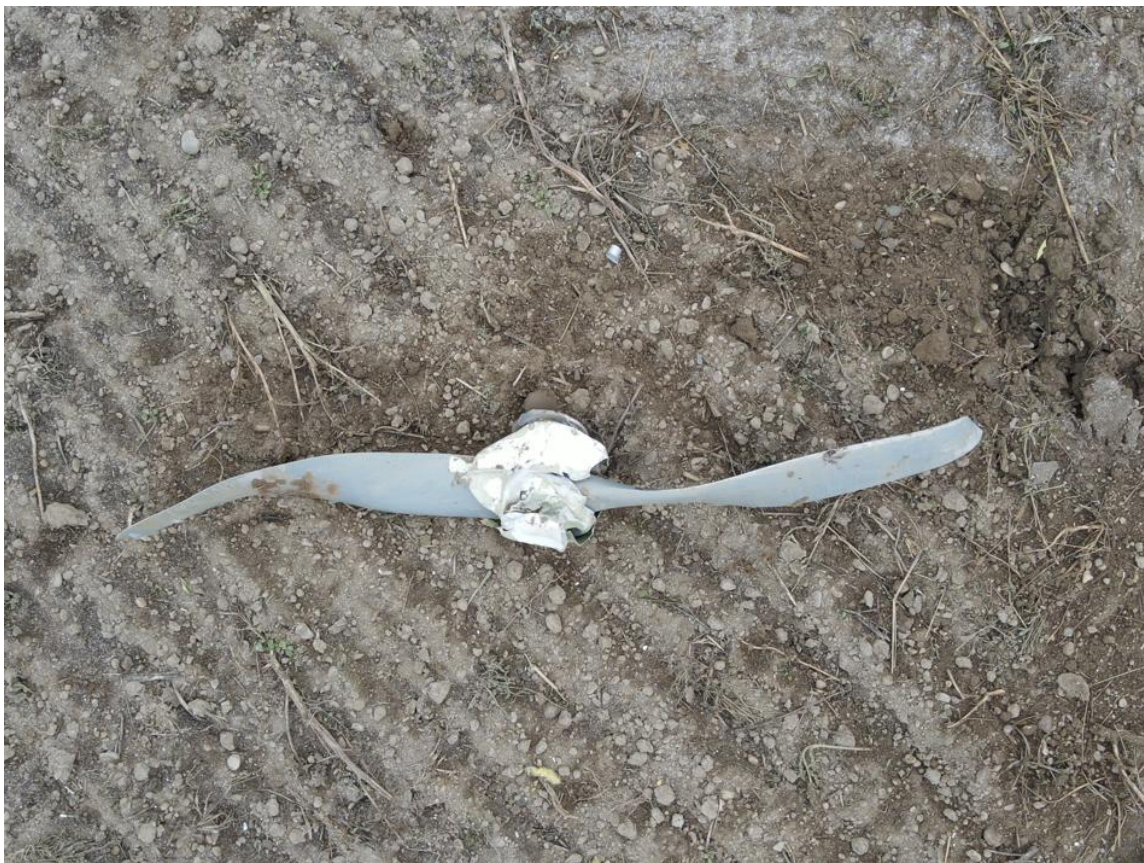
Upon impact with the terrain, a small crater approximately 30 cm deep and about 70 cm long was formed along the crash path. Aircraft wreckage was distributed over a distance of approximately 90 m from the initial point of impact. Both wings separated from the fuselage upon impact. The propeller blades were surface-damaged and bent (see figure below).

Figure 2: Fractured propeller blades at the accident site

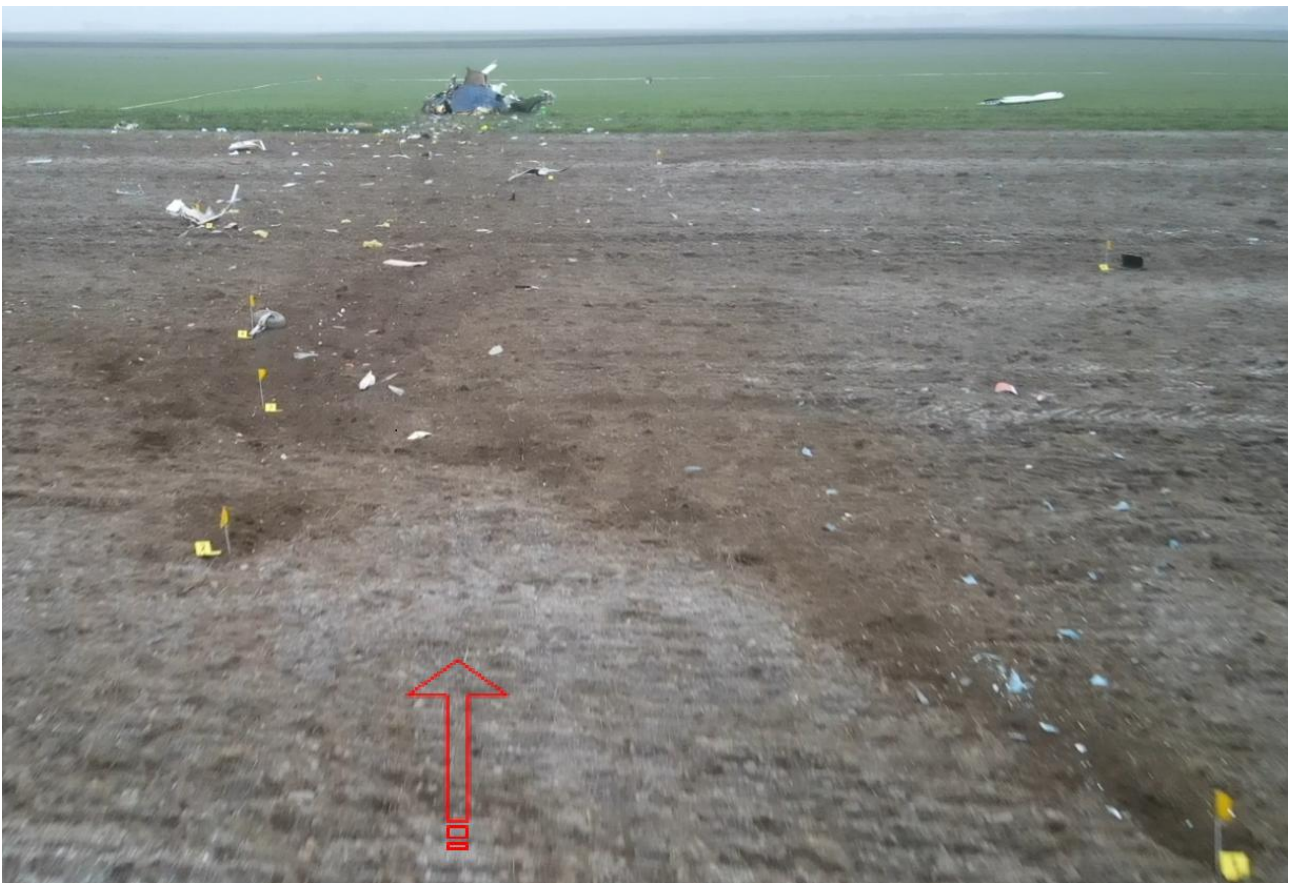
The engine separated from its mounts upon impact and came to rest along the crash path near the tail section. The aircraft cabin structure was completely destroyed and unrecognisable along the crash path. The lower part of the cabin, together with the rear seats, remained beneath the fuselage, which was inverted. The remaining part of the fuselage was inverted and resting on the vertical stabiliser.

Along the crash path, parts of the landing gear, wings, cabin and equipment were found. Within the wreckage area, the ELT device was located; it did not activate.

Figure 3: Aircraft wreckage along the crash path

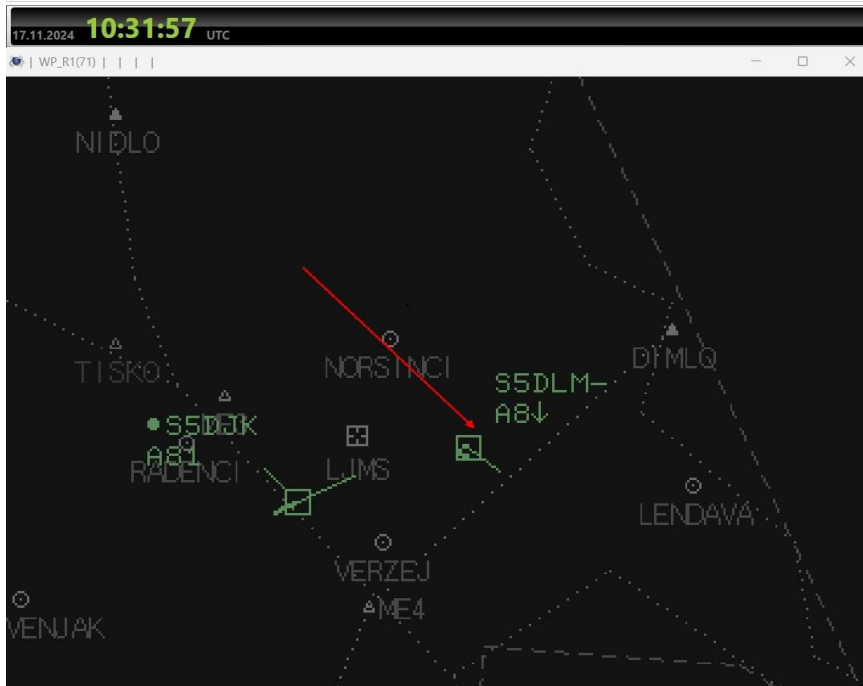
Figure 10: Last radar return of S5-DLM prior to impact with terrain at 10:31 UTC

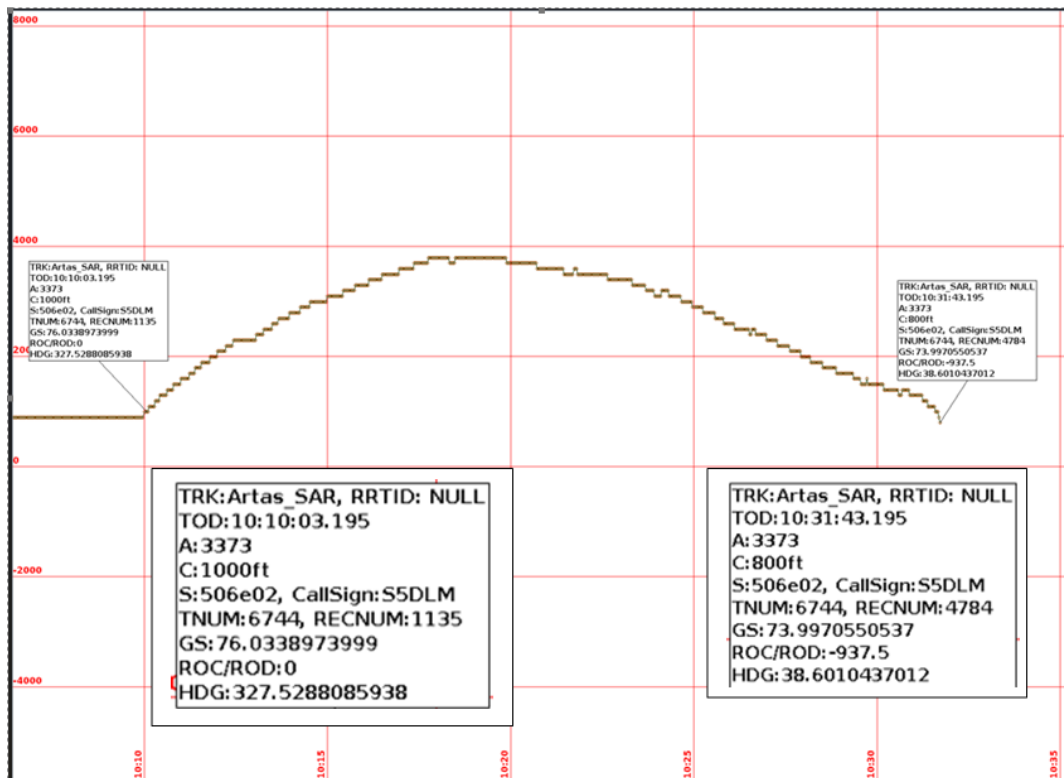
Figure 11: Profile of altitude changes of S5-DLM from take-off to the time of the accident

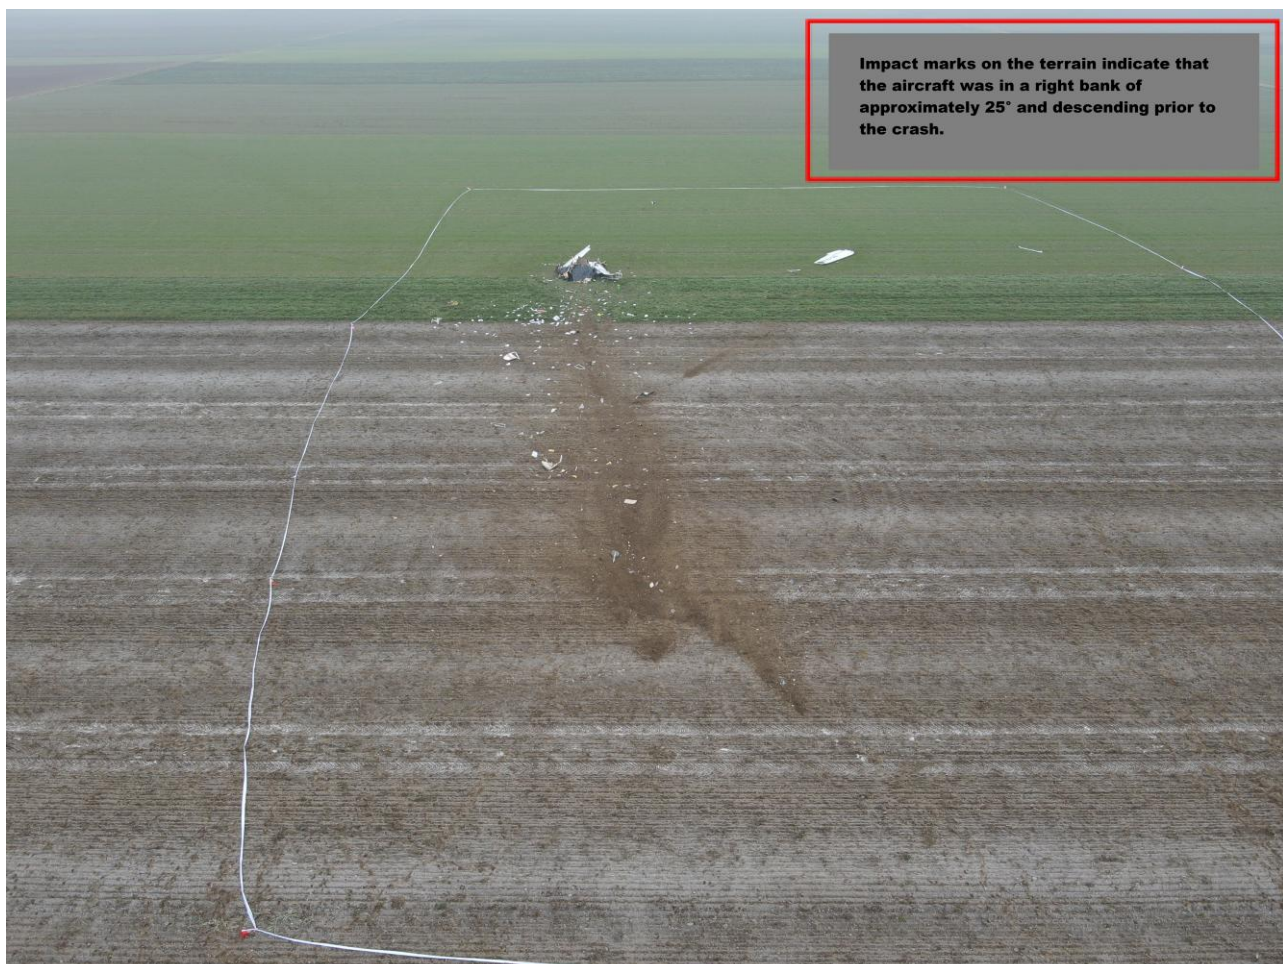
At the time of the site inspection, fog was present, visibility was reduced, humidity was 100%, and the air temperature was 2 °C. The aircraft wreckage was concentrated along the crash path over a length of approximately 90 m from the initial ground impact and a width of approximately 20 m. There was no post-impact fire.

Figure 12: Accident site of S5-DLM (photo: Police Directorate Murska Sobota)

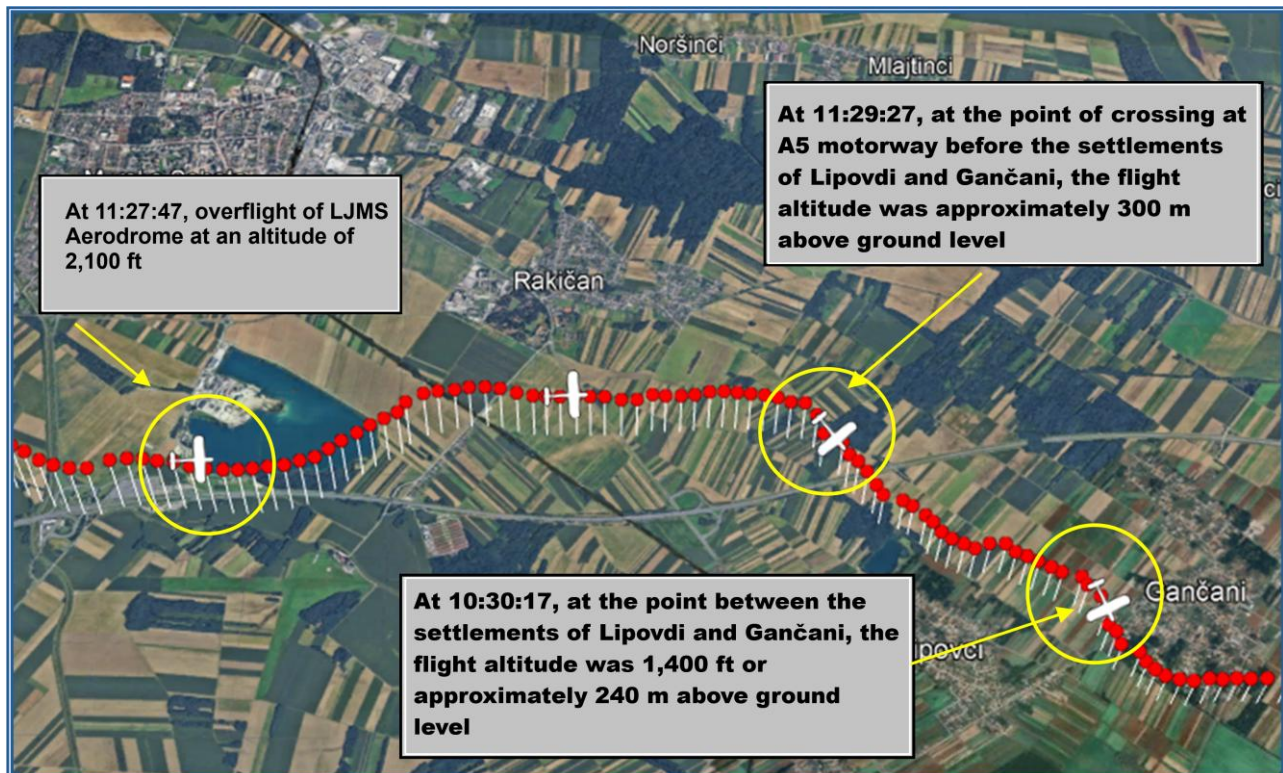
The aircraft then continued to descend steadily, and at 11:29:29, at the point of crossing the A5 motorway between the towns of Rakičan and Lipovci, it was flying in level flight at an altitude of 1,600 ft. Taking into account the terrain elevation of 550 ft, the flight at that location was conducted at approximately 300 m above ground level.

Figure 13: Altitude profile along the route prior to the accident

During the descent, at 11:30:17 the aircraft overflew the western part of the settlement of Gančani in a south-easterly direction of approximately 120°, and then continued for a few seconds in level flight on a heading of 090°, as shown in Figure 13.

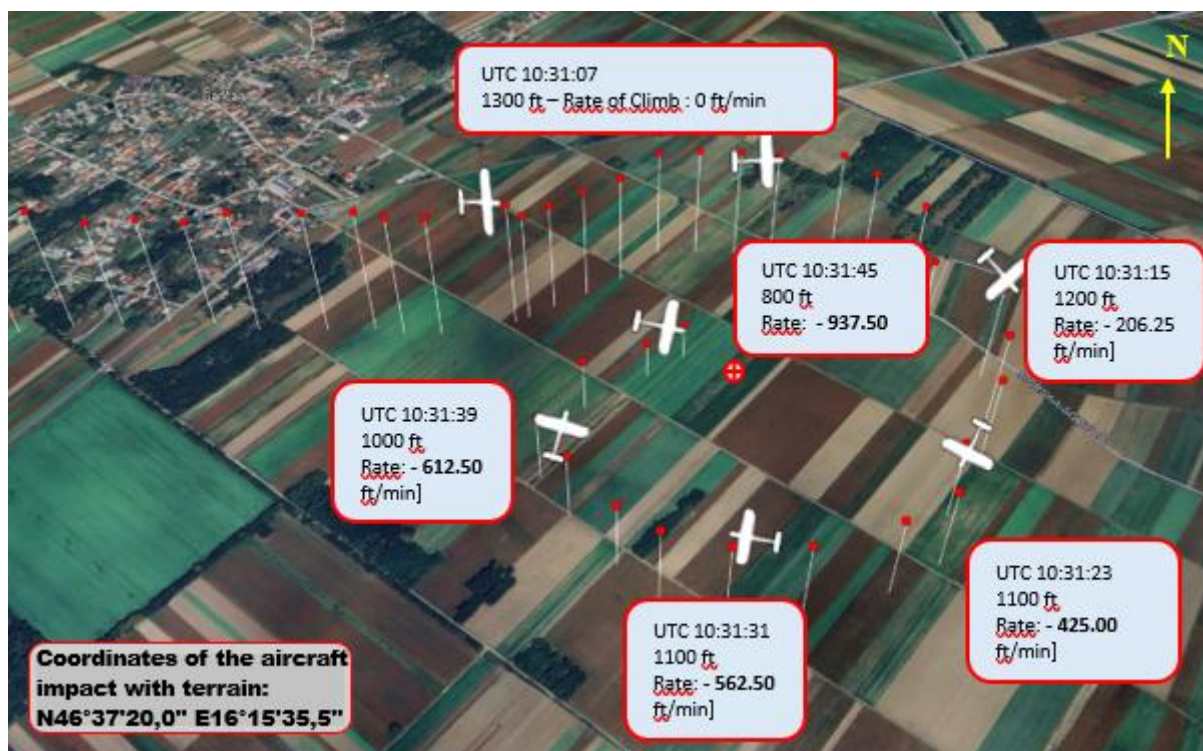
Figure 14: Flight data during the right turn manoeuvre prior to impact with terrain

From the altitude data during the execution of the right turn manoeuvre, it is evident that the rate of descent increased, such that during the 180° turn the aircraft lost approximately 100 m of altitude in 22 seconds.
