### NOTICE OF COMPLETION OF INVESTIGATION

**The accident of the WT9 DYNAMIC ultralight motor aircraft, reg. S5-PGP, April 26, 2024, LJSG (Hard landing)**

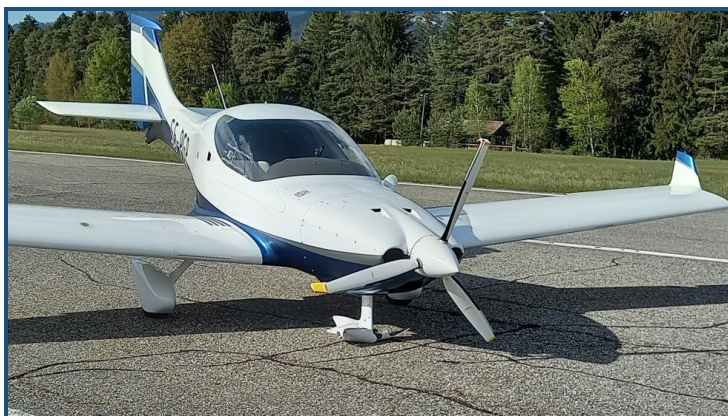
After entering the left school circle for runway 14, the flight proceeded according to the established procedure for landing and without special features. In the final phase of the landing, according to the pilot's testimony, "a sudden gust of wind pushed the plane down" so that when the landing gear collided with the RWY, the plane bounced several times." There was a break in the structure of the nose leg, and, as a result, the propeller collided with the asphalt RWY.

The event is categorized as a "hard landing," which occurred as a result of the non-stabilized arrival and late handling of the aircraft in the final phase of landing.

The aircraft device, which stores data on flight elements, underwent an inspection and analysis of the flight trajectory. The analysis reveals that during the final phase of the landing, the aircraft exceeded the manufacturer's limit for touching down with RWY, expressed as descent speed or as a "G" load value.

*S5-PGP after stooping at the accident site at LJSJ airport*
