AIR, MARINE AND RAILWAY ACCIDENT AND INCIDENT INVESTIGATION UNIT

**NOTICE OF COMPLETION OF INVESTIGATION**  
**Accident involving Diamond DA42 Twin Star, Reg. OE-FPV, 30 May 2025, Lesce**  
**Airport - LJBL**

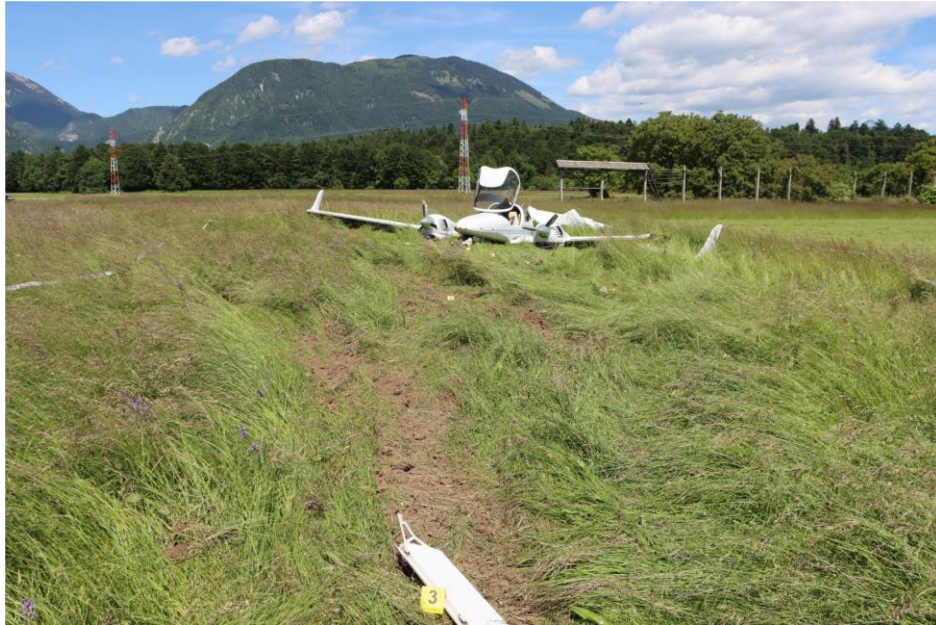
At approximately 30 metres above ground level, the airspeed still did not increase. Subsequently, despite both engines operating at full power, the aircraft began to lose altitude. The pilot manoeuvred the aircraft away from infrastructure and residential buildings and selected a field for an emergency landing. The aircraft landed on grass approximately 600 metres from the threshold of runway 32. During the off-airfield landing, the aircraft sustained substantial structural damage to the landing gear, lower fuselage, and wings. Upon impact of the left wing with the ground surface, the aircraft rotated approximately 180° relative to the landing direction. The fuselage fractured structurally in the tail section, separating it from the main fuselage. The tailplane and both stabilisers sustained major

structural damage and deformation. At the accident site, more than half of the blades on both propellers were missing.

Figure 1: OE-FPV at the accident site, aligned with the landing direction

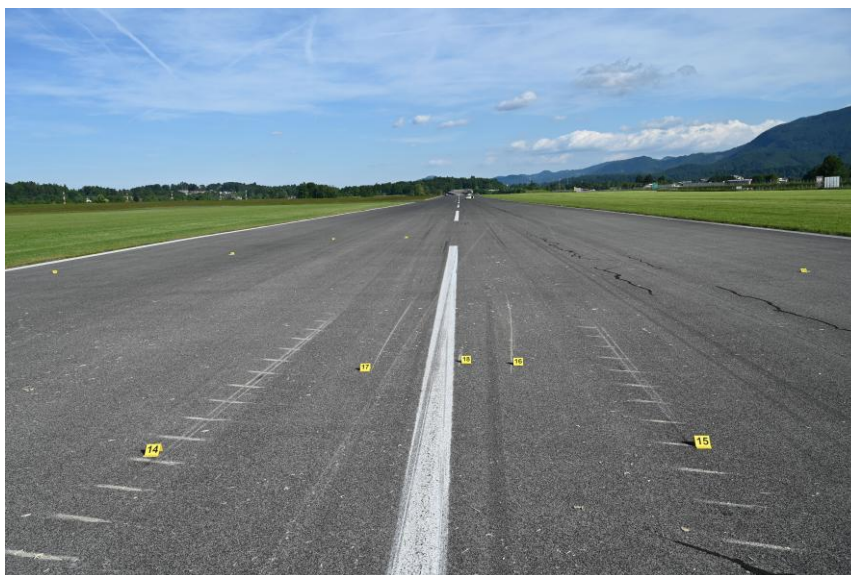
A survey of the runway was conducted, where traces of impact from both propellers striking the asphalt surface of the runway were documented (Figure 3).

Figure 3: OE-FPV - propeller strike marks on the runway during the take-off phase

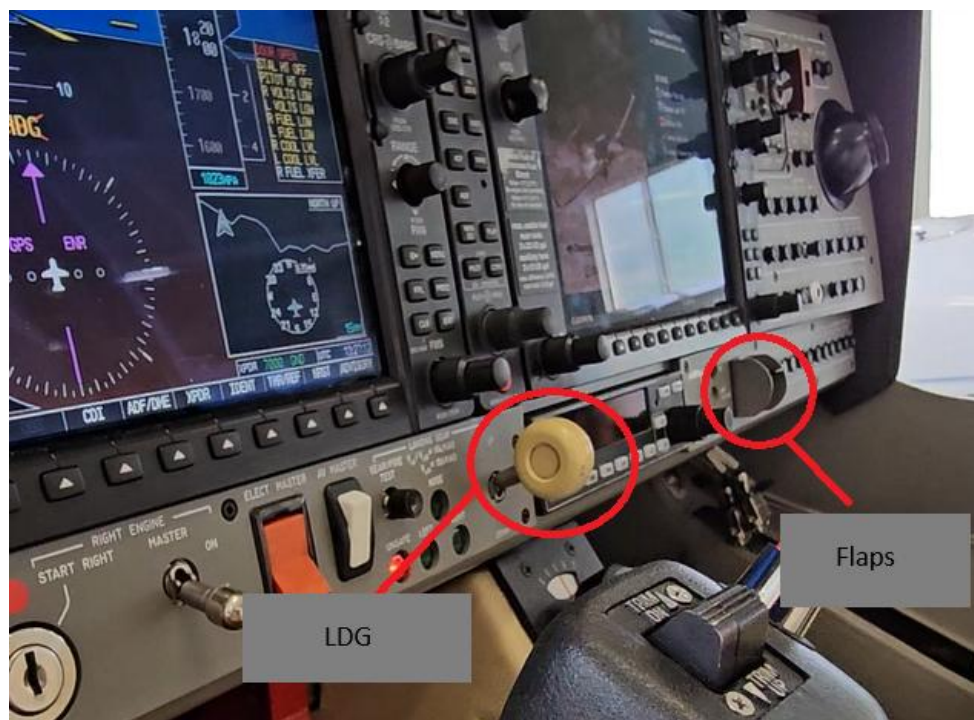
The investigation established that the experienced pilot, while performing a touch-and-go <sup>3</sup>landing, made an error in the sequence of aircraft configuration management, specifically between the landing gear (LDG) and the flaps.<sup>4</sup> The pilot reacted promptly and made an appropriate decision to perform an emergency landing in the take-off direction, thereby mitigating the consequences of the error.

Figure 4: OE-FPV - position of configuration control levers: left - LDG, right - Flaps
