NOTICE OF COMPLETION OF INVESTIGATION

Serious incident involving Evektor SportStar aircraft, Reg. S5-DNA, January 29, 2025, LJMB

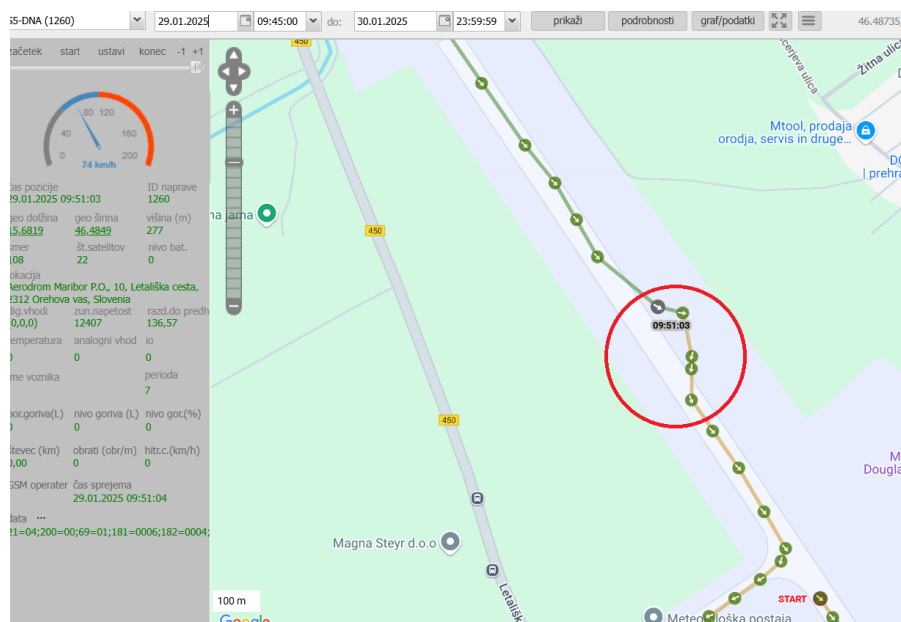
The aircraft initially touched down with increased vertical speed on all three wheels. On the next touchdown, the nose wheel made contact first, resulting in a propeller strike on the runway. After the final bounce, the aircraft veered left and came to a stop approximately one meter off the runway in the grass.

Figure 2: Aircraft trajectory during landing

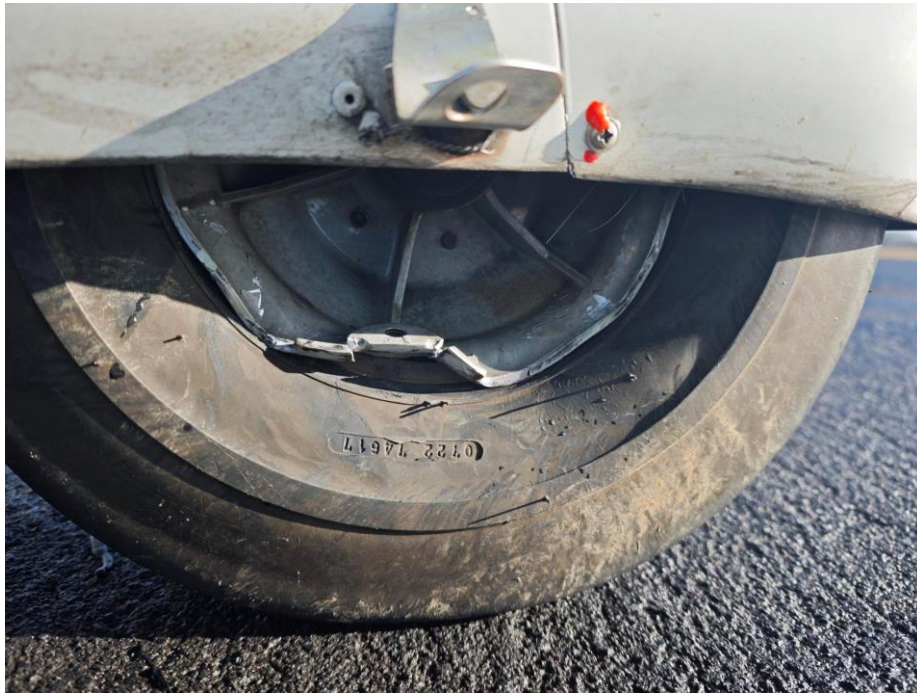
As a result of the incident, the propeller, nose wheel rim, and lower section of the left wing sustained damage (see images below). The pilot remained uninjured.

Figure 3: Aircraft damage - nose wheel

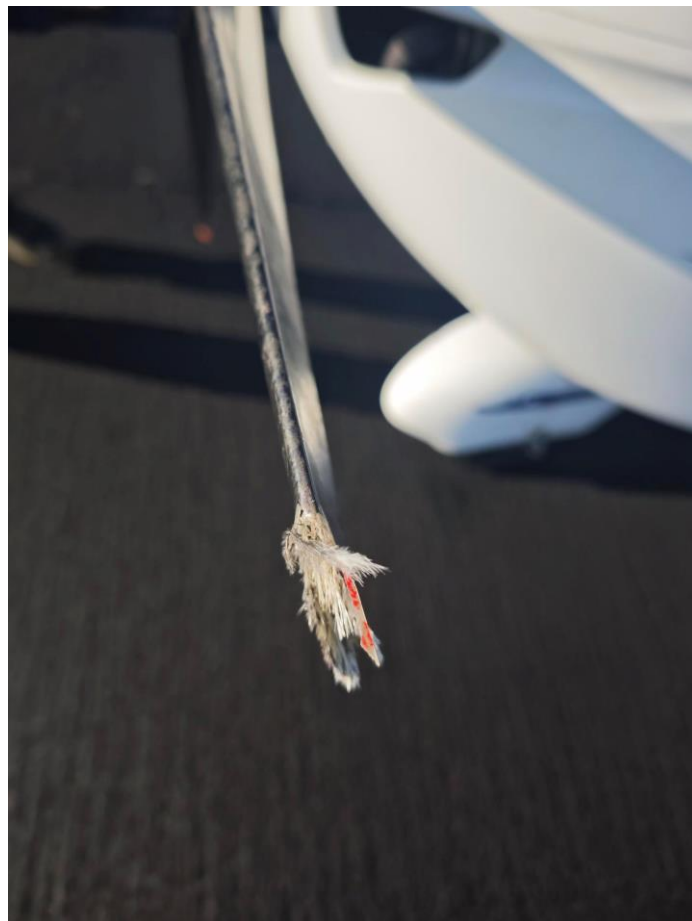
Figure 4: Aircraft damage - propeller

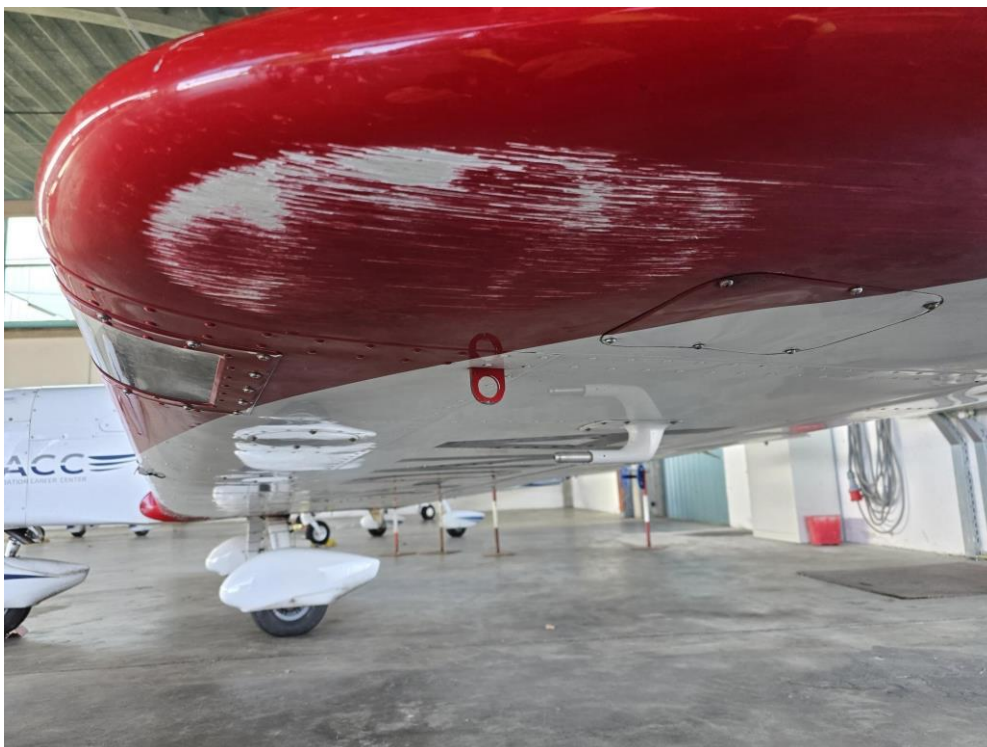
During the turn, the aircraft banked to the left, and the lower part of the left wingtip scraped along the runway.

Figure 5: Aircraft damage - wing
