AIR, MARINE AND RAILWAY ACCIDENT AND INCIDENT INVESTIGATION UNIT

### **NOTICE OF COMPLETION OF INVESTIGATION**

#### **Serious incident involving WT9 600 FG Dynamic, Reg. D-MSHU, 1 May 2025, Mangart near LJBL**

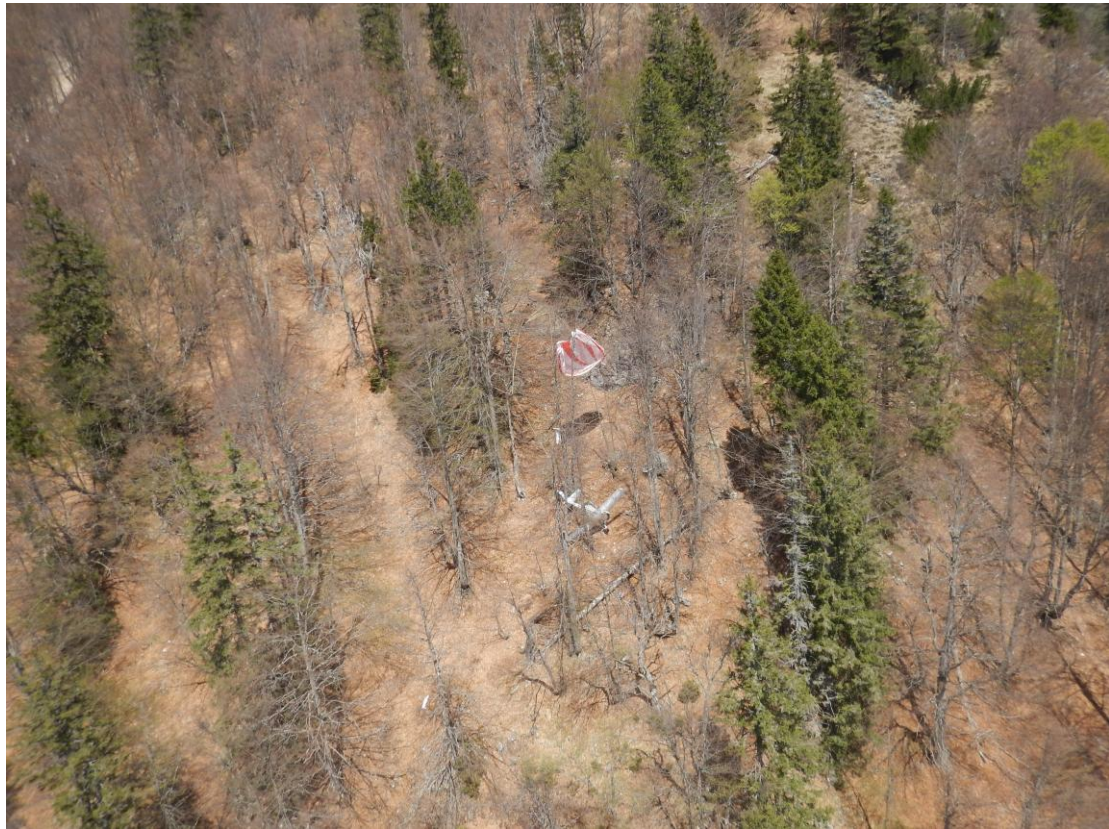
As control of the aircraft was lost during a steep and rapid descent, the pilot deployed the ballistic recovery parachute system. Within seconds, the aircraft came to rest suspended in a tree on steep mountainous terrain.

Figure 1: D-MSHU at the occurrence site

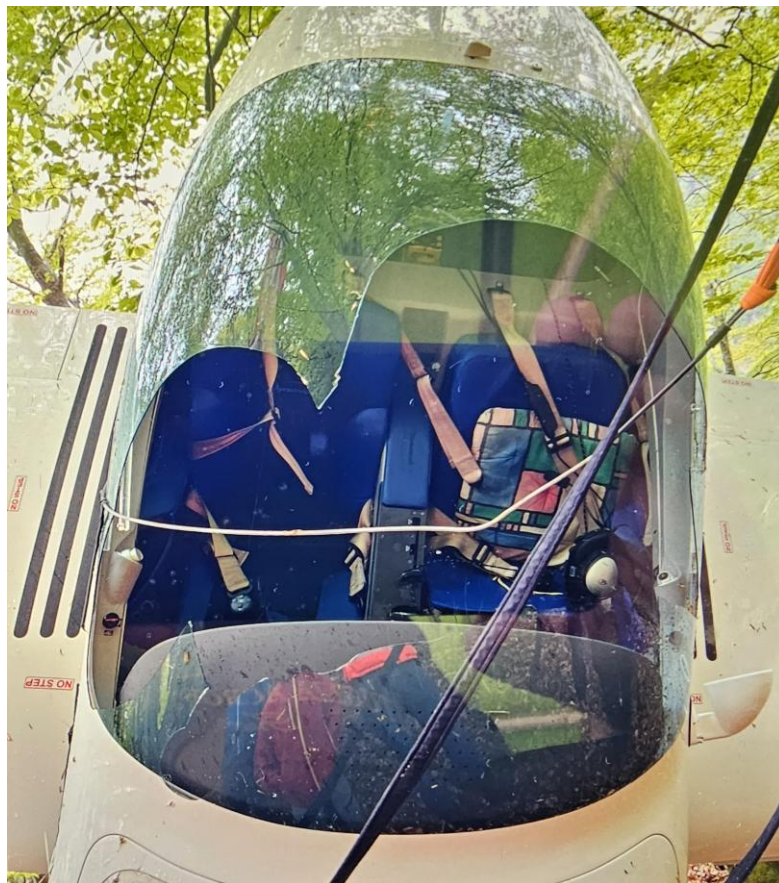
Approximately 5 NM prior to reaching Kanin, the aircraft entered an area of light turbulence. As the aircraft decelerated during descent, the turbulence intensified to a degree that the passenger seated on the right-hand side struck their head against the canopy. The canopy fractured in the front windshield section, creating an opening of approximately 0.5 m<sup>2</sup>.

Despite the use of a three-point safety harness, the passenger seated on the right side struck the canopy with his head during a period of strong turbulence. The impact caused the canopy to crack, resulting in an opening in the front section of the cockpit enclosure.

Figure 7: D-MSHU at the occurrence site with fractured front canopy
