AIR, MARINE AND RAILWAY ACCIDENT AND INCIDENT INVESTIGATION UNIT

**NOTICE OF COMPLETION OF INVESTIGATION**  
**Outlanding of the DG-300 glider, registration mark S5-3021, on 23 May 2026 near the**  
**settlement of Blejska Dobrava**

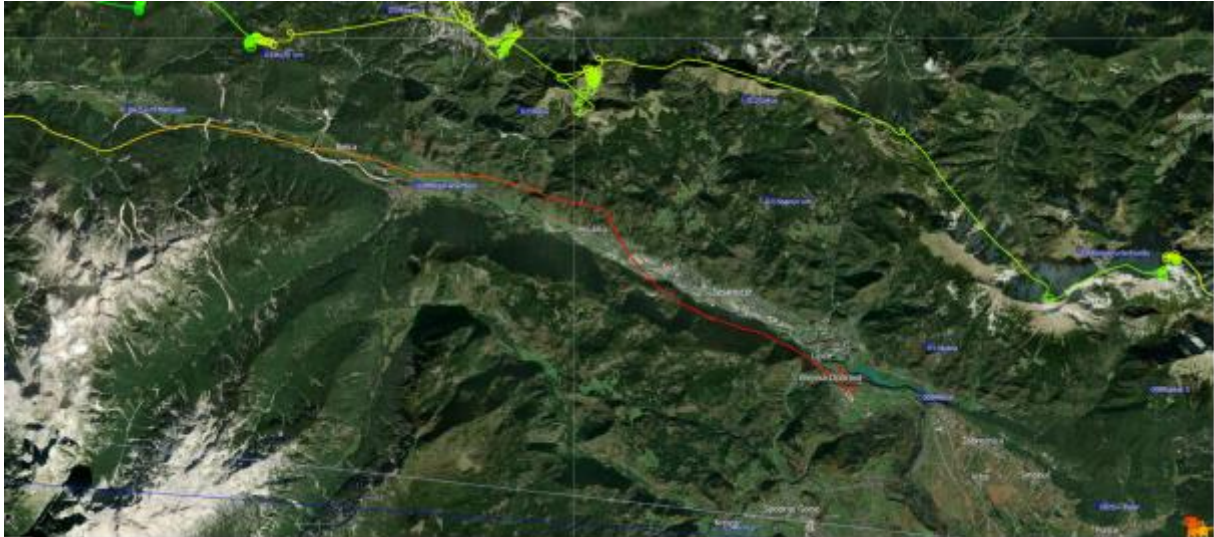
Figure 1: Flight track (red line) of the final part of the flight between Kranjska Gora and the landing site near Blejska Dobrava

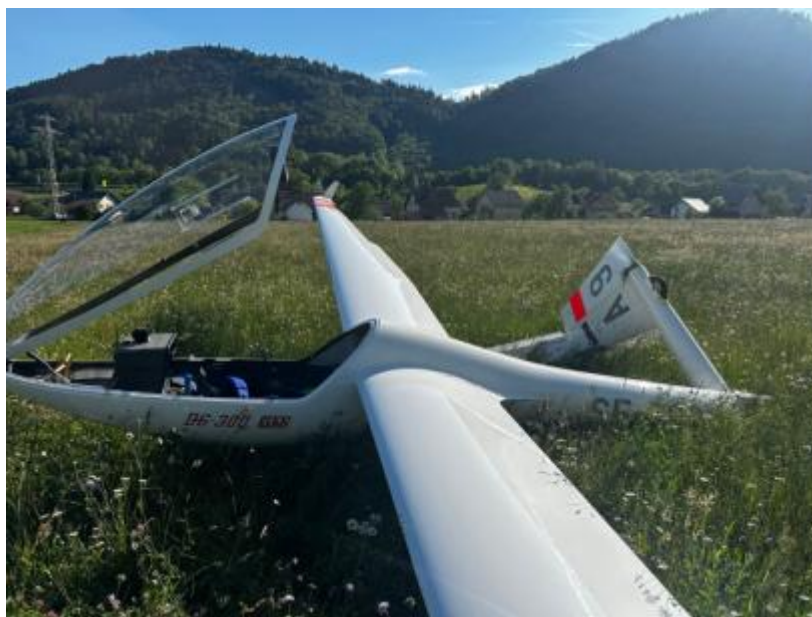
Due to power lines near the planned landing site, the pilot executed the final approach slightly higher. After clearing the power lines, he extended the airbrakes and accelerated the glider towards the ground. After touchdown, despite heavy braking, he noticed that he was rapidly approaching a power line pylon and tall grass; therefore, to avoid a collision, he decided to execute a ground loop to the right. The glider turned sharply and came to a stop after a few dozen meters. The pilot was not injured, while the glider sustained damage to the extent that a thorough inspection and repair are required. According to the initial assessment, the damage consists of a fuselage fracture and damage to the ailerons.

*Figure 2: Damaged glider*
