Maritime Accident and Incident Investigation Services

**M/V "GRANDE COLONIA"**

CONTACT WITH THE PIER  
DURING BERTHING MANOEUVRE  
IN PORT OF KOPER  
ON  
JULY 19, 2015

National occurrence no: 3/2015  
EMCIP casualty No: 2484/2015

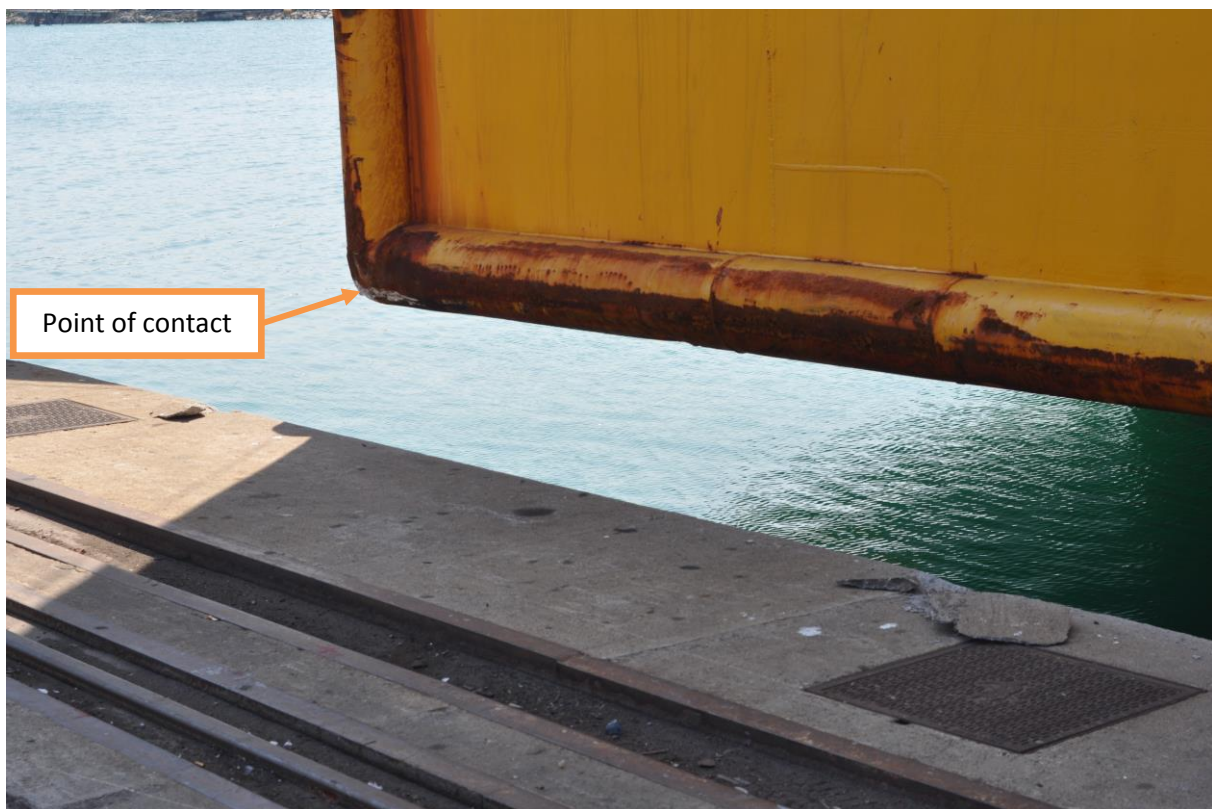
Master ordered to slack bow lines, tighten after bow spring, pull stern lines and slack forward quarter spring. Due to the poor communication between fore and aft mooring posts, fore mooring ropes were slacked too much and therefore ship’s bow swing to the port side, while stern part touched the pier with the reinforcement beneath loading ramp.

Picture 3: Point of contact, ship’s stern starboard side

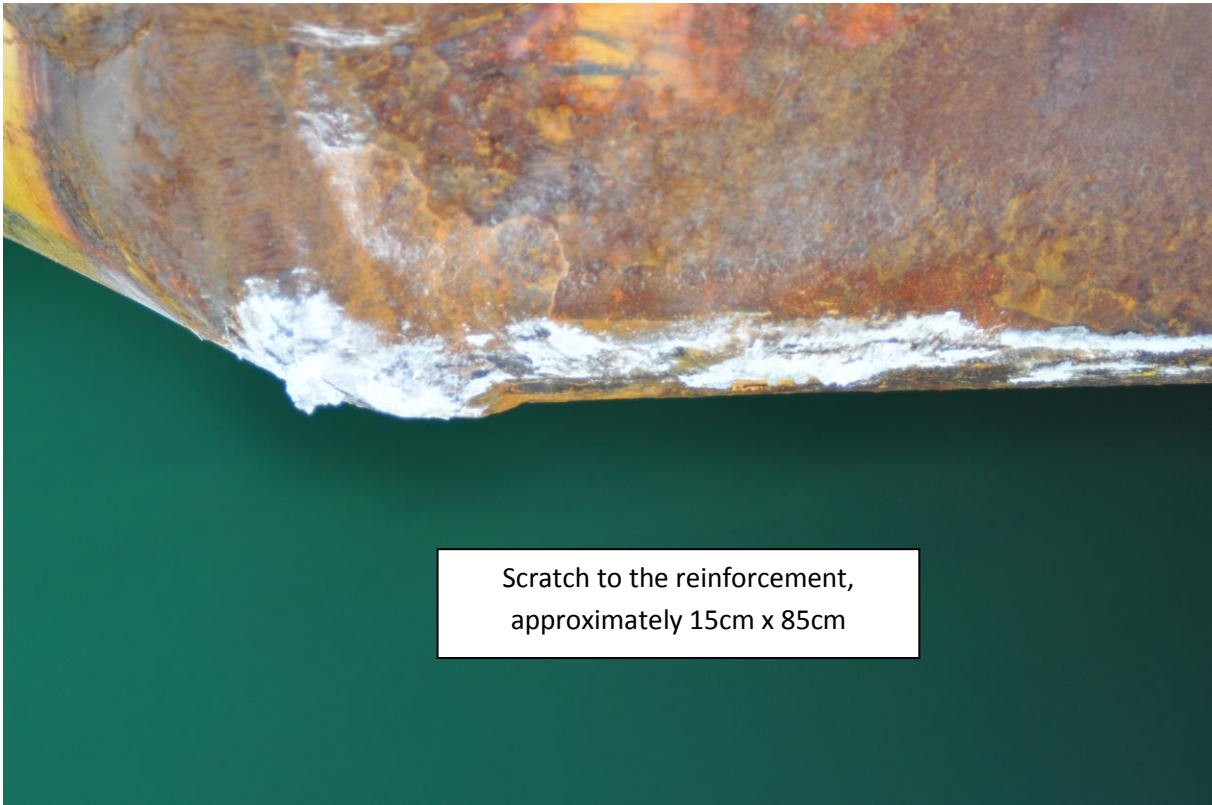
Picture 4: Damage to the reinforcement

Ship did not suffer any damage, only minor scratches of the painting on the stern ramp reinforcement occurred.

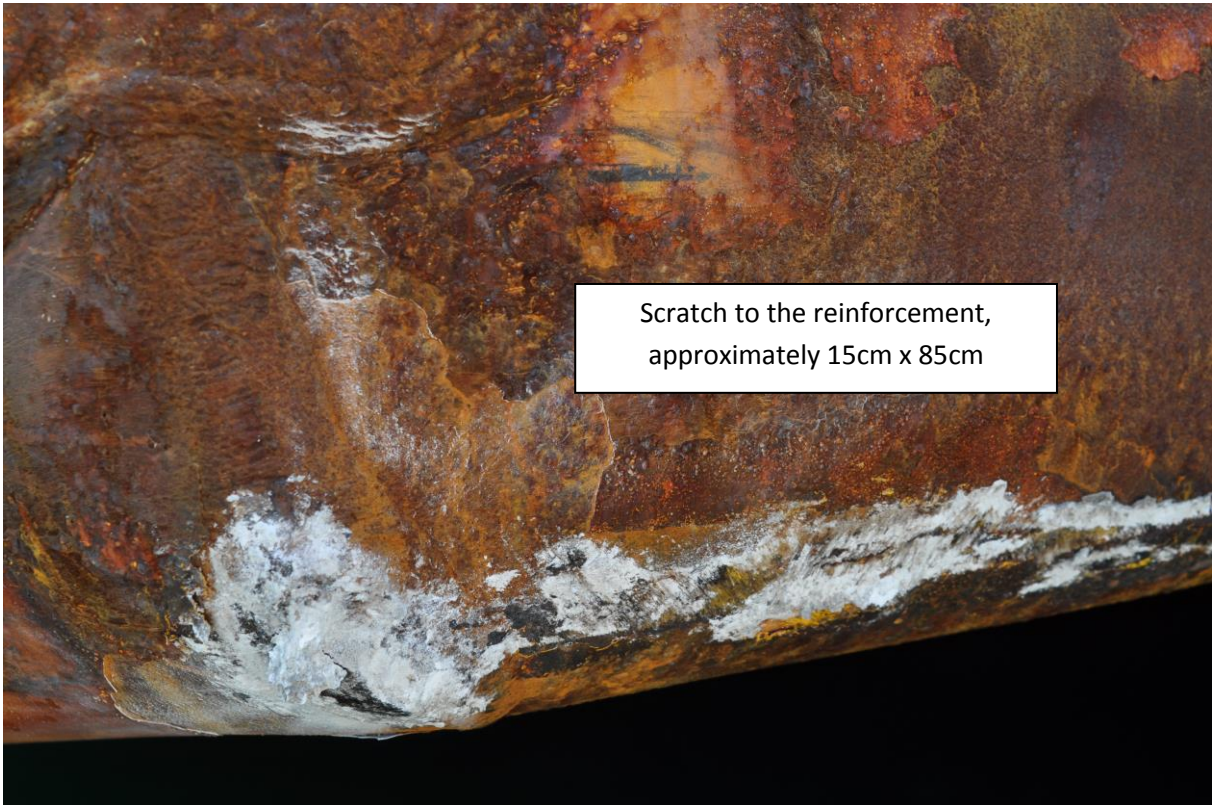
Picture 5: Damage to the reinforcement

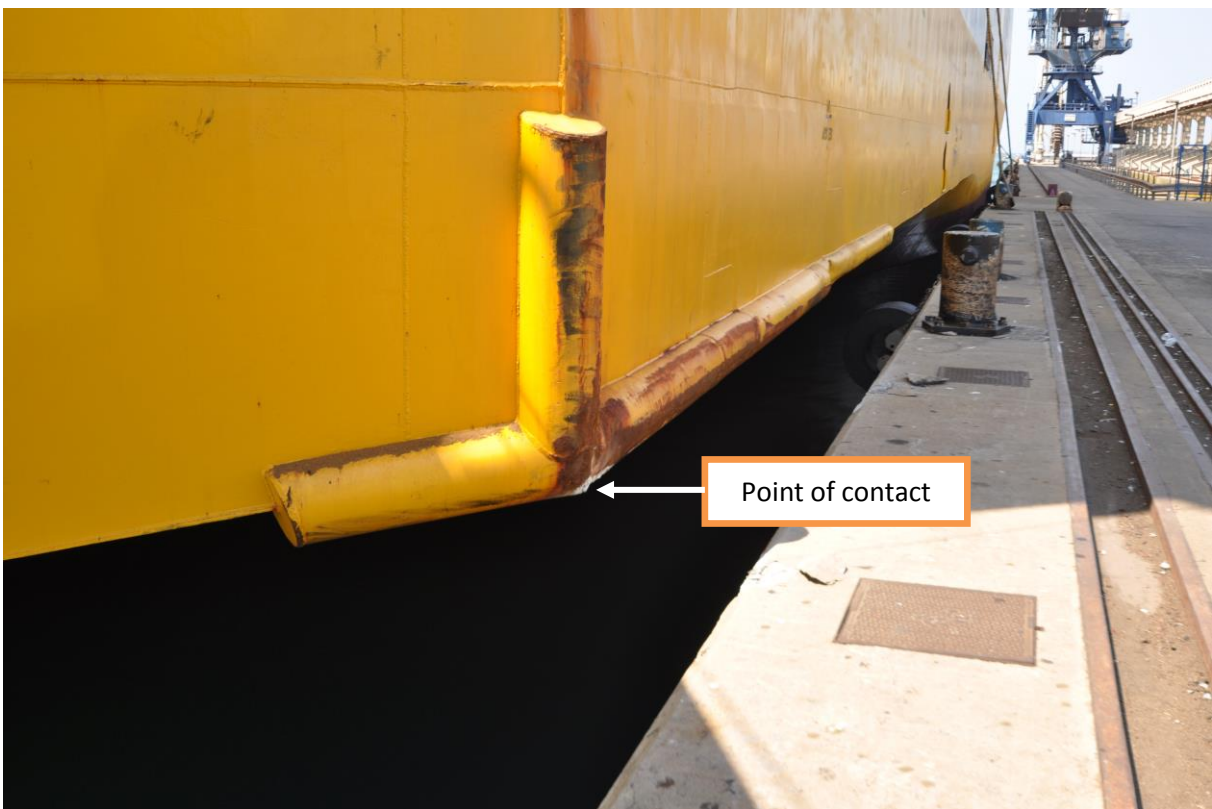
Picture 6: Point of contact, ship's stern starboard side

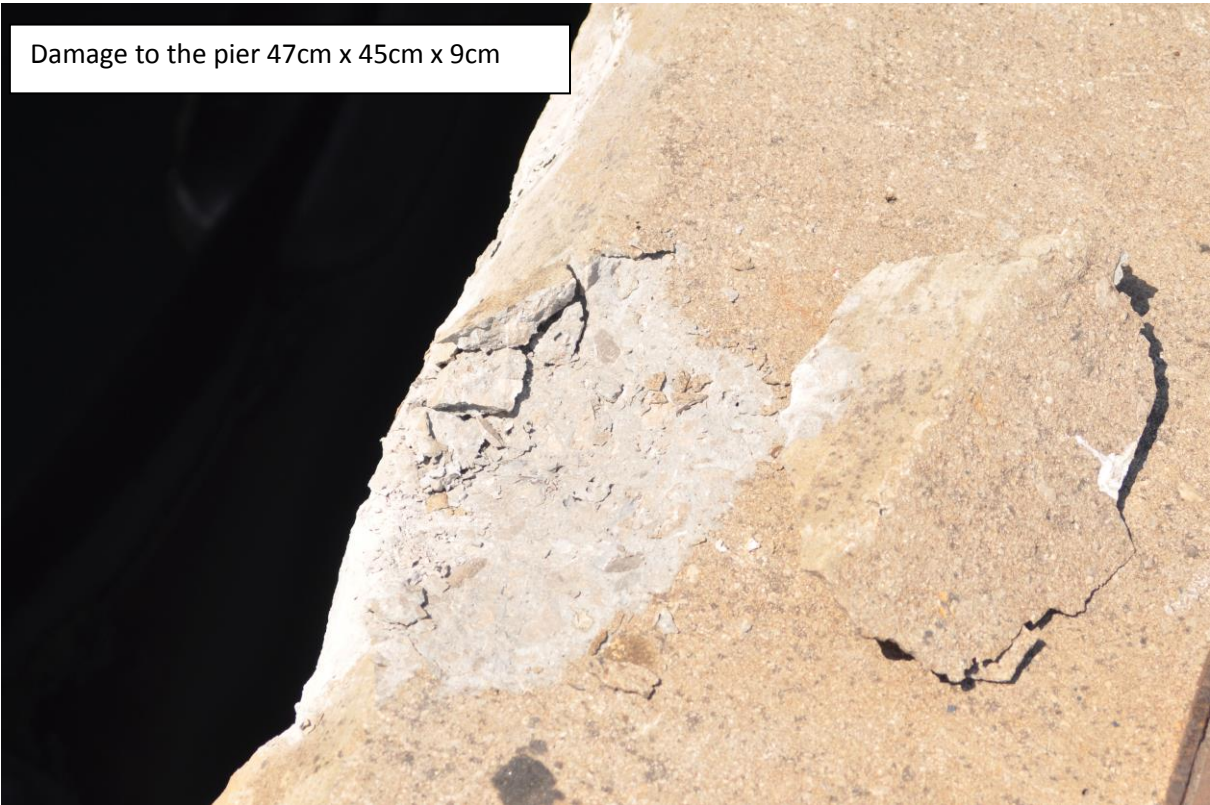
Due to the impact to concrete pier a minor damage occurred on two spots:

- Fragment of concrete, dimensions 26cm x 21cm x 10cm, and
- Fragment of concrete, dimensions 47cm x 45cm x 9cm.

Picture 7: Damage to the pier

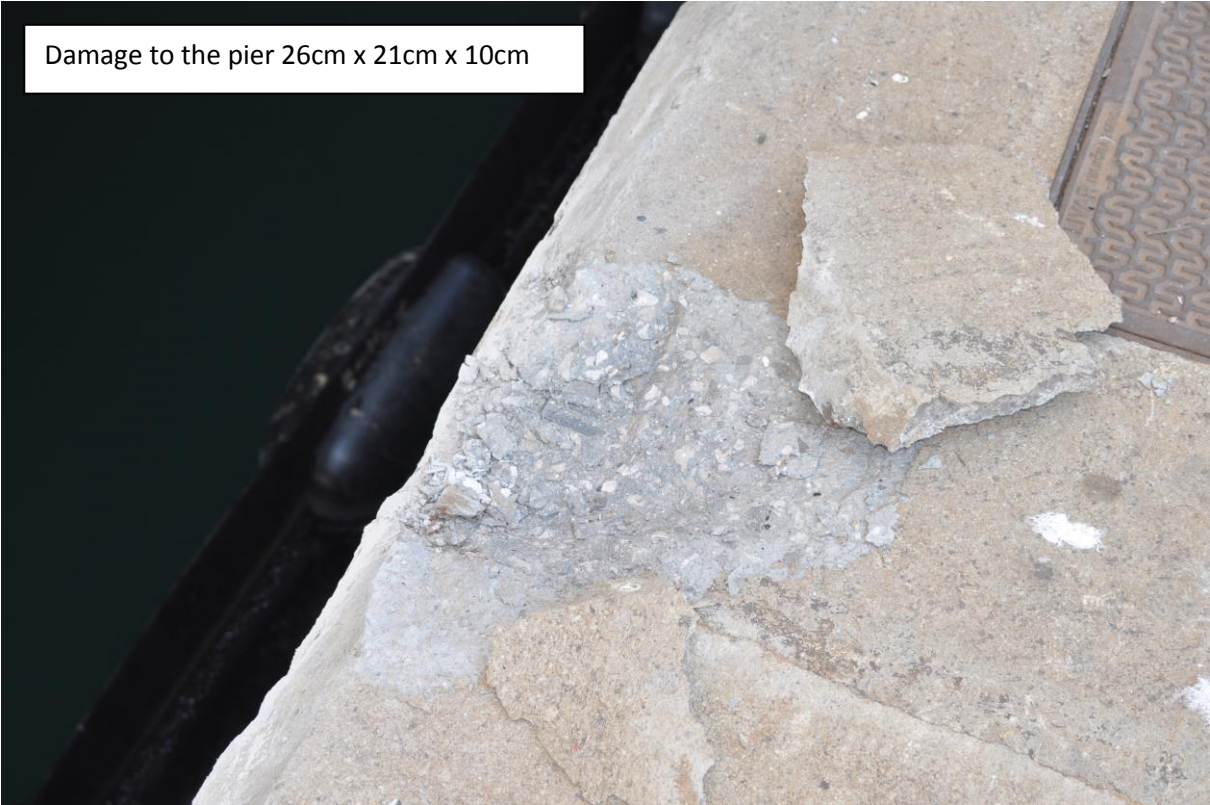
Picture 8: Damage to the pier

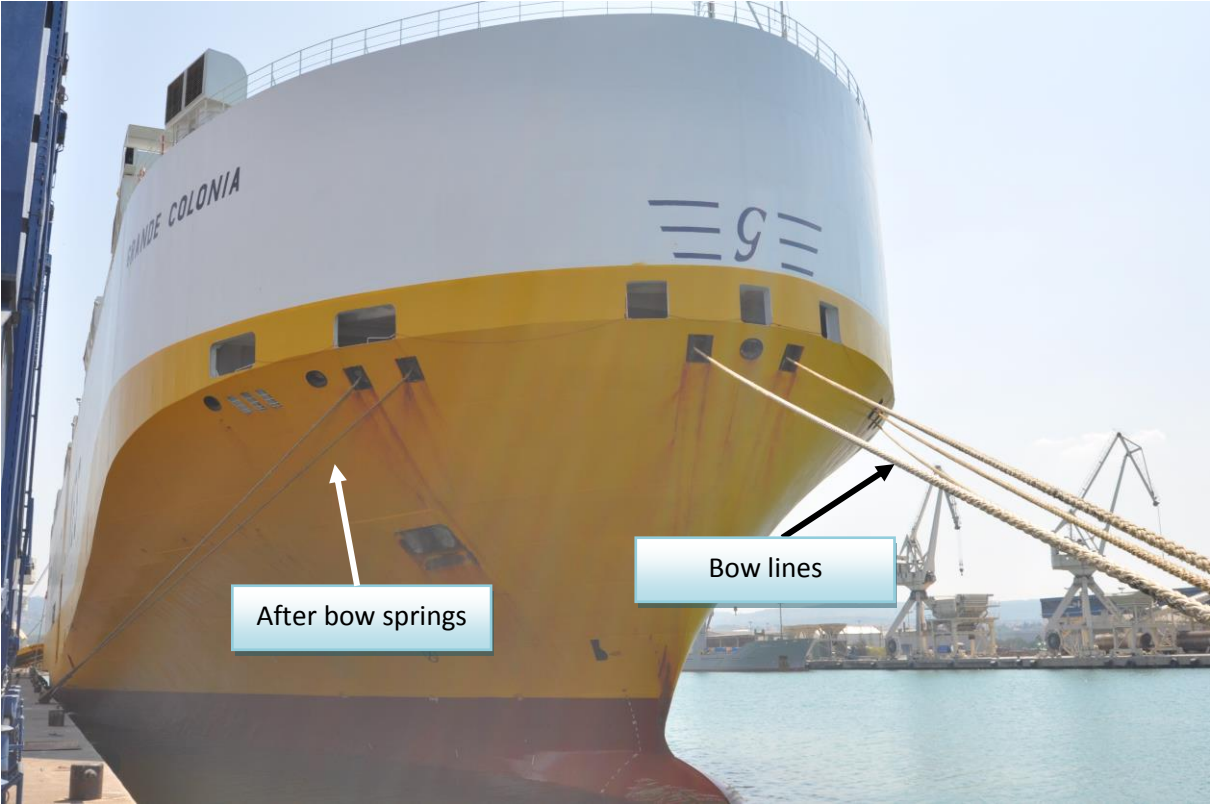
Picture 9: Ship's bow mooring lines

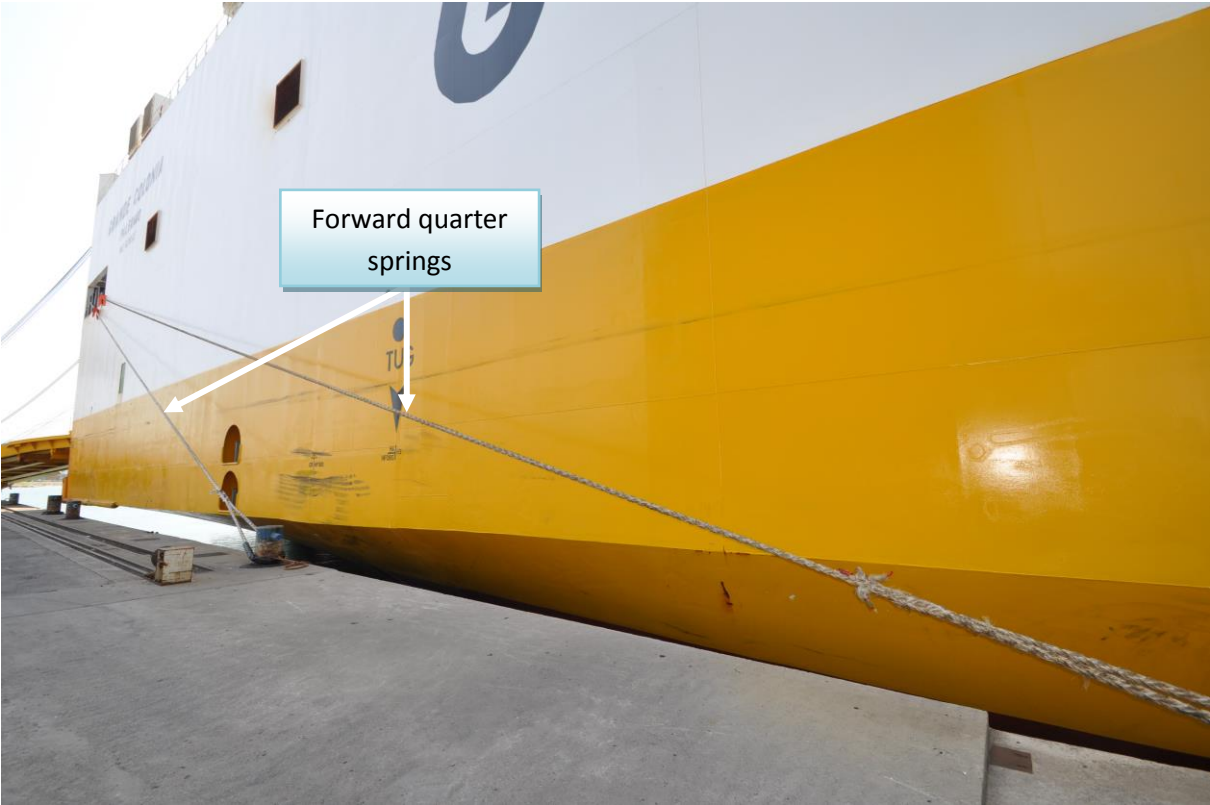
Picture 10: Ship's forward quarter springs

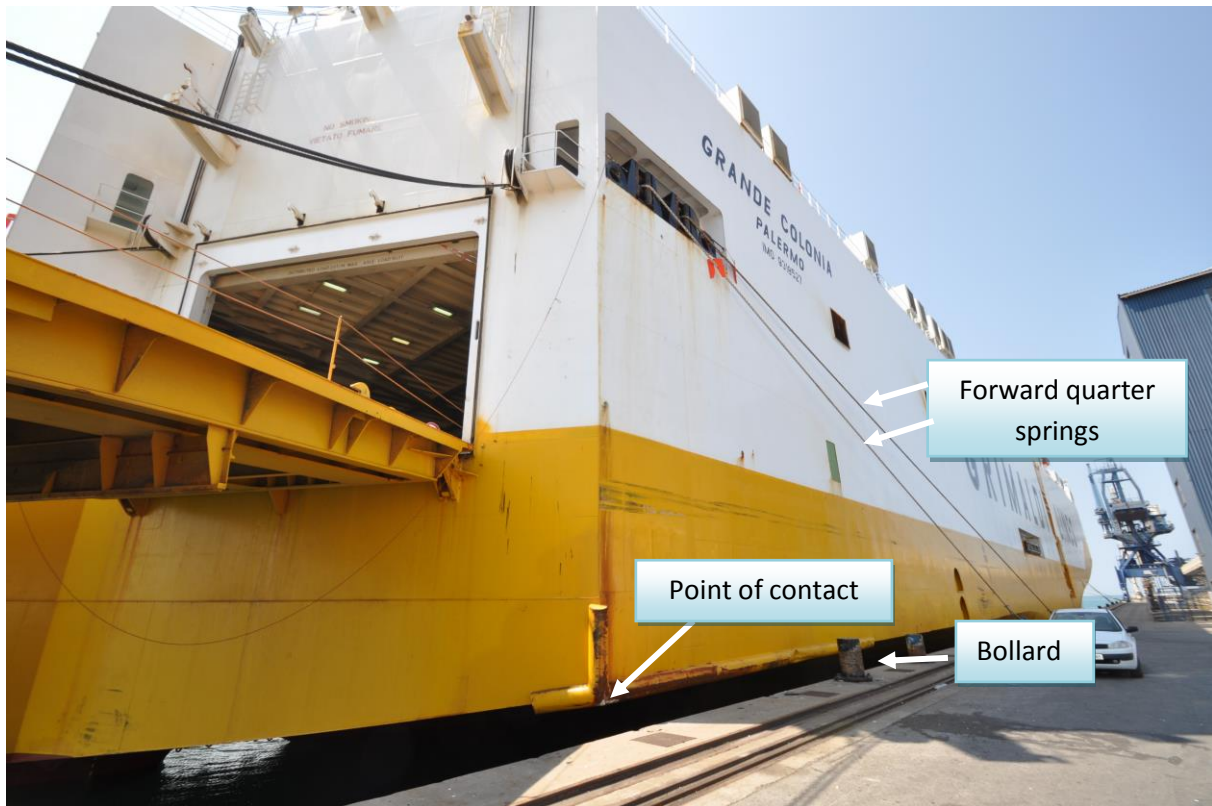
Picture 11: Ship's stern mooring lines
