REPORT ON INVESTIGATION FOR SERIOUS CASUALTY BY THE M/V MAERSK HOUSTON

breakaway from pier, bottom touching, contacts with
shore infrastructure and moored tugboat
in the Port of Koper
19. 07. 2023

AIR, MARITIME AND RAILWAY
ACCIDENT AND INCIDENT
INVESTIGATION UNIT YYY

Final Report

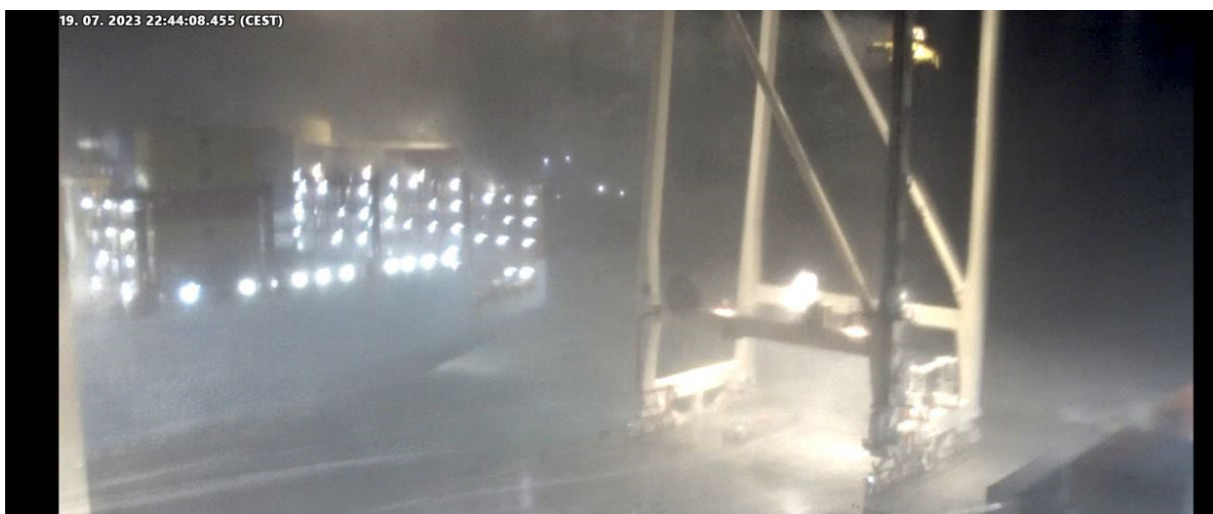
- 22:43:24 third stern line parted.

Figure 2: Astern drift of the ship from the pier at 22:44:08 hours

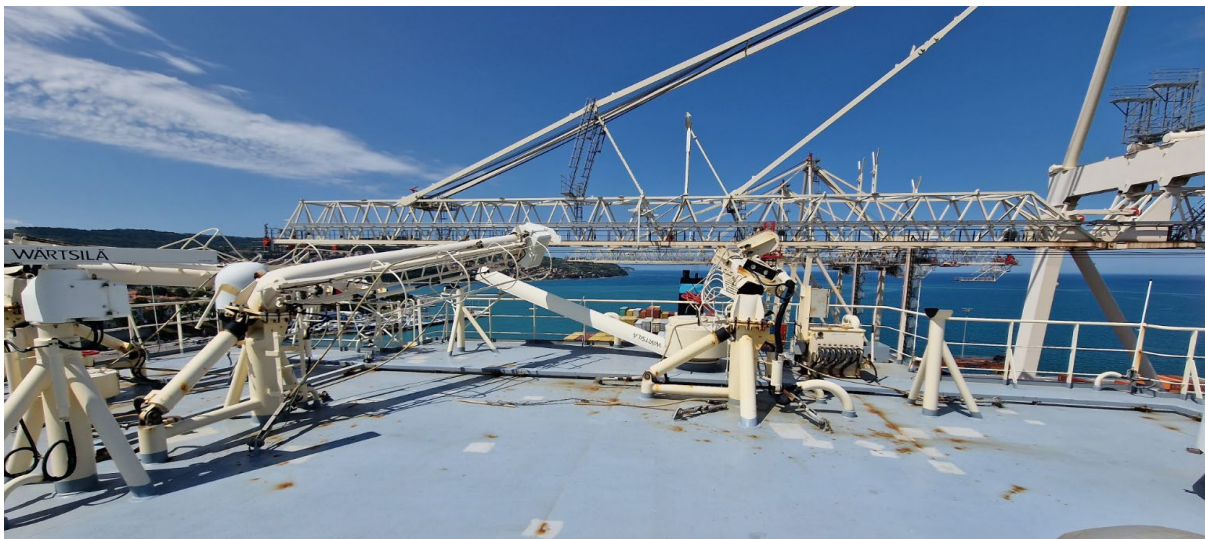
- Due to the strong winds, the ship's mooring lines, 14 in total, snapped.
- The ship's navigation and communication equipment installed on four masts was broken after contact with the lowered STS 59 crane boom and bent towards the aft after part of the deck.
- Minor damage to the bow plating and bulwark (contact of the ship's forward bulwark with seaside leg 2 of the STS 58 crane).
- Minor damage to the stern plating due to contact with the shore and with the tugboat Sirius.
- Abrasions on the rudder blade due to contact with the concrete mooring support of berth 1.
- Repeated mechanical damage was noted on 10 x 40" containers at Bays #58 and #62: bumps, torn sheet metal, and holes – probably caused by container spreader grips¹.

Figure 3: Damages on Maersk Houston - Monkey Island

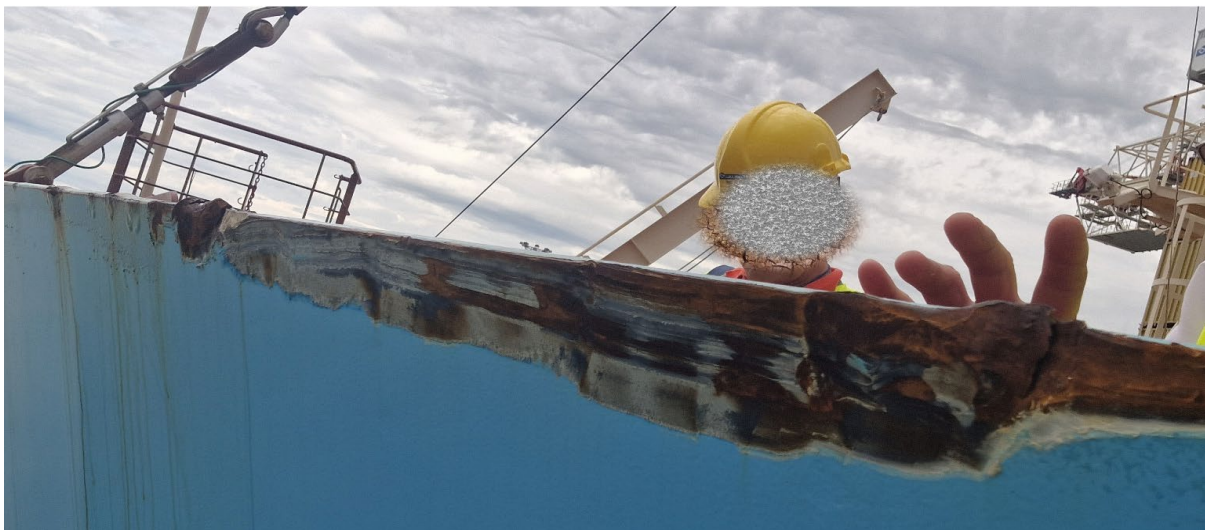
Figure 4: Damage on bulwark

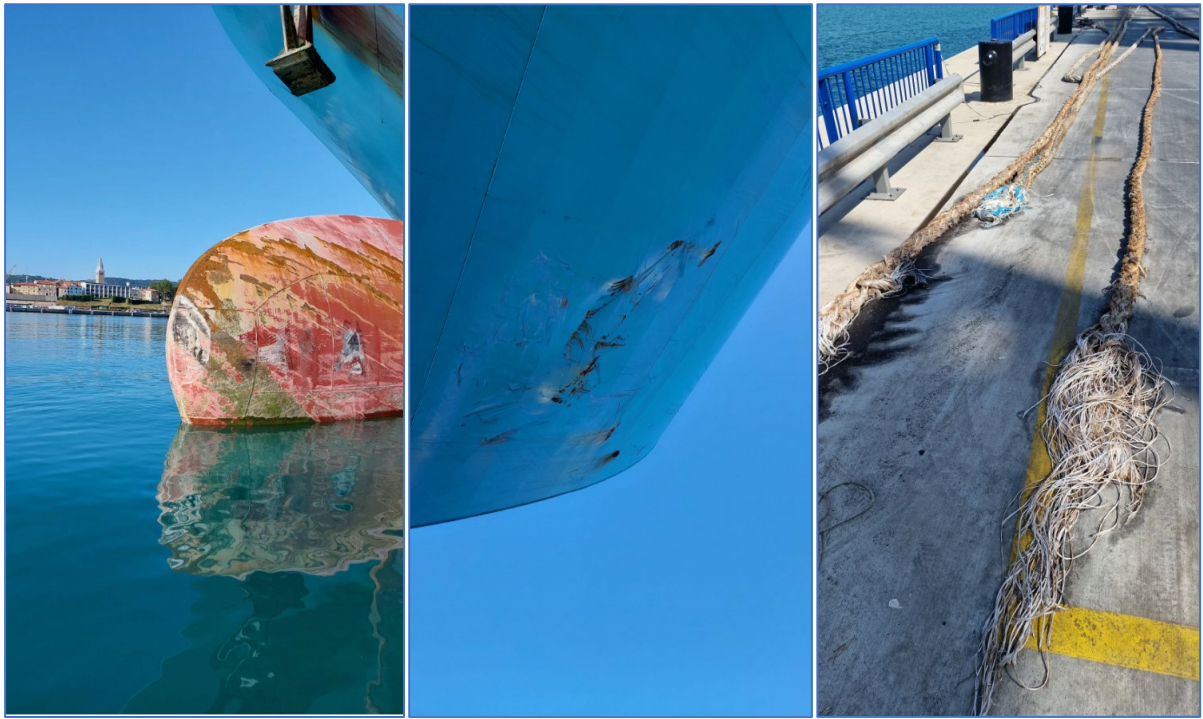
Figure5: Bulbous bow-shore contact with Pier 1, port quarter plating-contact with tugboat, broken stern lines

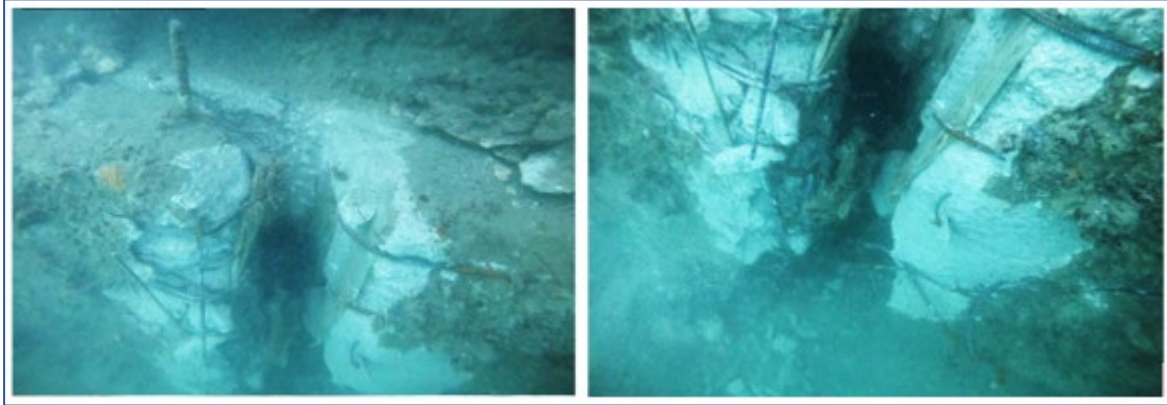
- Damage to the passenger's pier vertical foundations in three places at a depth of about 30 cm was due to contact with the ship's rudder. There are changes in depths due to the sliding of the ship's bottom.⁶

Figure6: Upper and lower part of the foundation wall of Berth #1 (source: Sirio)

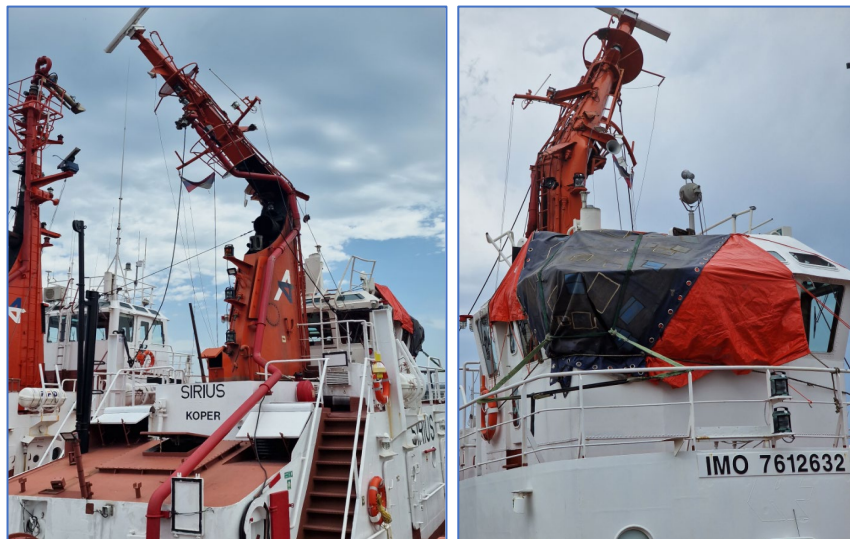
The following damage was caused to the tugboat Sirius⁷ because of contact by the Maersk Houston when the tugboat Sirius was moored sideways to the tugboat Wotan at Berth 1, Passenger Pier, Basin:

- Damage to the bridge (bridge structure, windows, equipment),
- Signal mast (distorted and broken, including fire-fighting equipment piping, vertical stairs, radar support, and various signaling fixtures and equipment)
- Rubber bumper on the right side of the cladding

Figure7: Tugboat Sirius - damage to the bridge and main mast.

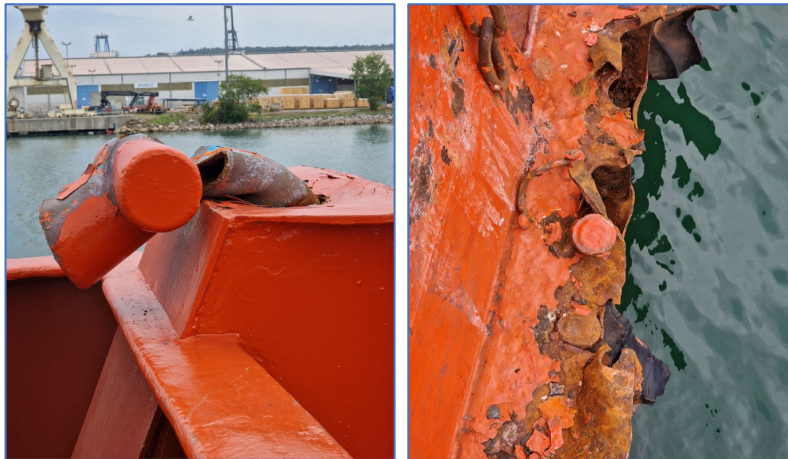
Collateral damage was caused to the tugboat Wotan, to which the tugboat Sirius was laterally moored. The towing mooring bit on the bow and the protective fender on the left side of the tugboat are damaged.

Figure 8: Tugboat Wotan, collateral damage

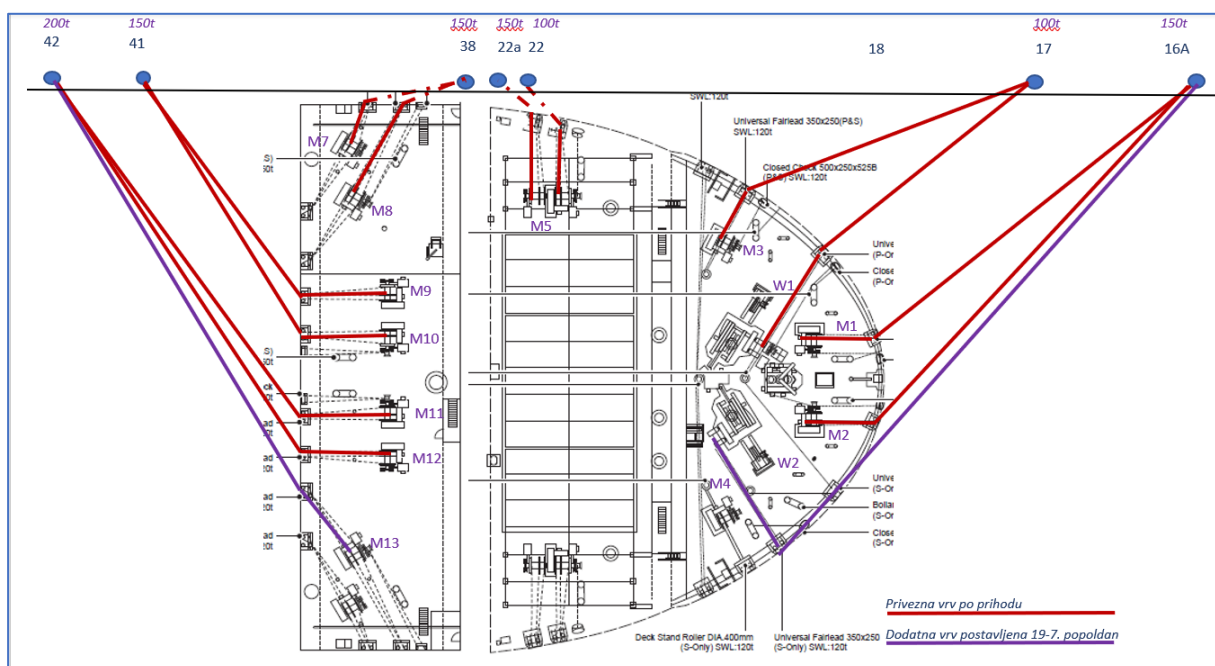
Prior to the arrival at Berth 7D, the Port of Koper Operational department (planners) issued a Pilotage Plan specifying the berthing position by referencing the forward (bow) bollard position. The bow position was aligned with the 18th bollard. The mooring ropes were to be deployed along the entire length of the designated berthing position on the container terminal. They are usually set by the linesmen, but the final deployment rests with the responsibility of the master. The final mooring configuration was four plus two (4+2) lines fore and aft. On arrival and at the ship's berthing, the pilot asked the master if he wished to use the option of mooring the (some) stern lines to the mooring buoys. As the mooring boat had to be called in to use them and the weather was calm at the time of the mooring, the master refused this option, as it was confirmed in the interview with the master. An illustration of the mooring to the mooring buoys is shown in Figure 10, page 11. The next day, 19th July, after being informed by the PSC officer and following the information given by the CNP duty officer regarding the possibility of stormy conditions, the master ordered that mooring is to be reinforced with one additional line both forward and aft. Figure 22 below illustrates the mooring scheme.

Figure 22: Schematic of the mooring of the Maersk Houston at berth 7D

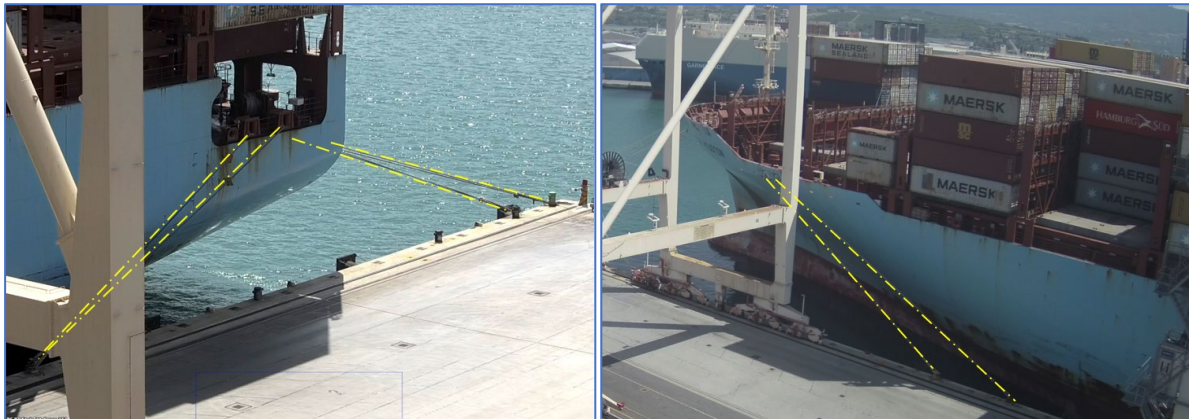
The longitudinal strength of the mooring in the direction of the Basin was provided by only two forward springs, while the stern lines and springs were short and operated at a high vertical angle and moderate horizontal angle to the shore, which reduced their effectiveness. Figure 23 shows the routing of the most critical lines, i.e., the stern lines and forward springs. The figure clearly shows the high vertical angles of the springs and the short stern lines.

Figure 23: Fwd springs, Aft springs, and stern lines

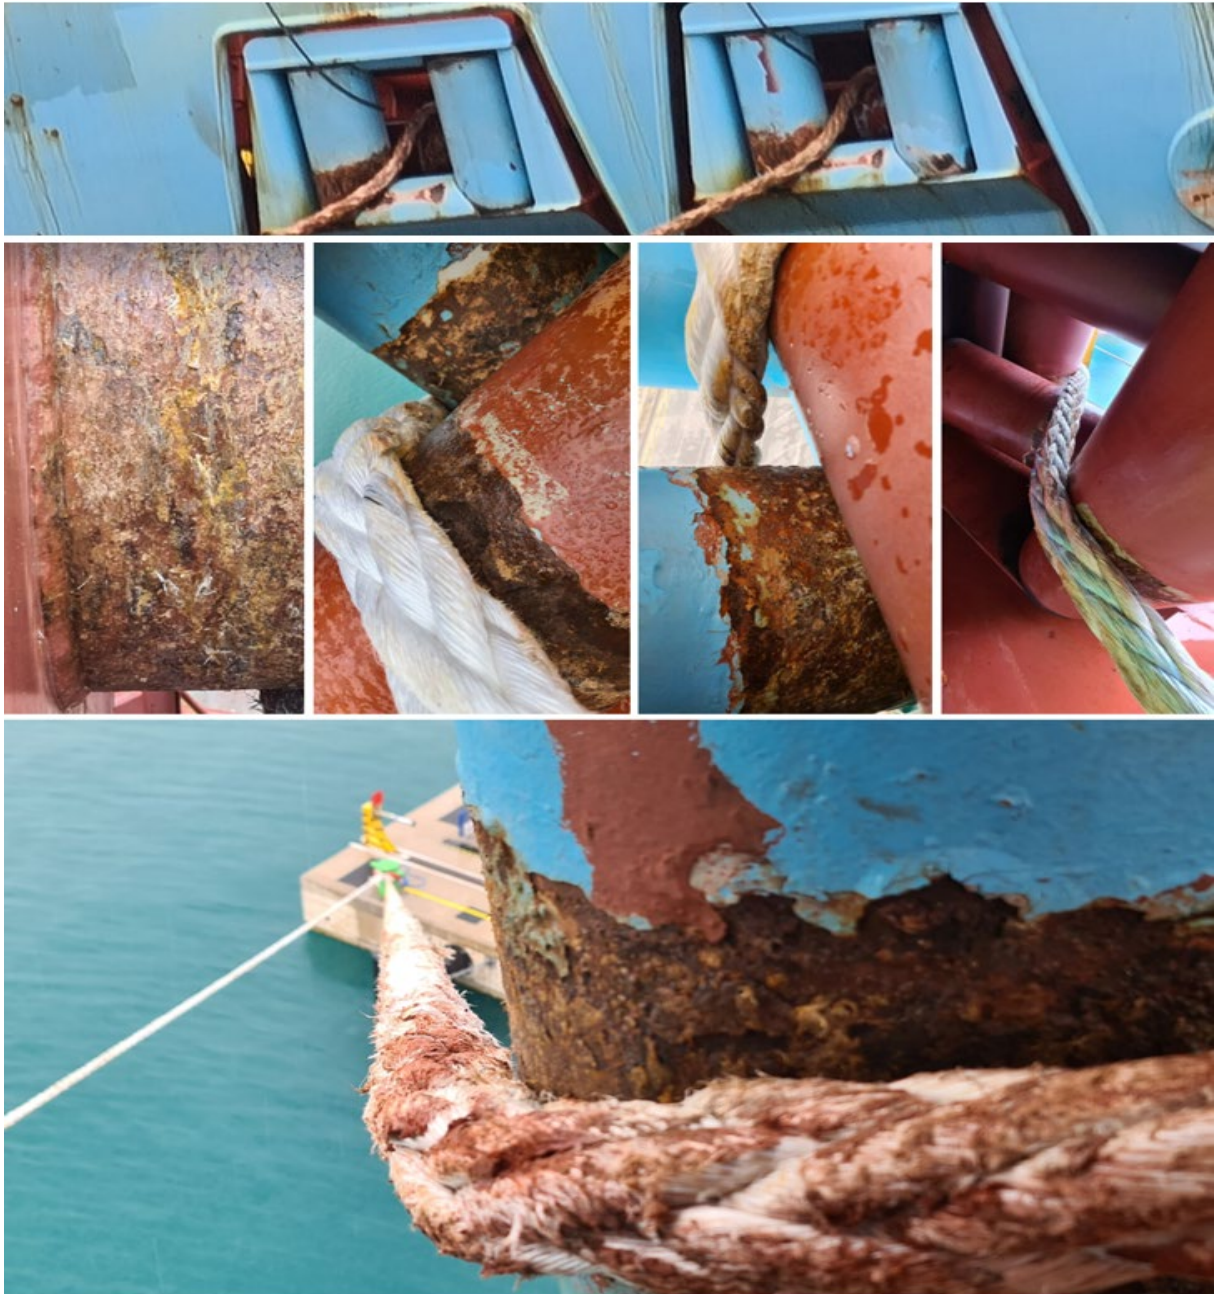
The inspection on board the Maersk Houston showed that the maintenance of the mooring drum surfaces and equipment is in poor condition, which was reflected on the ropes. In addition to aging and degradation of the ropes due to constant friction against rusted equipment parts, any major change in the direction of the mooring rope affects its final MBL. The condition of the equipment on board the Maersk Houston at the time of the accident is illustrated in Figure 25 on the following page.

Figure 25: Inspection of ropes and guides, showing corrosion of mooring equipment

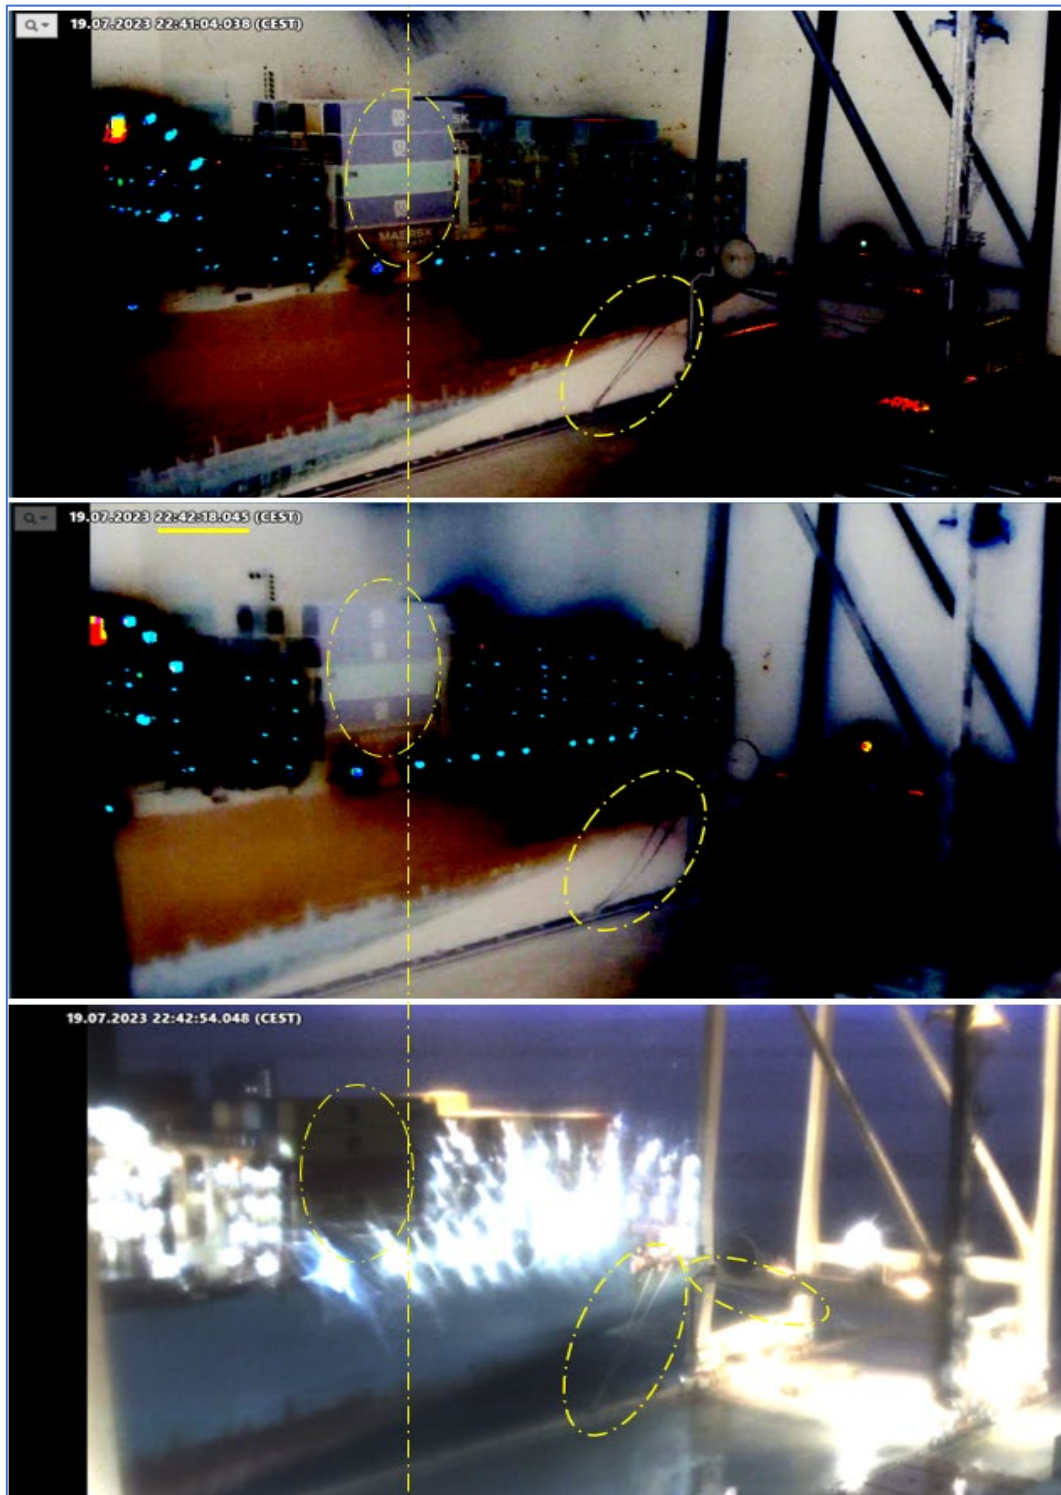
at 22:42:30, the wind reached 49,7 knots (25,6 m/s) from 328°. At 22:42:54, due to increased wind, the third sequence shows the ship drifting further away from the pier. The ship is still tied up, and the stern springs are heavily tensioned. Given the drift of the ship away from the shore, it is likely that the drum brakes have slackened at this point. The wind data indicate that the wind speed is between 45 and 47 knots, bearing 320°. The ship's course has decreased by 1° from the original course of the mooring along the shore, and the turning circle (ROT) has increased to 2,6°/min. At this point, the ship gained momentum.

Figure 26: Longitudinal and transverse movement and rope breakage at the stern (source: VNC Luka Koper)

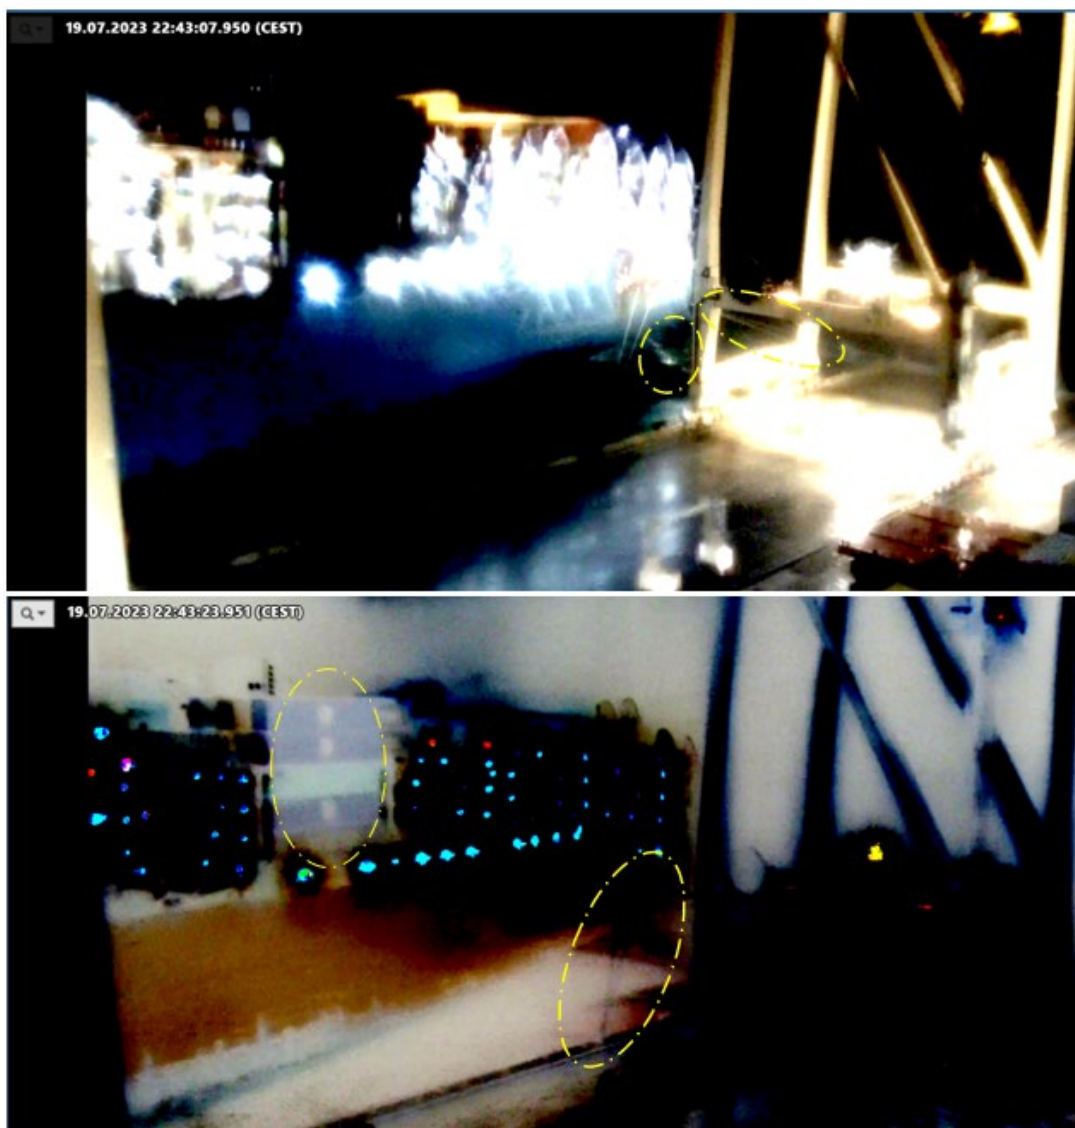
- 22:43:08 the first, one of the shortest stern ropes broke, as shown in the snapshot from video surveillance (Figure 27, top). The rope was placed on the innermost side and attached to bollard No. 41. The wind speed is 45 knots (23 m/s) from 327.5°.
- 22:43:21 a second rope is seen breaking at the stern, both stern springs are heavily stretched. The wind was 44.3 knots (23 m/s) from 326°. The ship's heading is 085,4°, indicating that it has changed 1,5° to port.
- 22:43:24 the distance between the stern and pier is quite large, and the two stern springs are still attached.
- 22:43:24 another aft rope breaks, the springs are stretched, and the two remaining ropes are visible in the picture.
- 22:43:46 The stern springs are still holding, but heavily stretched, with at least one additional rope visible on the stern.

Figure 27: Longitudinal and transverse movement, rope breakage aft (source: VNC Luka Koper),

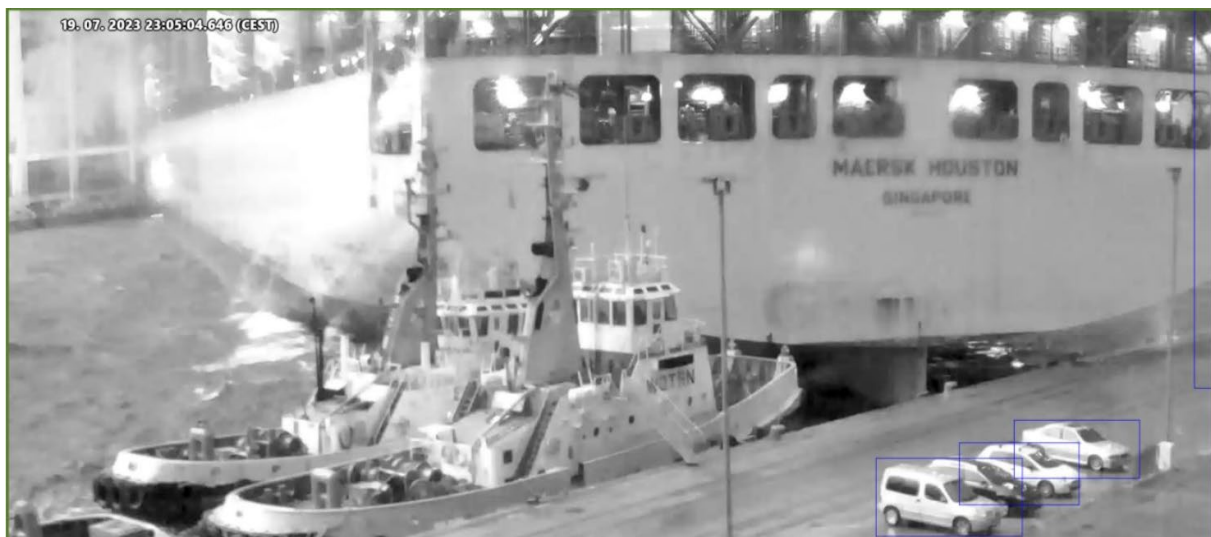
Figure34: Ship's contact with the shore (source: VNC Luka Koper)

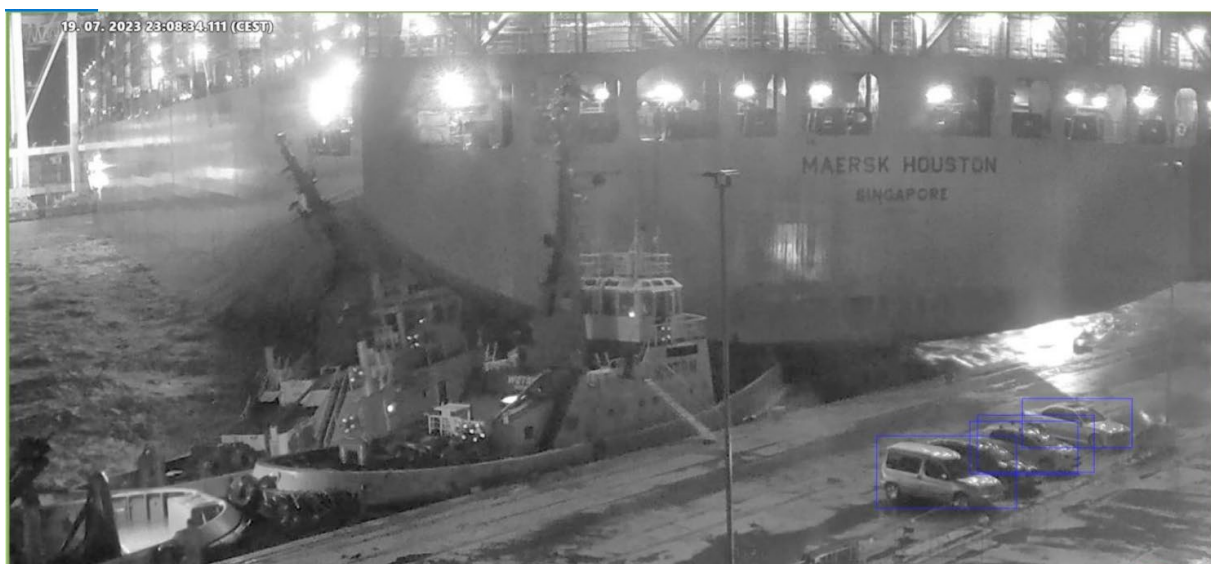
The ship's heading is 027°, COG is 119°. Bow thrusters are stopped, and stern thrusters are operating at 60% to port. At starboard quarter, the tugboat Mercur is pushing stern to port, main engine is not running (Figure 37). The wind direction is 056°, 23,7 knots (12,2 m/s). At 23:08, the ship's stern (port quarter) made contact with the tugboat Sirius, abeam tugboat Wotan, moored on Berth 1 (Figures 37 and 38).

Figure38: Maersk Houston in contact with the tugboat Sirius" (source: VNC Luka Koper)

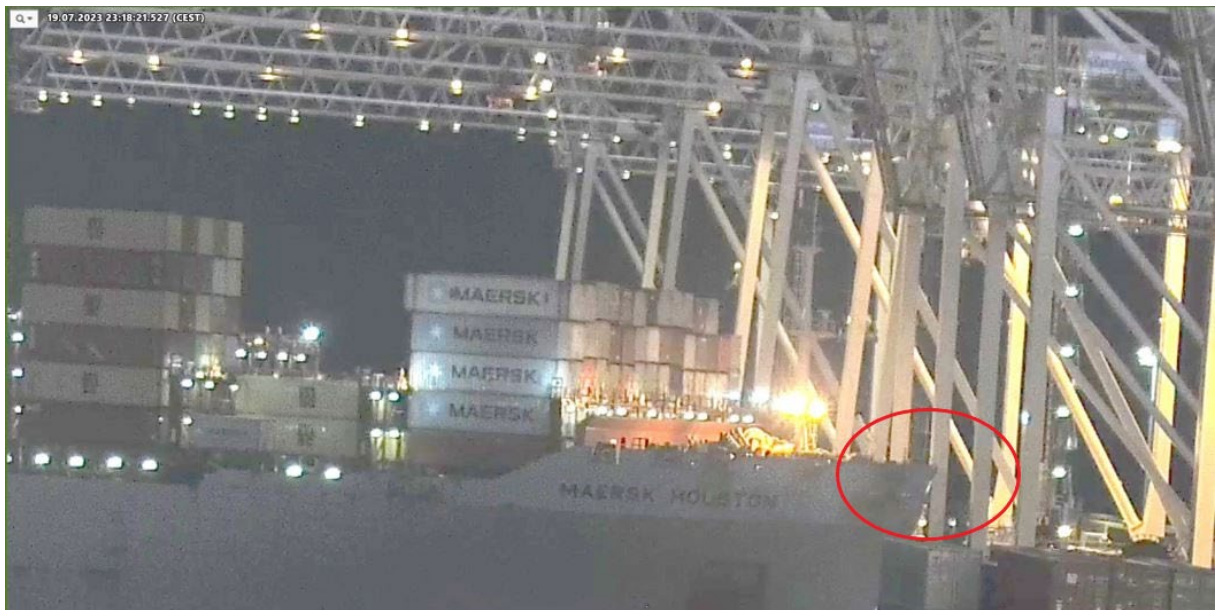
at the stern is pushing the ship to port, the other is pulling her to port (Figure 39). The wind direction is 081° , speed of 19 knots (9.6 m/s). At 23:18:22, with her upper left part of the bow plating (bulwark), the ship made contact with the vertical seaside leg 1 of STS 58.

Figure39: Ship in contact with lift #58 at 23:18:22 (source: VNC Luka Koper)
