SIMPLIFIED REPORT FOR MARINE INCIDENT BY THE RO-RO NEPTUNE THALASSA

VTS Rules Infringement on arrival at the Port of Koper

Pilot Station 02. 01. 2024

Izola, 20. 01. 2024

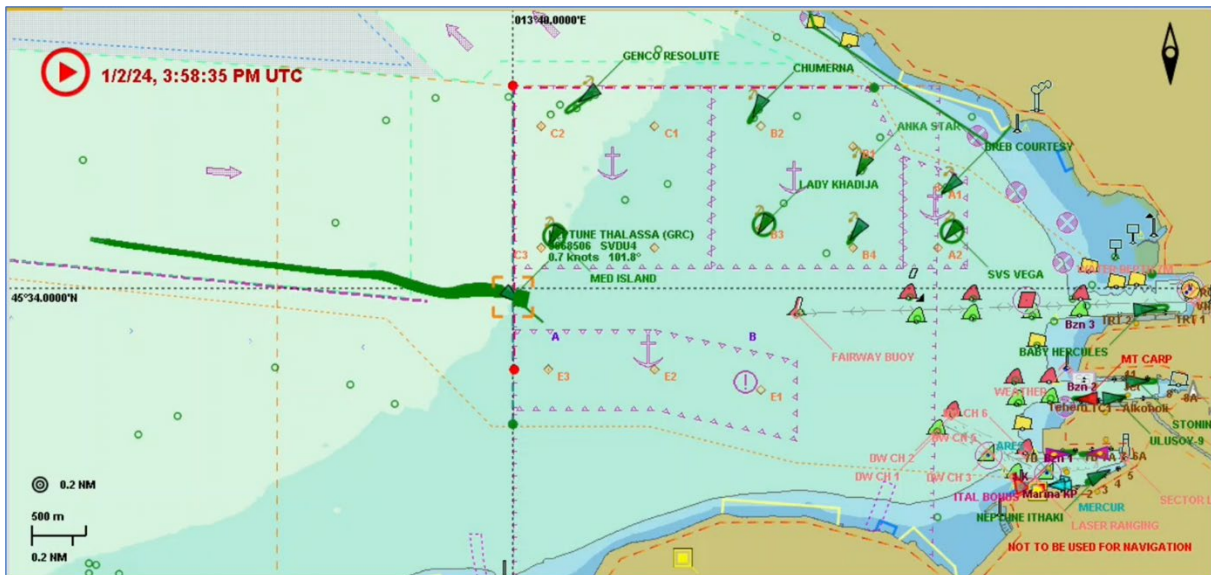
Figure 2: Passing Port limits (source:CNP)

16.58 LT the vessel crossed the Port Limits (Long 0130 40,0' E) and kept proceeding toward P/S "B".

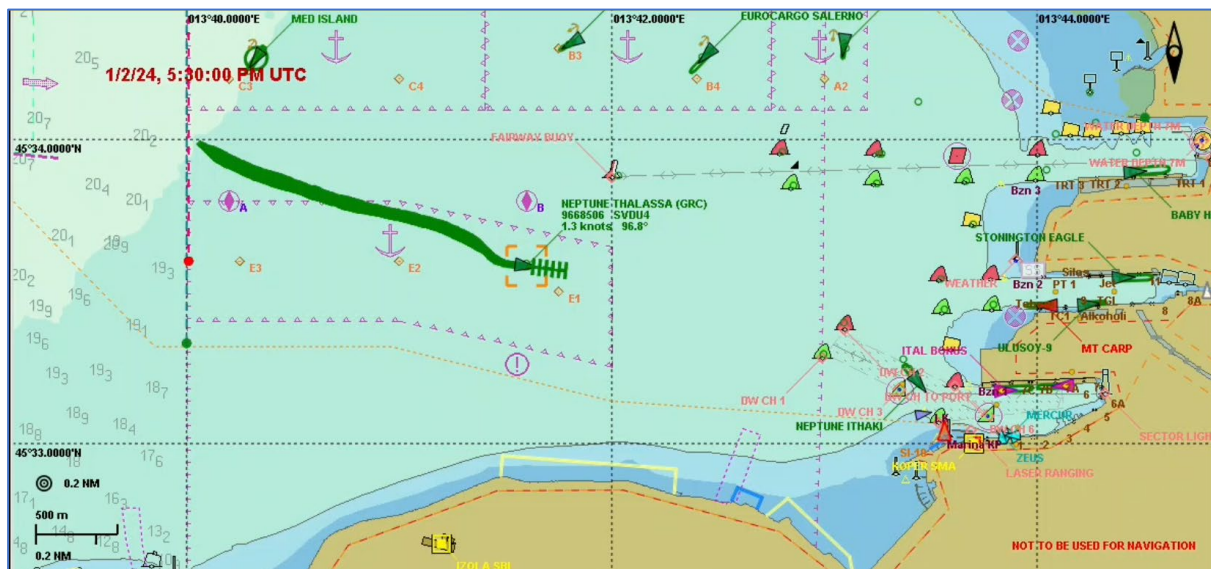
Figure 3: Situation at 18:34, 1st warning to stop the vessel (source:CNP)

At 18:30 vessel passed abeam of P/S, however not stopping, proceeding to Basin I entrance,

At 18:34 Traffic Control Center duty officer warned the vessel and instructed to slow down and wait for the pilot,

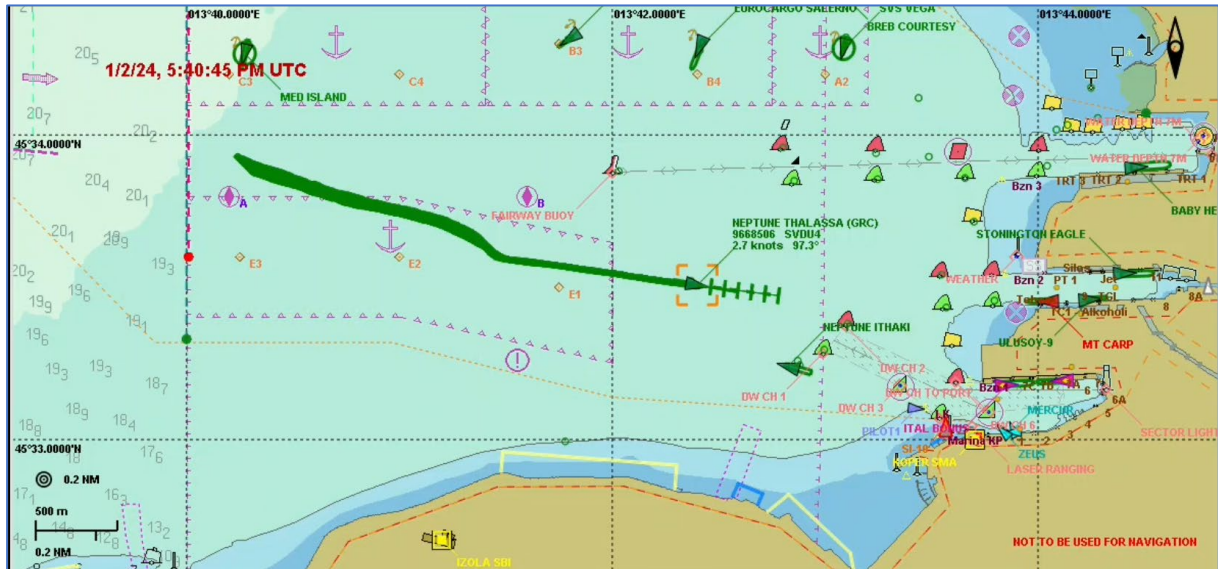
Figure 4: Situation at 18:40, 3rd warning to stop the vessel (source:CNP)

At 18:35 Traffic Control Center duty officer issued second warning and instructed vessel to STOP.

At 18:40 Traffic Control Center duty officer issued third warning and instructed vessel to STOP.

Despite clear instructions from duty officer at SMA Traffic Control Center to not to proceed ahead and to wait a pilot, the ship only stopped at 0,7 Nm after passing P/S “B” toward approach of canal entrance to Basin I. The Master has been warned in total three times to low down and then to stop the vessel. Clearly, the Master did not follow the given instructions about boarding a pilot at a designated pilot station to ensure the safety of navigation. Violation of the of the existing rules clearly and intentionally continued by proceeding without a mandatory pilot toward Basin I Canal entrance in the area where pilotage is mandatory as laid down in Article 81. of the Maritime Code (Official Gazette No. 76/23). Violation has been reported by Traffic Control Center duty office and information was provided to Maritime Inspection Division officer.
