# FINAL REPORT ON THE SAFETY INVESTIGATION OF A LESS SERIOUS MARINE CASUALTY ON BOARD BREB COUNTESS

**Serious occupational injury to a port worker during the loading  
of packaged sawn timber at berth No. 9, Port of Koper  
on 29 May 2026**

Unofficial English translation

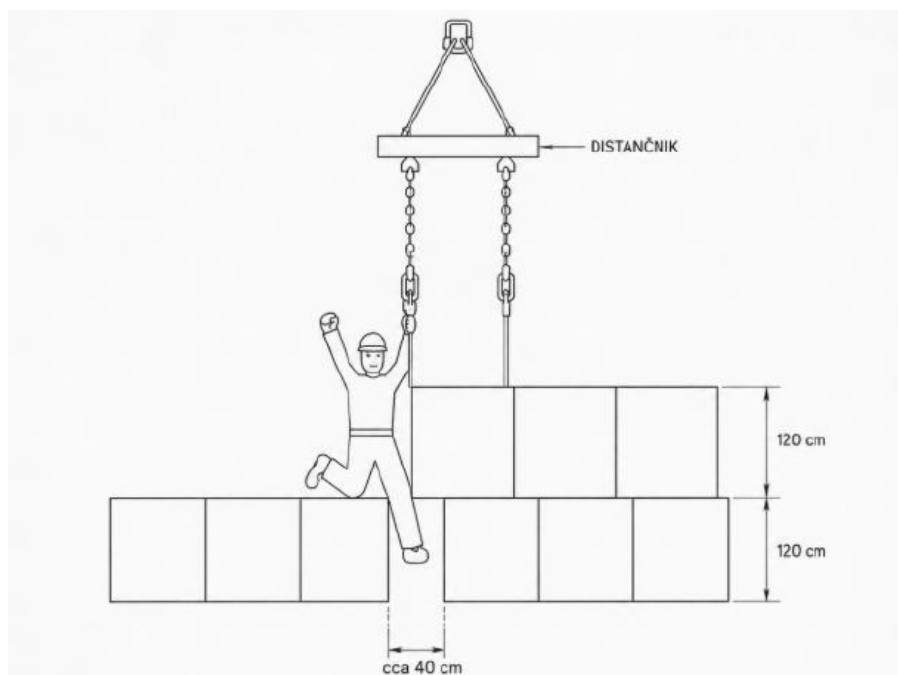
Figure 3: Sketch of the occurrence, source: LK, Event Investigation Record, p. 3/3

At approximately 18:20 local time, the injured port worker was releasing or unhooking lifting belts or chains from a timber bundle that had already been landed on the working surface. While releasing the third of five attached belts or chains, he stepped with his left foot into a residual gap between previously stowed timber bundles. The original gap was approximately 40 cm wide. The next timber bundle had partially covered it, but sufficient space remained for the foot to slip into it.

When the worker lost support, he held on to the attached belt or chain. His body rotated by approximately 45 degrees, causing an injury or dislocation of the left shoulder. The VNC/Incident Management report states that the injured worker said at the scene that he had fallen approximately 1 m into the space between the timber and dislocated his left shoulder. The co-worker or eyewitness confirmed the injured worker's account in a written statement.

The direct cause of the injury was the loss of support when the injured worker stepped with his left foot into a residual opening between previously stowed timber bundles. The original gap was approximately 40 cm wide and was only partially covered by the next timber bundle. When he lost support, the worker held on to the attached belt or chain, his body rotated and this caused an injury or dislocation of the left shoulder.

The investigating body recommends that Luka Koper d.d. / General Cargo Business Unit review the implementation of technological procedure TP 20021 for the loading and stowage of timber bundles and ensure practical, field-feasible measures for controlling temporary or residual openings between timber bundles when workers are still required to access the cargo or working surface in order to release lifting belts, chains or other lifting equipment.
