# FINAL REPORT ON THE SAFETY INVESTIGATION OF A SERIOUS MARINE CASUALTY ON BOARD CMA CGM ADONIS

Occupational Accident of a port worker during the unlashing  
of containers securing equipment at berth 7D, Port of Koper  
on 04 April 2026

Capt. Vladimir Vladović

Izola, May, 25<sup>th</sup> 2026

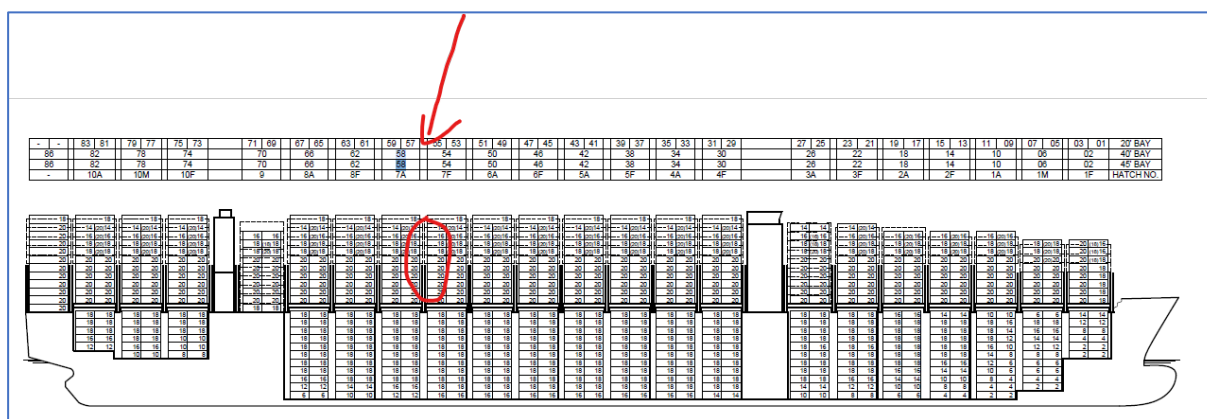
Figure 2: Bay plan indicating the area of Bay No. 58 and the location of the work activity.

The actual work practice deviated from these requirements. V.S. was working alone on the securing arrangement concerned, while the co-worker was positioned on the upper level. The released or previously released turnbuckle was not effectively placed, controlled or secured, and according to the co-worker's statement after the occurrence, it remained hanging downward. Consequently, the safety barrier relating to the control of released securing equipment was ineffective.

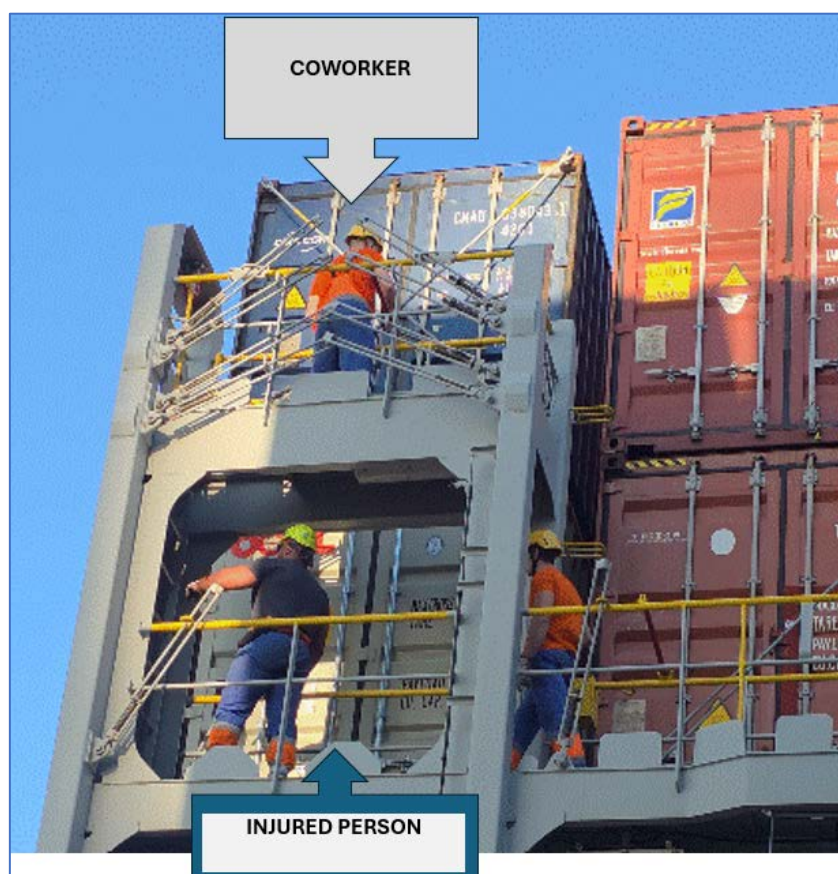
Figure 3: Reconstruction showing vertical relationship between the co-worker on the upper level and the injured worker on the lower level.

**E - Environment:** Weather and visibility conditions were favorable. The key environmental factor was the geometry of the worksite, namely the narrow lashing bridge platform on the seaside of the vessel and the simultaneous work carried out on different vertical levels. Such an arrangement created a direct falling path from the upper working level to the worker positioned below.

- V.S. was positioned below the area where work was being carried out and where released securing equipment was located.
- At the time of the occurrence, V.S. was not wearing the mandatory safety helmet.
- The task concerned was not carried out as controlled paired work, as required by TP 330010.
- Vertical separation between workers operating at higher and lower levels was not maintained.
- Released securing equipment was not immediately and effectively controlled, stowed or secured.
- Due to the nature of the duties of the work process supervisor, field supervision in this specific case did not enable the timely detection and correction of the deviation from the prescribed technological procedure.

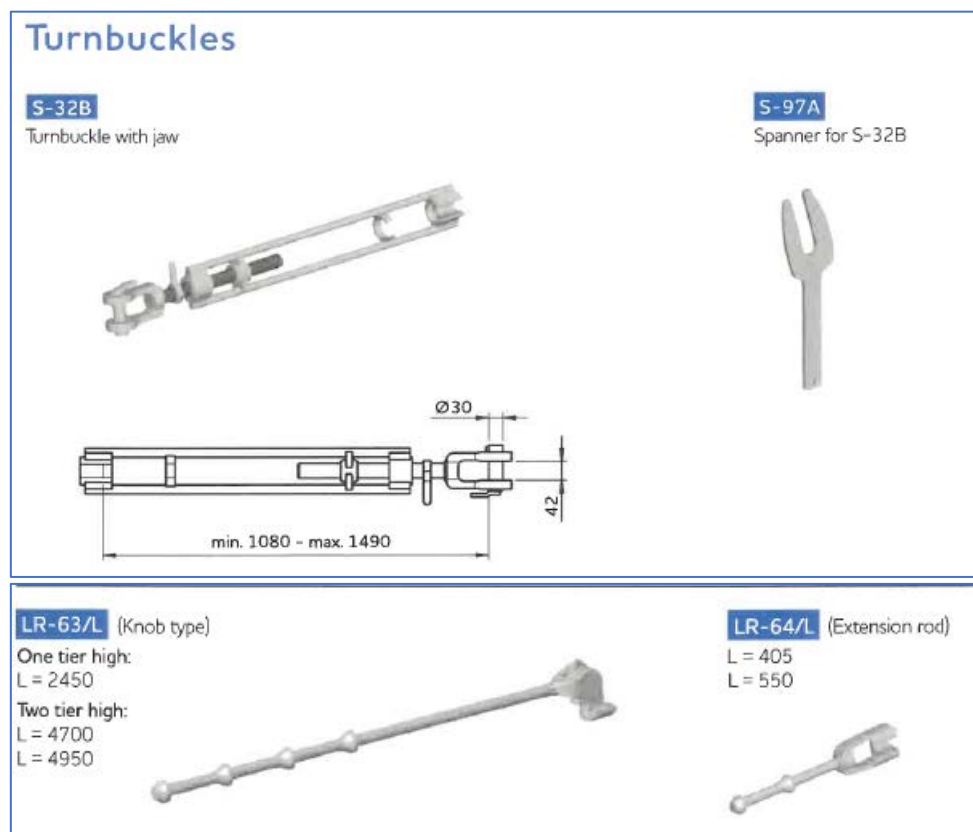
Figure 4: Type of equipment used: S-32B turnbuckle and LR-65B/L lashing rod. The specific turnbuckle involved in the occurrence was not preserved.

**H - Hardware:** The specific turnbuckle involved in the occurrence was not preserved; therefore, a technical examination of its condition could not be carried out. The type of equipment involved was identified as an S-32B turnbuckle and an LR-65B/L lashing bar. The conclusion best supported by the available evidence is the loss of control over the released turnbuckle, rather than a proven mechanical failure of the equipment.

The actual turnbuckle that struck V.S. was not preserved; therefore, its technical condition and any possible damage could not be examined. Co-worker E.R. was unable to explain why the previously released turnbuckle had fallen or rotated downward. Consequently, the precise physical mechanism of the fall remains partially undetermined.

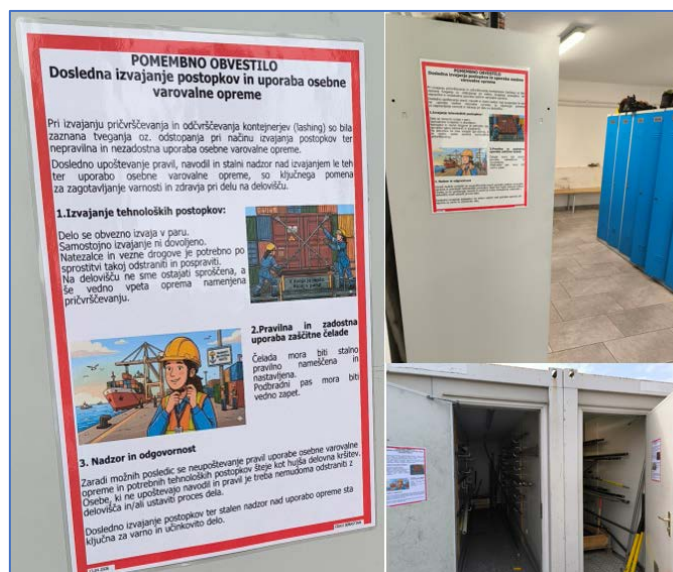
Figure 5: Example of the safety notice displayed following the occurrence

The above-mentioned safety action is assessed as relevant and timely. It addresses the immediate safety barriers identified in the occurrence under investigation, namely the proper implementation of paired work, control of released securing equipment, correct use of head protection, and supervision of compliance with prescribed requirements.

The displayed poster stated that lashing and unlashings operations must be carried out in pairs, that individual work was not permitted, that released turnbuckles and lashing bars must be immediately removed and properly stowed, and that safety helmets must be correctly worn with the chin strap fastened. The notice further stated that failure to comply with PPE requirements and prescribed procedures could result in removal from the workplace and/or suspension of the work process.
