Number: 010-138/2008/402

Date: 27 November 2008

## FINAL REPORT ON THE INVESTIGATION INTO THE RAILWAY ACCIDENT AT THE CEŠČA VASPRI NOVEM MESTU LEVEL CROSSING ON 20 AUGUST 2008

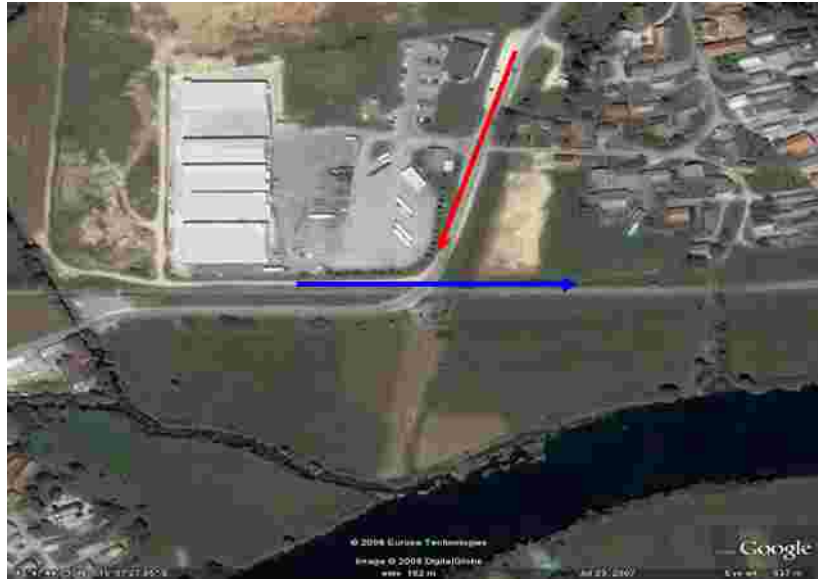
Figure no. 1: Bird's eye-view of the travelling direction of the car and the train

The red arrow shows the local road and the direction in which the road vehicle was moving, and the blue arrow shows the railway line and the direction in which the train was moving.

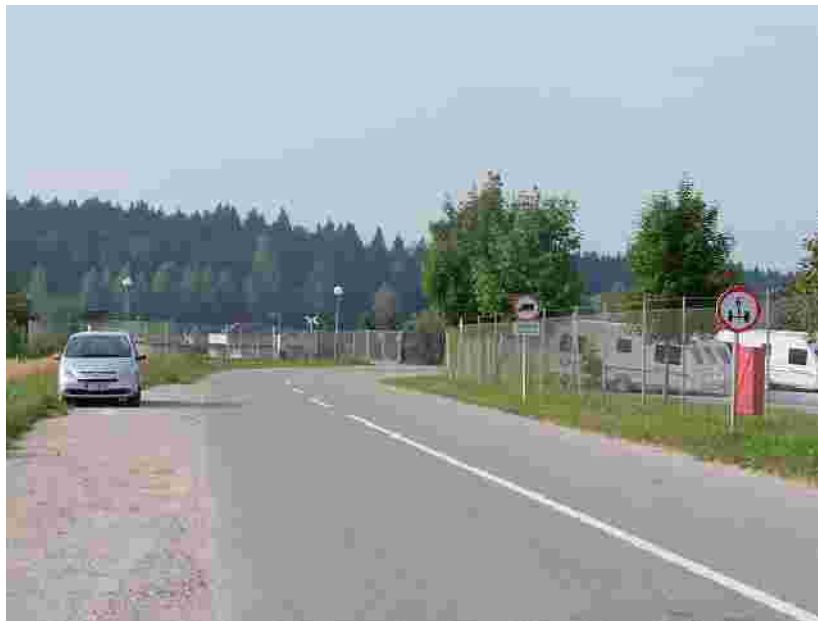
The indirect cause of the accident, revealed during the investigation, was the insufficiently marked level crossing, which does not warn road users, i.e. drivers of road vehicles, in good time of the approaching unprotected level crossing. A clear view over the level crossing is blocked by trees when they are in full leaf, as well as by an enclosed private area along the road where caravans were parked at the time of the accident. The view of the St Andrew's Cross sign is blocked by treetops for road vehicles travelling from the direction of Novo Mesto towards Zalog, and the sign only becomes visible 59 m before the level crossing.

Photo no. 2: Visibility of the level crossing at the time of the accident.

Given the direct cause revealed by the accident investigation and in order to ensure the safety of road users, we recommend that additional signs should be installed at distances of 240, 160 and 80 metres.

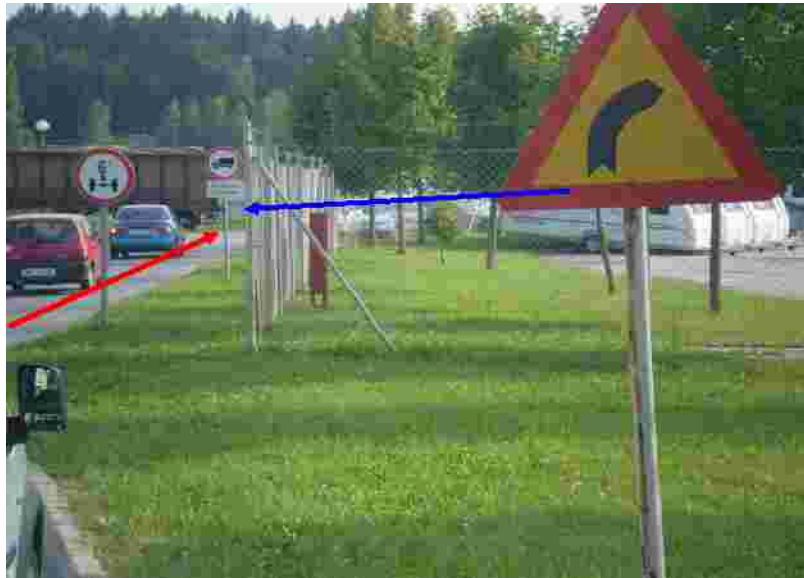
Figure no. 2: The red arrow shows the direction of the travelling road freight vehicle while the blue arrow shows the direction of the travelling train.

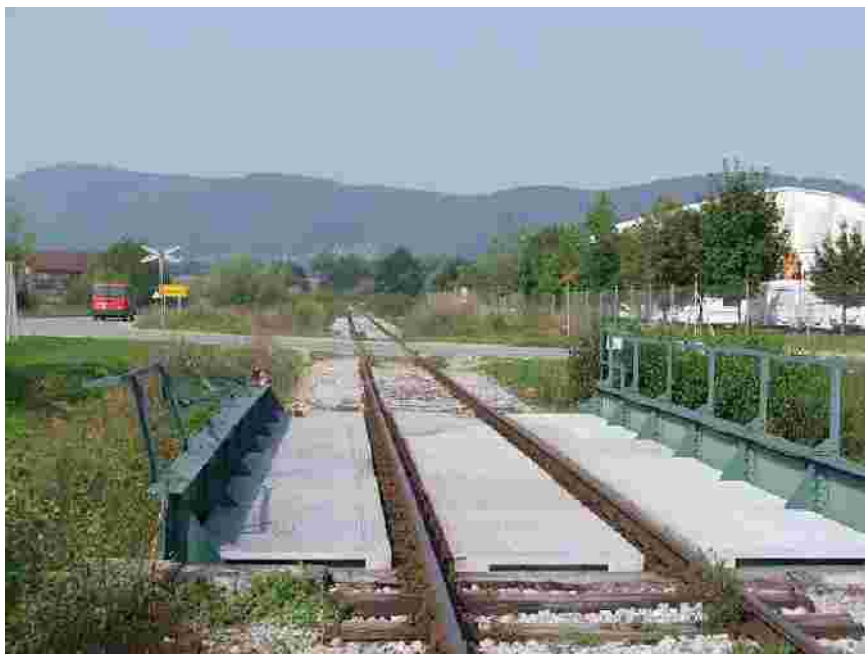
Figure no. 4: Level crossing at Češca Vas, which is an organised level crossing provided with traffic signs – two St Andrew's Crosses.

The level crossing at Češca Vas is not protected with barriers or half-barriers and there are no warning lights for road users to be alerted to approaching trains. There are only road signs – a St Andrew's Cross on either side of the railway line at the level crossing.

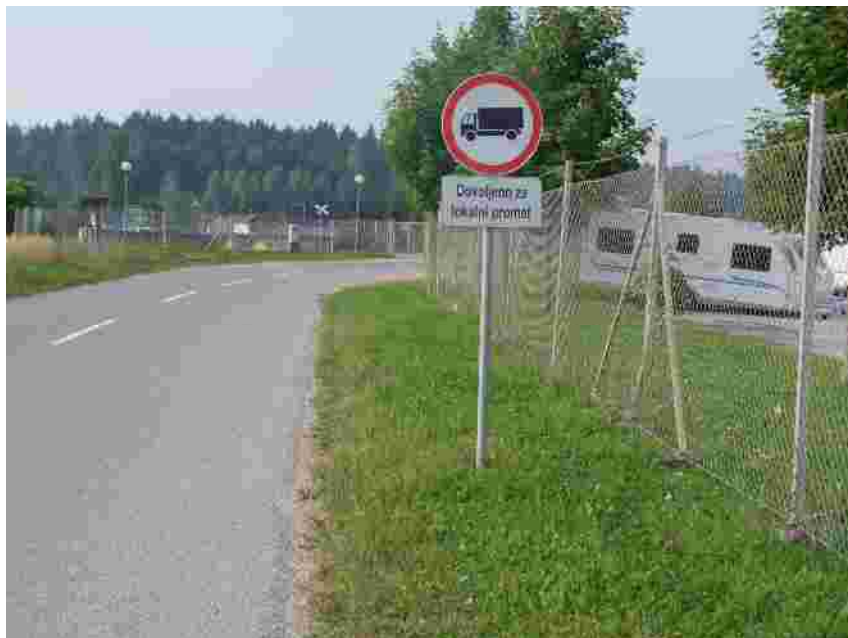
The vegetation and caravans in the yard in the vicinity of the road strongly hindered a clear view of the level crossing of both road users as well as train drivers. At this time of year, there is dense vegetation.

Figure no. 7: View of the level crossing, obstructed on account of the lush vegetation causing poor visibility.

One of the indirect causes of the accident was the insufficiently marked level crossing, which – at this time of year on account of the lush vegetation – is not clearly visible and the railway line hardly noticeable when the train is travelling from the direction of Straža towards Novo Mesto and road vehicles from the direction of Bršljin towards Zalog.

Another indirect cause of the accident was poor visibility at the level crossing due to parked caravans blocking the view of road and rail drivers alike.

On account of poor visibility of the railway line and of the St. Andrew's Cross road sign, blocked by vegetation at the Češca Vas level crossing from the direction Bršljin towards Zalog, we recommend:

- additional marking of the level crossing for the benefit of road users by means of I-37 road signs (approaching the level crossing of the road with a railway line without barriers or half-barriers);
- reducing the maximum permitted speed of road vehicles at an appropriate distance before the level crossing, for the Bršljin-Zalog direction, from the present 50 km/h down to a maximum 30 km/h.
