Ref. No: 375-14/2009/6

Date: 5 October 2009

**FINAL REPORT ON INVESTIGATION OF A RAILWAY ACCIDENT –  
COLLISION OF PASSENGER TRAIN NO. 2803 WITH ROAD  
FREIGHT VEHICLE AT THE CONSTRUCTED LEVEL CROSSING  
MARKED WITH ROAD SIGNS BETWEEN BLANCA AND SEVNICA  
STATIONS AT KM 481+840**

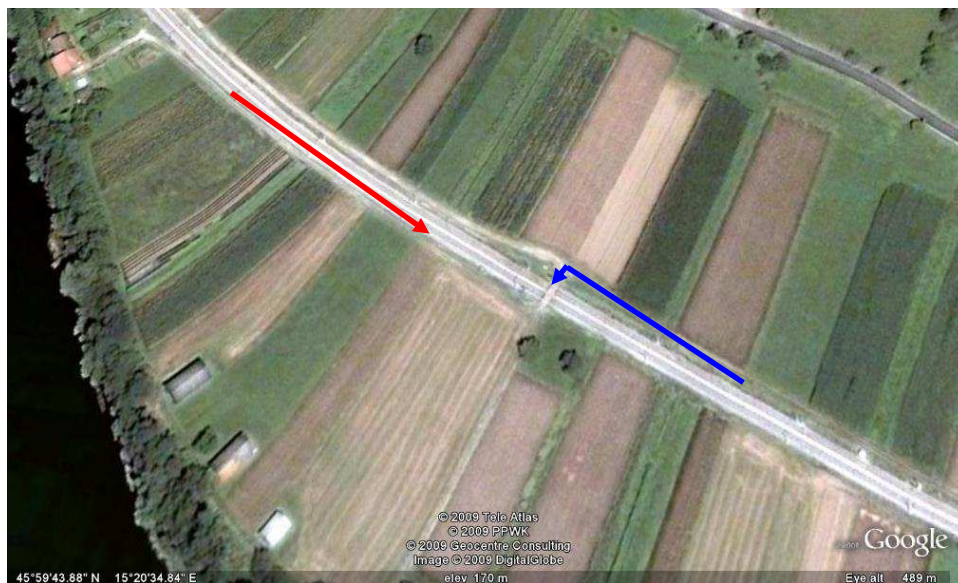
The road freight vehicle, a Fiat Doblo, was totally wrecked while the front and the automatic coupler of electric motor unit 312-119 were damaged. When the train was pushing the vehicle forward on the left-hand track, three switches for the automatic protection of the level crossings were damaged.

Figure 1: The blue arrow shows the direction of the road freight vehicle while the red arrow shows the direction of the local passenger train

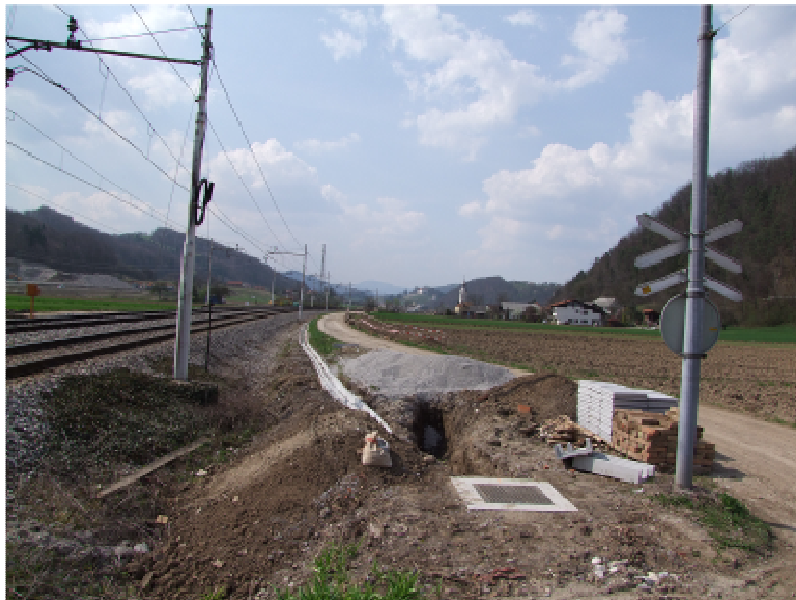
Ahead of the level crossing, there is a slight bend in the road running parallel to the railway line. The sighting distance of road users at the level crossing is 370 m for trains approaching from Sevnica and 399 m for trains from Blanca.

Figure 2: Visibility or view of the railway line from the level crossing in the direction of Sevnica

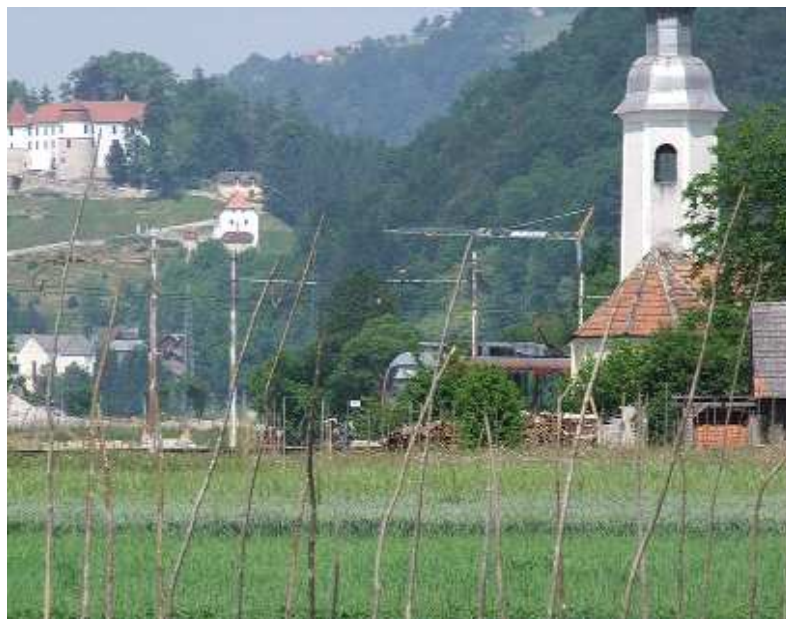
Figure 3: Train coming into a road user's view

It is possible that the driver while driving towards the level crossing observed the railway line in the direction of Sevnica and, since he did not see a train because the latter was at that moment hidden behind the bend, believed that no train is coming from this direction. For this very reason, immediately ahead of the level crossing he probably focused on checking for trains in the direction of Blanca. At the moment he entered the danger zone of the level crossing, he suddenly saw the train approaching on his left along the left-hand track.
