MINISTRSTVO ZA PROMET

Number 375-15/2009/7

Date: 30 October 2009

**FINAL REPORT ON THE INVESTIGATION INTO THE RAILWAY  
ACCIDENT – RAIL WORKS MANAGER RUN OVER BY FREIGHT  
TRAIN NO 52102 ON THE LEFT-HAND TRACK BETWEEN RAILWAY  
STATIONS LAŠKO AND RIMSKE TOPLICE AT KM 514+930**

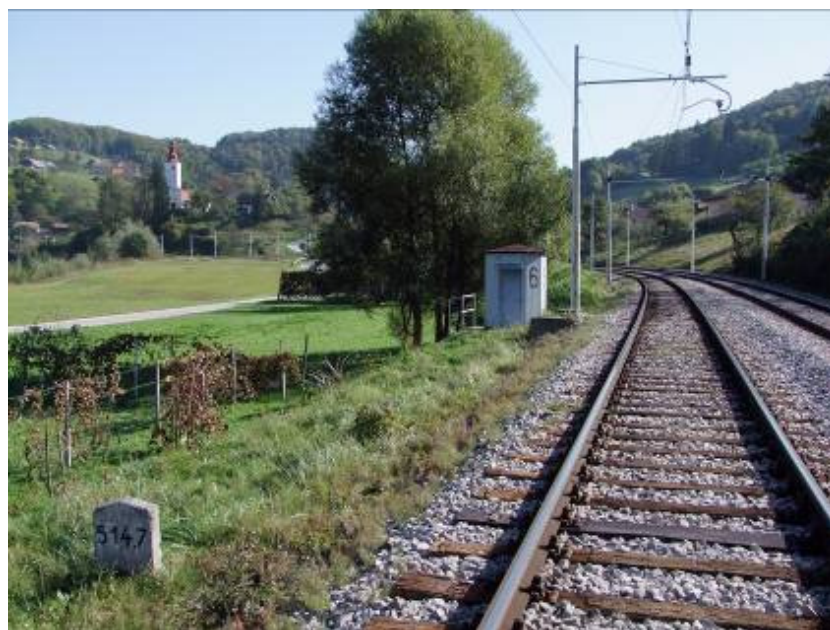
Because of the left-hand curve, the railway line cutting, a residential building and the vegetation at the left-hand side of the railway line ahead of the accident site, the field of vision of the locomotive driver of train no 52102 was reduced to 150 m.

Figure 2: Reduced visibility on the left-hand railway track, 230 m before the accident site

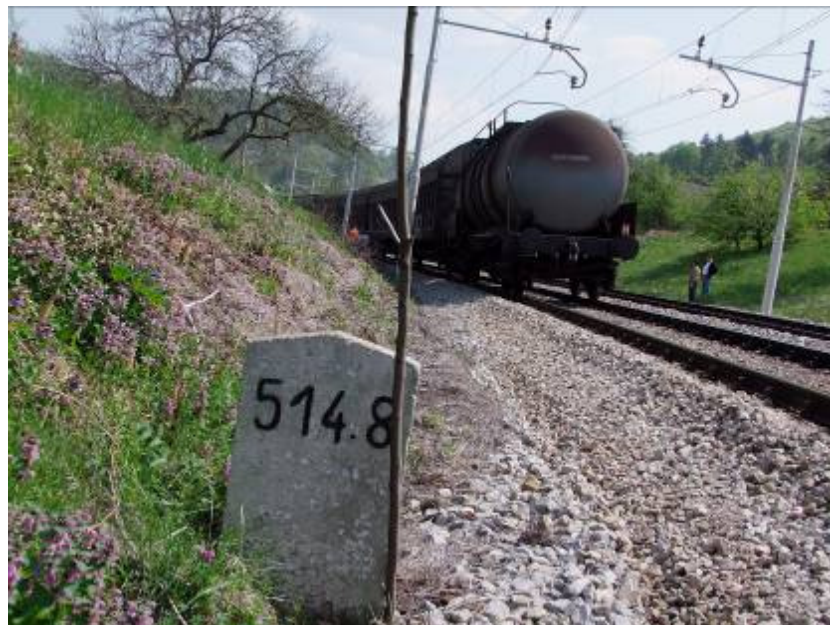
Figure 3: The rear of stopped train no 52102 located at km 514+848

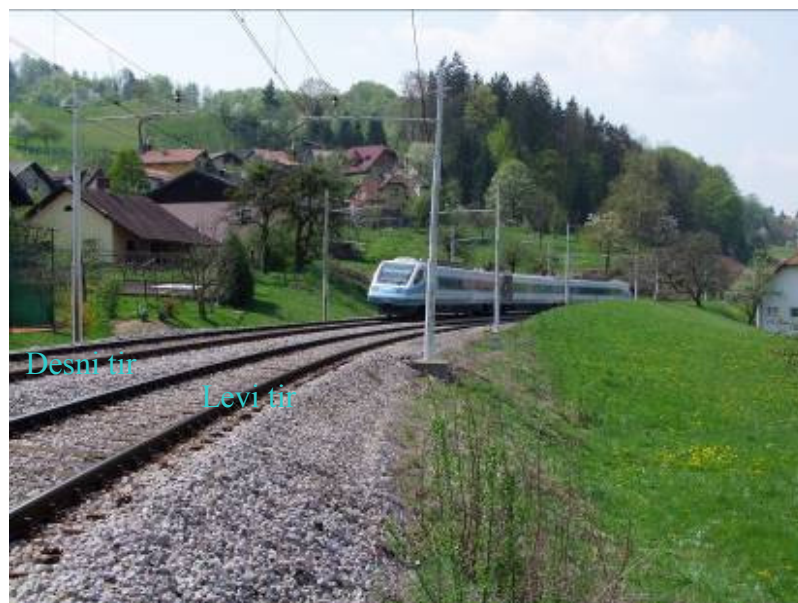
One of the reasons for the rail works manager’s walk in the very track of this section may also have been the fact that it was difficult to walk next to the track because of the rising ground continuing immediately under the railway ballast and because of the drainage duct for rainwater.

Figure 4: Layout of the terrain at the left-hand track in the area where the rail works manager was walking in the left-hand track
