SEKTOR ZA PREISKOVANJE ŽELEZNIŠKIH NESREČ IN INCIDENTOV

Number: 375-21/2009/9

Date: 14 May 2010

FINAL REPORT ON INVESTIGATION INTO A RAILWAY ACCIDENT – COLLISION OF FREIGHT TRAIN NO. 42772 WITH PASSENGER VEHICLE

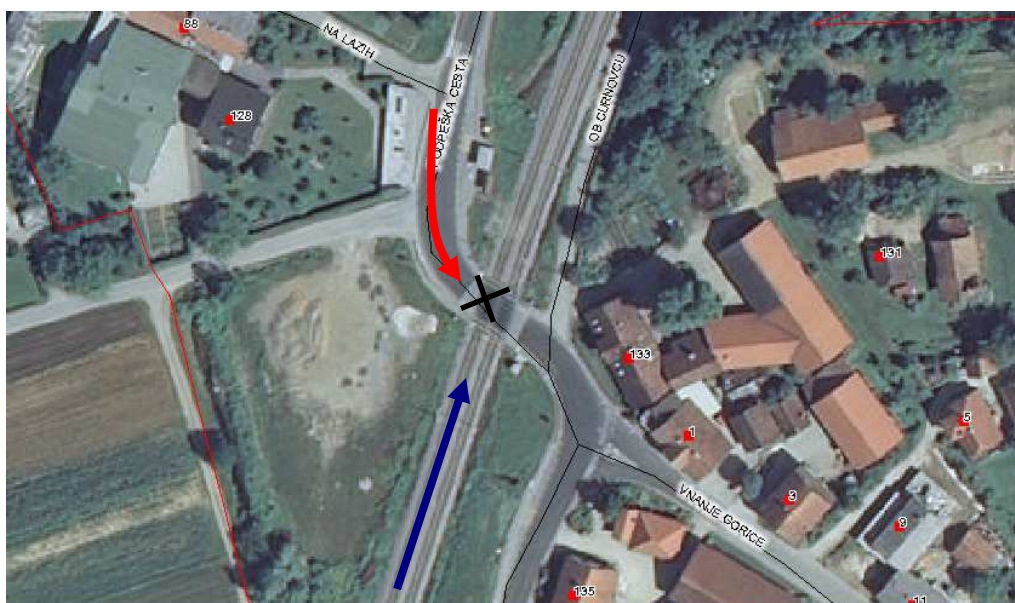
At a speed of 75 km/h, train no. 42772 hit the right-hand side of the passenger vehicle with the front of its locomotive, pushing the vehicle a distance of 327.8 m before it stopped. The passenger vehicle became attached to the fender and the coupler at the front of the traction vehicle and ended up wedged under it.

Figure 1: View of travelling direction of train and passenger vehicle, and site of the collision

Since lowered half-barriers are often circumvented at level crossings designed in such a way that the lowered half-barrier protects only half of the road (the lane in the travelling direction and not the opposite lane), gradual modification of protection at this type of level crossings with half-barriers for both lanes from both directions or barriers covering the entire width of the road is recommended.

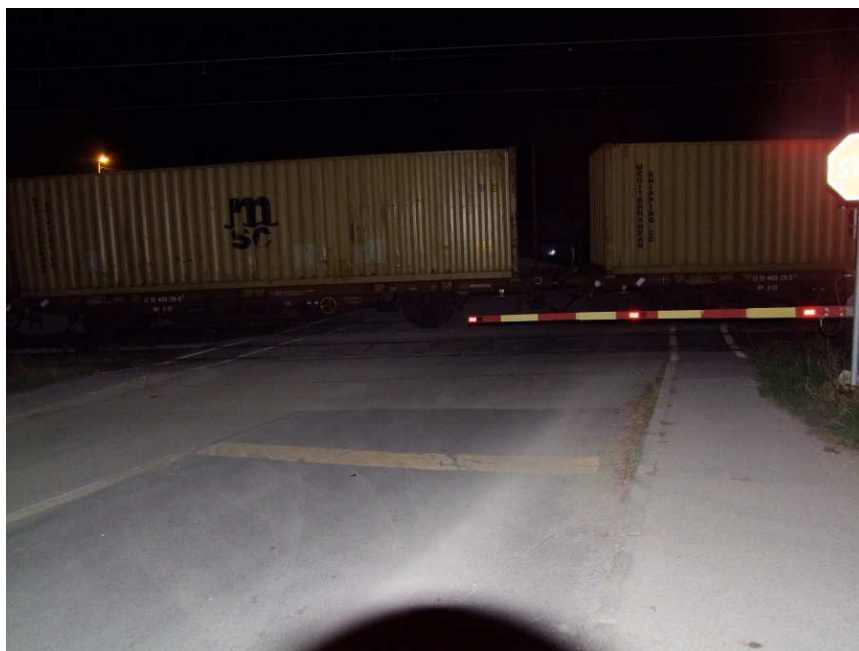
Figure 2: Functioning of the device for protection of the level crossing immediately after the accident when the train involved in the accident was still standing on the level crossing and the consequences of the accident were being removed.

The NPr-4 Vnanje Gorice device protecting the level crossing at km 575+460 was in perfect working order at the time of the accident. The half-barriers were horizontally lowered across the road.

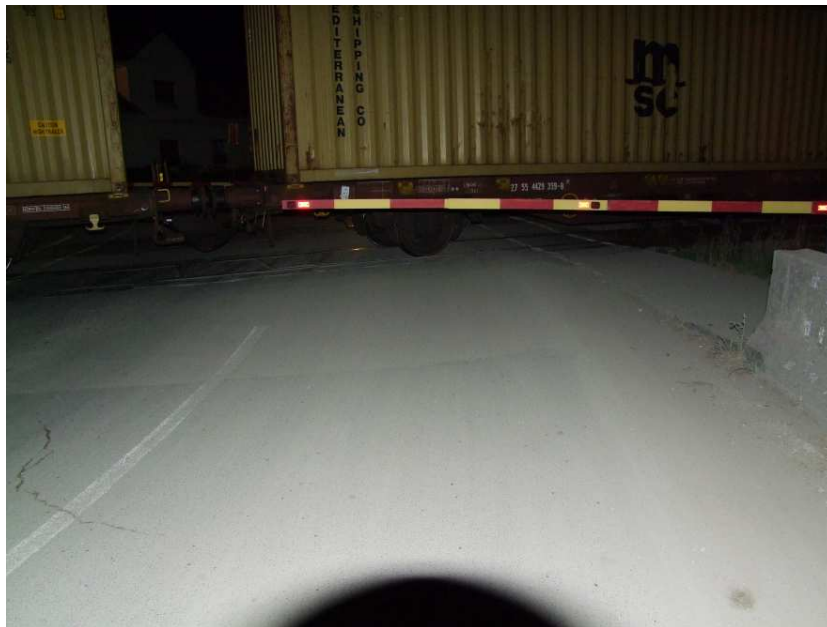
Figure 3: Half-barrier at Vnanje Gorice level crossing reaches as far as the illustrated point

It was established during the investigation that the direct cause of collision between train no. 42772 and the passenger vehicle at the level crossing with half-barriers between Brezovica and Preserje stations at km 575+460 was the driver of the passenger vehicle, who failed to give way and thus tempted fate, and who, despite the fact that the signalling and safety devices at the level crossing were in perfect working order and the half-barriers were lowered, thus unmistakably warning road users of the approaching train, drove his vehicle onto the opposite lane, circumvented the lowered half-barrier and drove in front of the locomotive.

Where level crossings are fully protected, i.e. where barriers or half-barriers extend over the entire width of the road, road users always stop in front of the barrier, since otherwise they would damage their vehicles by breaking the barrier or half-barrier.

Since lowered half-barriers are often circumvented at level crossings where the lowered half-barrier protects only half of the road, i.e. the lane in the travelling direction and not the opposite lane, a gradual modification of protection at this type of level crossings with half-barriers for both lanes from both directions or barriers extending over the entire width of the road is recommended.
