REPUBLIKA SLOVENIJA
MINISTRSTVO ZA INFRASTRUKTURO IN PROSTOR

SLUŽBA ZA PREISKOVANJE NESREČ

Number: 375-30/2010/2
Ref. No.: 00031020

**FINAL REPORT ON THE INVESTIGATION OF A RAILWAY ACCIDENT – COLLISION OF
REGIONAL PASSENGER TRAIN NO. 2615 WITH A LIGHT GOODS ROAD VEHICLE AT
HALF-BARRIER PROTECTED LEVEL CROSSING
"LEVEL CROSSING – VNANJE GORICE", AT KM 575+460, BETWEEN VNANJE GORICE
AND PRESERJE STATIONS**

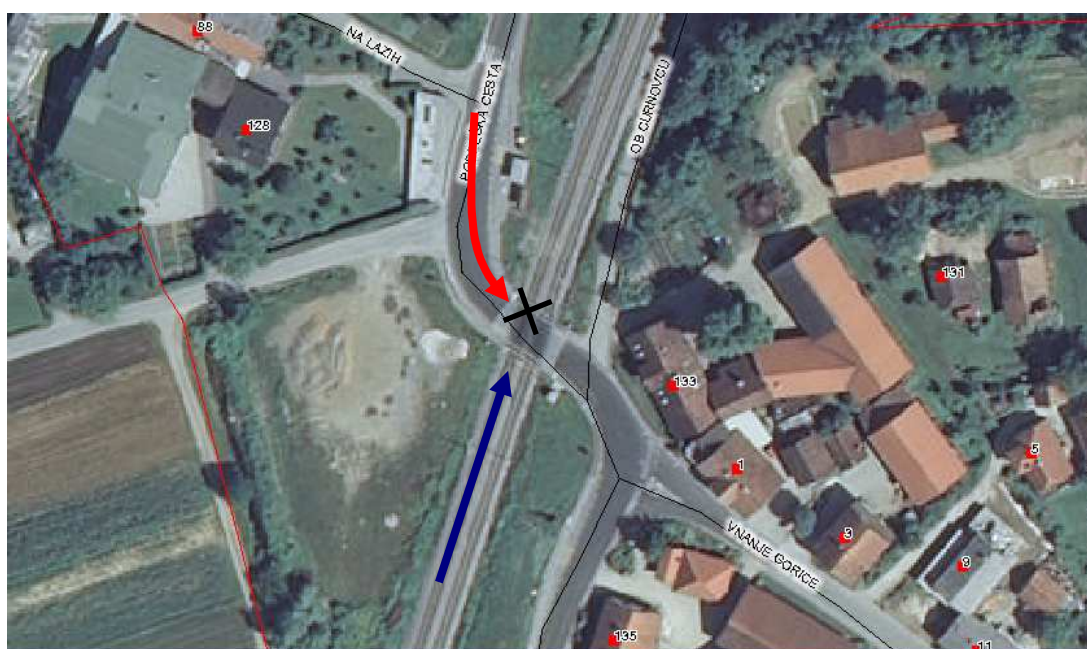
Figure 1: The travelling direction of the train is indicated by a blue arrow, the travelling direction of the road goods vehicle by a red arrow and the site of the collision by a black cross

The direct cause of the accident was the driver of the light goods vehicle tempting fate by circumventing the lowered half barrier and driving onto the right-hand track at the moment when regional passenger train no. 2615 entered the level crossing along this track.

The indirect cause of the accident can be attributed to the type of level crossing protection in use, which enables road users to simply circumvent the lowered half barriers and drive onto the part of the road intersecting the railway line. Special consideration should be given to level crossings in urban settlements.

Since road vehicles frequently circumvent lowered half barriers at level crossings where the lowered half barriers protect only one half of the road, i.e. the lane in the travelling direction and not the opposite lane, a gradual modification of protection at this type of level crossing, with half barriers for both lanes from both directions or barriers extending over the entire width of the road, is recommended.

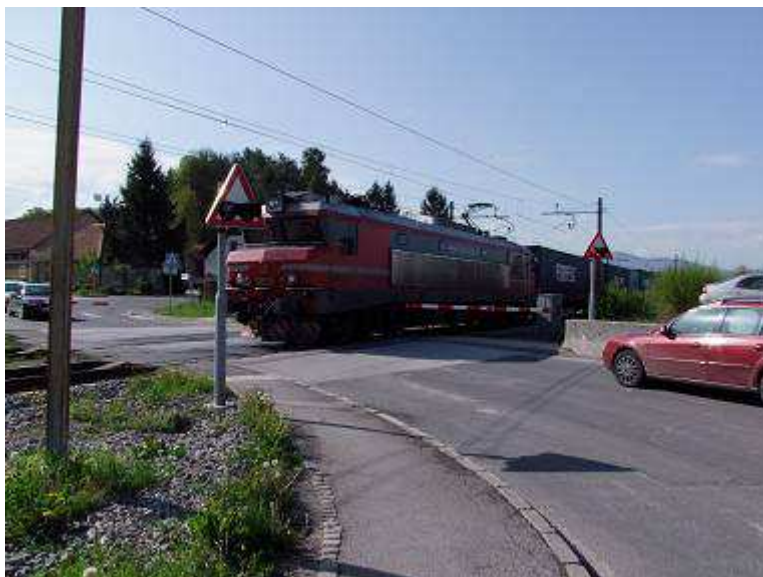
Figure 3: Display of level-crossing protection during the passage of trains

The device is equipped with two half barriers closing the two driving lanes in front of the level crossing and with three light and acoustic signals.

activation of the device, the flashing lights on the light and acoustic signals turn on and flash alternately at a frequency of 1 Hz (1 flash per second). At the same time, warning bells are also activated; these sound with the same frequency as the flashing lights. After the 'pre-ringing time' has passed, i.e. after 15 seconds of the lights flashing and the bells sounding, the half barriers begin to lower. When, during lowering, the half barriers reach the position of an 85° angle to the road, the flashing position lights installed on the road side of the half-barrier arms turn on. When the half barriers reach a 10° angle to the fully lowered position, the bells turn off, while the lights remain flashing while the device protecting the level crossing is turned on, i.e. until the half barriers are in the fully raised position again (at an angle of 90° to the road). The half barriers take 10 seconds to lower.
