**SUMMARY OF THE FINAL REPORT**

**ON THE INVESTIGATION OF THE ACCIDENT INVOLVING**

**DG-808C, REGISTRATION D-KEAJ**

**ON 4 MAY 2016 IN THE AREA OF GRAŠKA GORA**

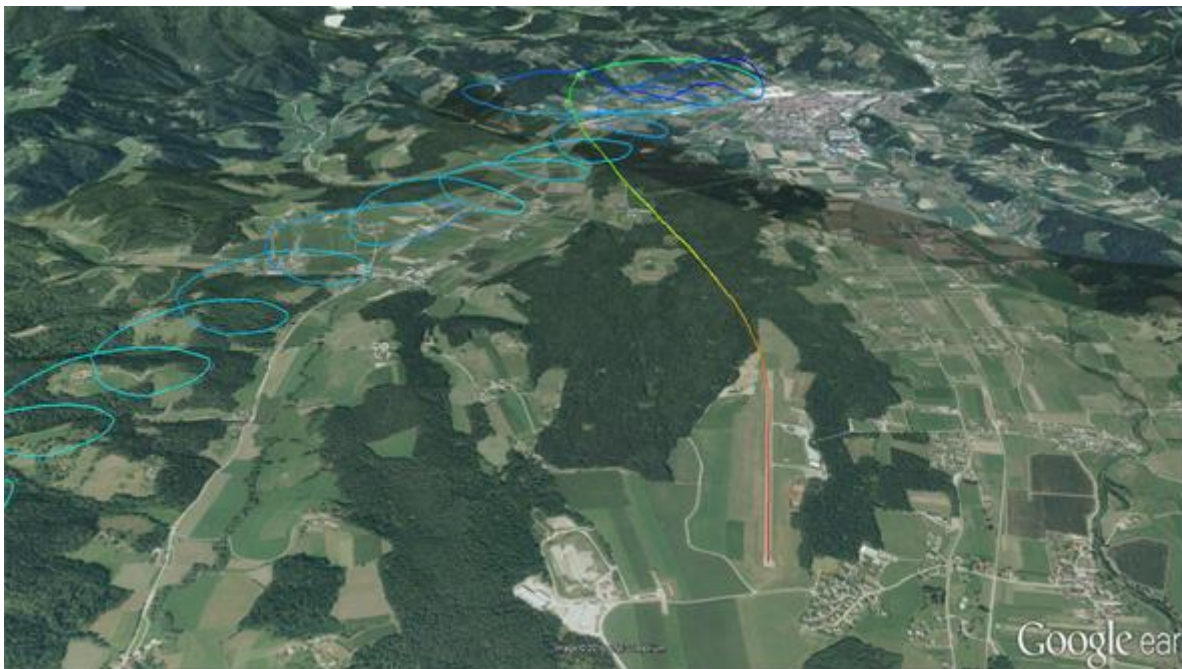
With the engine running, the aircraft entered a regime of steady left-hand orbits with a gentle descent, in which the bank angle remained within a narrow range (estimated at approximately 50–55°) for the entire remainder of the flight, with no tendency to increase or to level out. During this time, the strong northerly wind gradually drifted the aircraft towards the Graška Gora area. After just under ten minutes of flight in this regime, with no recorded attempt to correct the heading, reduce engine power or transmit a distress call, the aircraft – without at any time rolling out of the orbit – collided with a wooded slope at an elevation of 819 m. The aircraft was completely destroyed on impact and the pilot sustained fatal injuries.

*Figure 1: Flight path of the aircraft prior to the crash*

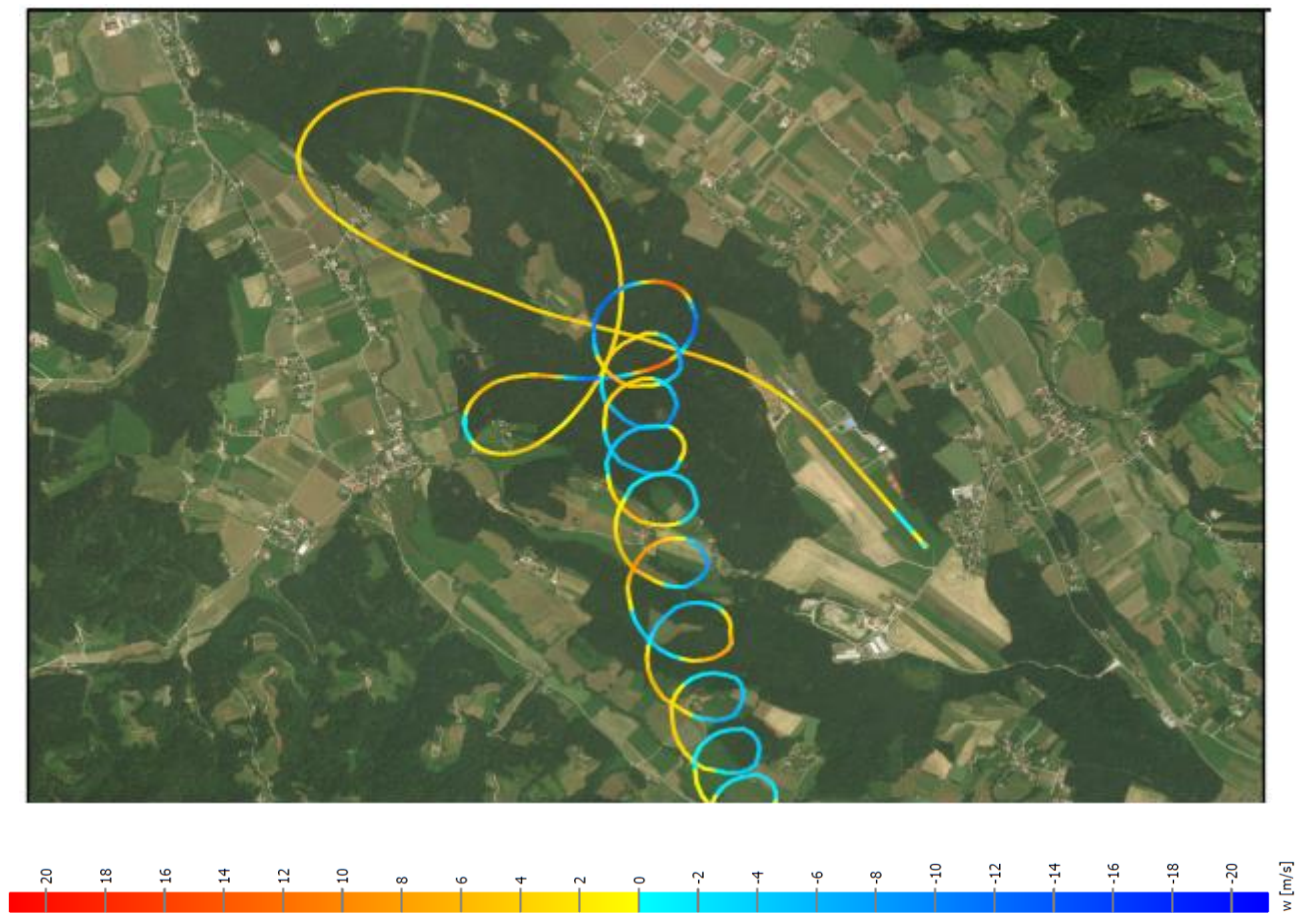
Figure 2: Flight profile showing climb and descent values

- **07:08:37 LT (Climb):** Normal take-off from runway 32 at Slovenj Gradec Aerodrome. Within 5 minutes and 17 seconds the aircraft climbed to an altitude of 1,337 m AMSL (rate of climb 2.7 m/s, average speed 133 km/h), with continuous and uninterrupted operation of the SOLO 2625 01 engine (high ENL signal level).

- **07:13:54 LT (Onset of the critical event):** After reaching 1,337 m AMSL, the aircraft suddenly entered a steep and continuous left turn. From this point onwards, the telemetry recorded no deliberate control inputs by the pilot.

- **07:13:54 – 07:23:28 LT (Steady left-hand orbits):** For 9 minutes and 34 seconds, the aircraft flew steady left-hand orbits with a radius of about 200 m (one revolution every 20–25 seconds) and an average bank angle of about 50–55°, which did not change significantly throughout the interval. The average speed of 186 km/h considerably exceeded the speed during the preceding climb (133 km/h), while the average rate of descent was 0.9 m/s. Within individual orbits, the vertical speed fluctuated between approximately –12 m/s and +13 m/s, indicating unsteady altitude oscillation within each orbit rather than a steady, controlled descent. The engine operated at full power throughout, with no attempt to reduce throttle, level the wings or transmit a distress call, and the aircraft did not roll out of the orbit even in the last recorded seconds before impact. The strong wind
