# FINAL SAFETY REPORT OF LESS SERIOUS MARINE CASUALTY FOR PILOT BOAT KP-965

Contact with mooring buoy in Basin I of Port of Koper  
14. 04. 2026

Maritime Accidents and Incident Investigator

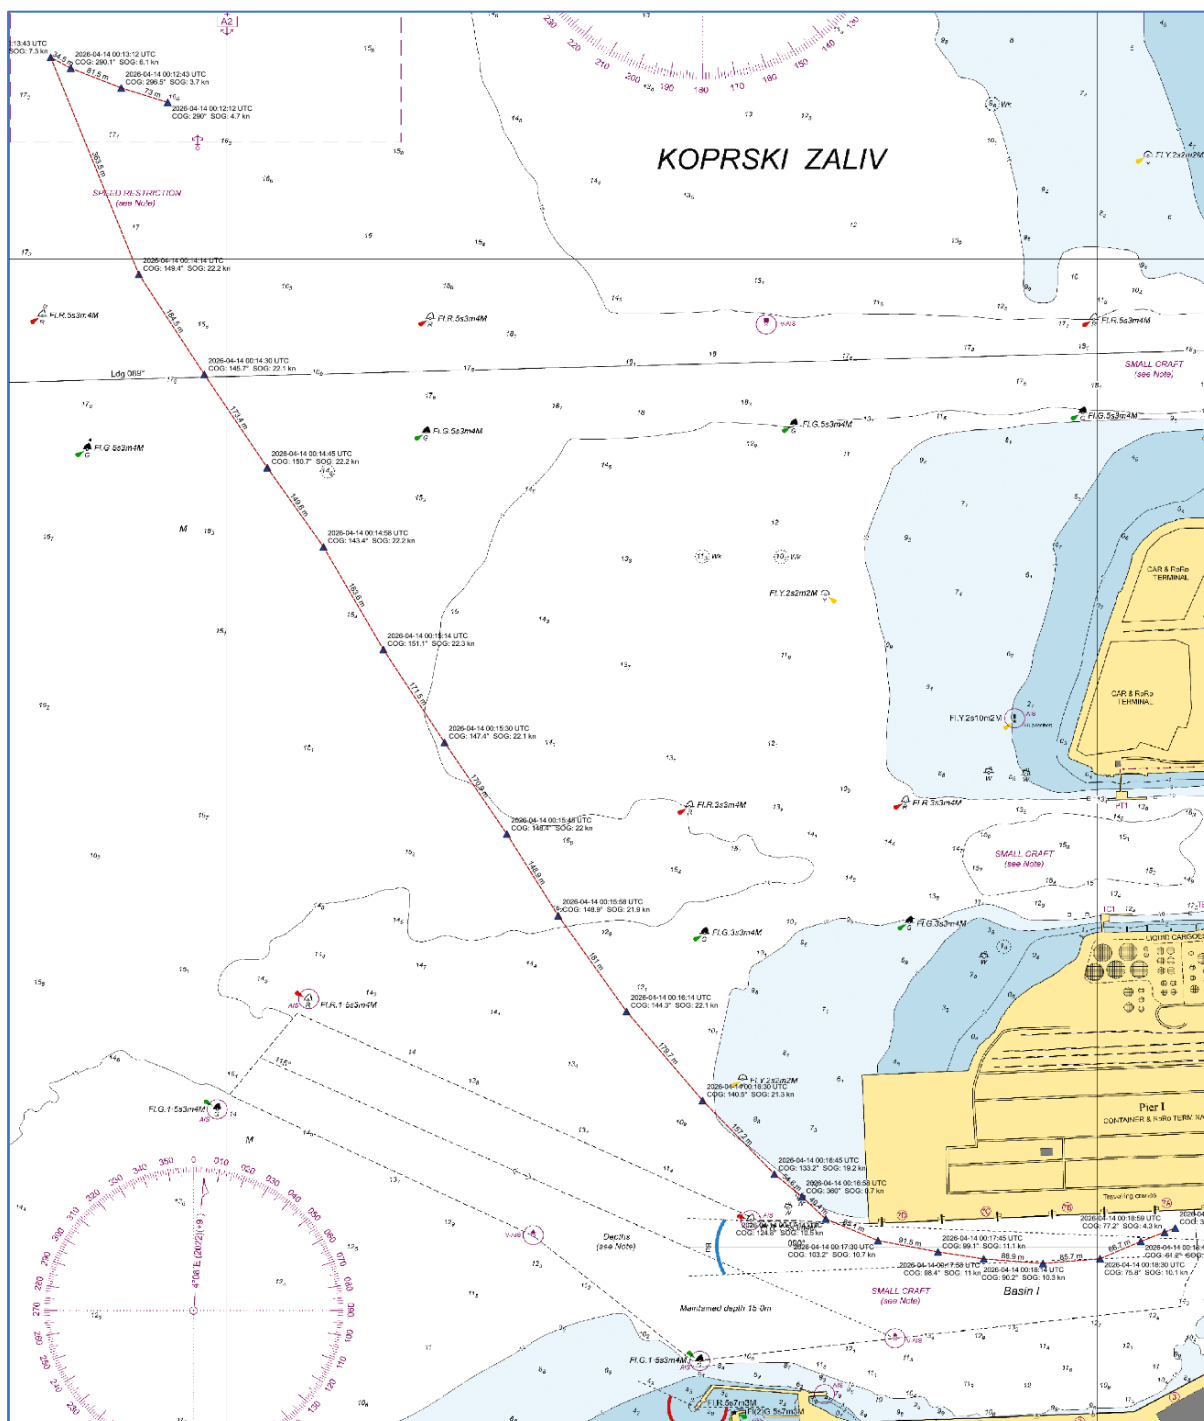
Figure 2: Reconstruction of the KP-965 track based on raw VTS/AIS records. Source: SMA

Following the transfer, KP-965 accelerated to approximately 22 knots. The operator intended to proceed along a safe track outside the area of the mooring buoys, but according to his own statement he temporarily lost active monitoring of the intended track. Before the high-speed night passage, no explicit allocation of lookout and cross-checking duties had been agreed. Because one seat was under repair, the crew member was seated aft on the port side, with restricted forward visibility and without direct access to the navigation displays; the pilot monitored the passage passively.

It is recommended that KOPP define and implement operational criteria for the safe speed of pilot boats when navigating between port basins, particularly at night and in the vicinity of mooring infrastructure, considering visibility, available maneuvering space, lookout and navigation equipment.

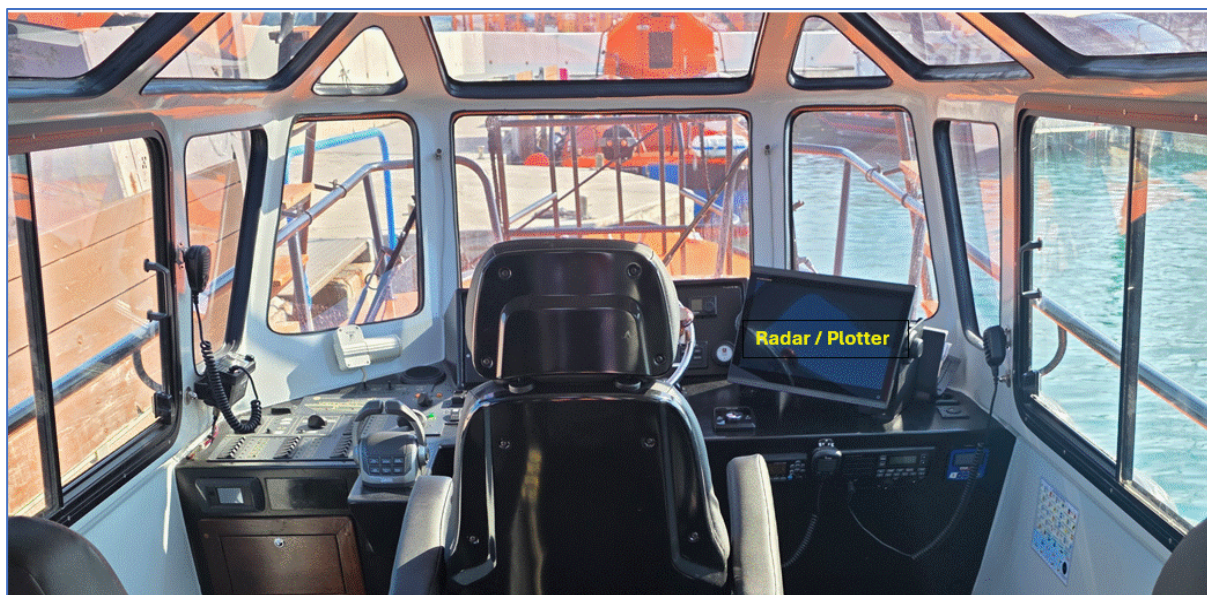
Figure 4: Forward view from the cabin and position of the radar/plotter. Source: MAIIS.

| Element | Finding |
|---|---|
| H – Hardware | Propulsion, steering, radar and plotter showed no technical failure before contact; the buoys were not visible on the electronic display. One seat was under repair. |

| Barrier | Observed condition | Assessment |
|---|---|---|
| Radar / plotter | The equipment was operational, but the buoys were not visible on the display; radar cross-check was not demonstrated. | Degraded |

It is recommended that KOPP standardize the use of radar, plotter and other navigation sources, including verification of the suitability of chart data, display limitations, selection of an appropriate scale and mandatory cross-checking of position and hazards. Any discrepancies identified between official nautical charts and electronic displays on pilot boats should be recorded, assessed in terms of risk and appropriately addressed.

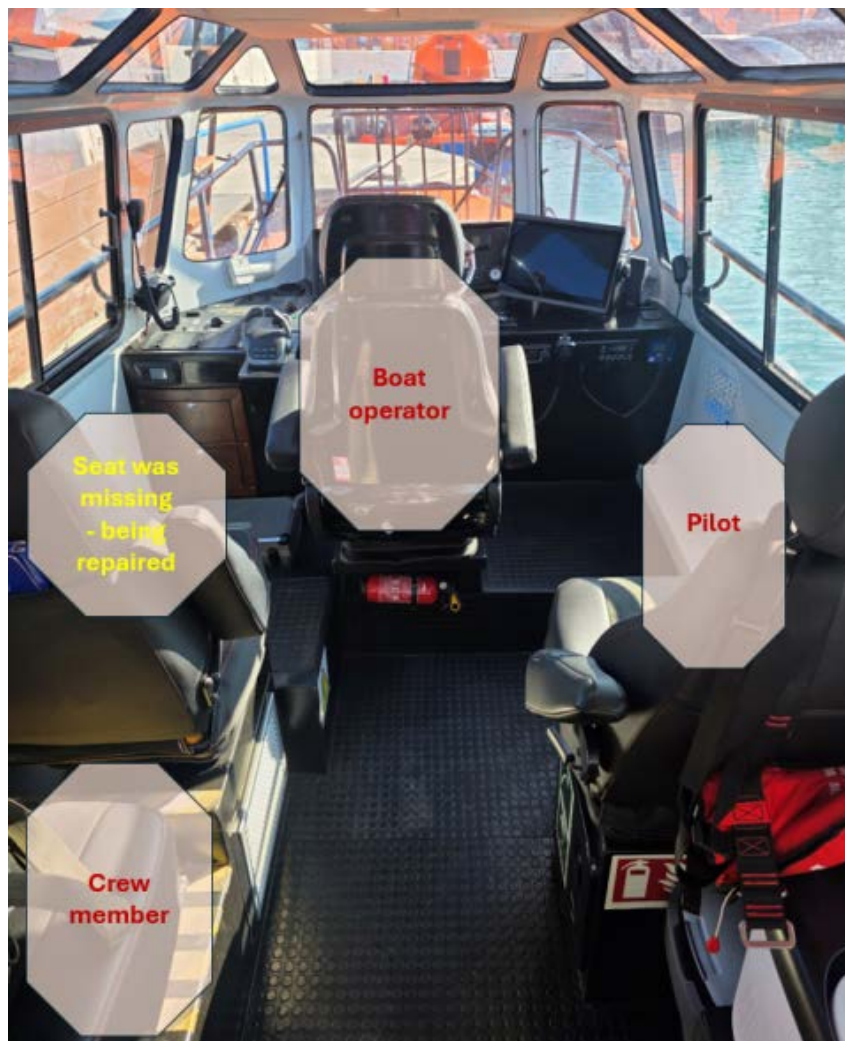
Figure 5: Confirmed seating arrangement of persons (reconstruction), source: MAIIS

| Element | Expected safe practice | Actual practice | Assessment |
|---|---|---|---|
| Seating arrangement | Supporting person to have an adequate view and access to information. | One seat under repair; crew member without direct access to the displays. | Degraded |

| Barrier | Observed condition | Assessment |
|---|---|---|
| Seating arrangement | The temporary configuration restricted the crew member’s field of view and access to navigational information. | Degraded |

It is recommended that KOPP clearly define the duties of the pilot boat operator and the additional trained person with regard to lookout, monitoring the vessel's position and heading, use of navigation displays and timely warning of hazards, considering the actual seating arrangement and field of view.

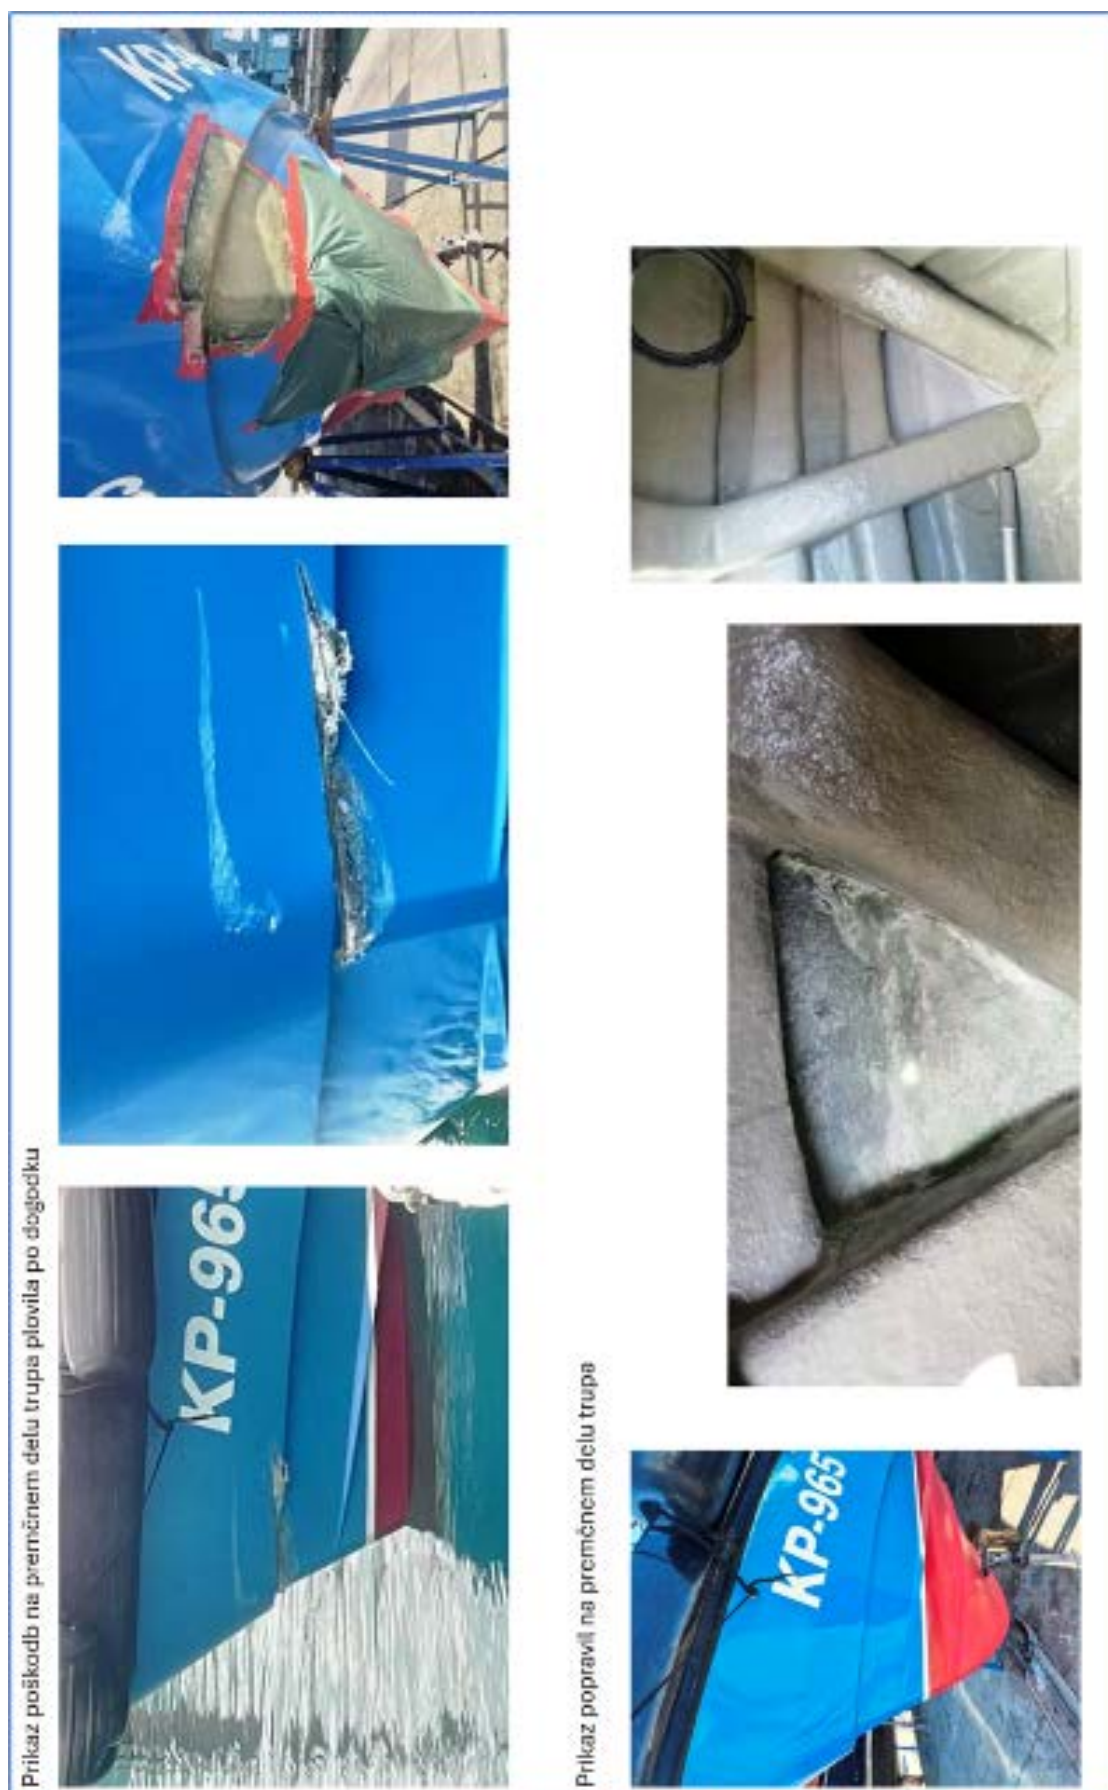
## Annex 1. – Illustration of damage to the boat

No personal injuries occurred; however, the pilot fell from his seat during the sudden event. KP-965 sustained damage to the forward GRP laminate, one propeller shaft and both propellers. The buoy sustained damage to its guard rail, including a broken supporting post, while the basic mooring function remained intact. No pollution occurred.

| Area | Finding |
|---|---|
| Vessel | Damage to the forward GRP laminate; one bent propeller shaft; both propellers deformed. |

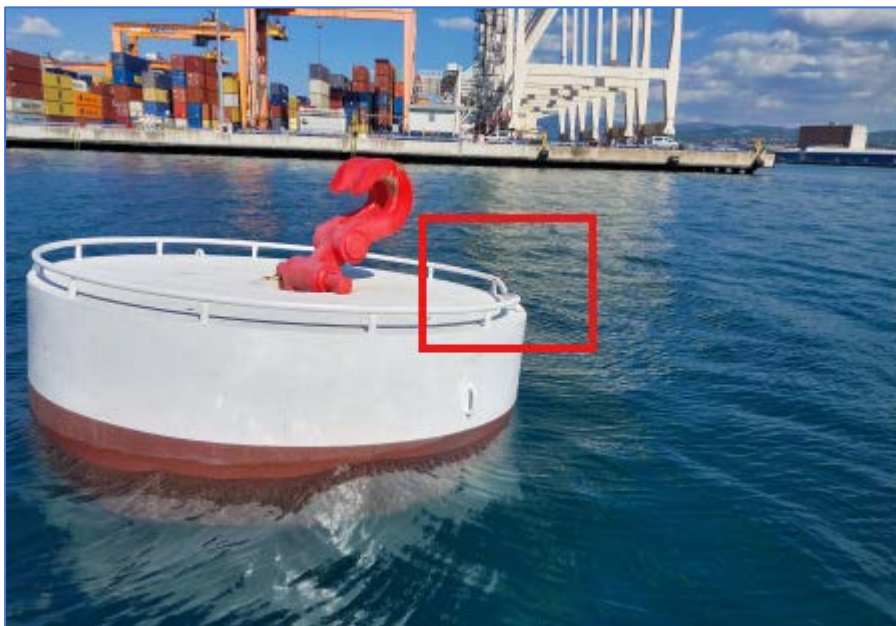
| Area | Finding |
|---|---|
| Buoy 2/I | Damaged guard rail and broken supporting post; the basic mooring function remained intact. |

Photo of a mooring buoy; damage indicated by the red square
