FINAL REPORT

Aircraft Accident

An-2

Registration mark HA-MKK

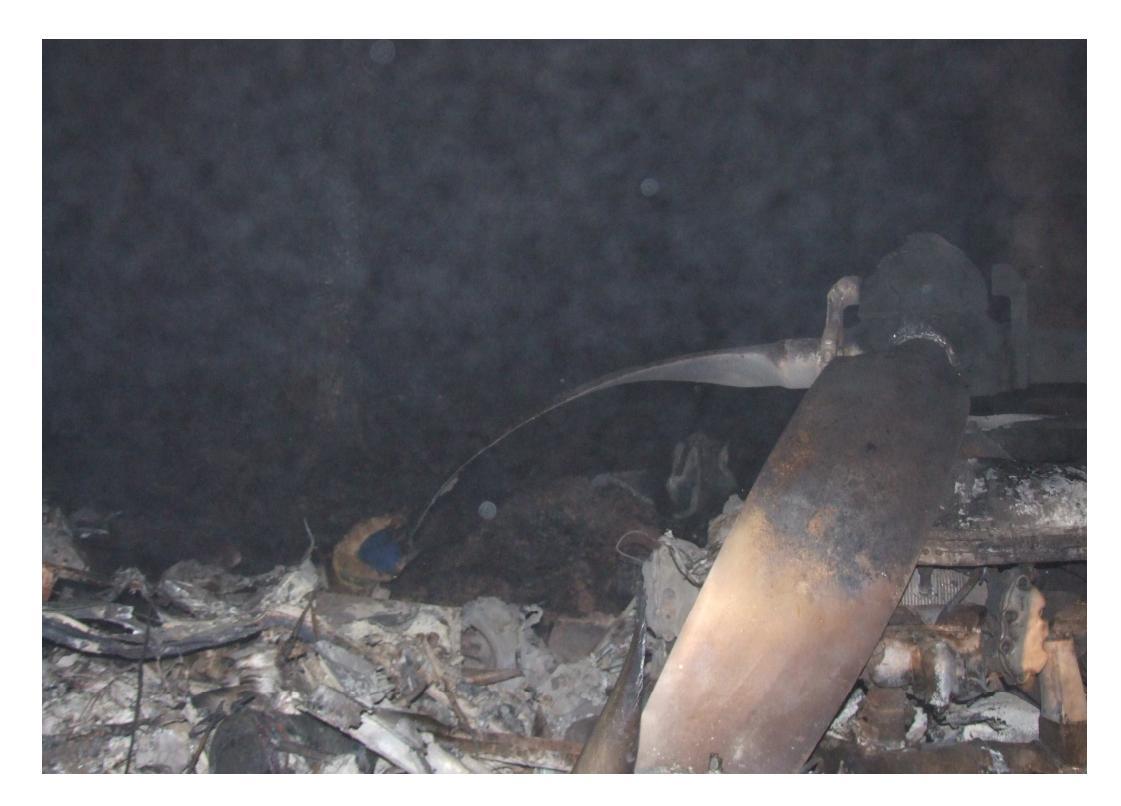
Photo No.1: Wreckage on crash site 11.01.2008

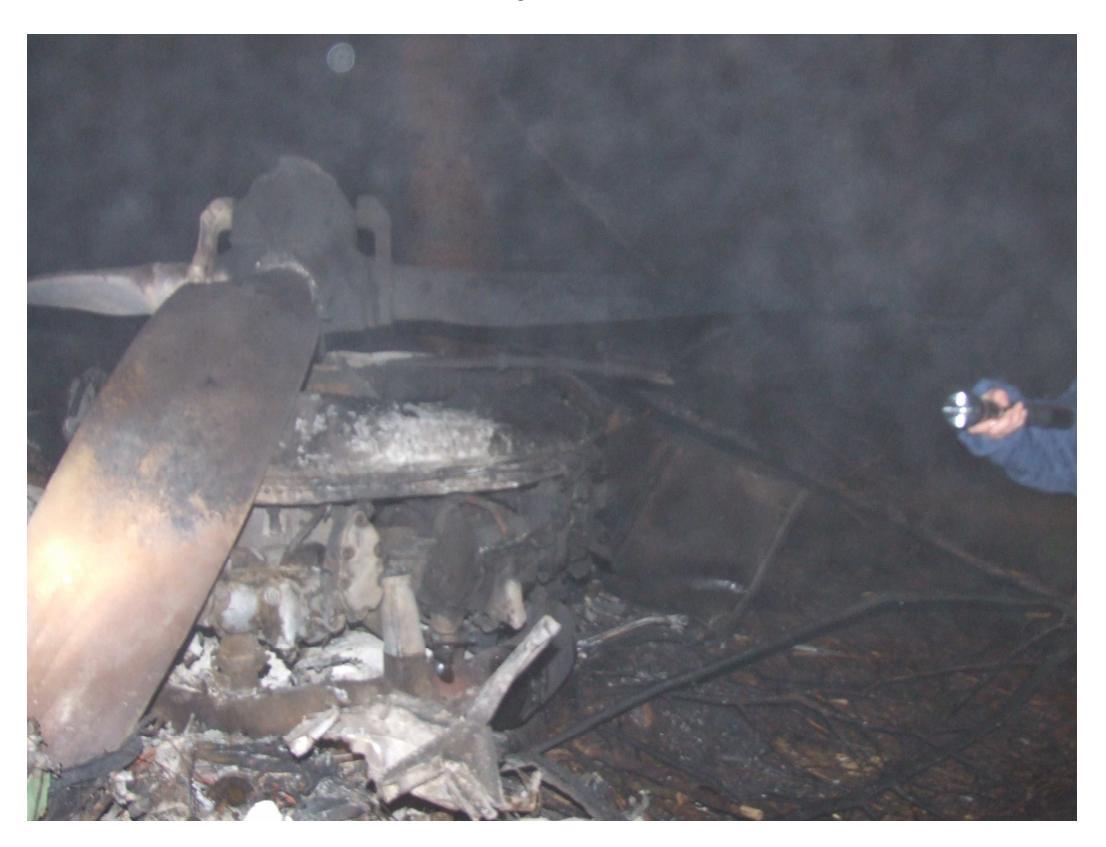
Photo No.2: Wreckage on crash site 11.01.2008

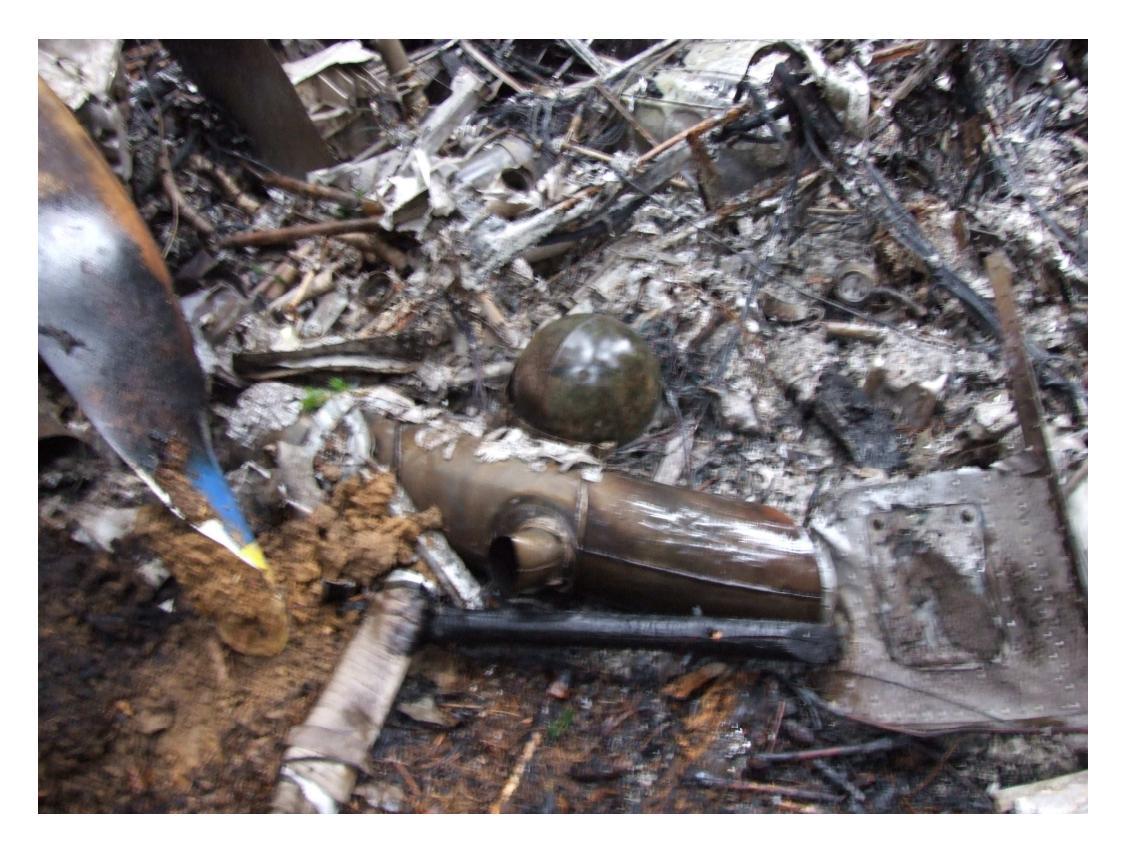
Photo No. 3: Wreckage on crash site 12.01.2008

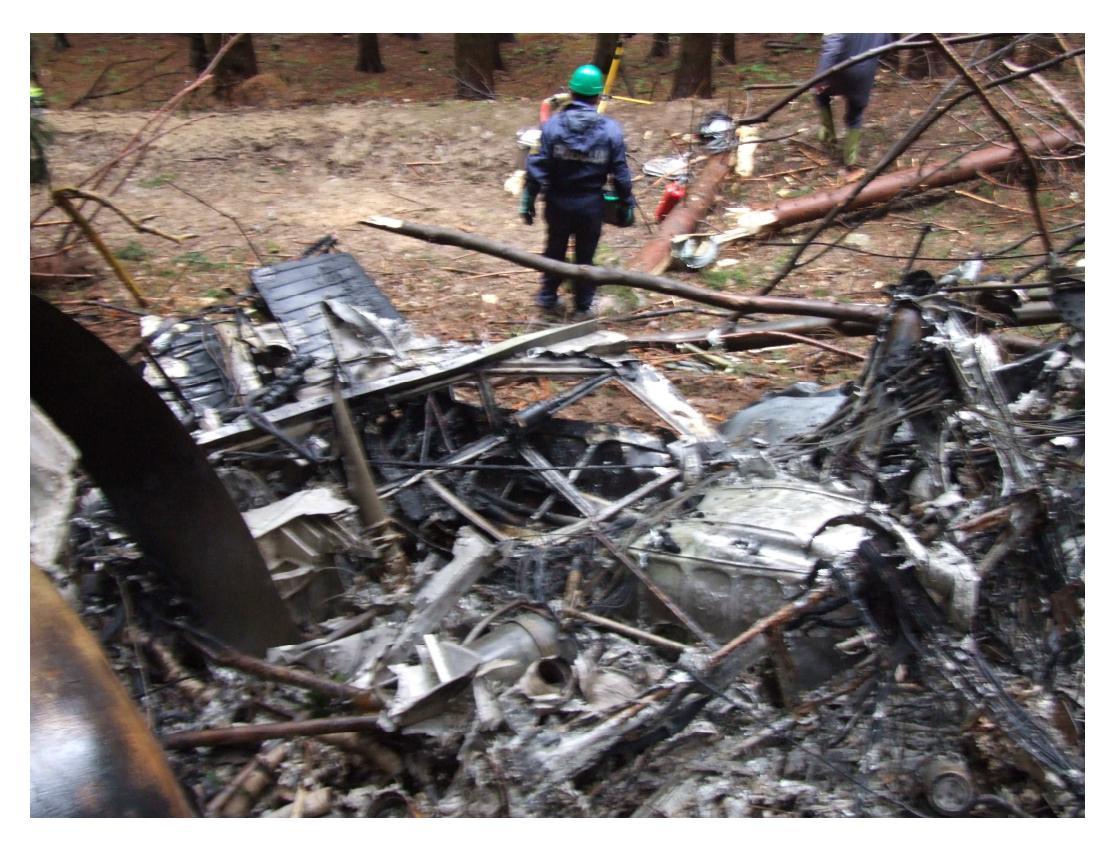
In the crash, the fuel tanks and fuel installations on the engine were damaged, which caused the spillage of the entire quantity of fuel from the fuel tanks along with the fire. The fire caught over the engine and over the entire aircraft wreckage, which was concentrated on the crash site. The fire was extinguished by firefighters.

Photo No. 4: Wreckage concentrated on the crash site

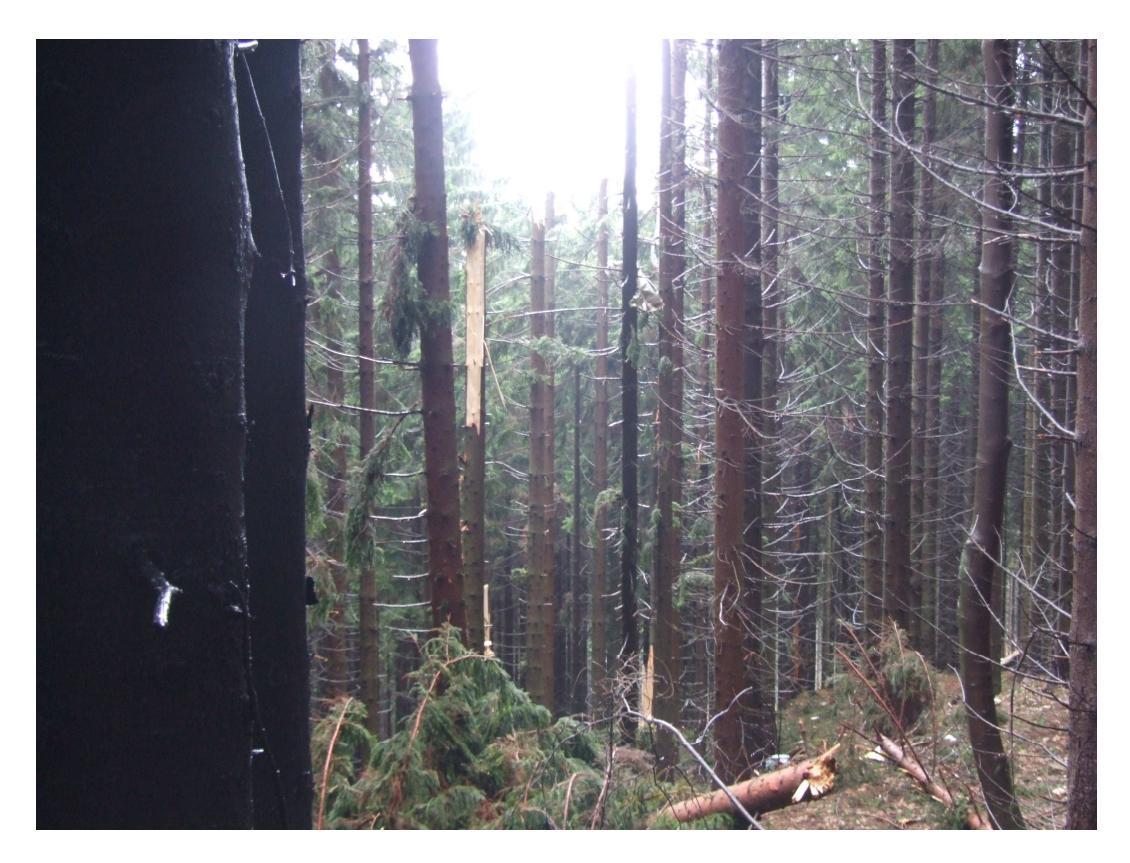
First, the aircraft crashed into the highest branches of trees on the slope of Mount Javor. In the crash, 16 trees and some forest undergrowth at the fire scene were destroyed. There was no other damage.

Photo No. 5: Trees destroyed in impact direction

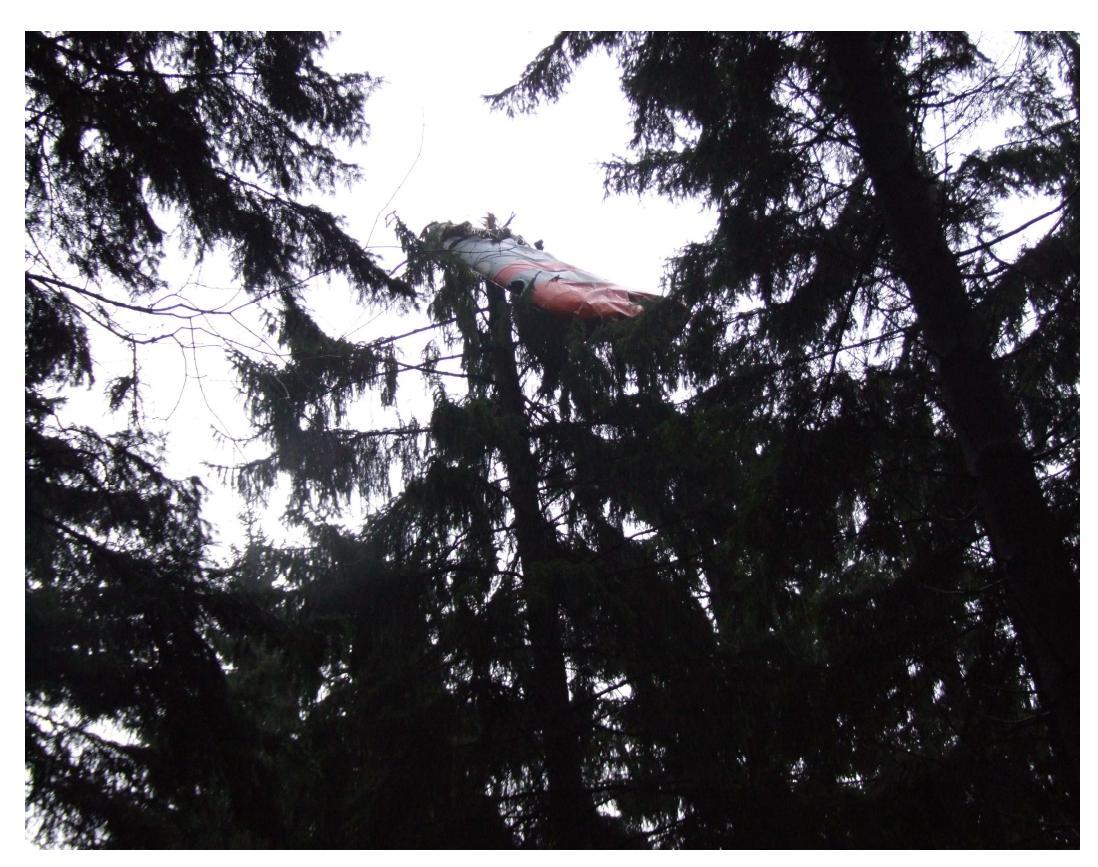
Photo No. 6: Piece of wing on the tree in impact direction

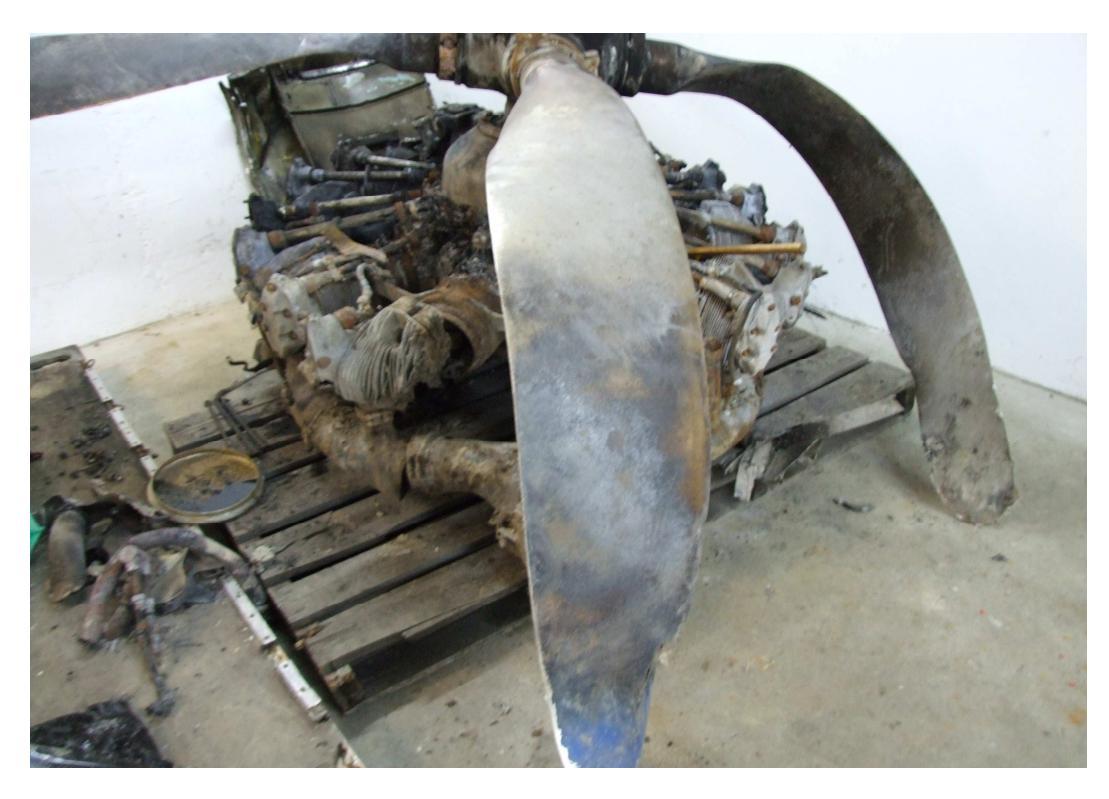
Photo No. 1: Engine investigation

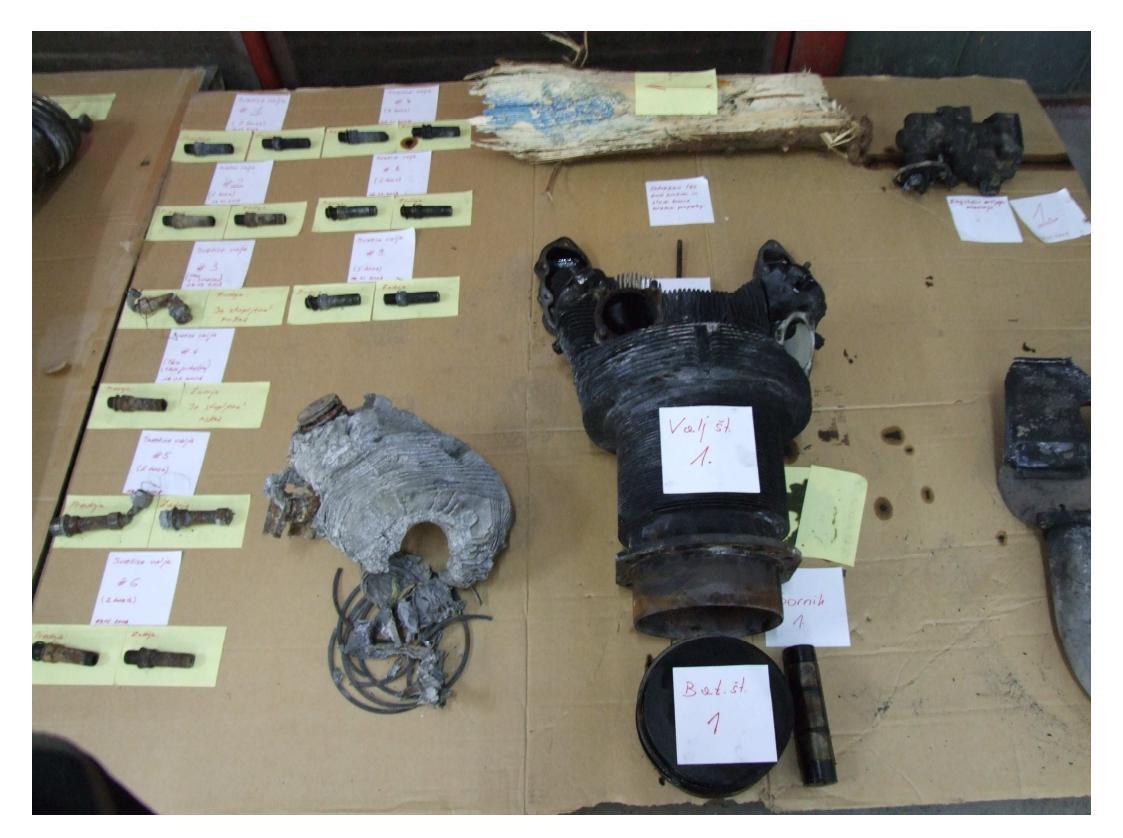
Photo No. 2: Engine parts investigation

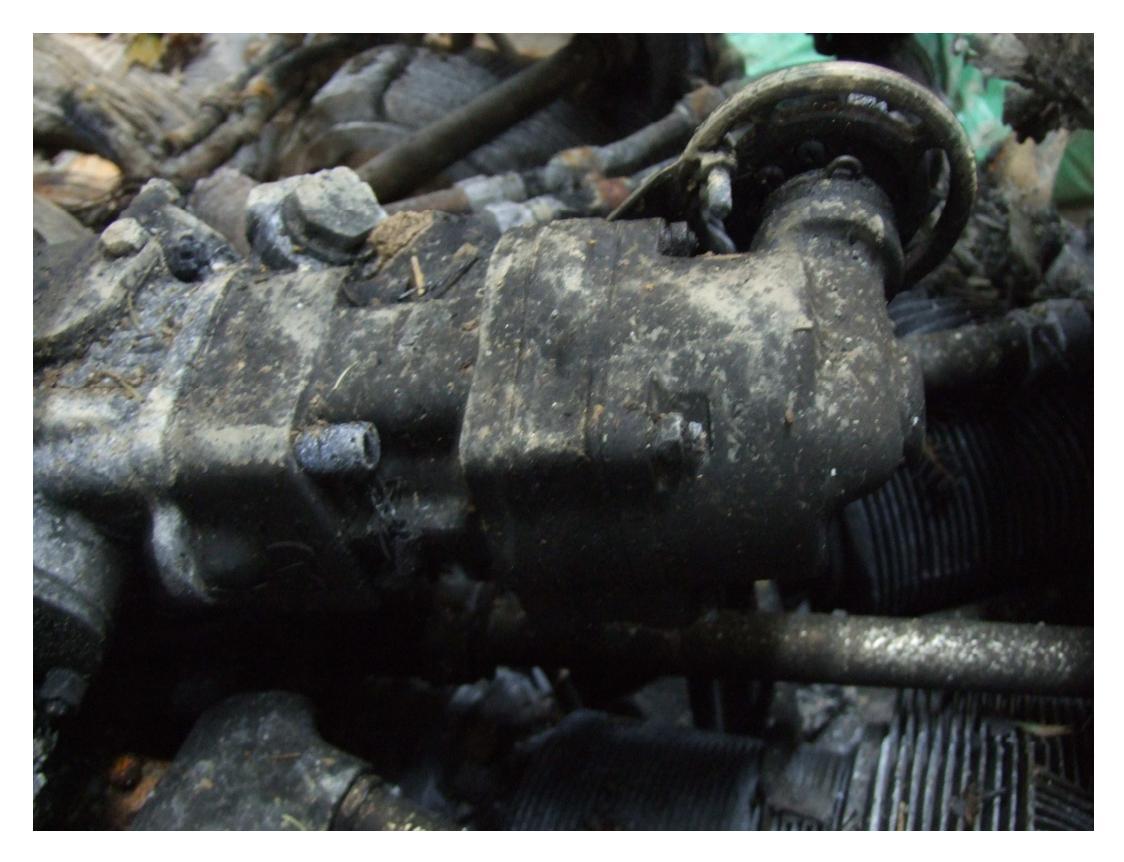
Photo No. 3: Investigation the Speed Governor

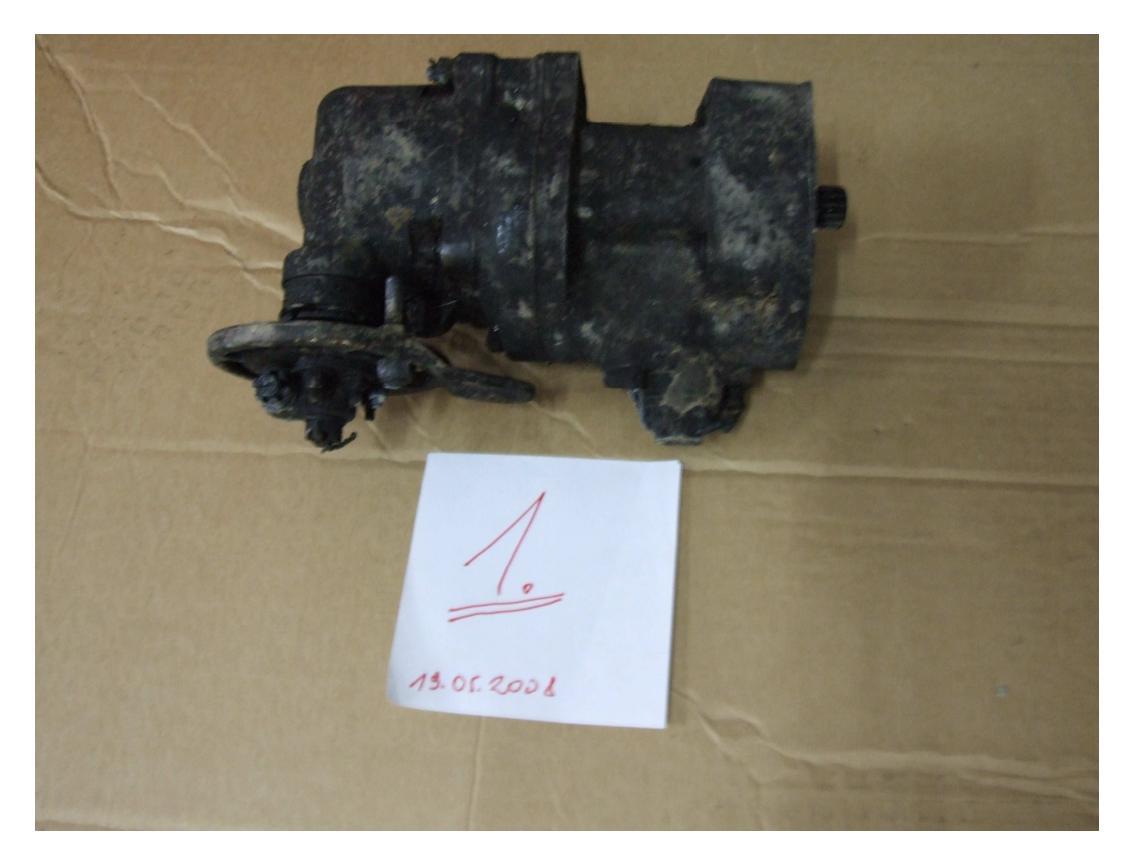
Photo No. 4: The Speed Governor was in cruise position

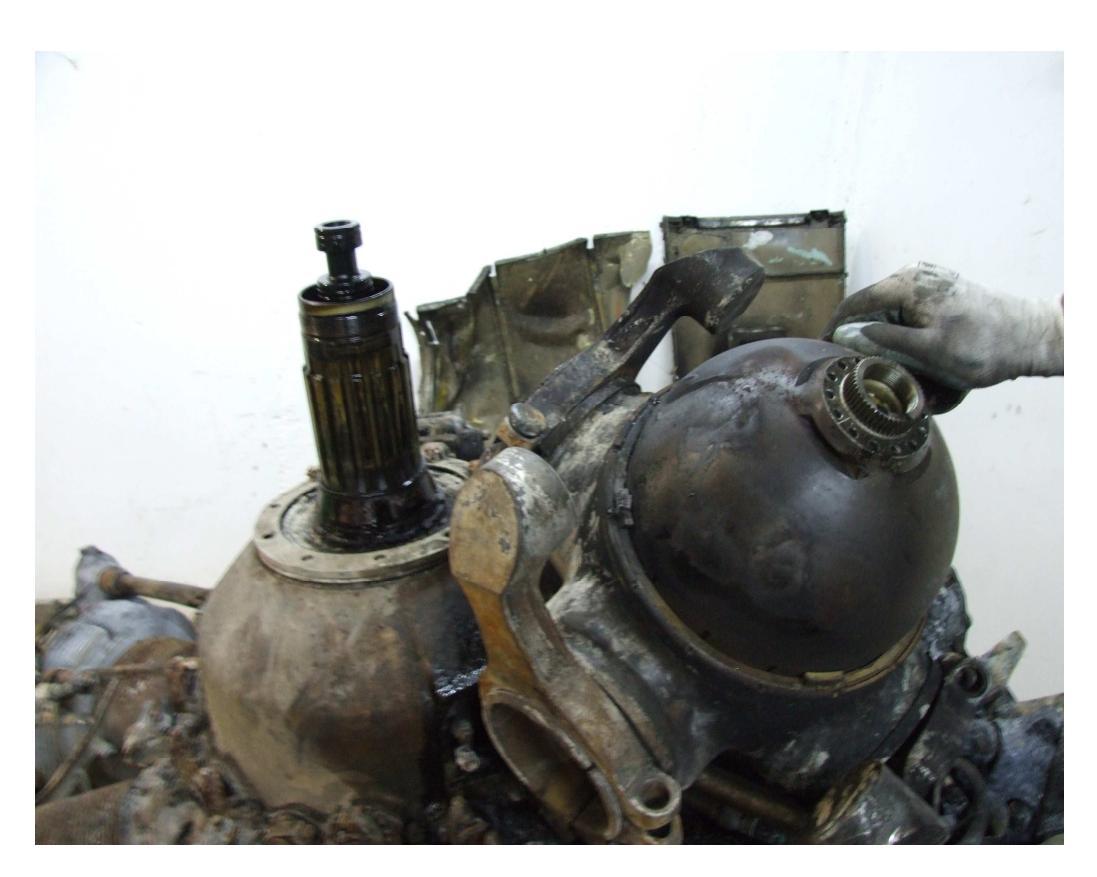
Photo No. 5: Propeller investigation

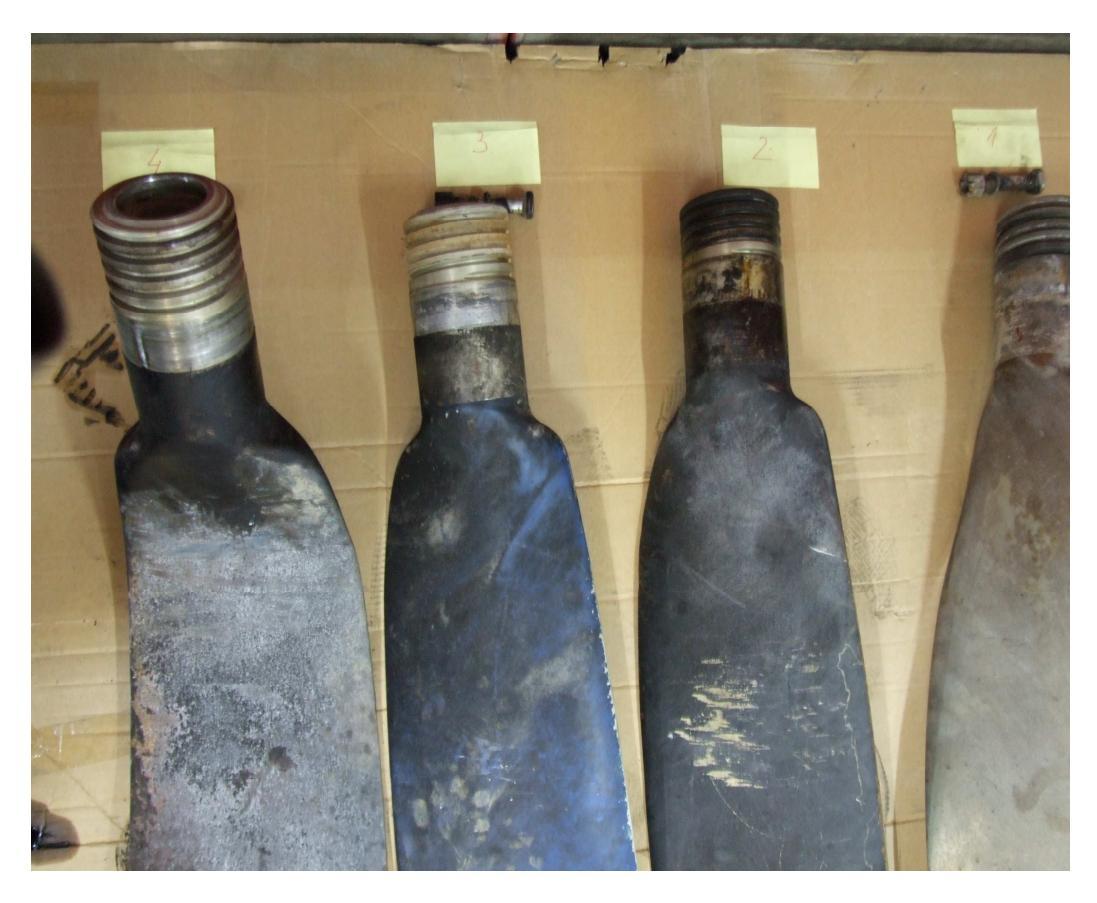
Photo No. 6: Propeller blades investigation

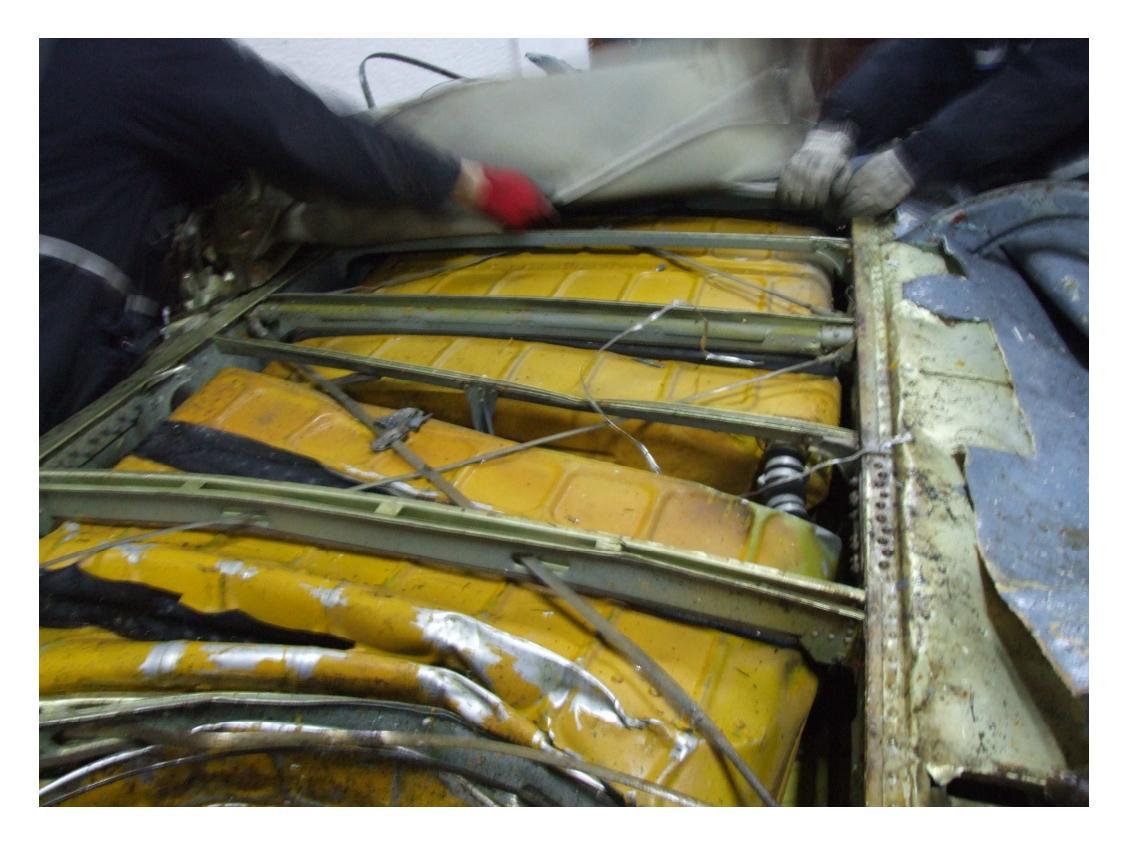
Photo No. 7: Fuel tanks and wing investigation

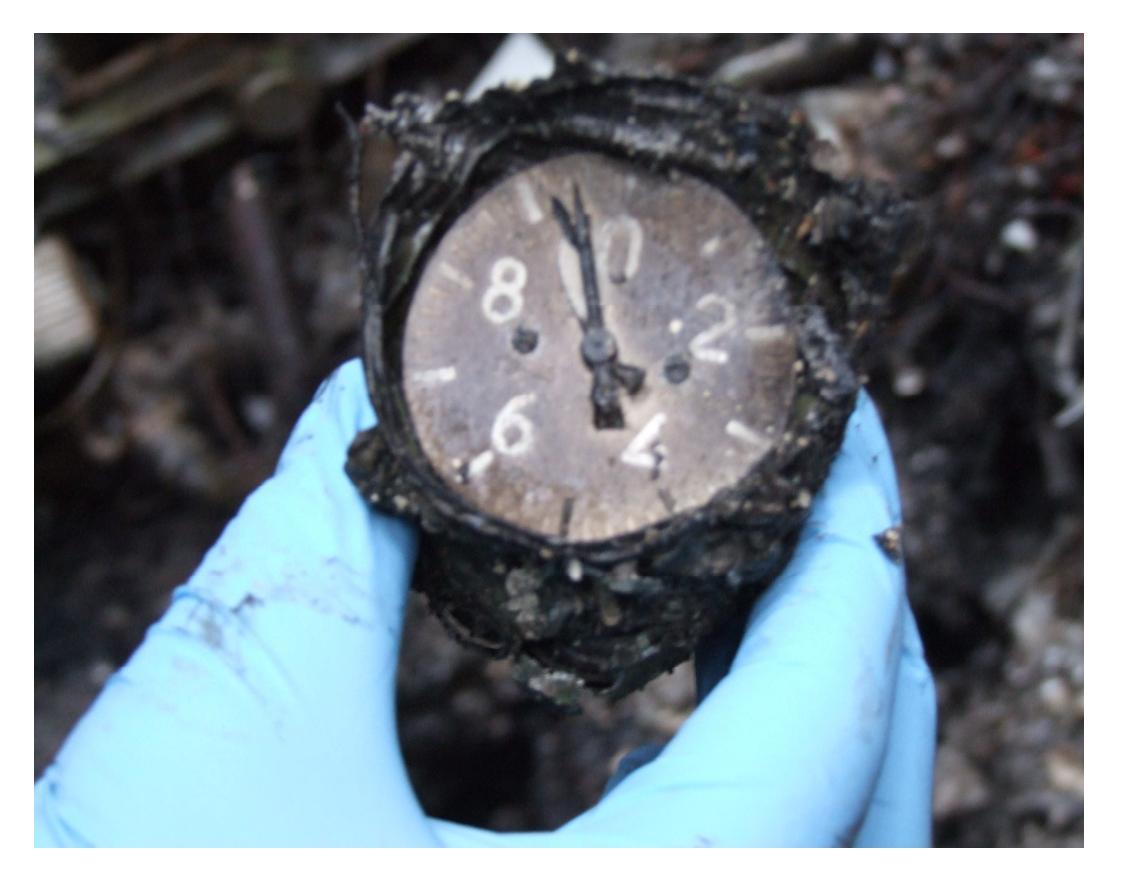
Photo No. 8: Metric altimeter indicator
