MINISTRY OF TRANSPORT

AIRCRAFT ACCIDENT AND INCIDENT INVESTIGATION DIVISION www.mzp.gov.si, e: mzp.splni@gov.si Langusova 4, Sl-1535 Ljubljana, t: +386 1 478 8000, f: +386 1 478 81 89

Number: 37200-8/2008/39-0010133 Date: 28 August 2009

# FINAL REPORT OF THE ACCIDENT INVESTIGATION COMMISSION INTO THE ACCIDENT OF ULTRA-LIGHT AIRCRAFT »WILD THING« REGISTERED D-MWTF ON 23 JUNE 2008 NEAR POSTOJNA CITY

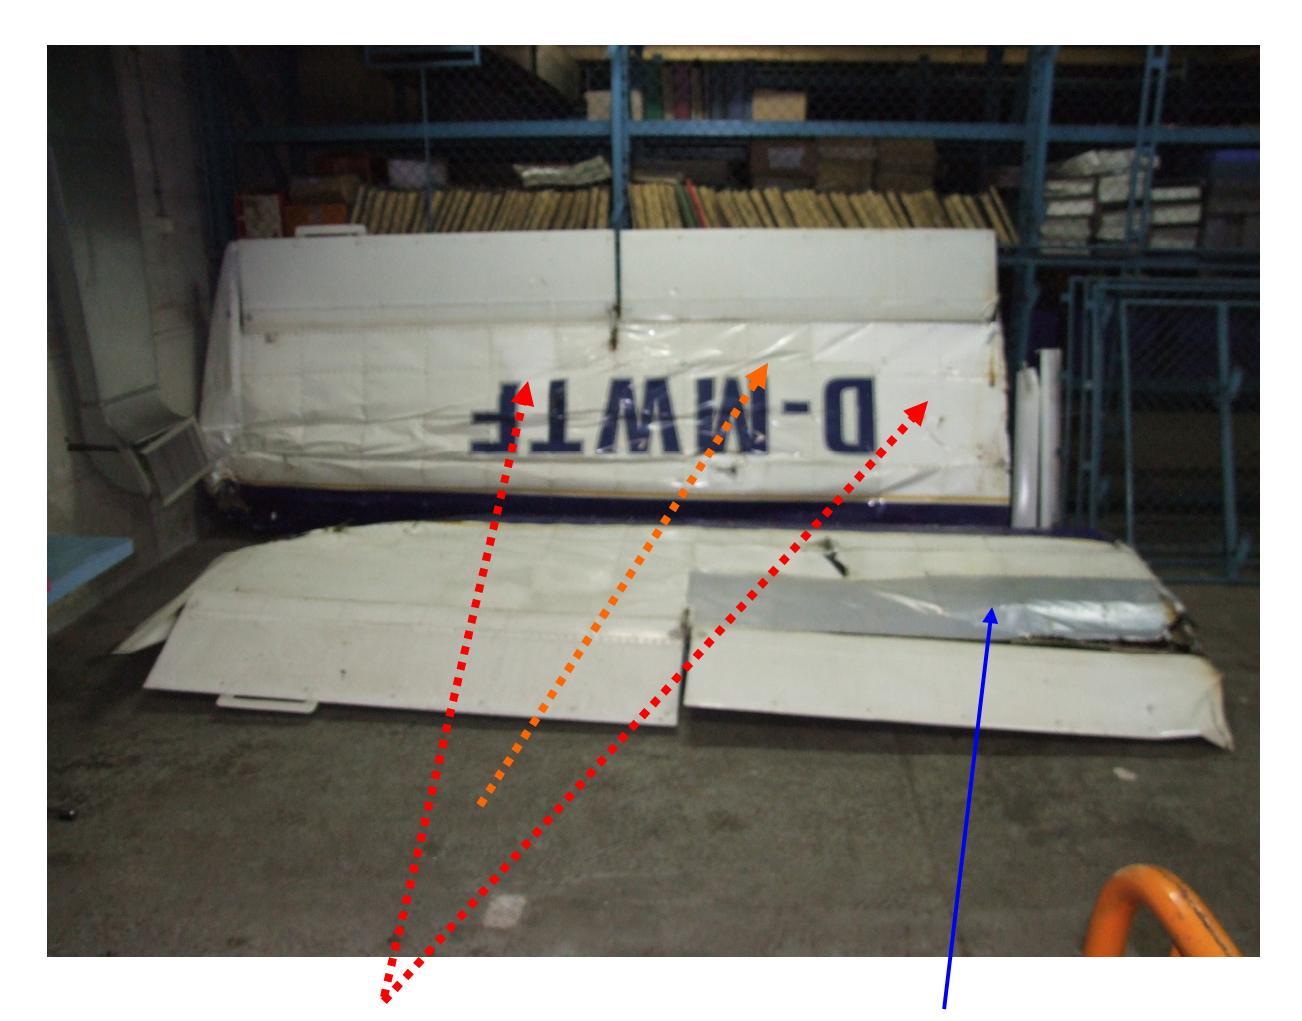
- About Unscheduled Maintenance and Major Repairs no data exist.
- Probably two major repairs of the wing were performed in the past (See picture below).

DIFFERENT SHADES OF COLOR UNCOLORED WING COVERING

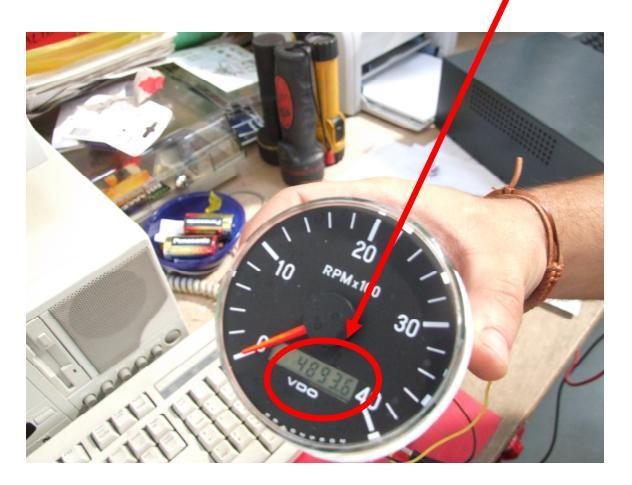
• On the day of accident the **TT** of the aircraft was **4.893,6 hours** (See picture below).

- According to Aero Light Club documentation aircraft Flying Time (FT) was 3.075 hours 05 minutes. Difference between TT and FT is 1.818 hours 31 minutes (37%).
- Maintenance List entry dated 19 Jun 2008 point out that the aircraft had on the day of accident 40,7 h after last 50 hours inspection.
- But according to the Aero Light Club Data Base aircraft had only12 h 22 minutes after inspection.
- Engine type JABIRU 3300 A, S/N 33A 746, 120 HP, year of manufacture 2005. On the day of accident the TT of the engine was 1.966,9 hours.
- Last 50 hours inspection was performed jointly with annual aircraft inspection.
- Propeller type **HELIX**, two bladed.

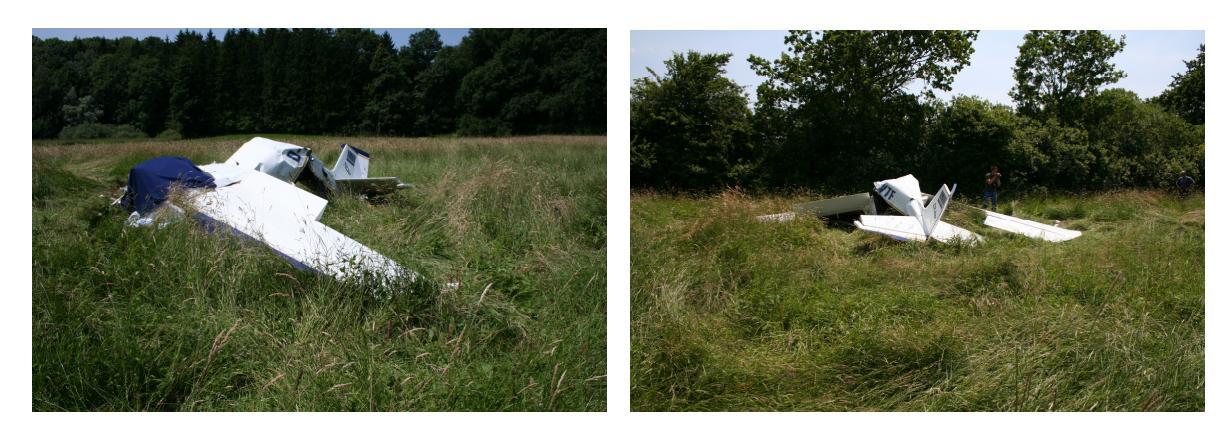
• Wreckage on Accident Site indicated that the aircraft was stalled (See pictures below). Aircraft impact to the ground first with right wing and after that with propeller, nose gear and engine (cowling).

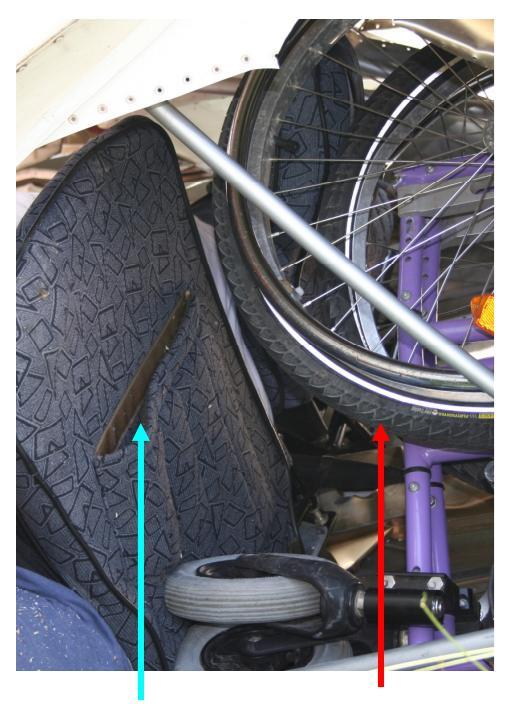
PILOT'S SEAT WHEELCHAIR

#### NOTE: Wheelchair and Bag in Luggage Compartment were NOT FIXED.

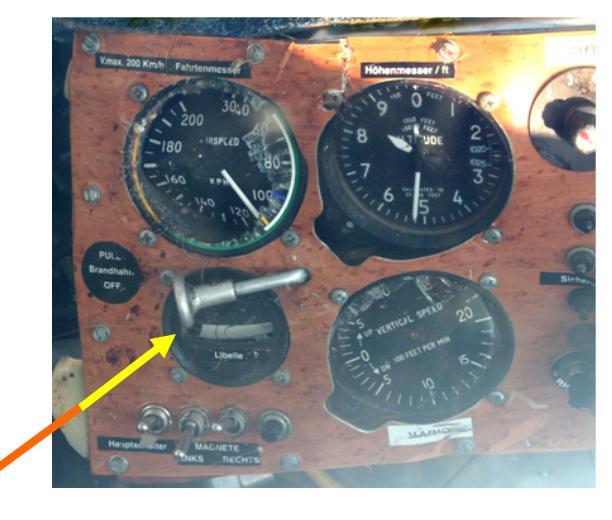
NOTE: Factually on Air-Speed Indicator Vso = Vs<sub>1</sub> (<u>impossible equal status</u>)

- Altimeter: - 1.480ft (minus 1.480 feet was impact result), Pressure setting: 1022 mb

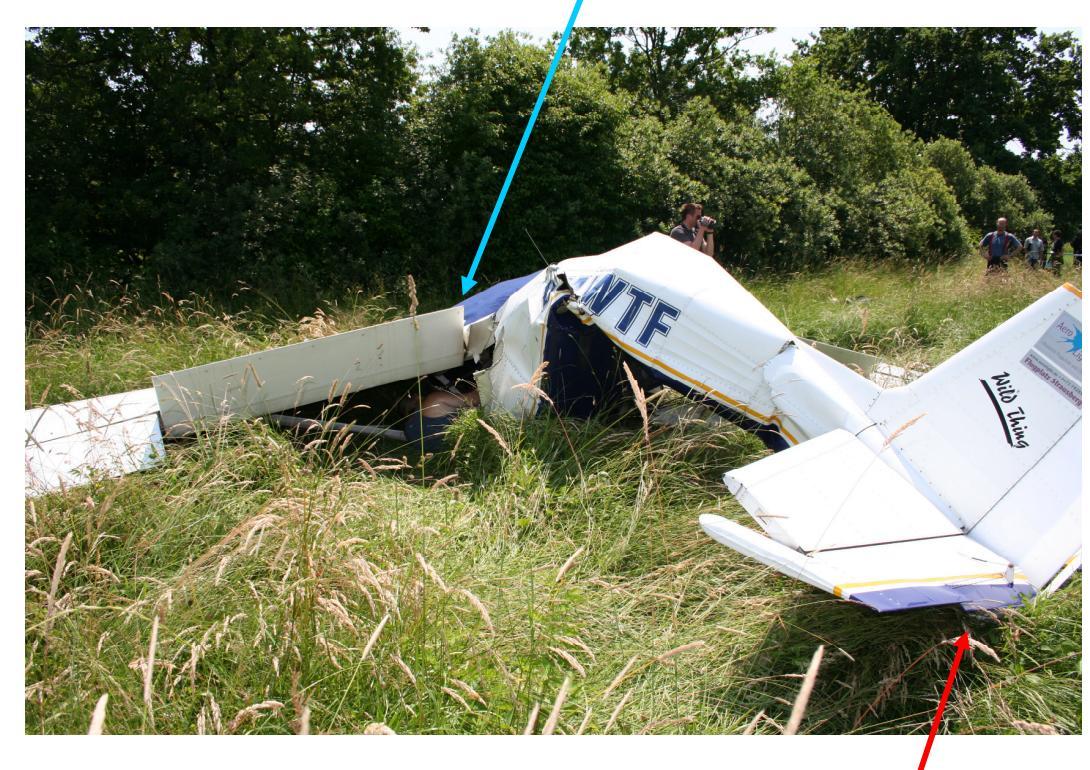
- Flaps Lever: DOWN POSITION - FLAPS UP

- Trim: NOSE UP POSITION (See detail on picture)-
- Emergency Locator Transmitter: OFF
- "Jeppesen" VFR Charts of different countries were also found in the cockpit.

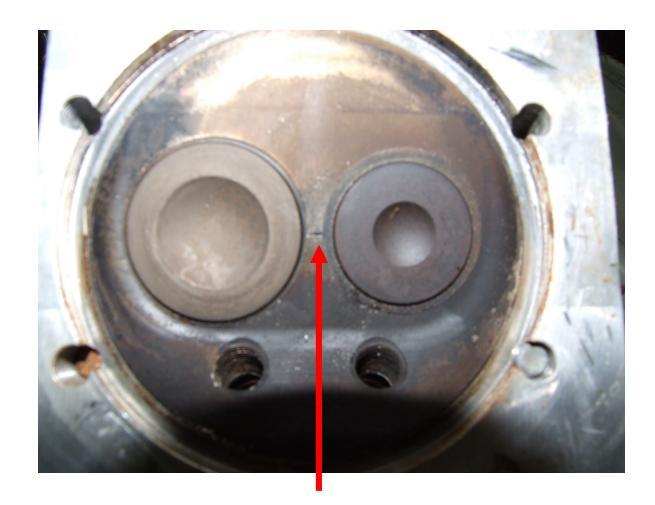
Engine was detailed inspected. Valve adjustment was correct. Only a small crack between exhaust valve and suction valve of the Cylinder Head No. 1 was found (See picture on next page).

#### CRACK ON THE CYLINDER HEAD No. 1 (WITH LARGEST TEMPERATURE CHANGES)

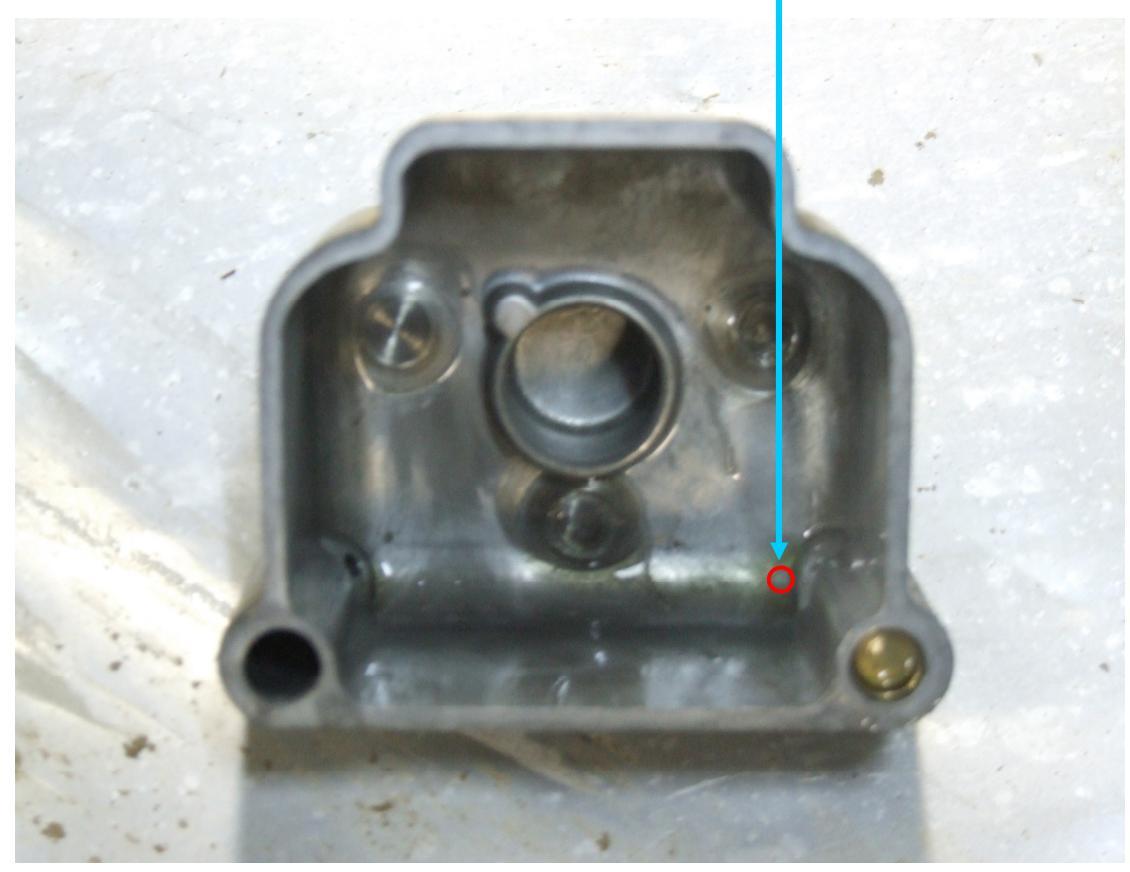
- Oil filter was in normal condition.
- > Carburettor was clean and had no evidence of pre-impact malfunction.
- Carburettor float chamber was full of fuel. Only a droplet of water was found in the Float Chamber (See picture below – red circle).

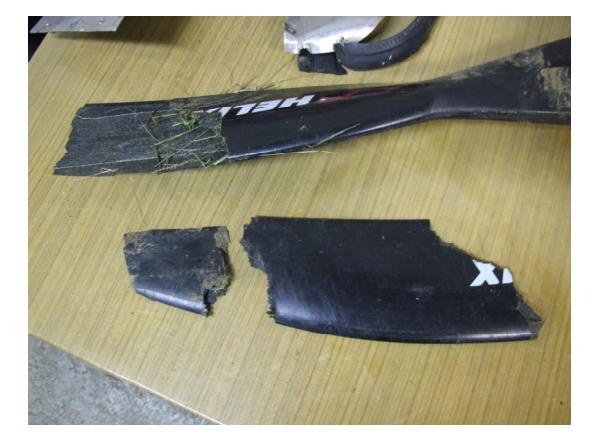
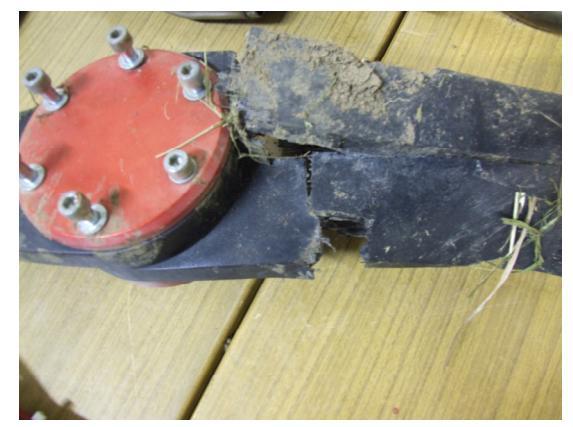
- > No evidence of pre-impact propeller malfunction was found.
- > A crack of propeller blades indicates that the propeller rotated in the time of impact.

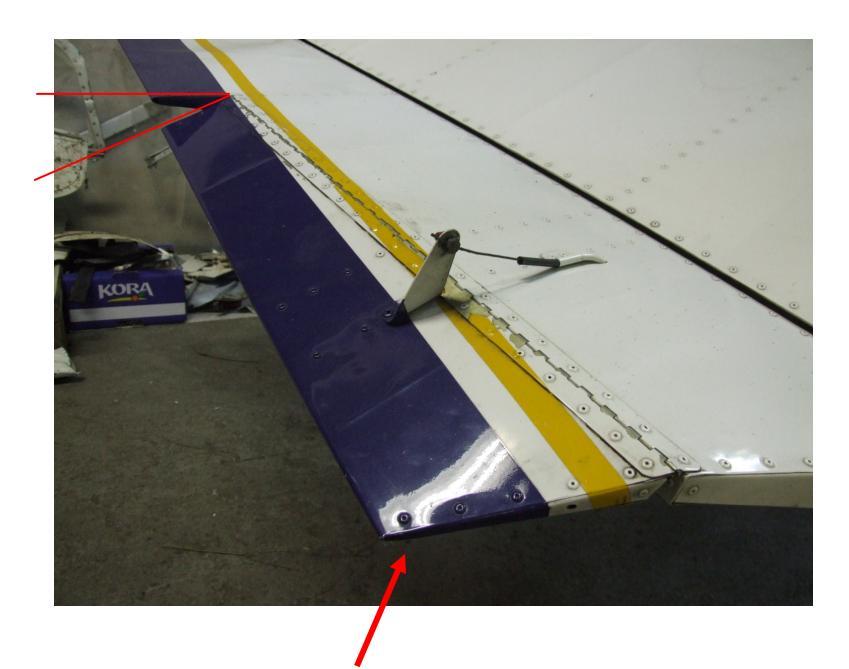
> Elevator Trim setting: full "NOSE UP" position.

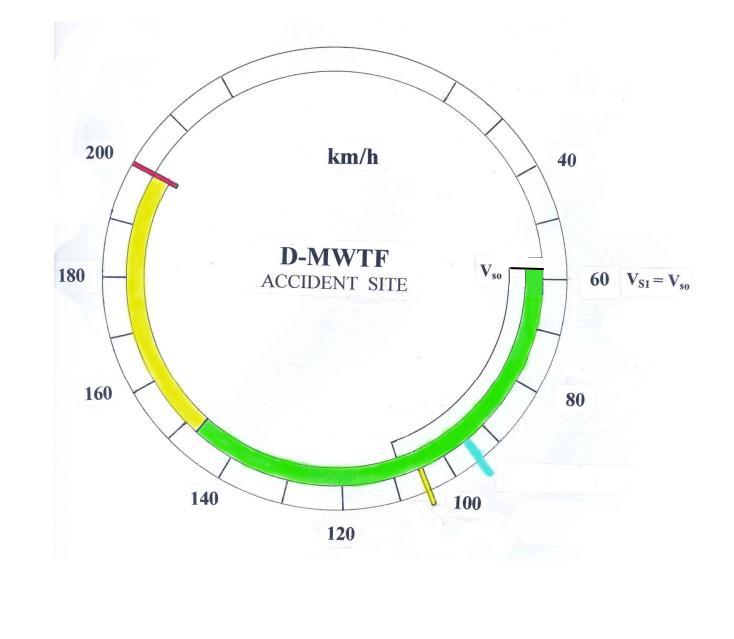
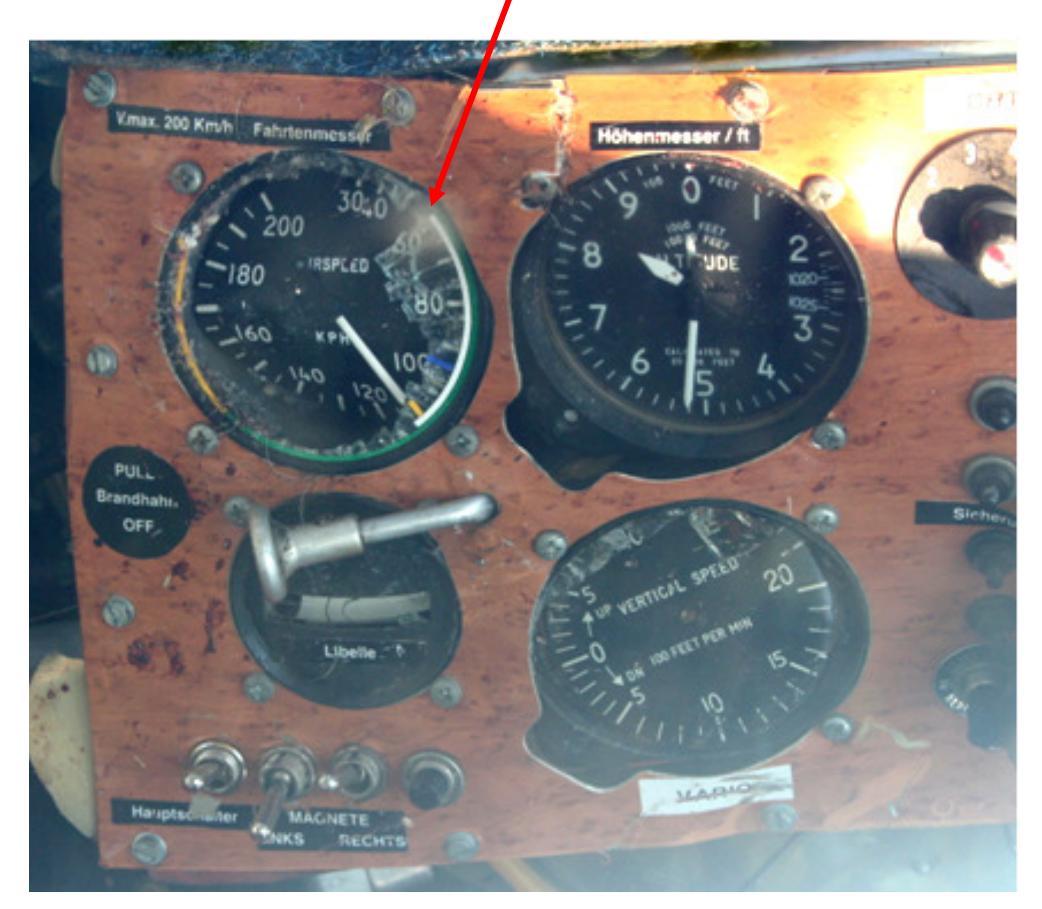
58km/h (White and Green Arc)

- <u>Important fact is</u> that Air Speed Indicator's White Arc and Green Arc start at speed of 58km/h (See illustration and picture below).

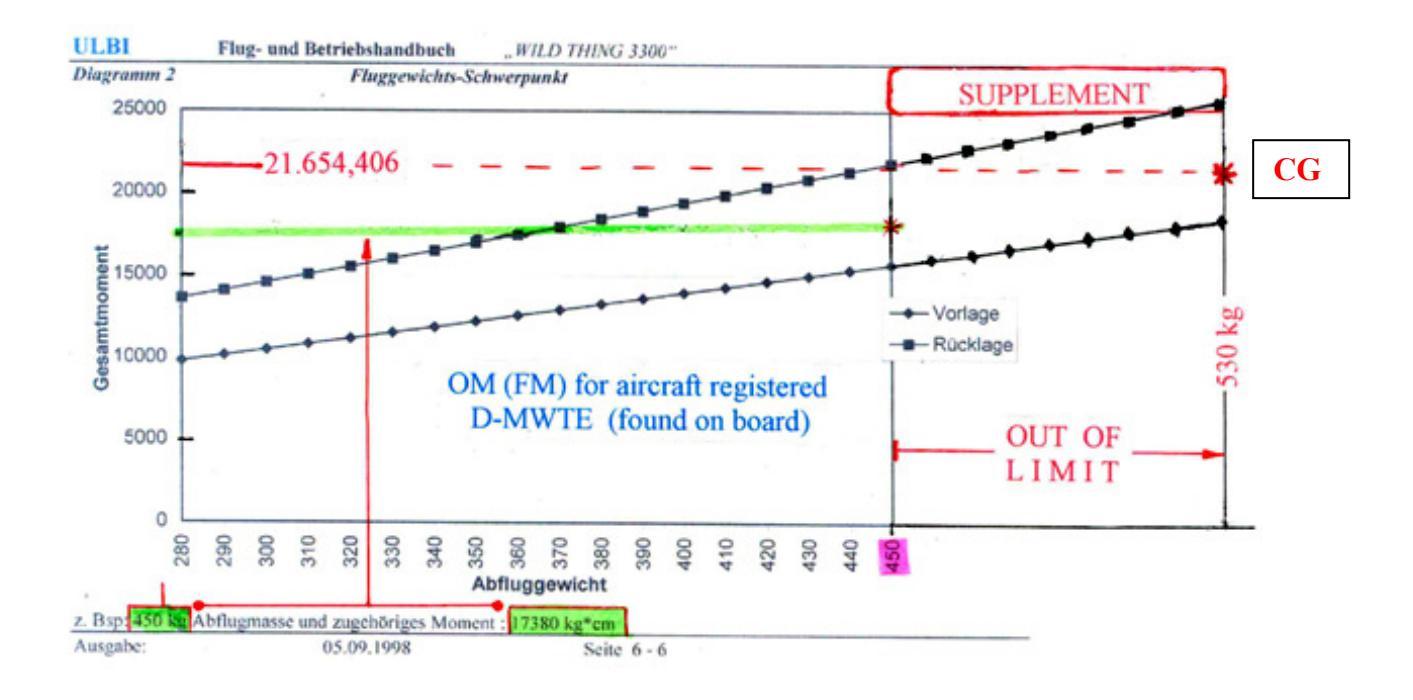
FLIGHT WEIGHT and CENTRE of GRAVITY DIAGRAM (CG)

From diagram it is obvious that the aircraft was overloaded but Centre of Gravity (CG) was in limits.

CONCLUSION: Permitted loading for subject aircraft was 151,4kg. 54kg (75 l) of fuel were in both reservoirs before flight. Only 97,4kg of load was left over, but pilot loaded the aircraft with 177,7kg.

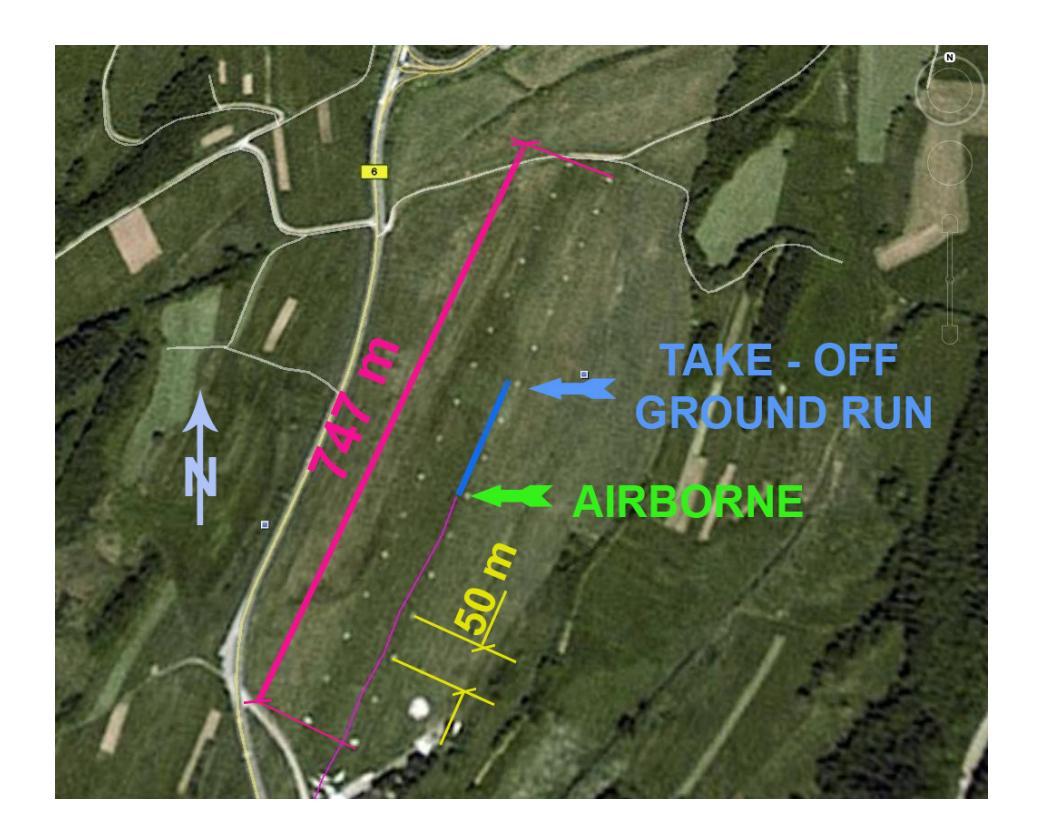
CONCLUSION: Pilot did not use available RWY distance. He used only a little more then half. In the case of emergency pilot lost in advance the available distance of approximately 350m.
