AIRCRAFT ACCIDENT AND INCIDENT INVESTIGATION SERVICE

Number: 37200-3/2012/132-00121171 Date: 23 October 2014

FINAL REPORT

ON THE INVESTIGATION OF THE AIRCRAFT ACCIDENT INVOLVING HOT AIR BALLOON LINDSTRAND LBL 600C REGISTRATION MARK S5-OLO, WHICH OCCURED ON 23 AUGUST 2012 OVER THE LJUBLJANA MARSHES

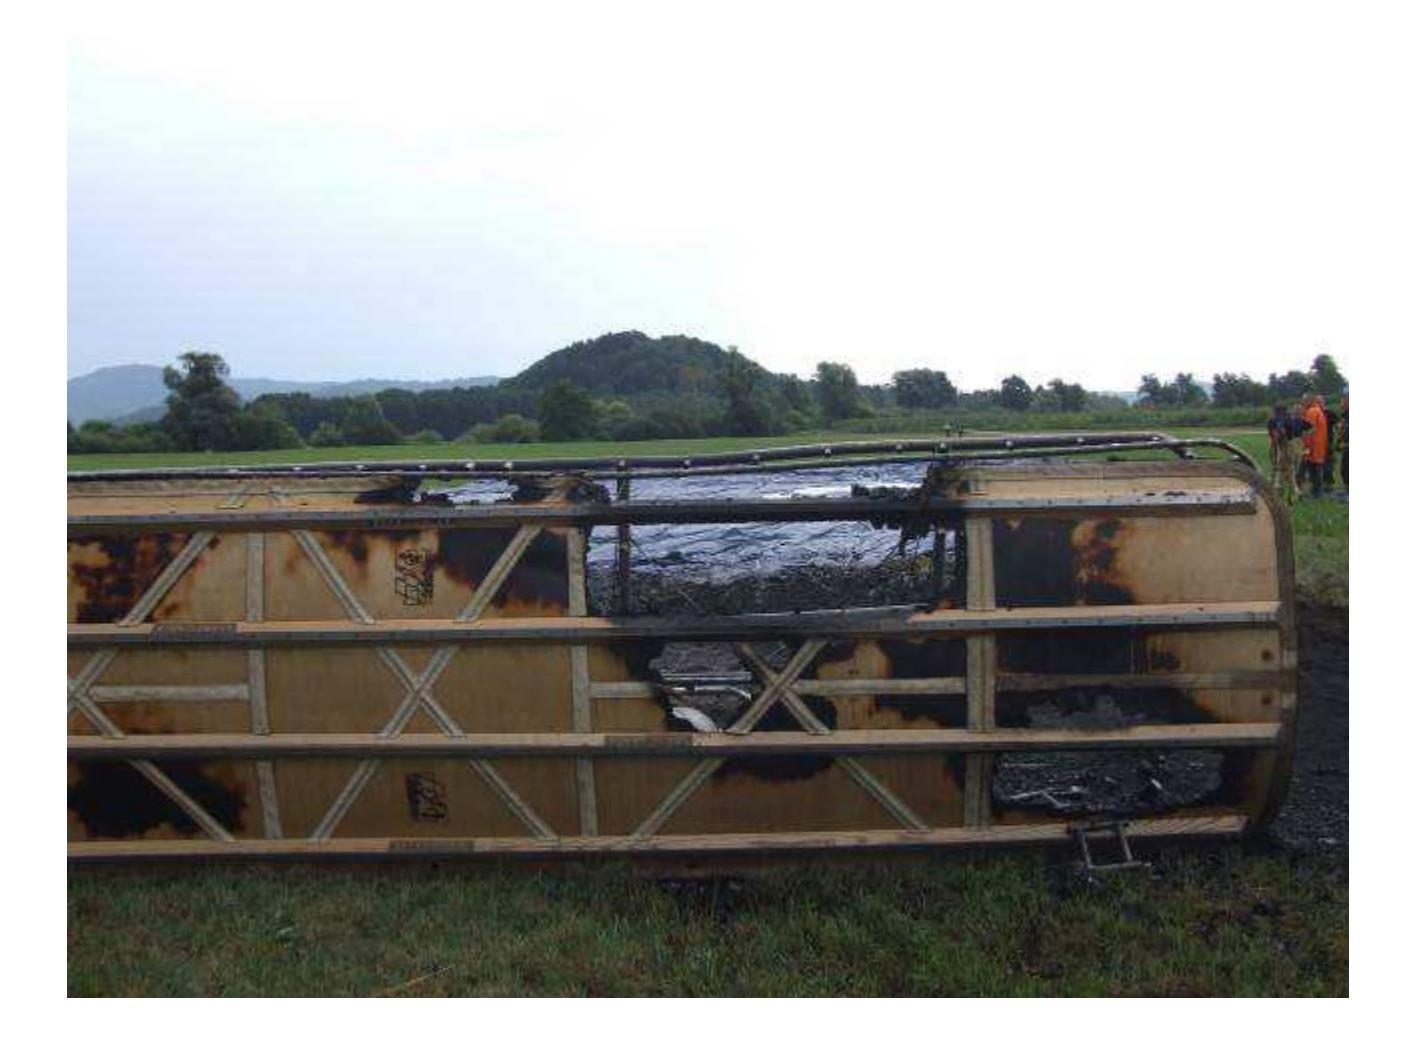
In the collisions with the ground and the canopy, and later in the fire, the envelope, basket, burner, tank, and equipment were 100% destroyed.

Picture 3: Damage to balloon S5-OLO at the final resting place

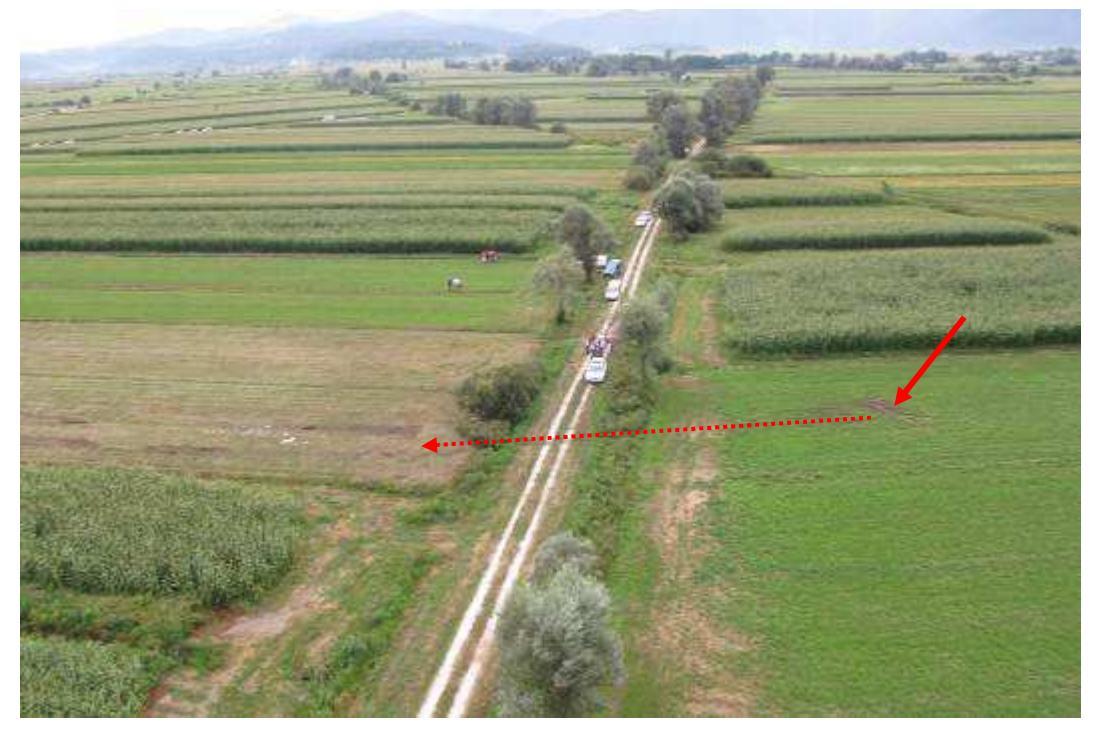
In the collisions with the ground and the canopy, and later in the fire, a small area of grass and canopy were damaged. There was no other damage.

Picture 4: Display of the damage after the first collision

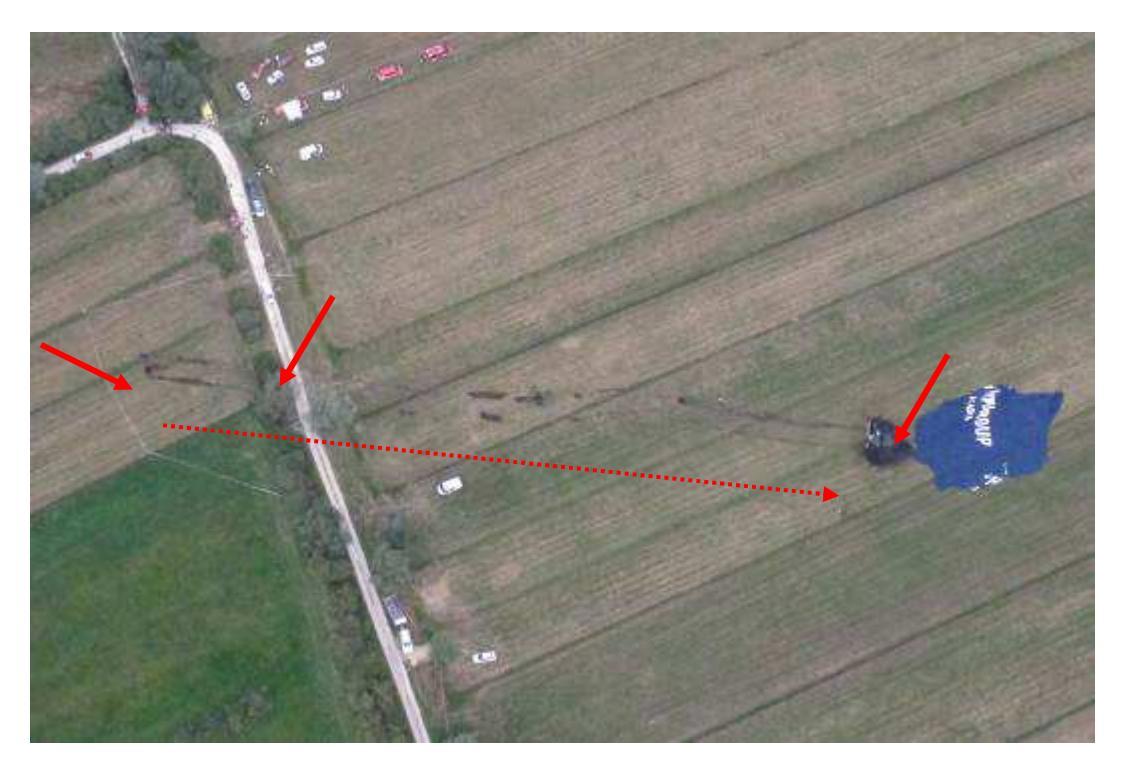
Picture 5: Display of the damage after the second collision

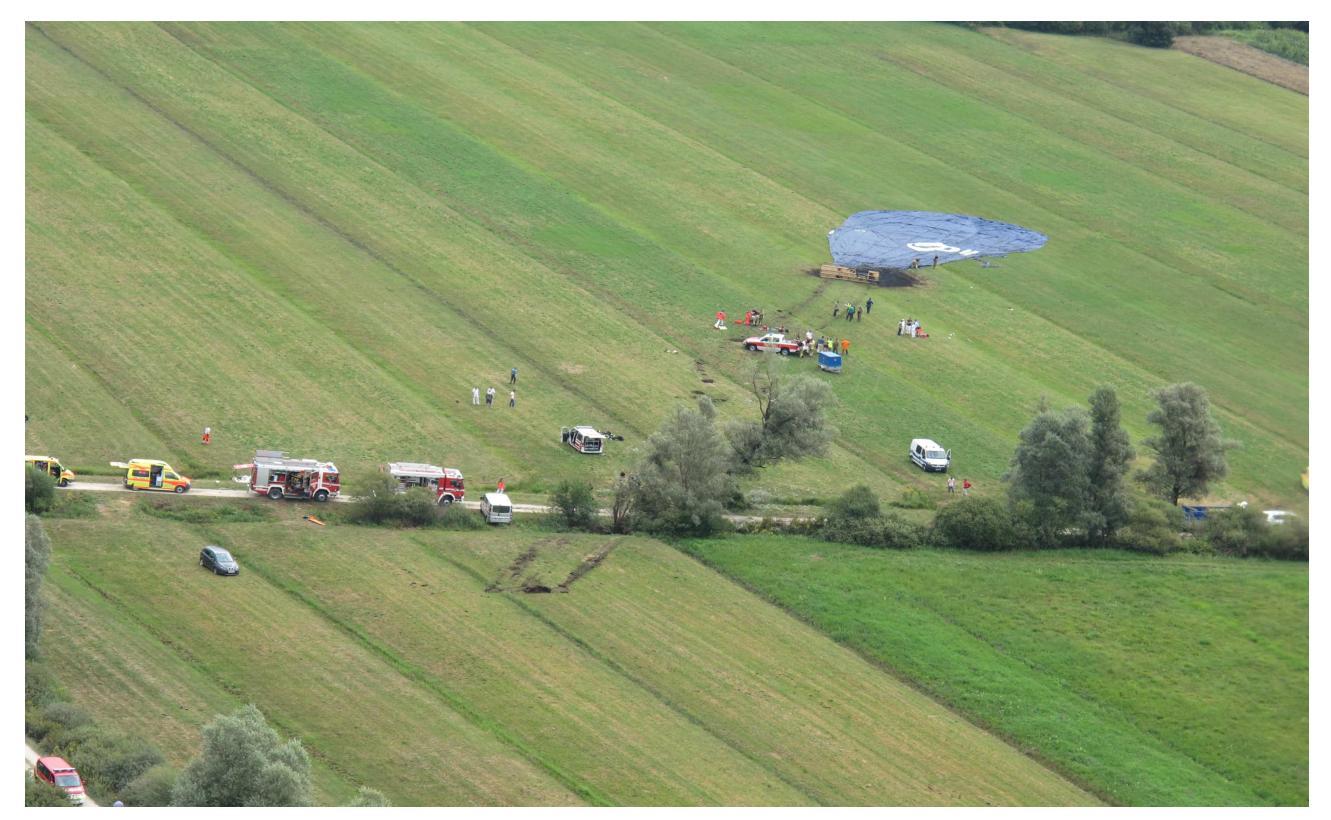
When investigators from the Accident and Incident Investigation Service arrived at the scene of the accident, the balloon was located in a grassy field. EMTS, doctors, fire-fighters, and police officers were present at the scene of the accident, which had already been secured. The scene was observed and documented in photographs. After the inspection, the hot air balloon was removed from the scene of the accident.

Picture 41: Scene of the accident

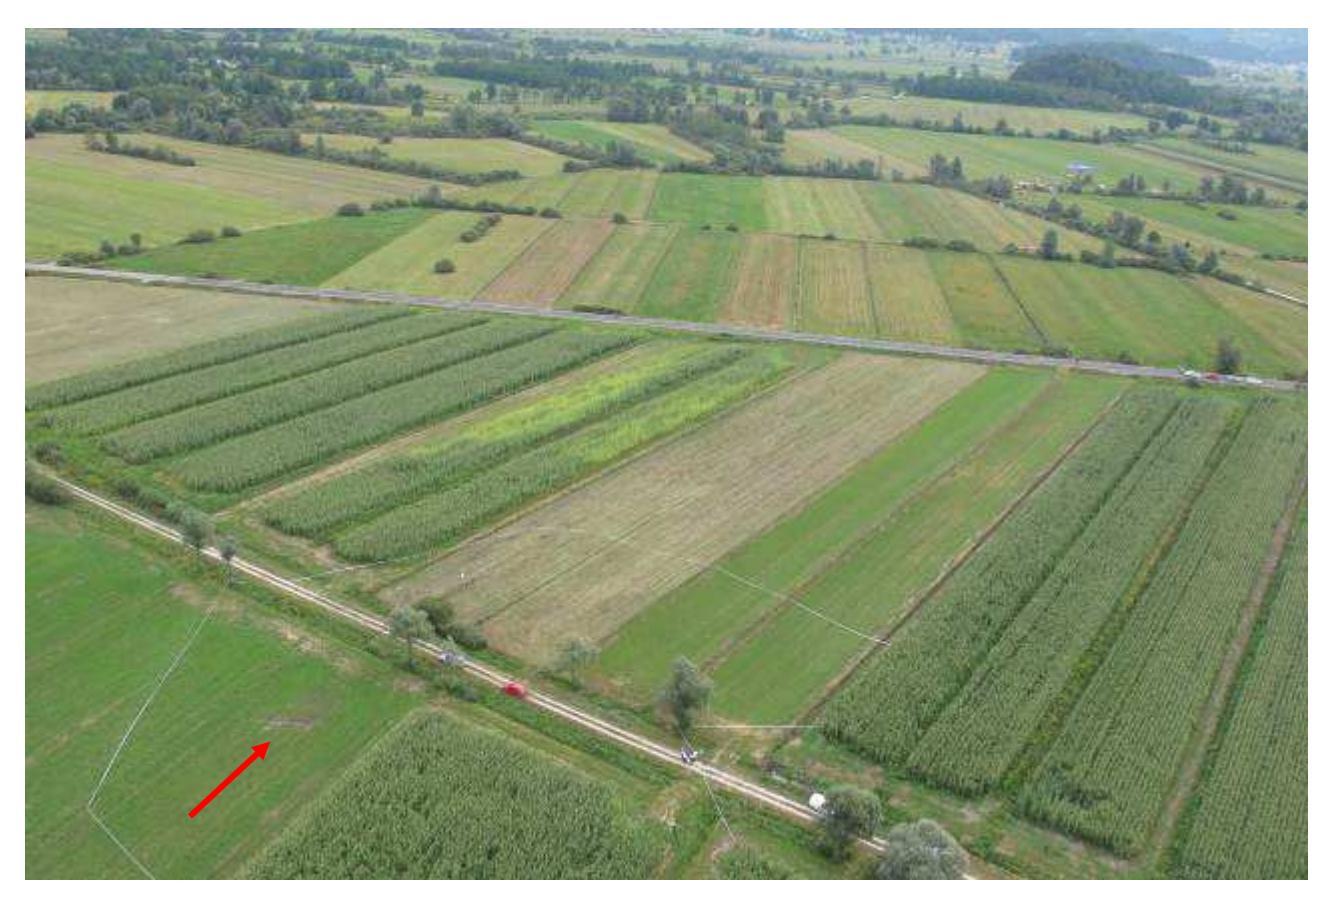
Picture 45: Balloon S5-OLO's first impact with the ground

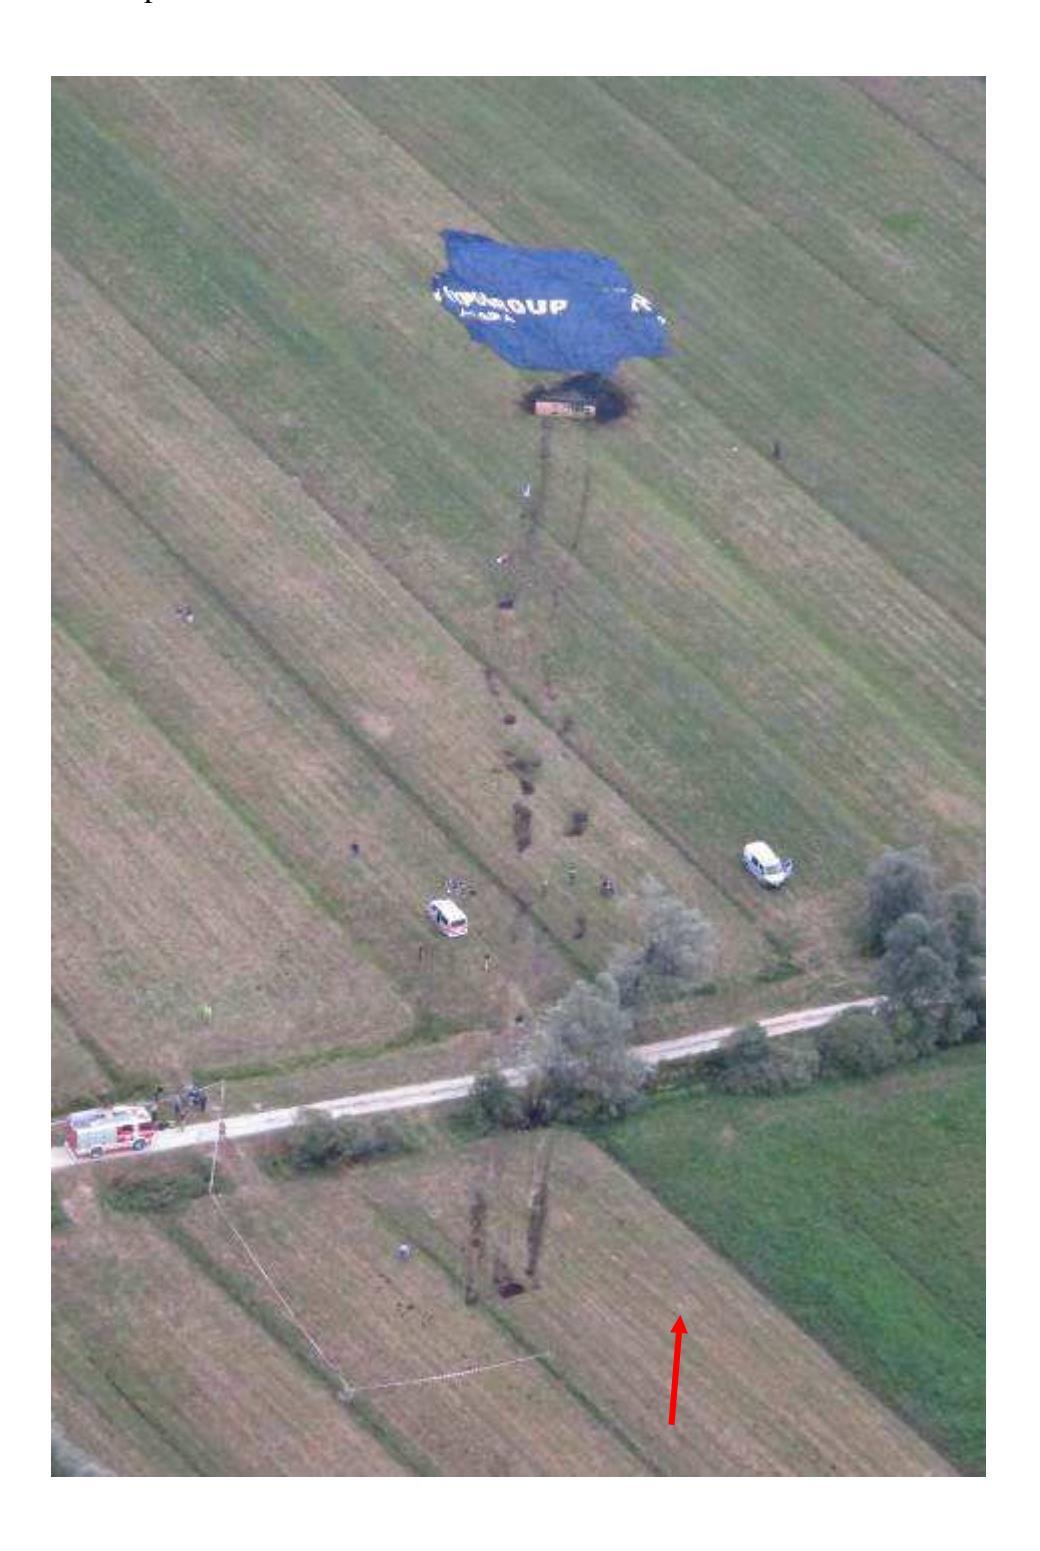
N45°59.322' E014°31.534'. The balloon's final resting spot was 740 meters east of the site of the first impact 1 minute and 20 seconds later.

Picture 46: Balloon S5-OLO's second impact with the ground

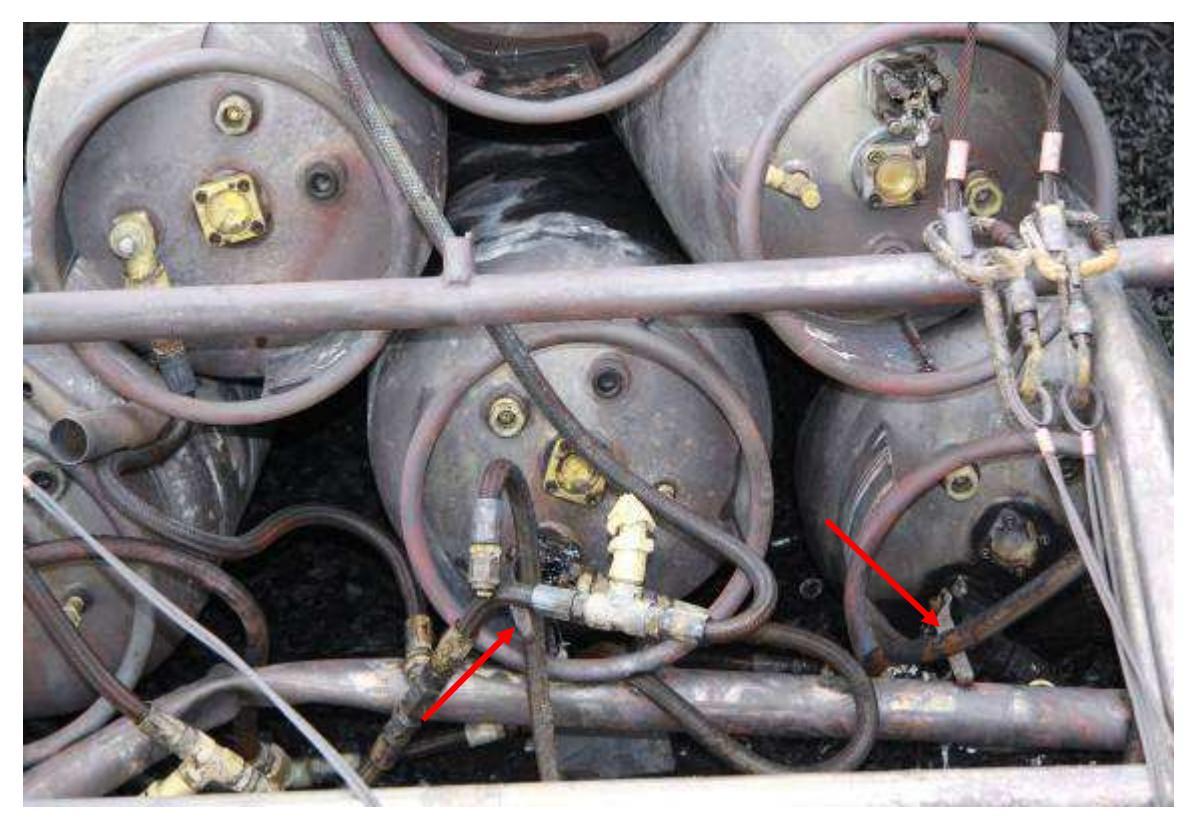
It was determined when analyzing the cause of the fire that when the balloon's basket hit the canopy the pipes in the gas rigging in the basket were damaged and as a result there was a gas leak from 7 tanks, which had their valves open, all the way until the balloon came to a complete halt. The immediate cause of the fire were pipes damaged in the impact with the canopy, the indirect cause was the open shut-off valves on the tanks, which were not closed by the pilot before the impact.

Picture 58: View of the open shut-off valves on the tanks at the scene of the accident

- 1. Open shut-off valves on the tanks, which the pilot failed to close when landing,
- 2. Impact with the tree canopy, damage to the gas rigging, and consequently the leaking of gas from open tanks.

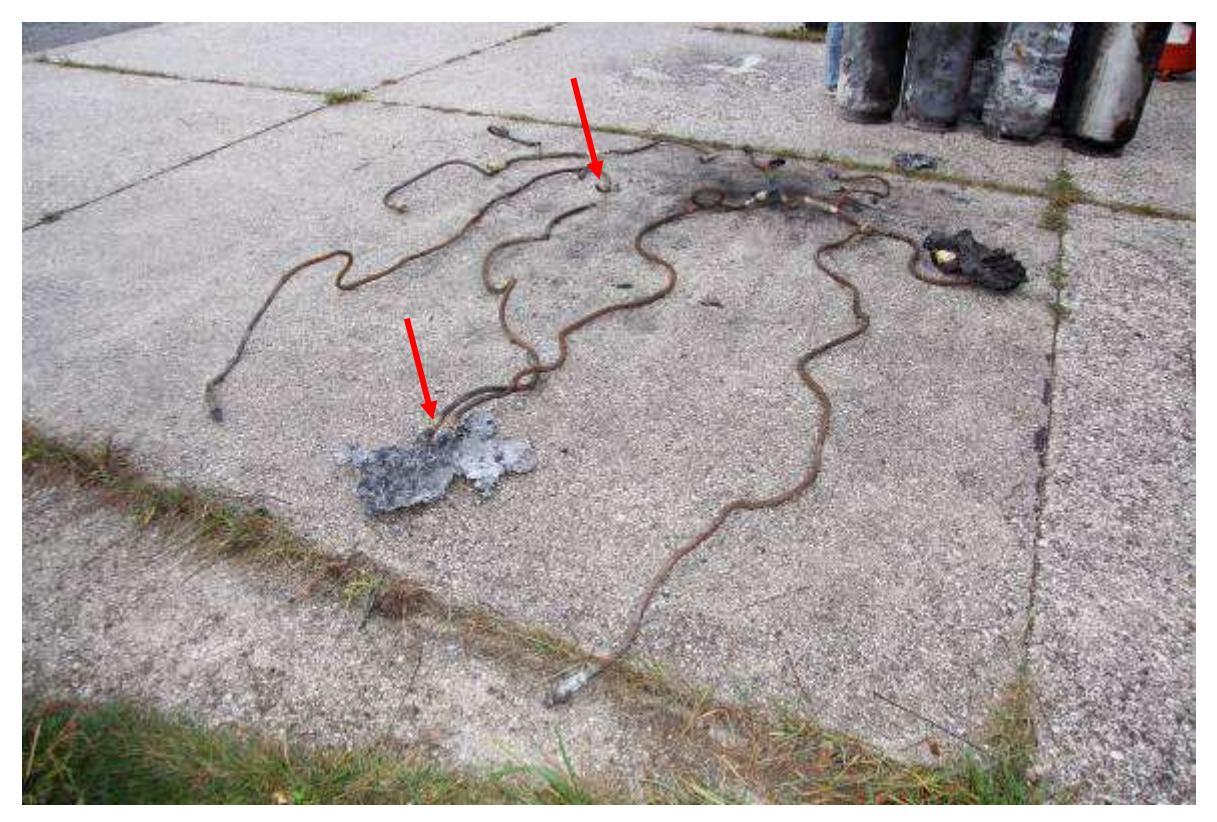
Picture 59: View of the damaged pipes in the gas rigging

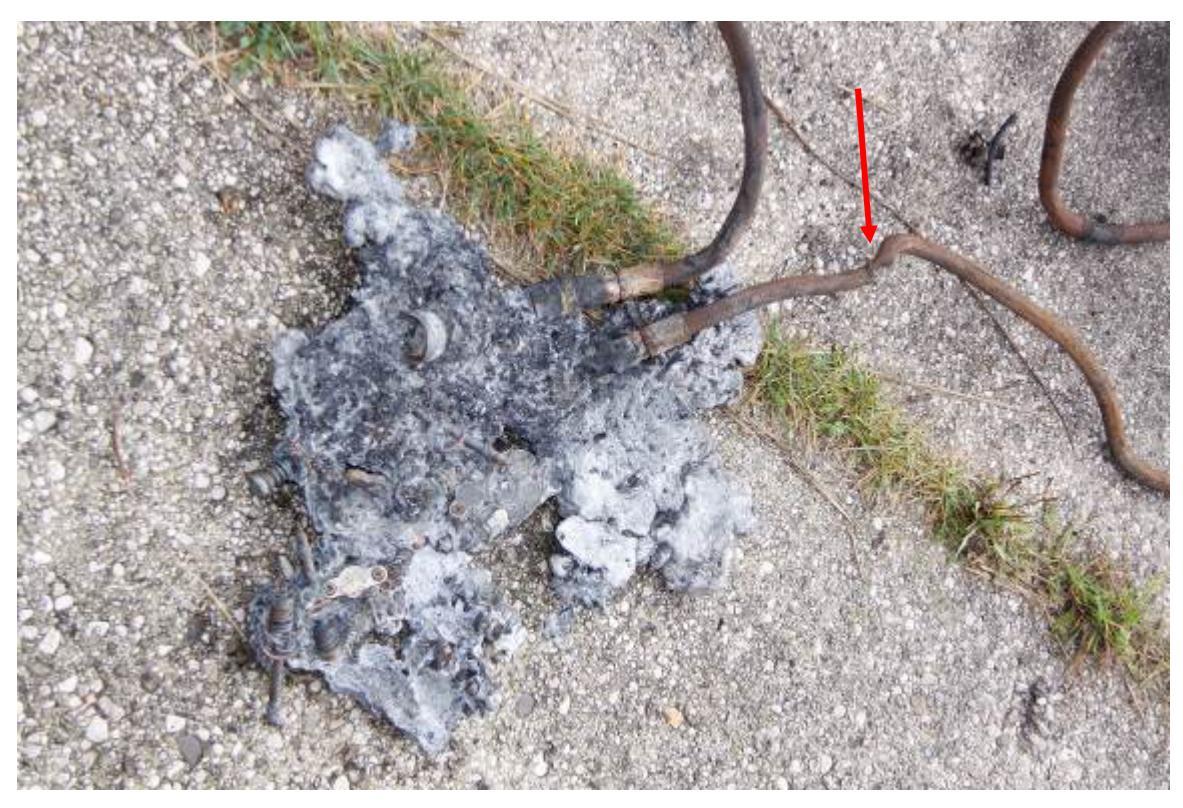
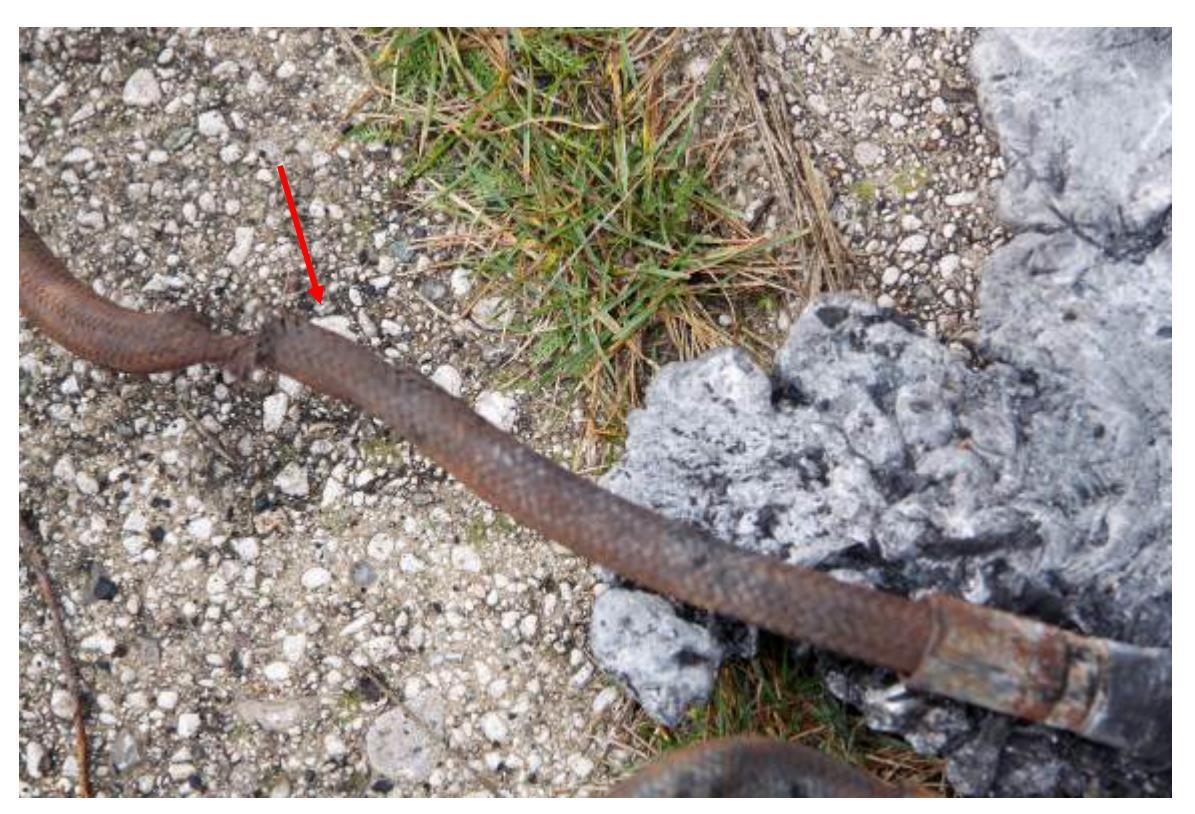
Picture 60: View of the damaged pipes in the gas rigging near the burner

Picture 61: View of the damaged pipes in the gas rigging near the burner
