SLOVENIA SAFETY INVESTIGATION AUTHORITY

FINAL REPORT ON ACCIDENT INVESTIGATION OF AIRPLANE PIPER PA32-301T N710CC at Predmeja – near Ajdovščina, 14th July 2016

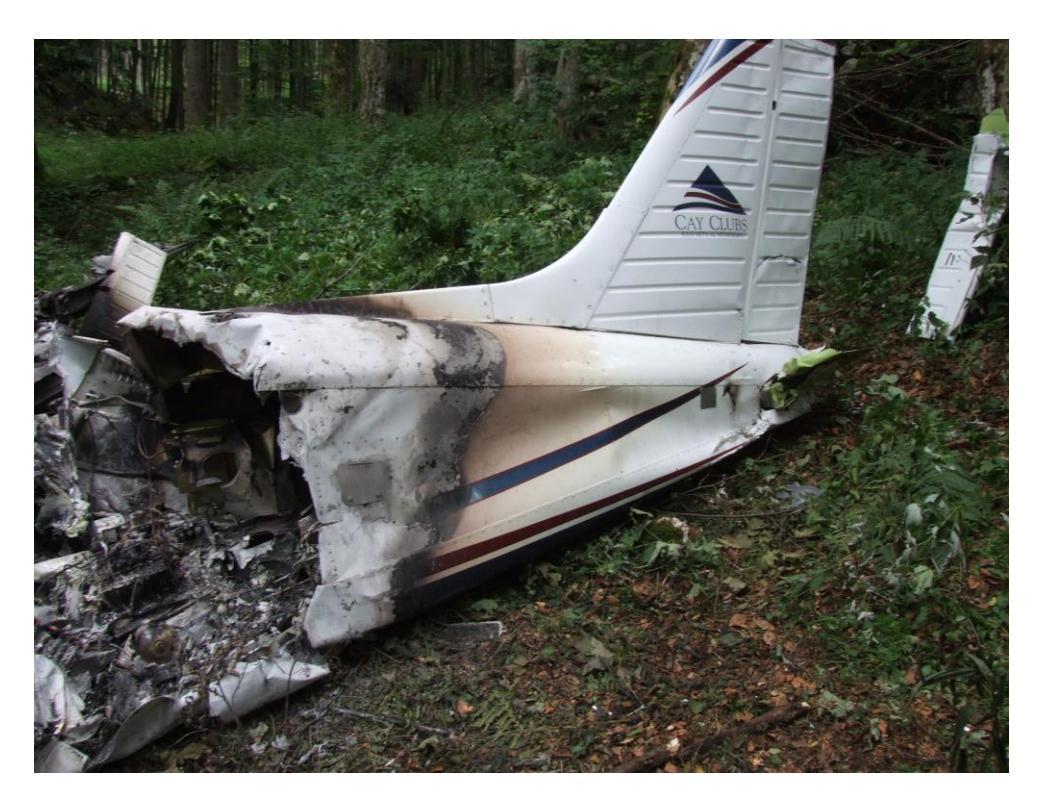
The aircraft caught fire after the impact. Fire reached almost to tail where elevator surfaces were missing. Parts of left and right part of the elevator were discovered later, approximately 1 km away from the crash site. Left and right part of the elevator were found approximately 350 meters apart. Forward fuselage and wing were completely destroyed by fire.

Image 3: Tail surfaces at the crash site

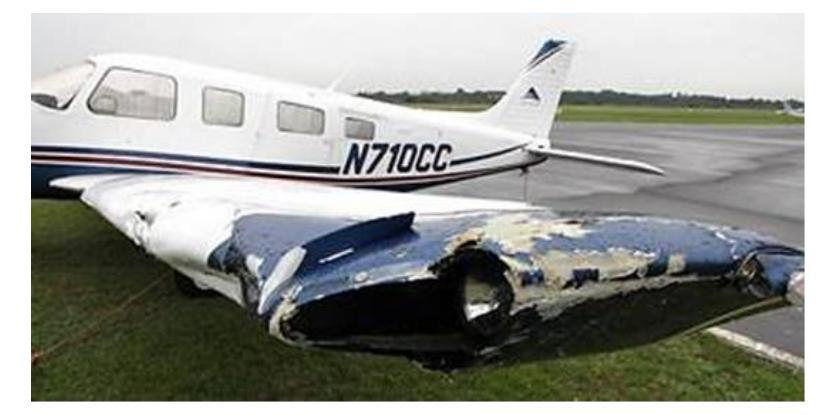
Image 4: Damage to the left wing induced during the storm on 23RD August 2010 at Bonn/Hangelar (EDKB) airport

In August 2010 left wing of the airplane N710CC was extensively damaged during thunderstorm at Bonn/Hangelar airport. When AN-2 airplane was moved by wind gusts, it hit N710CC which was parked nearby.

Aircraft was removed from operation and repair works on damaged parts of the wing were conducted. Documentation on repair works did not include any abnormalities and repaired parts of wing, according to thorough examination results of wreckage, did not contribute to the accident.

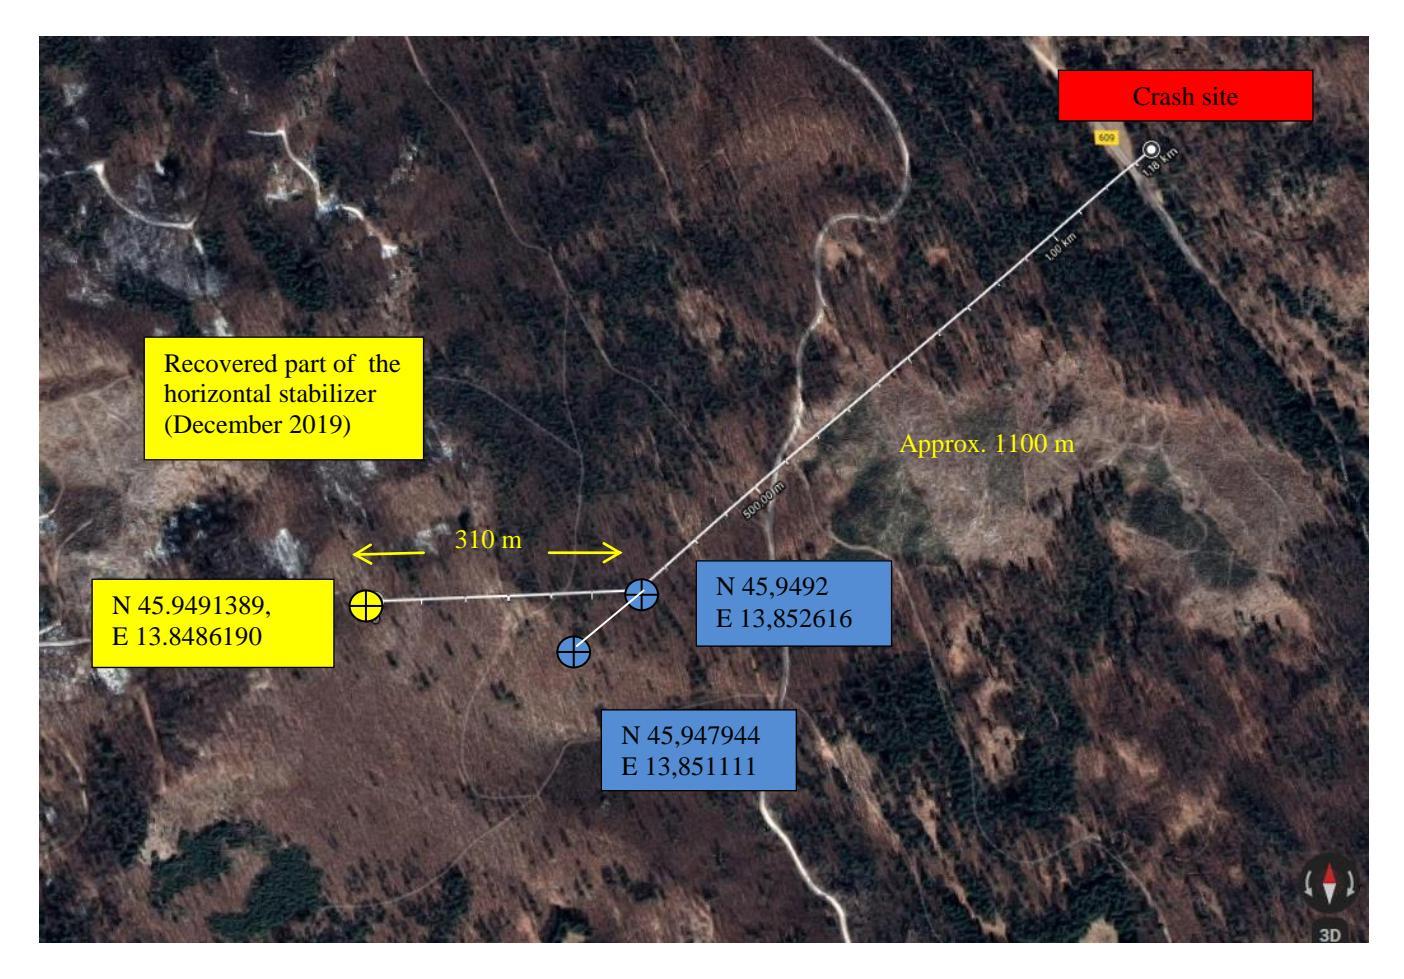
Two parts of horizontal stabilizer were recovered in search action on 8^{TH} October 2016 in the area approximately 1 km SW of point of impact of the airplane. Later, in December 2019, a smaller part of metal size of 45 x 30 cm was recovered and identified as part of the horizontal stabilizer.

Image 17: Position of recovered parts of horizontal stabilizer

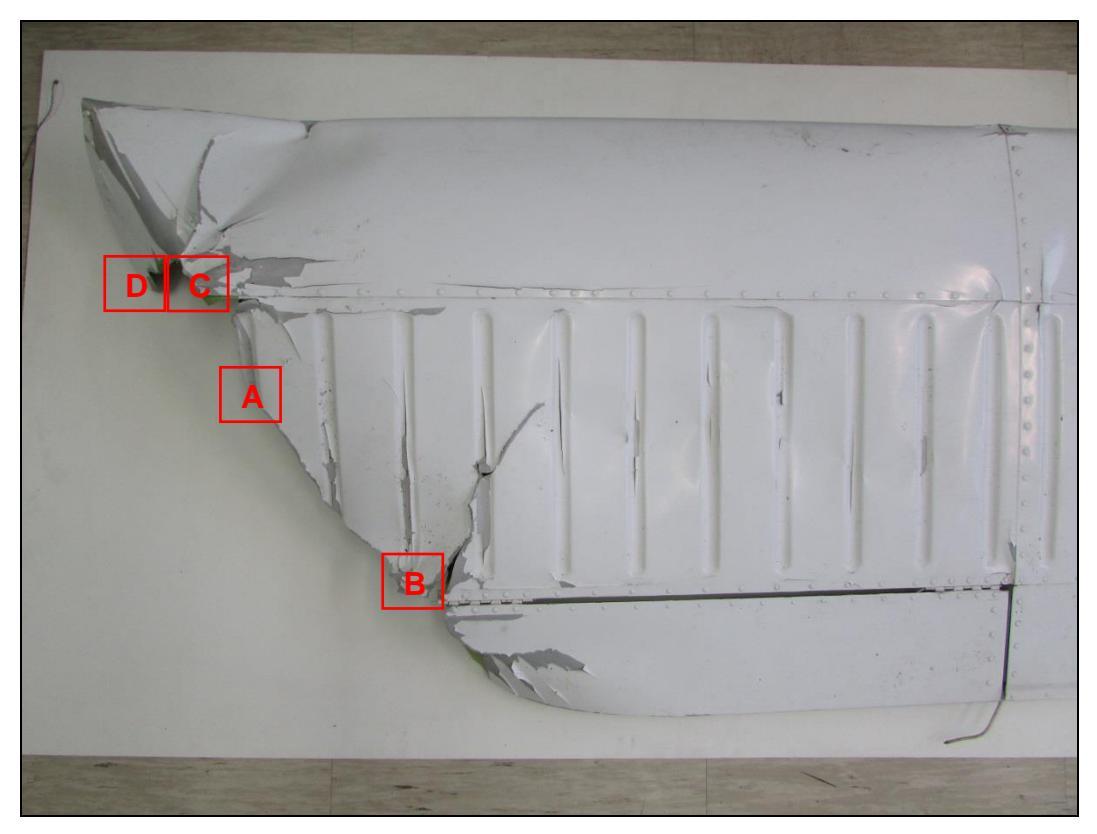
From analysis of the horizontal stabilizer we can conclude, that horizontal stabilizer failed after a few consecutive cycles of alternating banding (in multiple directions), which is known as low cycle fatigue. Alternate banding of the horizontal stabilizer could indicate dynamic aeroelastic phenomena called flutter⁵.

Image 18: Upper surface of horizontal stabilizer with part of trimmer surface (right side)

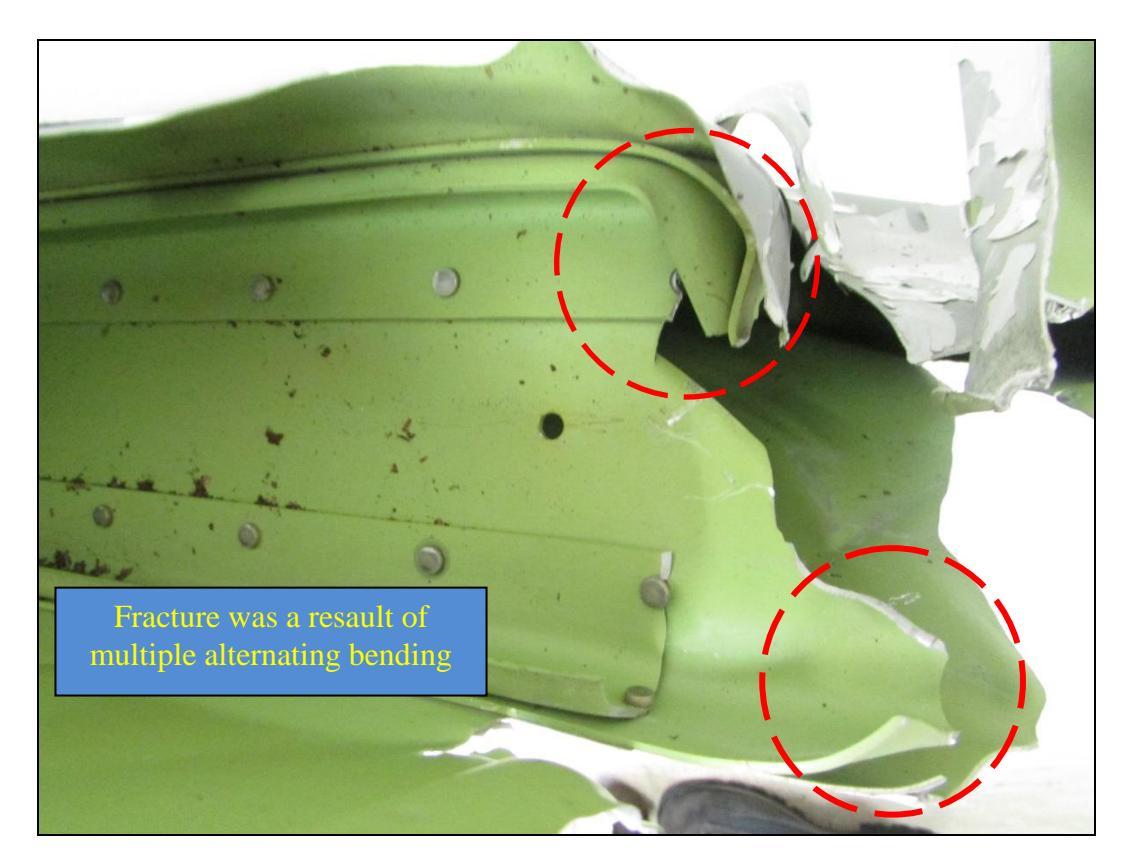
Image 20: Point of fracture on a profile of a spar (upper side is down!)

Both initial points of fracture are marked with circles. Looking at the shape of the side of the profile we can conclude, that fracture was a result of multiple alternating bending.

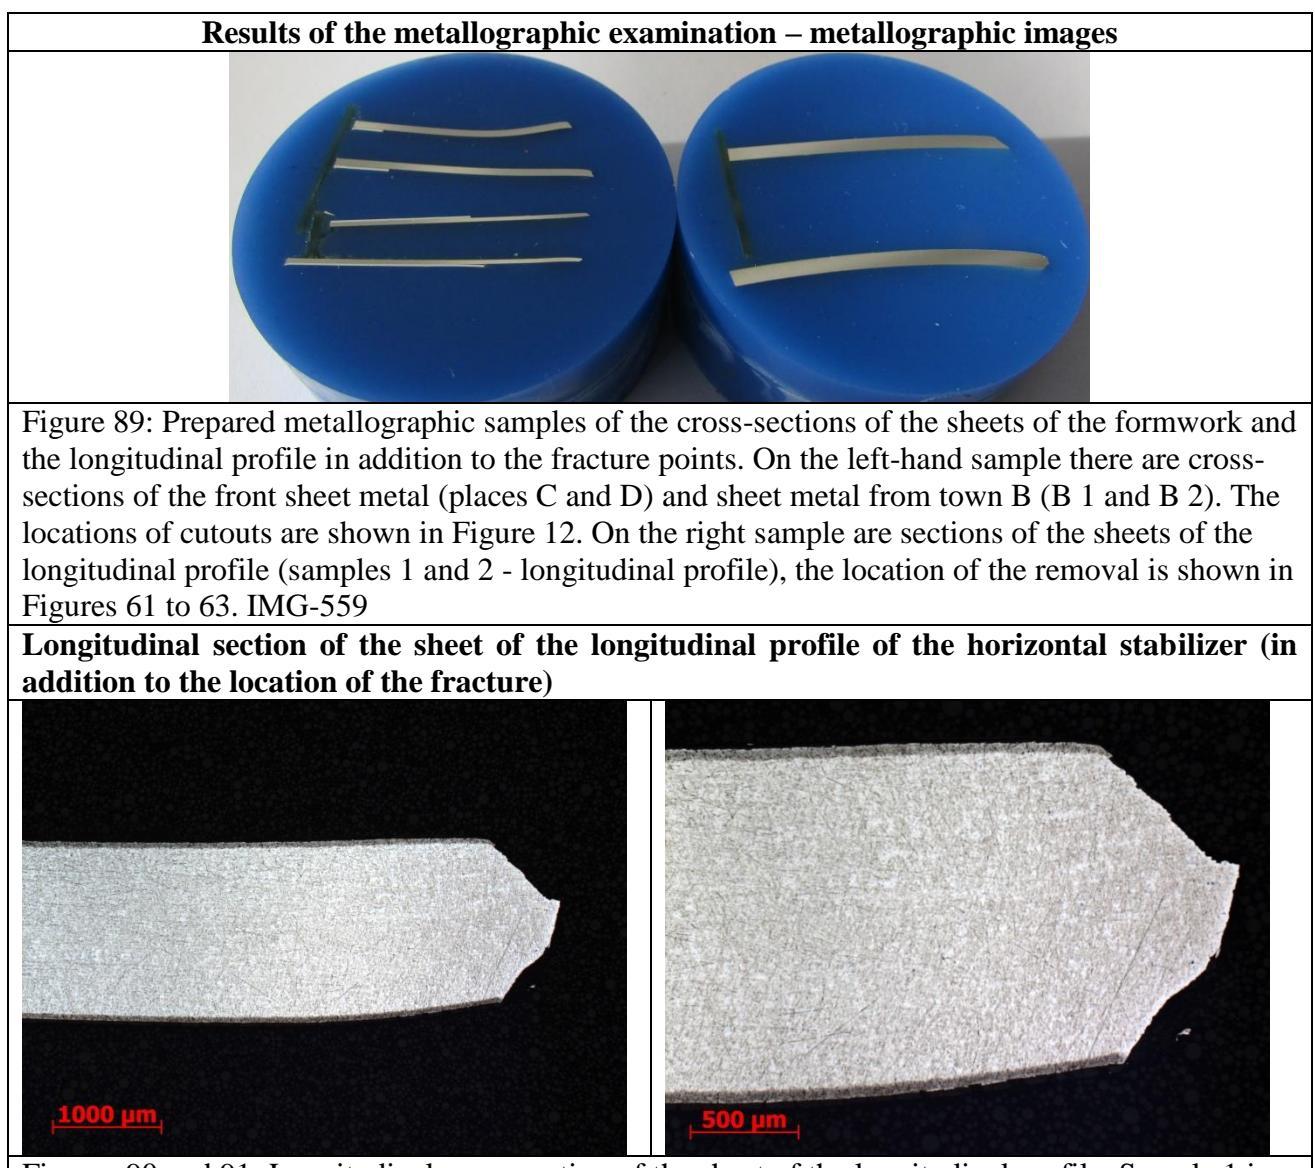
Figures 90 and 91: Longitudinal cross-section of the sheet of the longitudinal profile. Sample 1 in addition to the fracture. The shape of the fracture is due to the alternating bending load (polished).

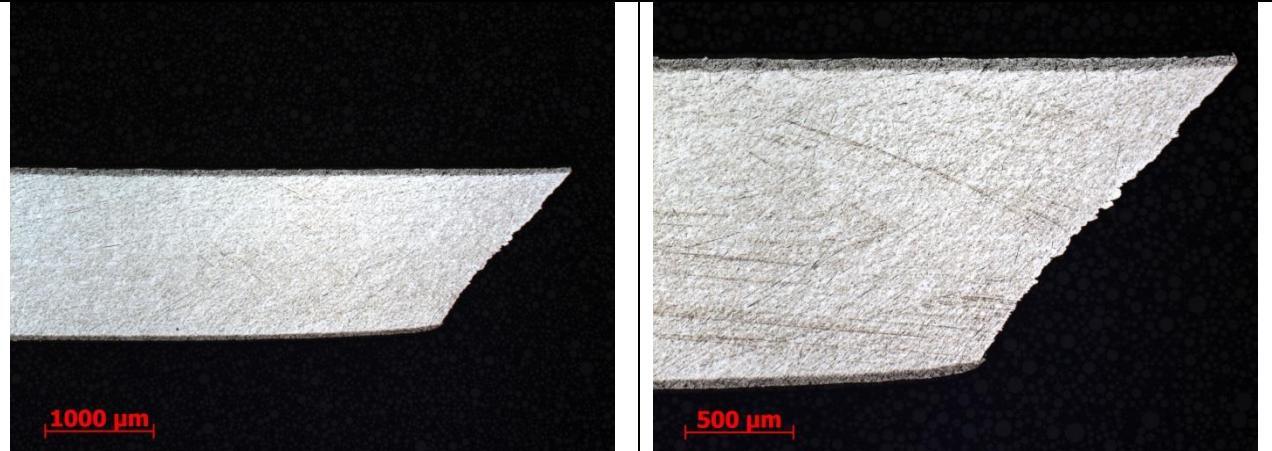
Figures 100 and 101: Longitudinal cross-section of the sheet of the longitudinal profile. Sample 2 in addition to the fracture. The shape of the fracture is consequence due to bending and tensile stress (polished).

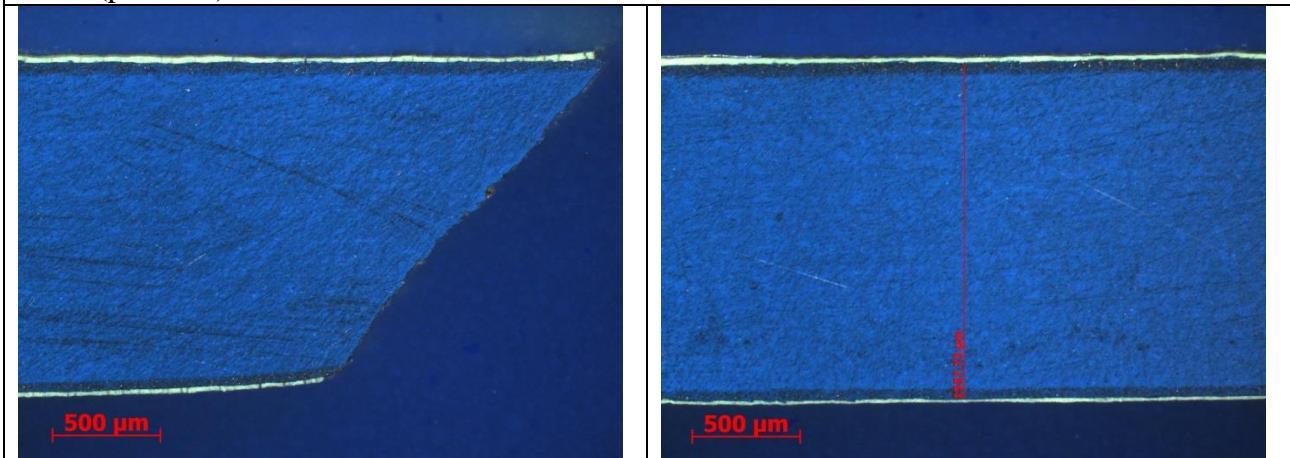
Figures 102 and 103: Longitudinal cross-section of the sheet of the longitudinal profile. Sample 2 in addition to the fracture and at a distance of approximately 20 mm from the fracture (unetched, polarized light illumination). The corrosion coating (primer) on the surface is cracked due to the elongation of the sheet near the fracture. The sheet thickness is 1.560 mm.

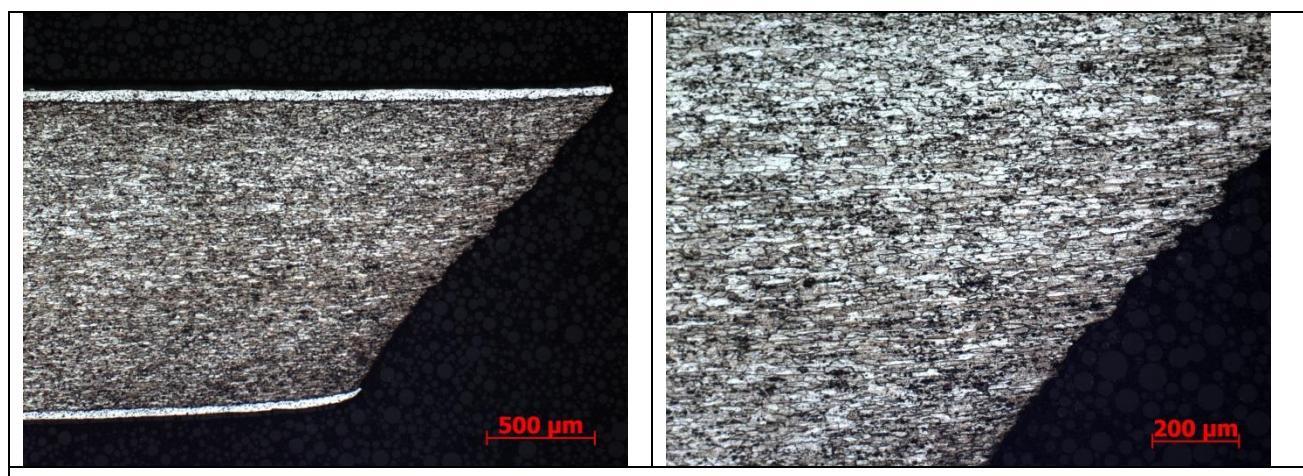
Figures 104 and 105: Longitudinal cross-section of the sheet of the longitudinal profile. Sample 2 in addition to the fracture. Due to the elongation and contraction of the sheet metal near the fracture, crystall grains are also cold deformed. As a result, the hardness near the fracture increased (etched). The break is relatively tough and is similar to the usual tensile failure.

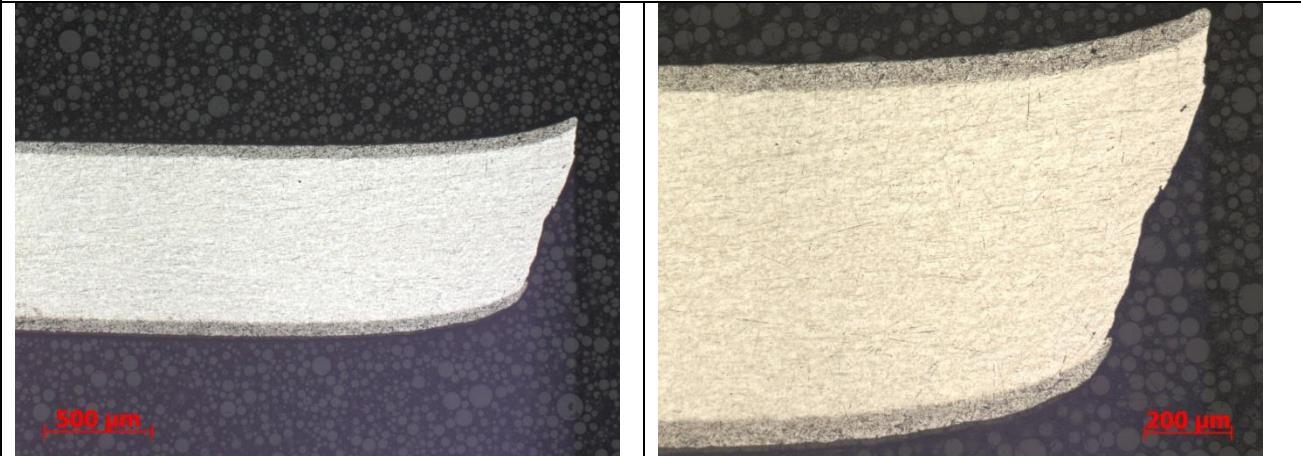
Figures 114 and 115: Sample C next to the fracture. The shape is characteristic of the bending - tensile fracture (unetched). The breakthrough is tough - ductile.

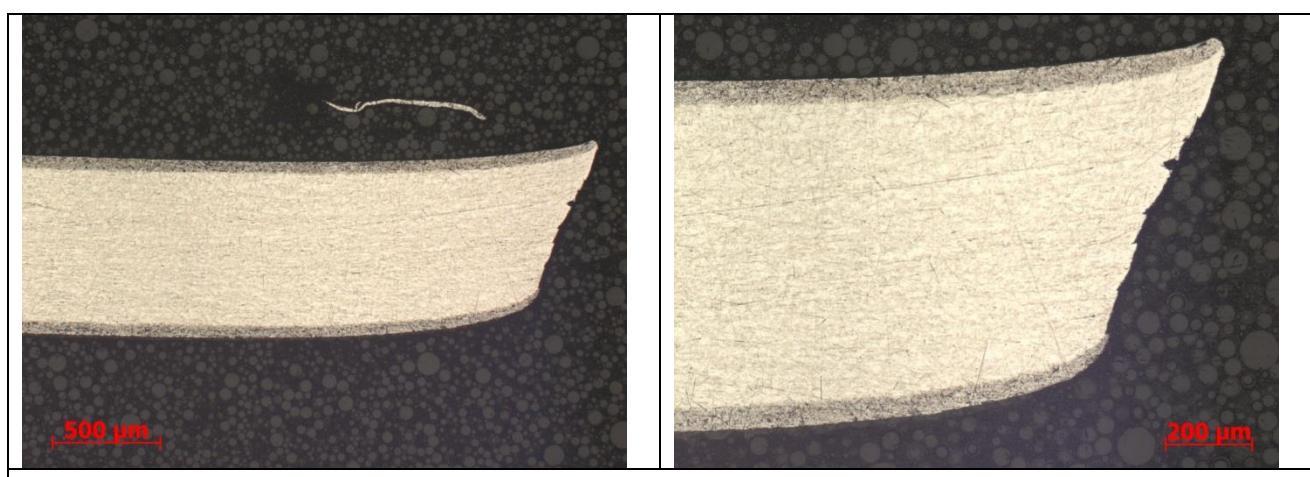
Figures 121 and 122: Sample D - cross-section of sheet in addition to fracture. The shape is characteristic of the bending - tensile fracture (unetched). The breakthrough is tough - ductile. The surface layer of the claded alloy is also ductile.

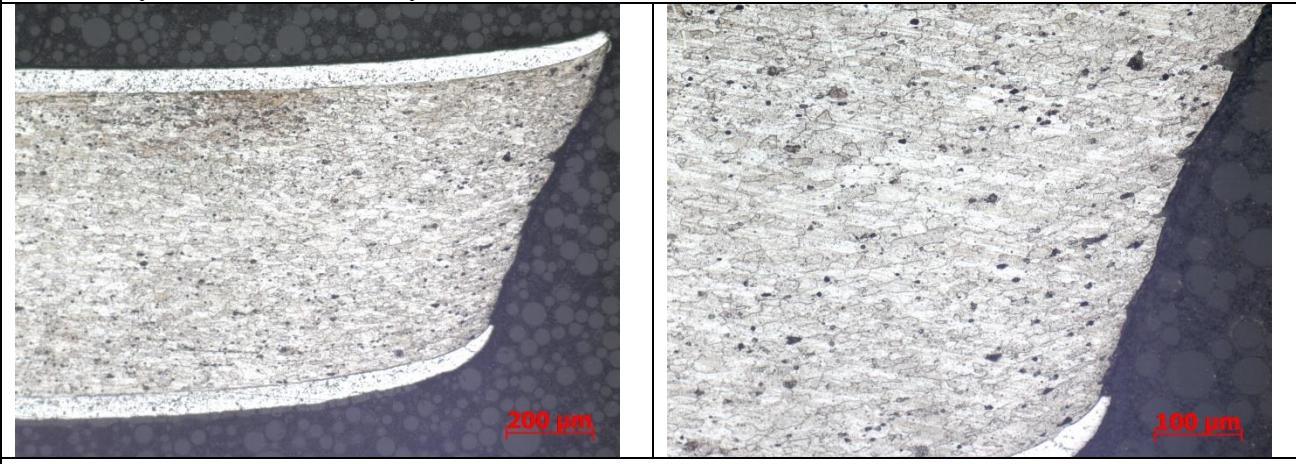
Figures 123 and 124: Sample D - cross-section of sheet in addition to fracture (etched). The microstructure at the break is strongly plastic deformed.

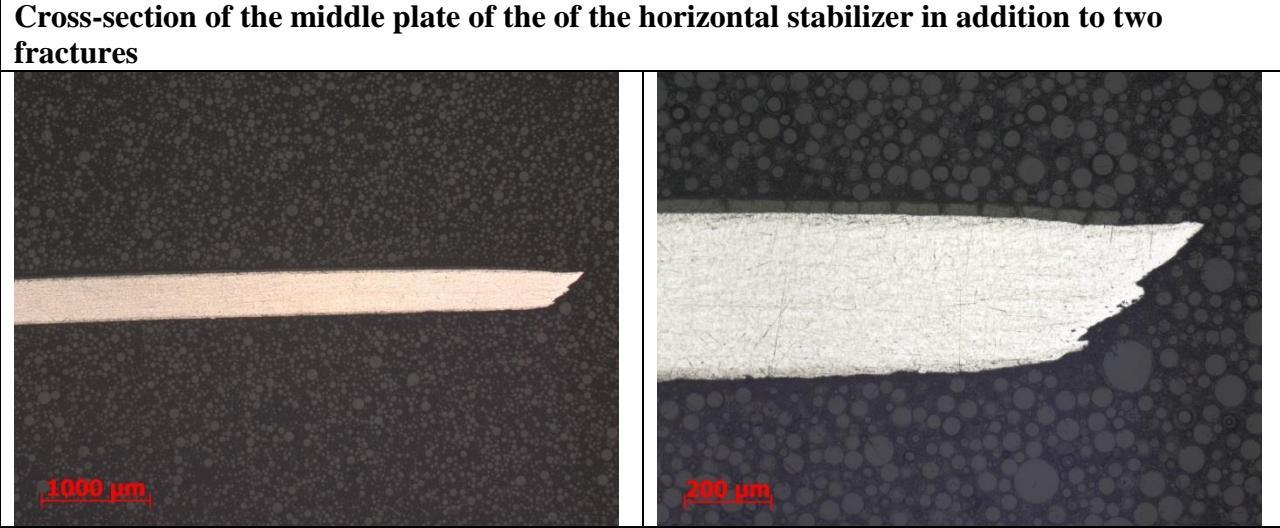
Figures 129 and 130: Sample B 1 - cross-section of the middle sheet next to the fracture (unetched). The shape is characteristic of collapse in tensile loads. The sheets are also slightly curved as a result of the presence of bending loads.

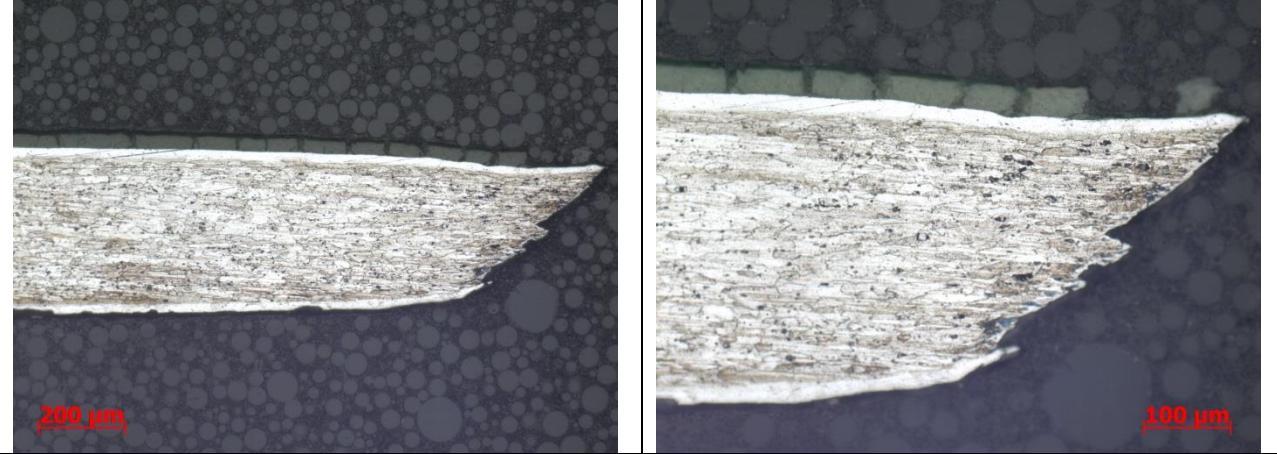
Figures 131 and 132: Sample B 1 - cross-section of the middle plate next to the fracture (etched). The breakthrough is tough - ductile. The microstructure at the break is strongly plastic deformed

in the direction of tensile loads. The corrosion coating (green) is cracked due to excessive elongation. In addition to the breakage, the corrosion coating on the outer side of the sheet metal fell off.

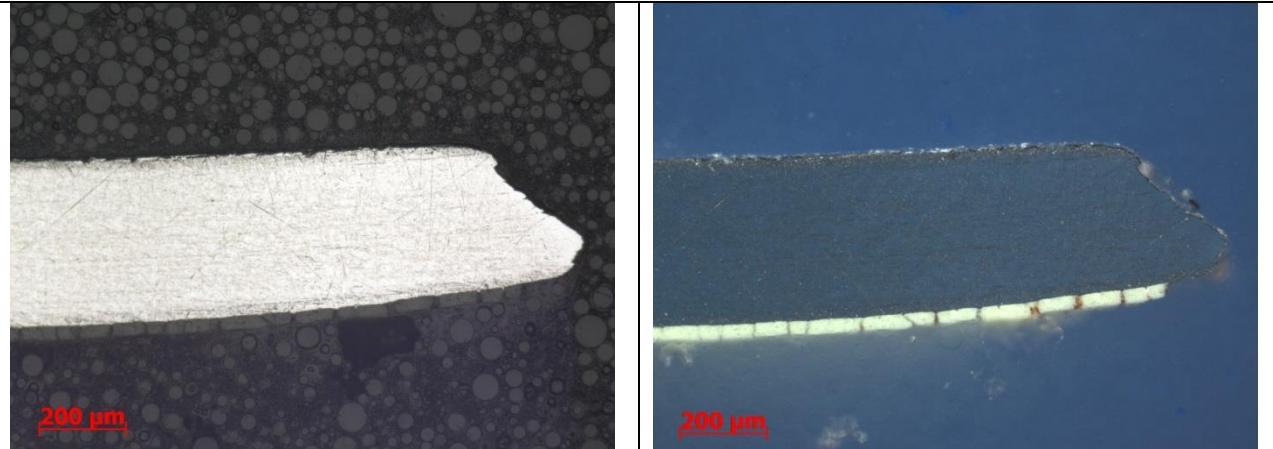
Figures 137 and 138: Sample B 2 - cross-section of the middle plate in addition to the fracture (unetched, white and polarized light illumination). The shape is characteristic of collapse in tensile and bending loads. The anti-corrosion coating (green color - on the right figure below) is

cracked due to excessive elongation. In addition to the fracture, the corrosion coating on the outer side of the sheet metal fell off.

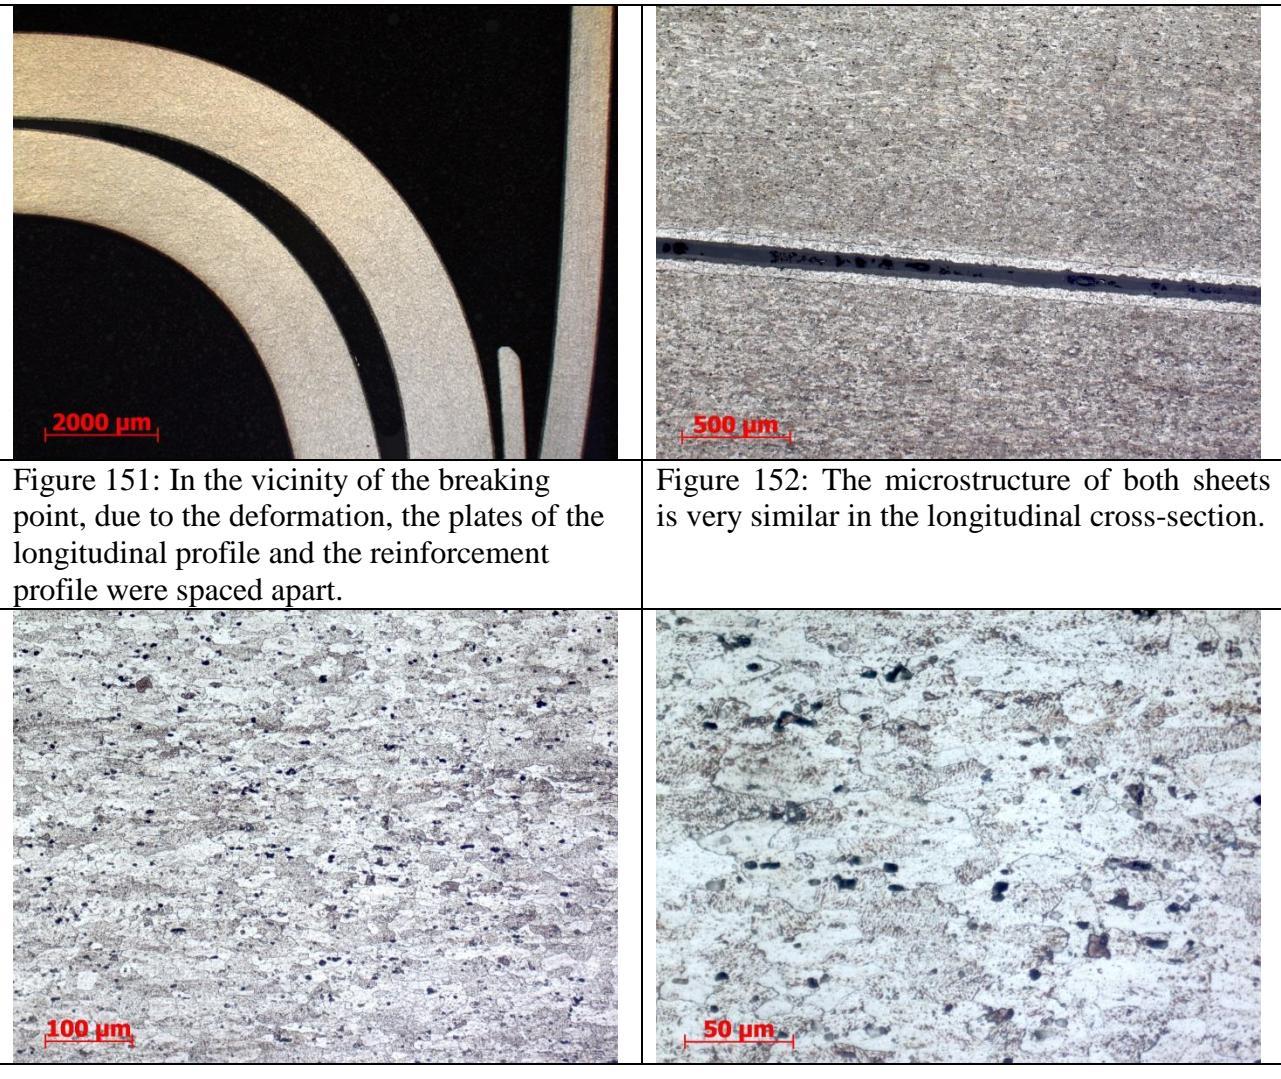
Figures 153 and 154: Sheet of the longitudinal profile in the transverse cross-section. Details of microstructure of metal sheet of the alloy 2024: various precipitates of intermetallic compounds are dispersed over crystall grains α . In the transverse direction, the orientation of the crystalline grains is less visible than in the longitudinal direction. At a distance of 8 cm from the fracture, no changes in the microstructure are observed, which could be due to fatigue of the material.

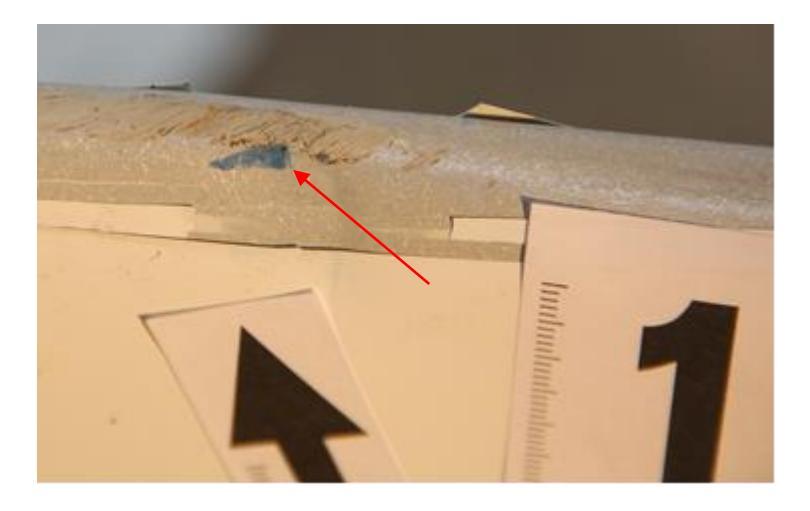
Image 22: Documenting of questionable scratches – colour traces
