REPUBLIC OF SLOVENIA MINISTRY OF INFRASTRUCTURE

FINAL REPORT ON THE ACCIDENT INVESTIGATION of the AQUILA AT01 motor aircraft, reg. mark OE-CYY, near Lesce airport (LJBL),

August 5, 2022

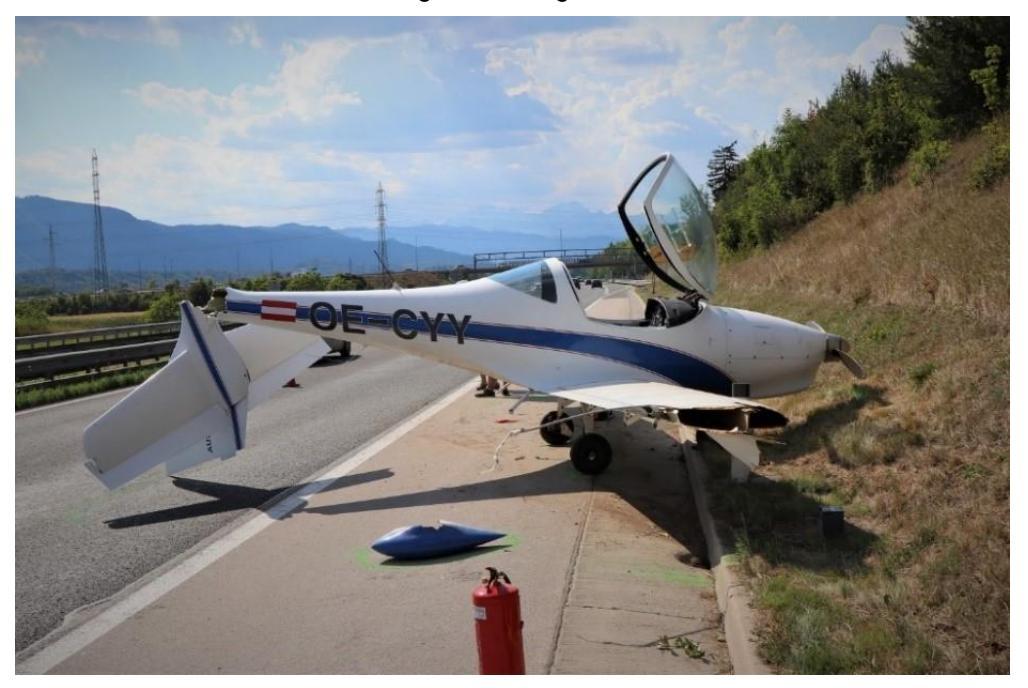
The aircraft landed on the Gorenjska highway in the direction of Jesenice. During the landing on the highway, the aircraft was not damaged until the moment when the pilot steered the aircraft to the far right of the runway to avoid a collision with vehicles, causing the right wing of the aircraft to slide along the embankment at the edge of the highway. During heavy braking and sliding of the right wing against the terrain, the nose leg of the landing gear was damaged (aerodynamic covers of the landing gear wheels, tyres), part of the right wing, right flap, and aileron of the aircraft were broken off and fell off, and the tail of the aircraft was damaged (broken off). Surface cracks were visible on part of the left wing. The propeller also showed surface damage. A small amount of fuel leaked from the fuel drain valve, which was pushed by the edge of the cracked abutment onto the concrete curb next to the damaged nose leg.

Figure 2: Position and damage of the OE-CYY at the stop point

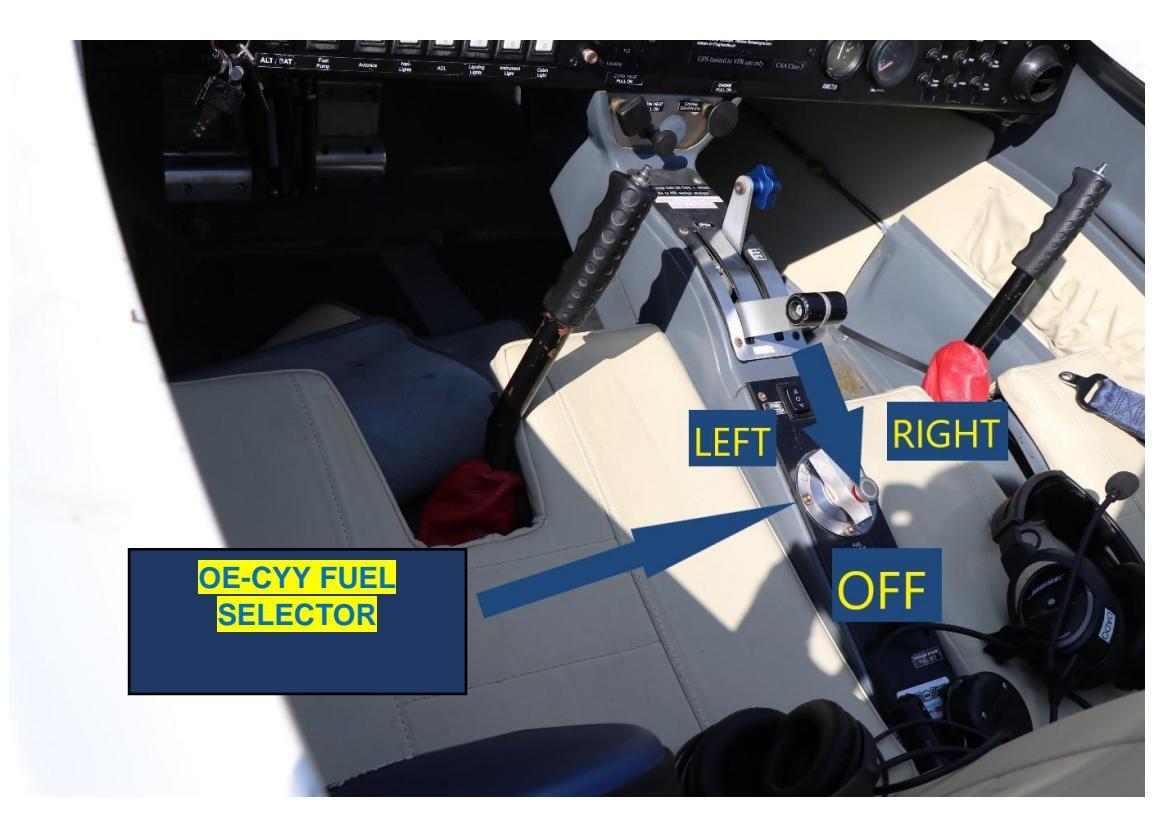
Figure 6: The position of the fuel selector OE-CYY at the scene immediately after the accident

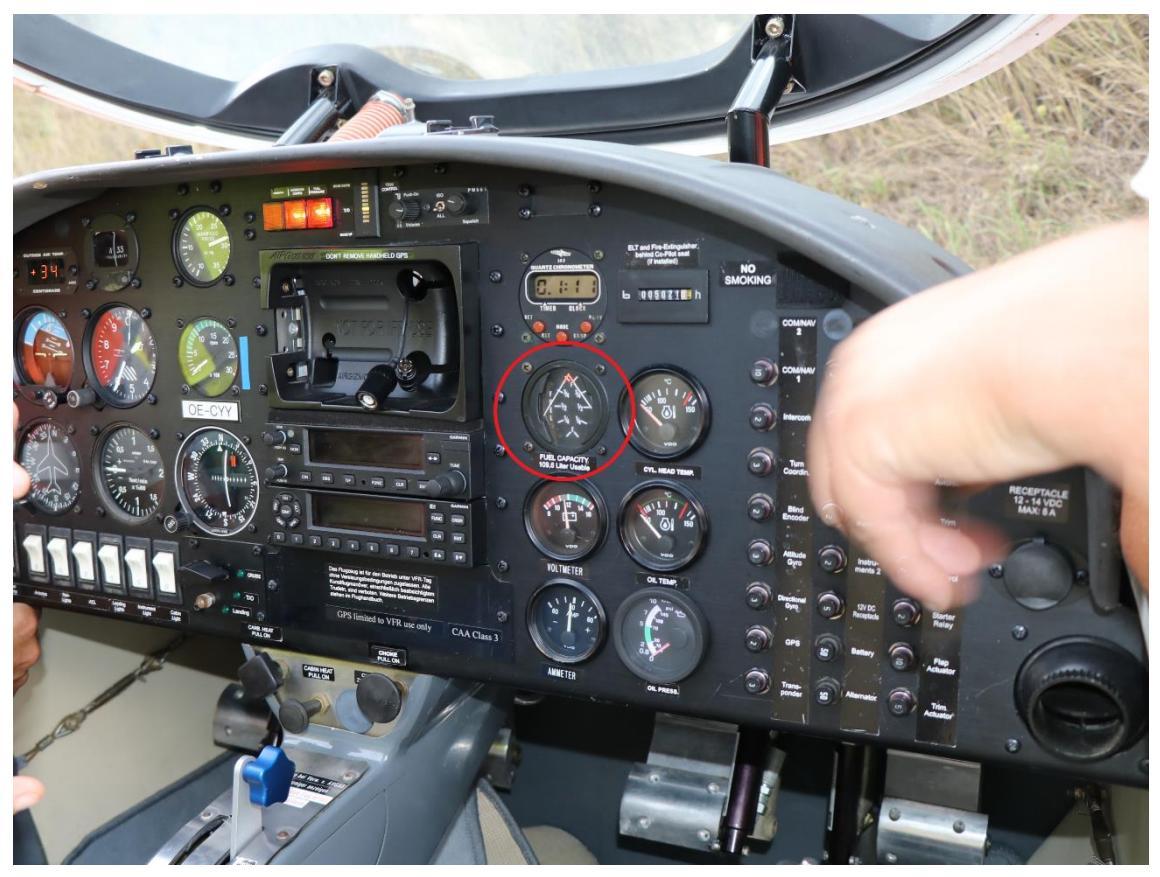
Immediately after the accident, the investigating authority was informed by ReCO and OKC Kranj. The scene of the accident was secured by the police until the arrival of the chief investigator. The pilot of the aircraft, a passenger, representatives of the police, fire brigade, and DARS were present at the scene of the accident to ensure the safety of traffic on the AC. The on-site investigation included a visual inspection of the amount of fuel in the wing tanks. It was found that the left wing tank was empty, while the right wing tank still contained about 1/2 fuel. The fuel quantity indicator in the aircraft cabin showed the maximum deviation of both indicators in the full position (Figure no. 11 (FULL).

Figure 11: Position of fuel instrument indicators at the scene

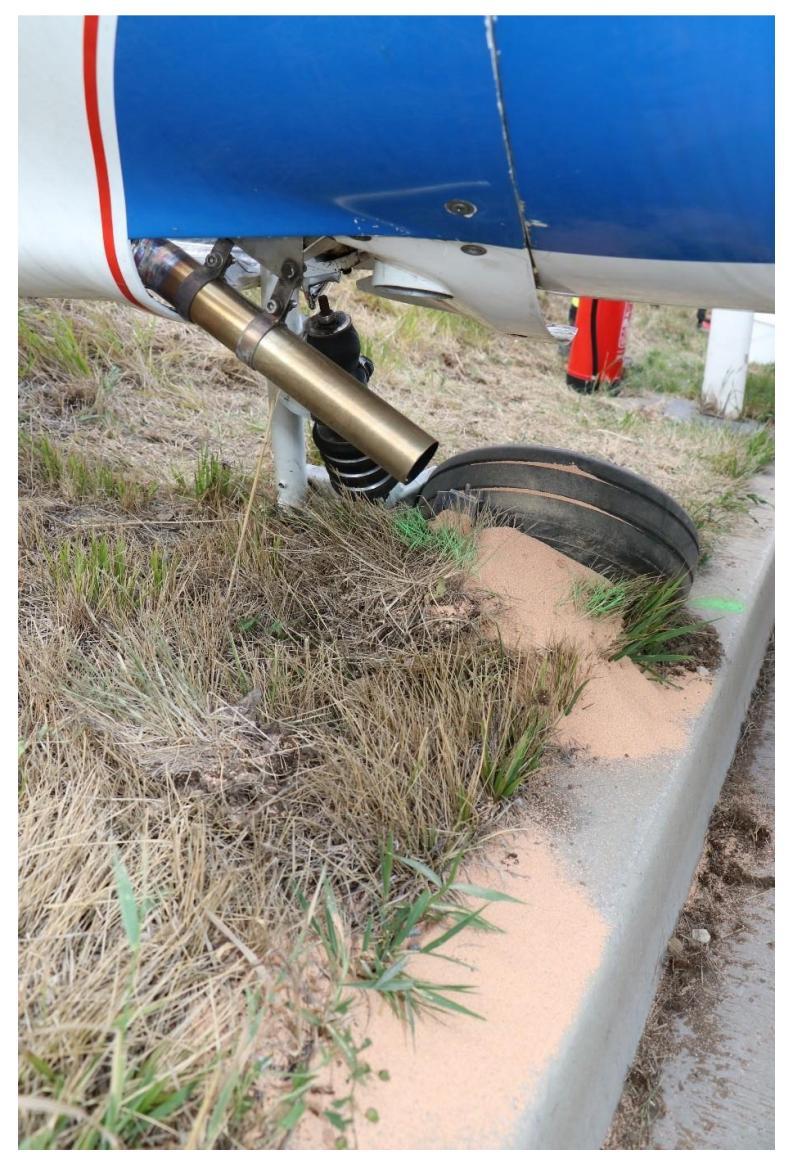
There was a fuel stain about 20 cm in diameter at the edge of the highway lane. According to the statements and documents obtained by the first responders at the scene of the accident, the fuel dripped for several minutes from the drain valve, which was pushed through the torn-off panelling of the lower part of the nose of the aircraft. The approximate amount of fuel that leaked from the depressed drain valve is between 2 and 3 litres (the leaked fuel was absorbed by the firefighters, Figure 12).

Figure 12: A small amount of fuel leaked from a fuel drain valve at the scene

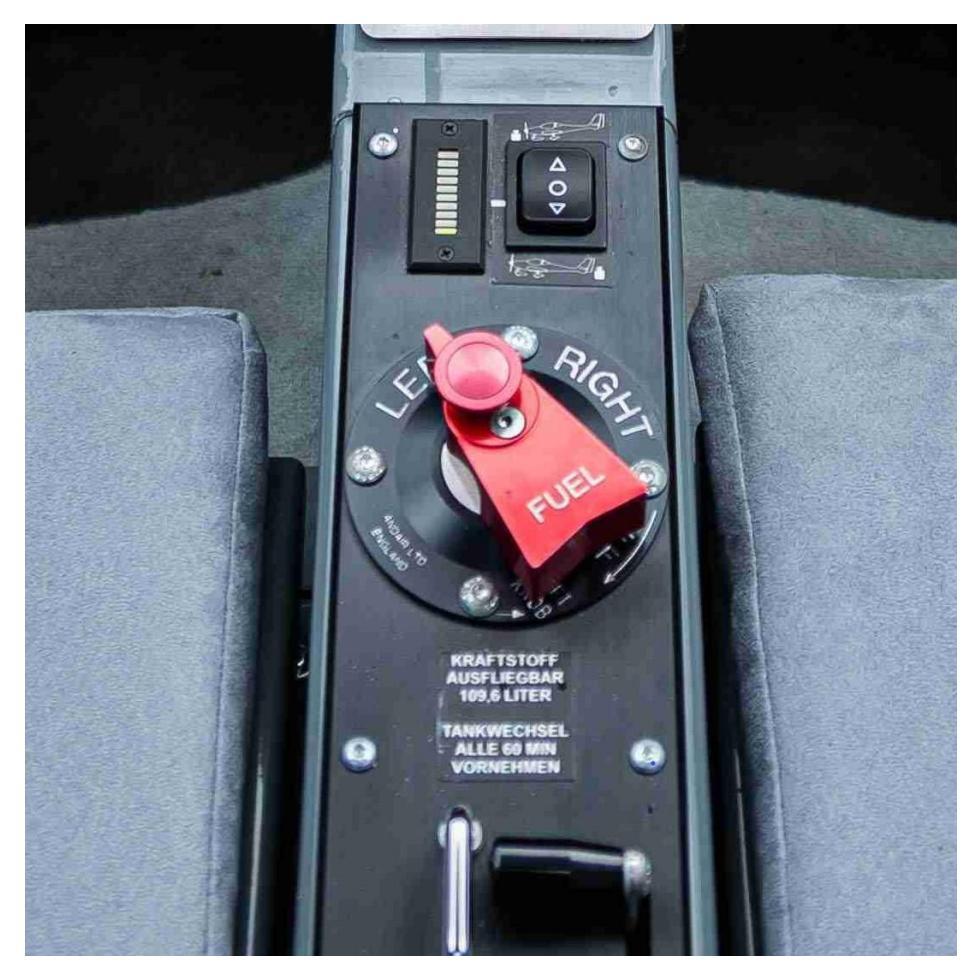
After completing the pre-flight inspection, the pilot set the fuel selector switch to the "LEFT" position and assumed that there were 50 litres of fuel in each of the two tanks, i.e., a total of 100 litres.

Figure 13: The position of the fuel selector at the time of the event

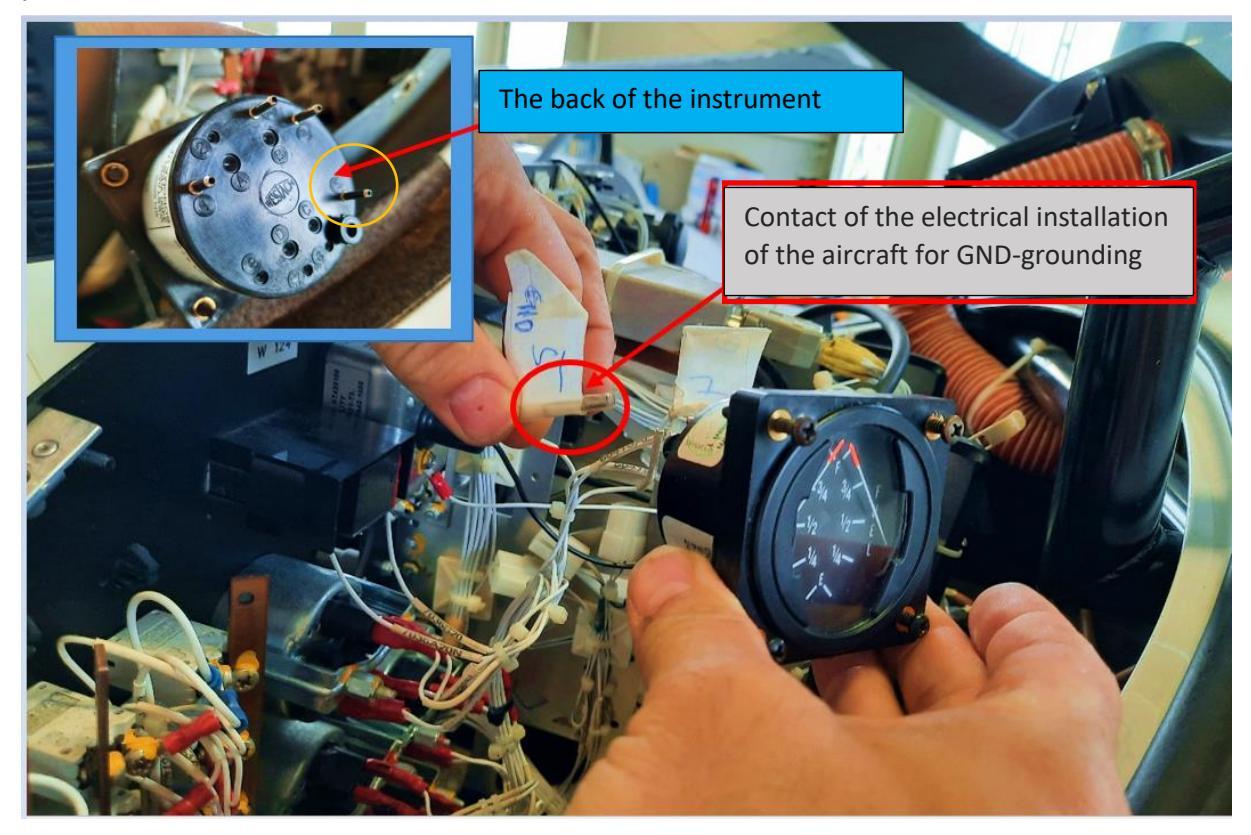
When draining the fuel from both tanks, the amount of fuel in the left tank was measured at 0.16 litres. The amount of fuel measured in the right tank was 31 litres. No water was found in the fuel. The water drainage system and the entire fuel installation system were checked to detect possible leaks. When checking the function of the fuel gauge on the cockpit instrument panel, it was found that one of the connection contacts on the back of the instrument was loose. The female part of the contact was approximately 2/3 outside the length of the male contact and in the non-contact position.

Figure 15: Display of a separate grounding contact: the instrument pointers indicate a position above the FULL (F) mark

The display of the manufacturer's device ⁵was compared with the position of the GND wire (GND is the abbreviation for "ground"). It turned out that the fuel quantity display is correct if the contact of the ground wire is correctly fitted (Figure 14). If the ground wire contact is loose or protruding (Figure 15), both fuel quantity instrument displays are completely off in the top position. **Such an instrument display can be identified as full of fuel.**

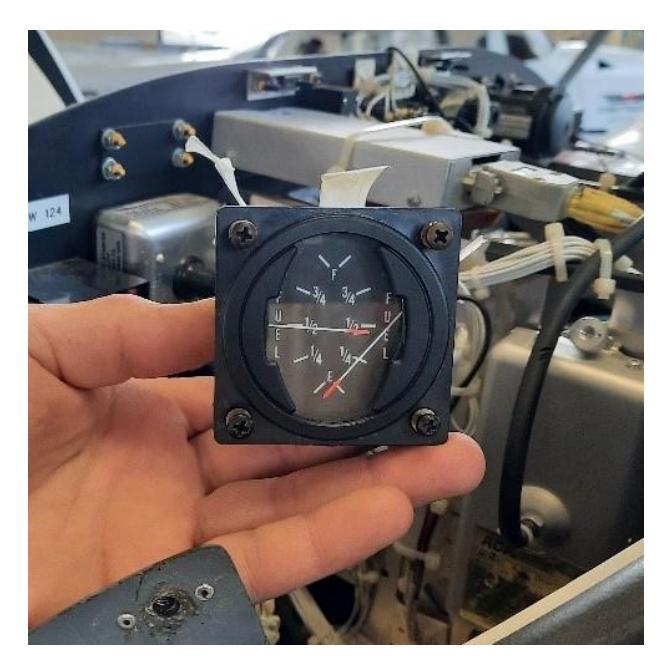
Figure 16: Indicators of the instrument when the GND contact is connected

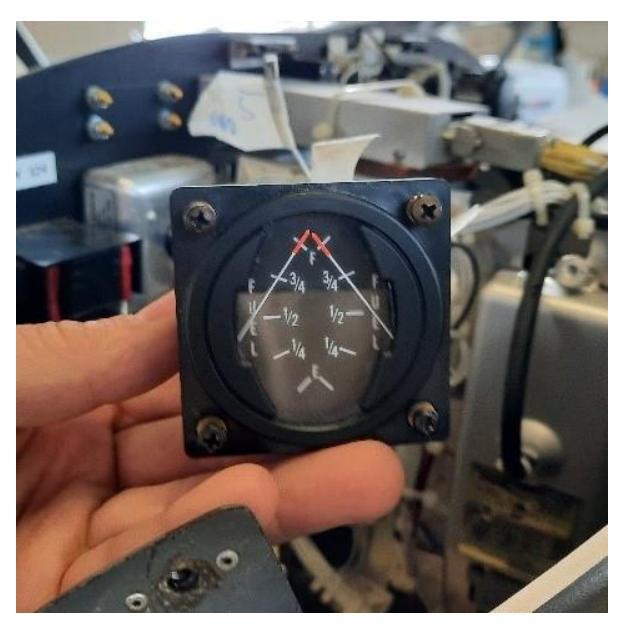
Figure 17: Indicators of the instrument when the GND contact is not connected

It was found that the pointers of the fuelling instrument of the same manufacturer in another aircraft⁶ have an identical position when the GND contact is disconnected, namely that both pointers are in the outermost upper position (Fig. No. 17).

- If there is a loose contact or if the contact of the grounding wire on the back of the device is exposed, both pointers of the measuring device indicate full or are in an extreme position.

- The interruption of the GND contact in the electrical installation of the aircraft is due to the loose contact of the non-matching contacts of the instrument with the electrical installation. The interruption of contact was most likely due to the influence of high temperatures, vibrations, or changes in the structure of the material.

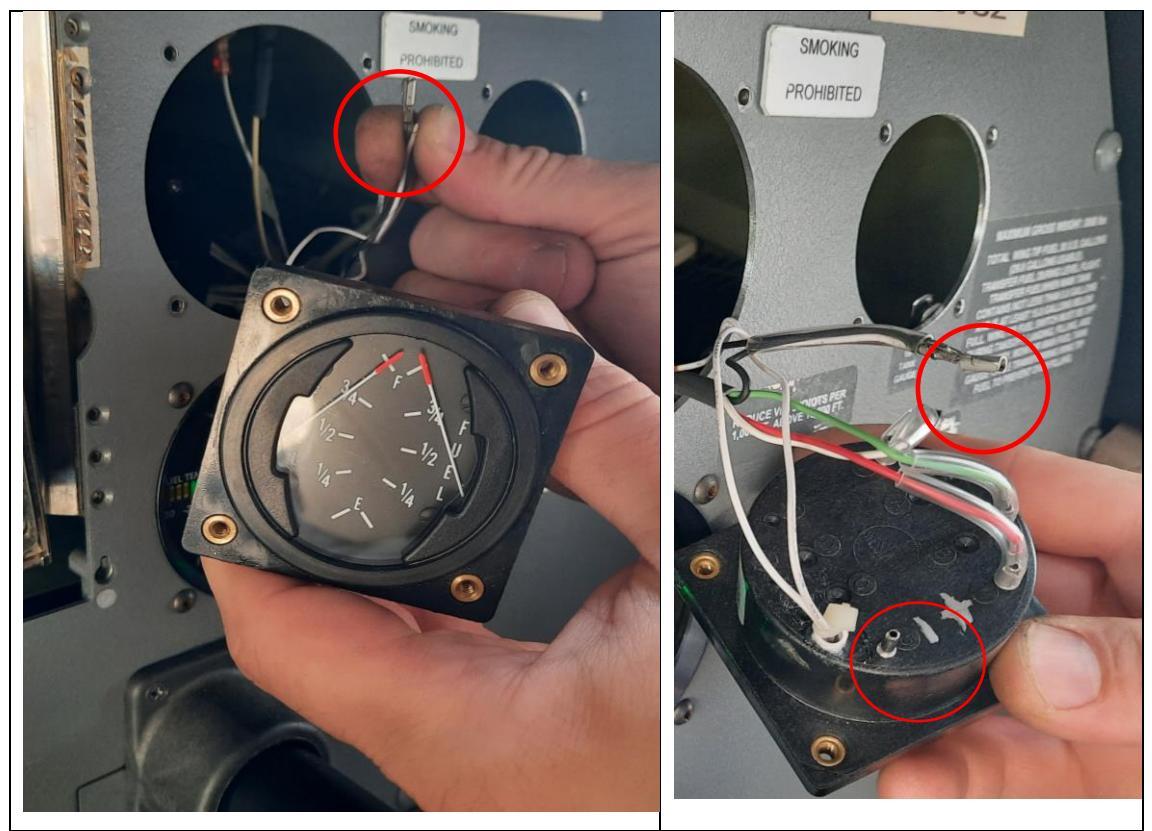
As part of the investigation, an analysis was carried out on another Cessna 206 GA aircraft equipped with an identical instrument from the same manufacturer, Westach, as the instrument in the aircraft involved in the accident. It was found that the pointers of the fuel instrument of another aircraft indicate the maximum deviation "full" in the event of an interruption of the GND contact, which is identical to the case of an interruption of the GND contact of the OE-CYY aircraft (Figure No. 15).

Figure 20: Performance check of the Westach fuel instrument on another GA category aircraft
