AIR, MARITIME AND RAILWAY ACCIDENT AND INCIDENT INVESTIGATION UNIT Tržaška cesta 19, 1000 Ljubljana T: 01 4

Številka: 37200-1/2022/71 Datum: 23. 07. 2024 unofficial translation

# FINAL REPORT ON THE ACCIDENT INVESTIGATION Of a hot air balloon Lindstrand LBL 150A, reg. mark OO-BDI, near Ig – Ljubljansko barje ,

# January 22, 2022

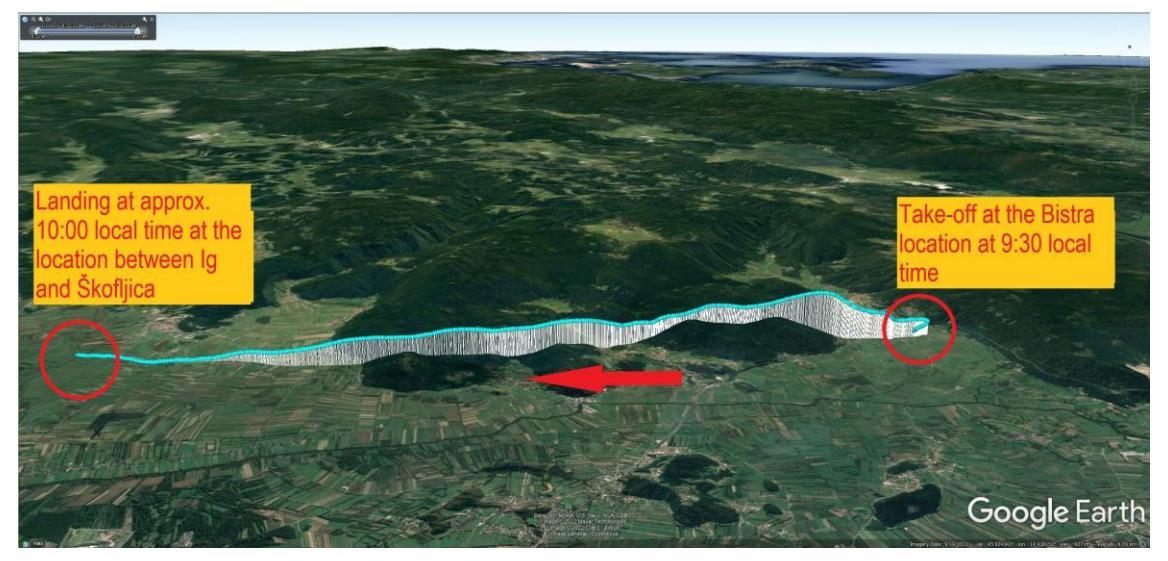
Figure 1: Radar recording of the flight trajectory - KZPS

In preparation, the pilot announced the flight plan with the responsible air traffic control centre (KZPS) and then checked the weather data. At the original location of the planned takeoff, he carried out a wind influence test by lowering a helium balloon. Due to the nature of the terrain and possible obstacles during the take-off, he decided to change the planned take-off place so that both balloons took off at 9.30am after a new wind test and a check of the weather data. The take-off point was located in the town of Bistra in the municipality of Vrhnika, which lies on the south-western edge of the Ljubljana Marshes, between Vrhnika and Borovnica. After taking off in an easterly direction, the two balloons ascended to an altitude of around 1,200 metres above sea level. The flight initially went according to plan and without any particular incidents. Visibility was sufficient, so the pilots of both balloons followed the flight path to the planned landing site, which was located in an open field immediately after crossing the high-voltage power lines near Iška Loka, north of Ig, about 16 kilometres from the take-off location. During the descent, the pilots of both balloons noticed that the wind speed had increased. They coordinated the landing by radio, preparing the passengers for what was likely to be a hard landing and giving them instructions. The pilot of the larger balloon switched off the burners and closed the valves of the

gas system before the basket of the balloon hit the ground. Four people fell from the inclined basket of the larger balloon due to a strong collision with the ground. As the weight of the basket decreased, the balloon rose again and collided with the basket on the treetop. After about 50 metres, the balloon descended to the ground again, dragging the inclined basket over the grassy terrain until it came to a halt about 250 metres from the point of initial impact. The basket of the smaller balloon flipped onto its front on the landing line and came to rest on the icy meadow. When the larger balloon landed, three people suffered serious injuries. Nobody was injured when the small balloon landed.

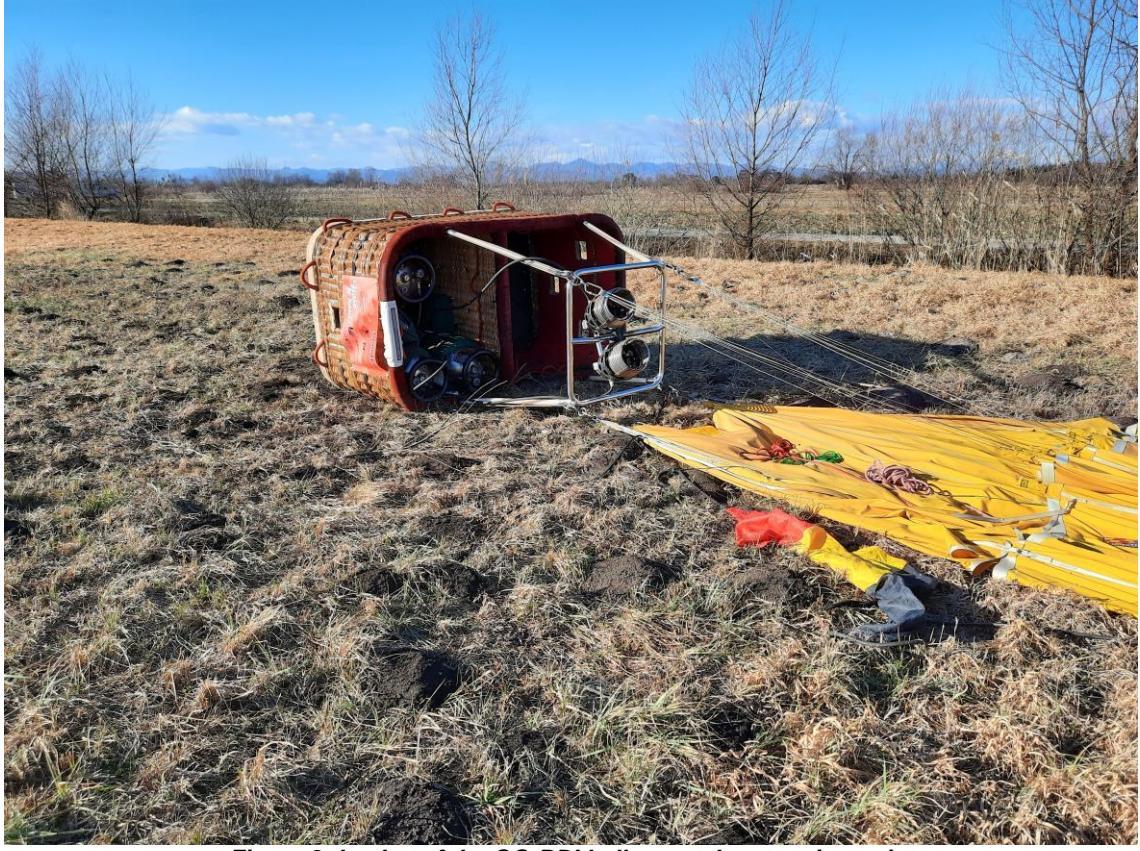
Figure 2: basket of the OO-BDI balloon at the stopping point

Apart from minor surface damage to the basket of the balloon, there was no further damage.

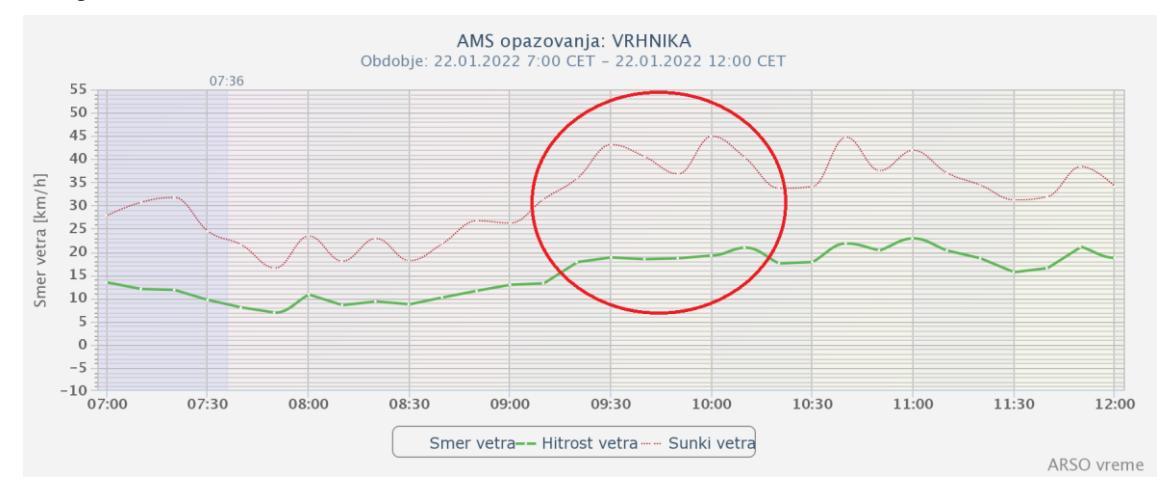
Figure 10: Measurements from the Vrhnika meteorological station, which is located at an altitude of 310 metres. The graph shows the average wind speed (green) and the maximum measured wind gusts (red). The time in the graph is local time (UTC+1)

- in the Ljubljana Marsh area, a strong west-to-south-west wind was blowing at an average speed of around 40 km/h at an altitude of 300 m above the terrain, and at altitudes of around 500 m above the terrain, the wind was even stronger at over 50 km/h (Figure 11);
- at the Vrhnika meteorological station, a gust of wind with a speed of up to 45 km/h was recorded (Figure 12);
- the atmosphere was turbulent at higher altitudes due to the stronger wind and the negative temperature gradient;
- the air temperature at the Vrhnika station increased, which is an indicator that no
  pronounced temperature inversion has formed near the ground. According to an
  analysis by ARSO, the reason for this is the presence of wind and the subsequent
  mixing of the lower layers of the atmosphere, which thus prevents the formation of an
  inversion;

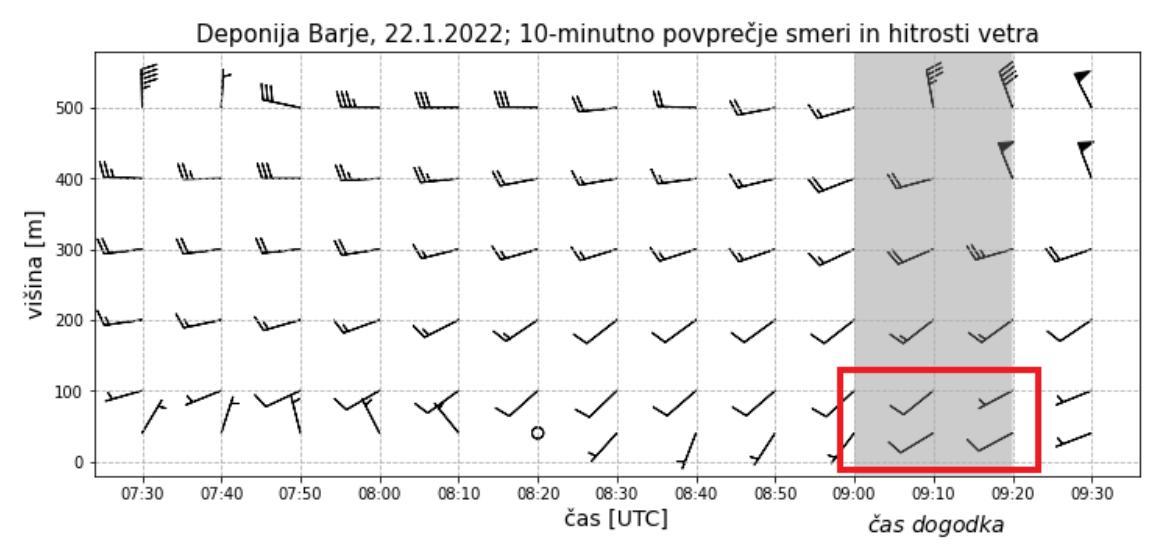
Figure 11: Measurements of the sodar at the site of the Barje landfill. The result of the measurements is a 10-minute average and does not include data on wind gusts. Typically, gusts on the ground reach a factor of about 1.5 to 2.5 in relation to the average ground speed

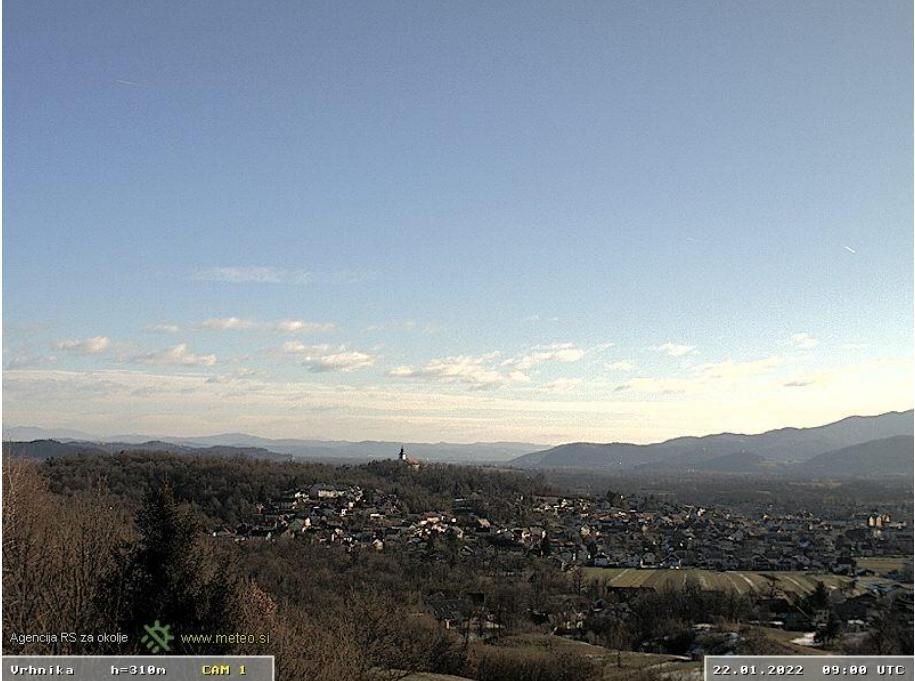
Figure 12: Panoramic camera figure from the location of the Vrhnika meteorological station in the direction of the marsh on January 22, 2022, at 9 UTC. The figure shows clouds of the fractus (torn) subtype, which are a fairly typical indicator of increasing wind at altitudes, as well as the presence of turbulence

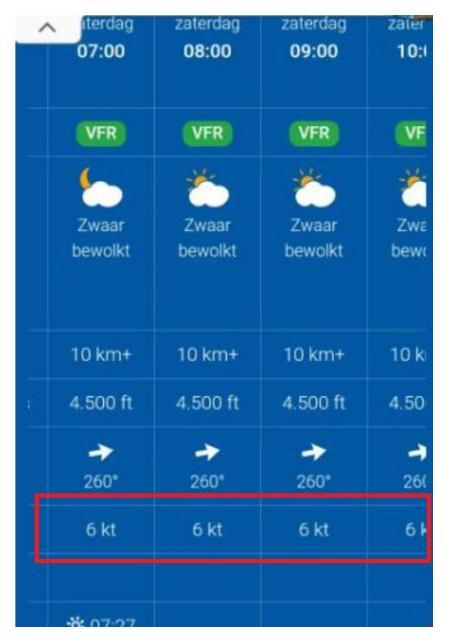
For the weather preparation of the flight, the pilot used the TAF data for LJLJ and data from the weather application, which is not known to be on the EASA list of national providers (Figure 15), which predicted a wind speed of 6 kt/s for the landing site. According to one of the passengers, the internet connection to the ARSO weather data was more difficult to access in the take-off area. Preparations for the flight included releasing helium balloons to test the effects of the wind before take-off.

Figure 15: Used weather app in preparation for flight

In the current year, the CAA, in cooperation with ARSO, should organise and conduct a workshop in the form of training and education of hot air balloon flight operators in the Republic of Slovenia with the aim of promoting and using the new ARSO weather application for the balloon flight sector. The focus of the training will be on the accessibility, quality, interpretation, evaluation, and handling of weather data in order to carry out high-quality weather preparation before flight in accordance with the provisions of EASA Part-BOP - BOP.BAS.145 Meteorological Conditions.

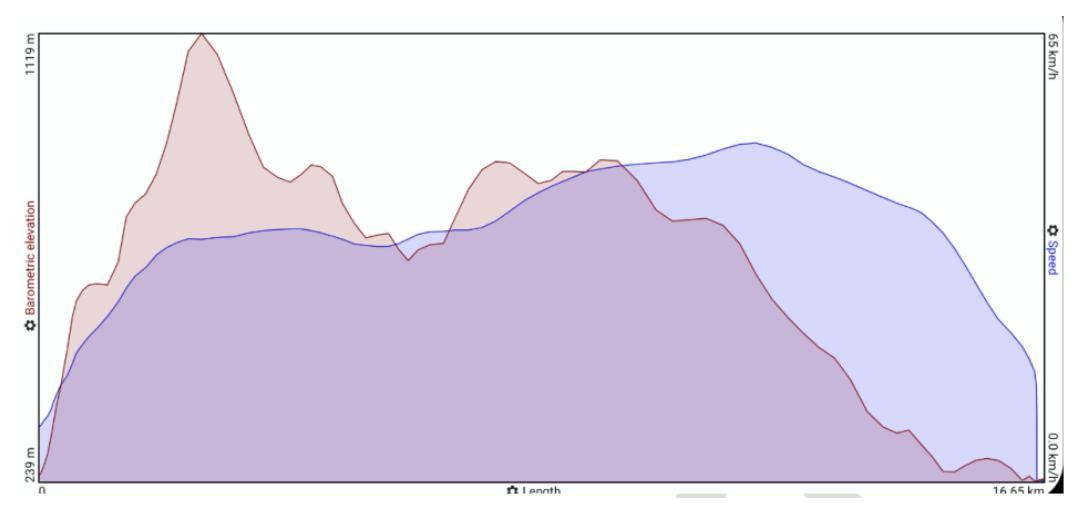
After the decision was made to carry out the planned flight, the OO-BDI balloon took off in formation with the smaller OO-BLM balloon at 9.30 a.m. local time near the village of Bistra, south of Ljubljana. After takeoff, the balloons ascended normally and without any unusual behaviour. At an altitude of 780 metres, the larger balloon reached its maximum speed, which at one point was 60.9 km/h, in an increasing westerly wind. The final altitude of the flight was 1200 m QNH. From the analysis of the flight path obtained from the KZPS radar image, it was evident that the wind speed during the balloon's descent and landing was significantly higher than expected.

Figure 16: OO-BDI flight profile (red color-altitude, blue color-speed)

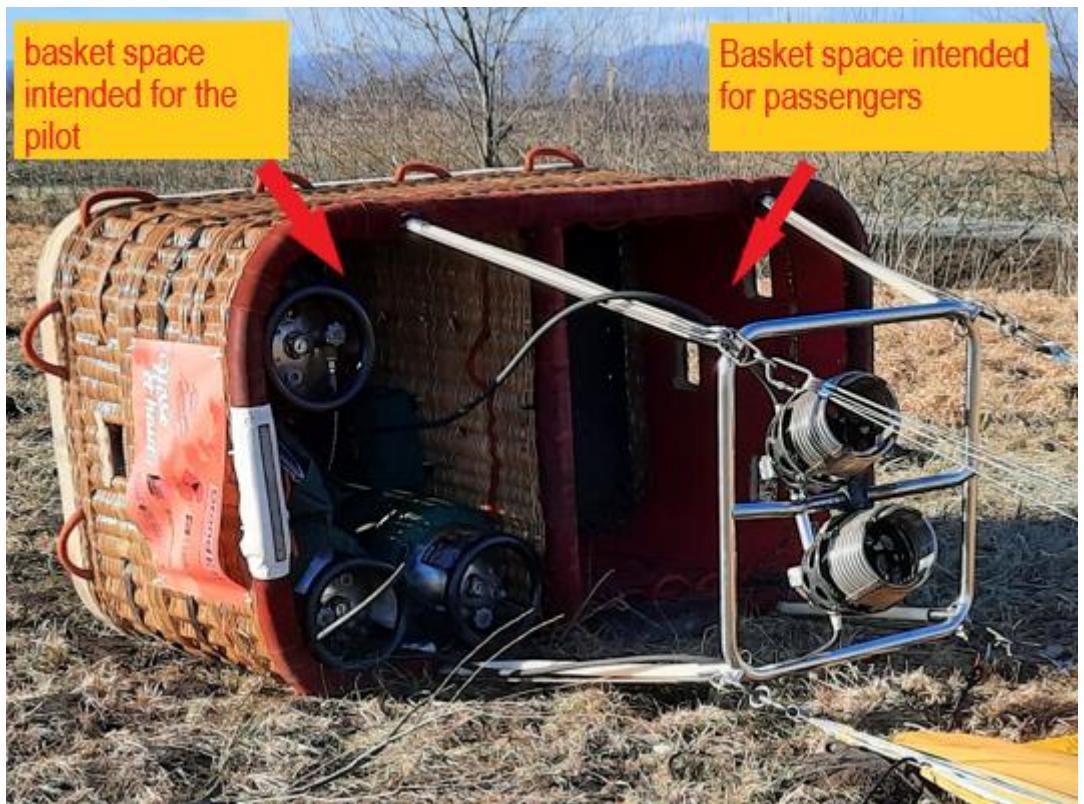
Figure 17: Basket of the OO-BDI balloon at the stopping point

The pilot was aware of the increasing wind on the ground, so in the phase before landing, he had the balloon fly in a straight line a few metres above and parallel to the ground surface (as can be seen on the KZPS radar images - figure no. 1) and at the same time warned the passengers that the landing would be hard and had them prepare for it. The pilot stated during the investigation:

According to the analysis, the smaller balloon had a landing speed of 18,5 kt (9.3 m/sec) at the time of the first collision. Both balloons had a continuous, gentle descent in a line from the beginning of the descent after crossing the power line with a westerly wind that was stronger than the estimated wind at the take-off site.

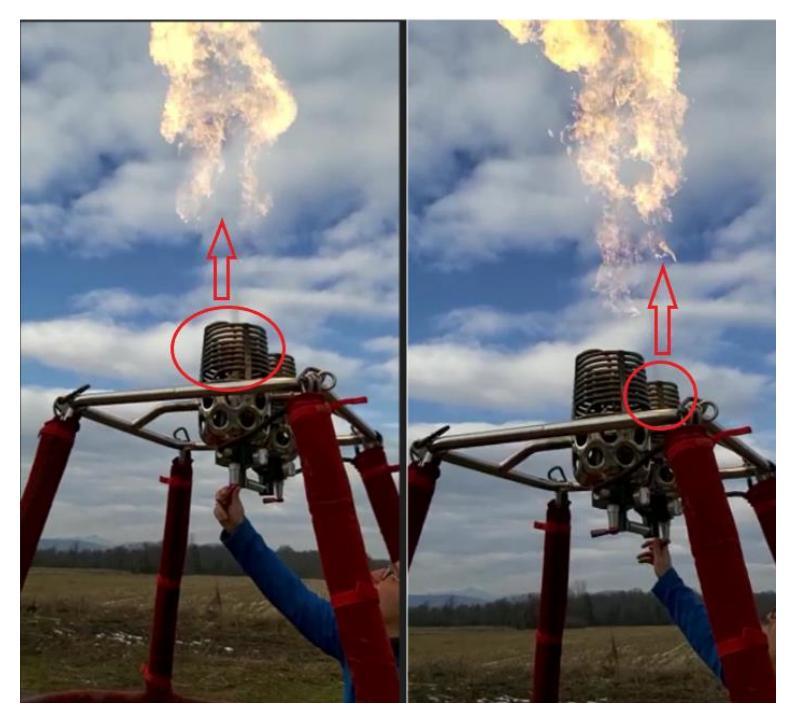
The ARC<sup>10</sup> documentation on the airworthiness<sup>11</sup> of the balloon was checked in relation to the type certificate valid at the time of the accident. When the functioning of the gas system was checked, it was found that both gas burners were working properly. The amount of gas in the gas cylinders enabled the planned flight to be carried out. The basket of the balloon and the balloon dome complied with the specifications in the manufacturer's manual and the issued EASA type certificates.

Figure 18: No irregularities were found when checking the operation of the burners
