FINAL REPORT

ON THE INVESTIGATION OF A SERIOUS INCIDENT

Airprox between an Aircraft and a Helicopter
within the LJMB Aerodrome Traffic Zone (CTR),
29 November 2024

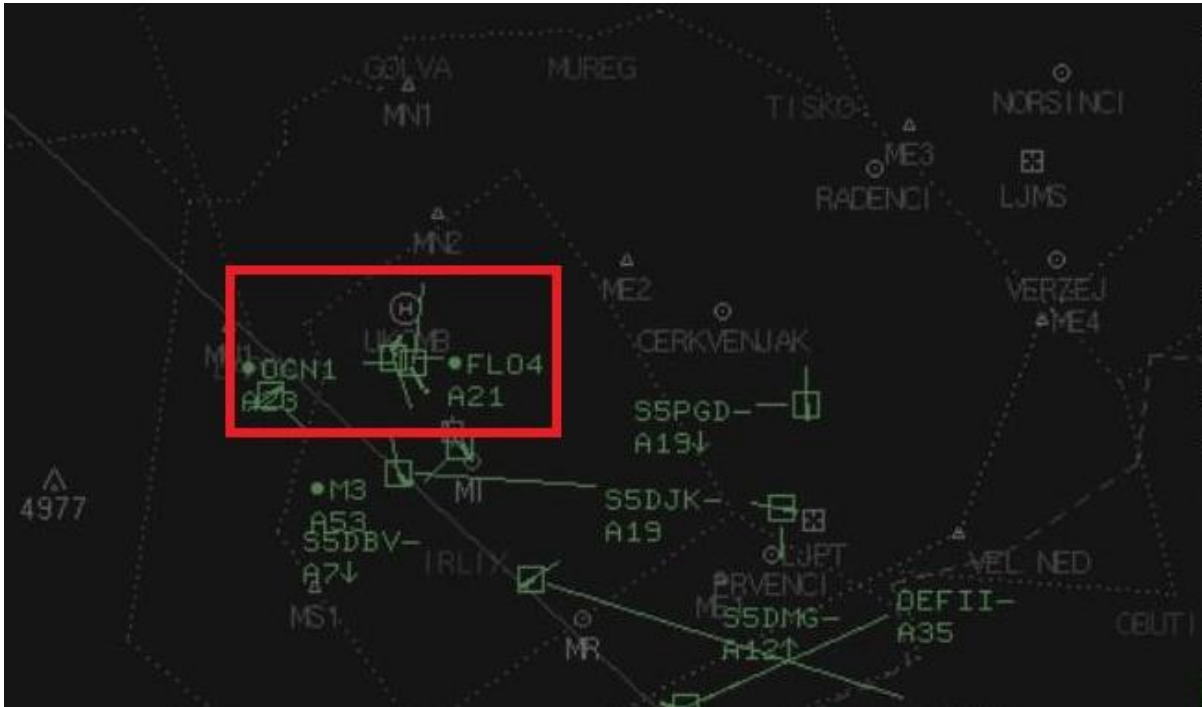
Figure 2: Radar display of traffic within the Maribor CTR at the time of the airprox between the aircraft (OCN1) and the helicopter (FL04)

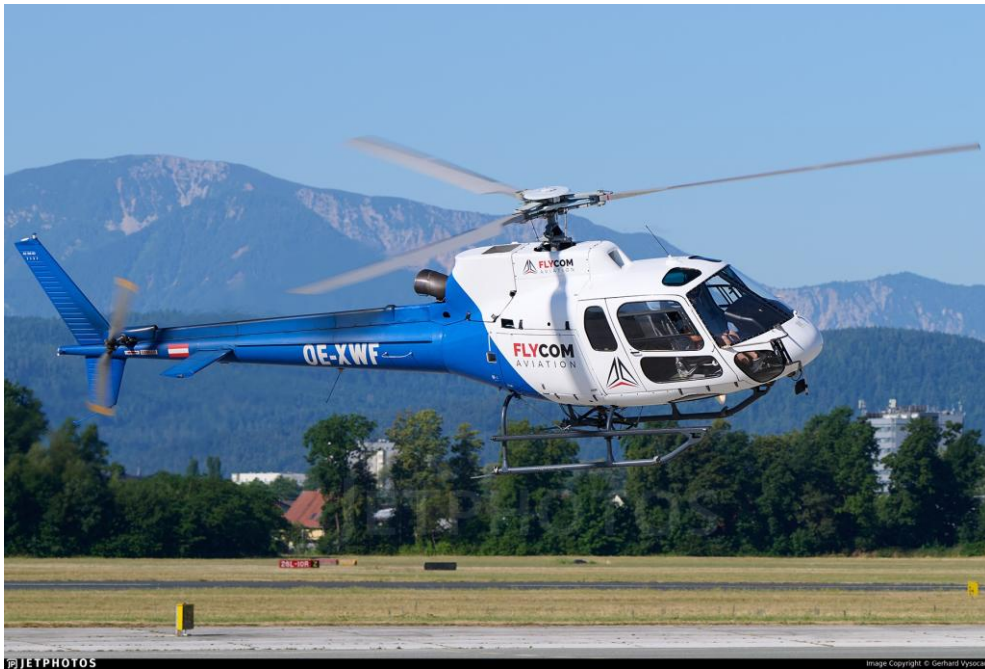
Figure 4: Aérospatiale AS350 B2

The AS350 B2 is a light, single-engine, multi-purpose helicopter developed by the French company Aérospatiale. Aérospatiale later merged into Eurocopter, which was subsequently rebranded as Airbus Helicopters.

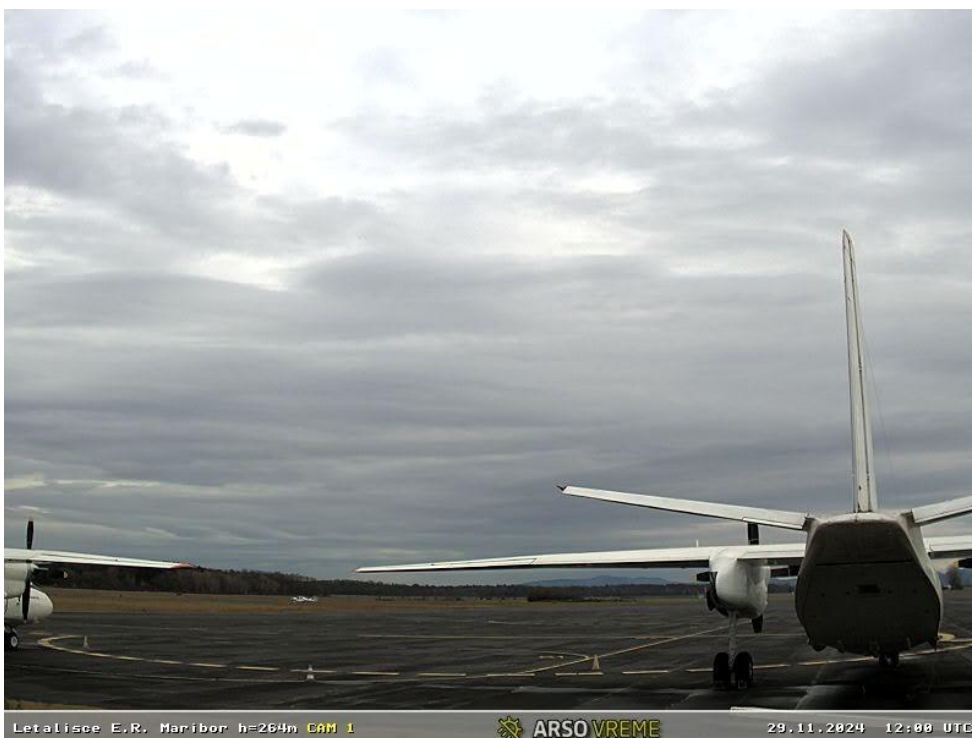
Figure 6 shows a camera image from LJMB in the direction of the runway (towards the southeast) taken on 29 November 2024 at 12:00 UTC, where stratocumulus cloud cover is visible.

Figure 6: Camera image at LJMB on 29 November 2024 at 12:00 UTC, facing southeast

The cloud base measuring device at LJMB recorded, between 11:30 and 12:00 UTC, the base of the lowest cloud layer at 7,000 ft AGL with a cloud amount of BKN (5/8 to 7/8 coverage). Based on measurements and observations, ARSO assessed that between 11:30 and 12:00 UTC on 29 November 2024 at LJMB:

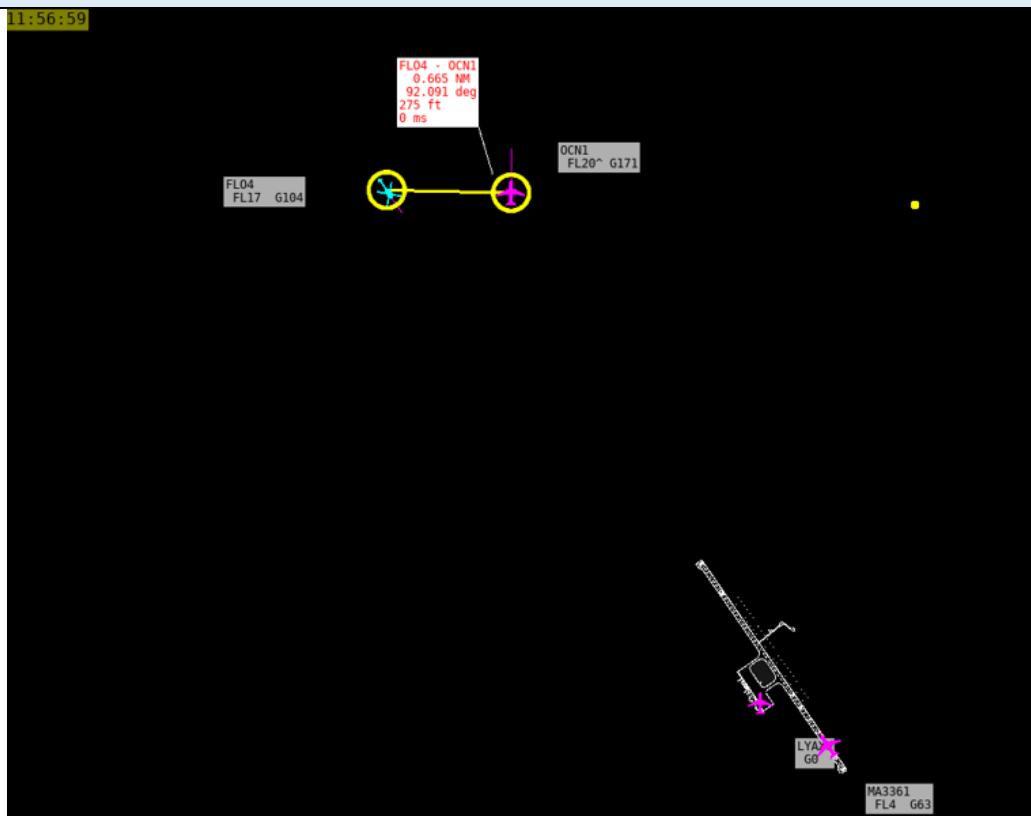
Figure 9: Point of minimum horizontal and vertical separation between the aircraft (altitude displayed as FL²). Data obtained from Slovenia Control surveillance systems (WAM – Wide Area Multilateration, Mode S Radar, ADS-B)

- The helicopter and the Airbus in the traffic circuit passed at approximately 275 ft vertical and 0.6 NM lateral separation. The Airbus pilot reported the conflict on frequency (“TCAS Traffic”). TCAS RA is inhibited at such altitudes, as the system cannot generate a descent advisory; therefore, the crew received only a TA (“TRAFFIC, TRAFFIC”);
