MINISTRY OF INFRASTRUCTURE

AIR, MARINE AND RAILWAY ACCIDENT AND INCIDENT  
INVESTIGATION UNIT

# PRELIMINARY REPORT

## ON THE INVESTIGATION OF AN AIRCRAFT ACCIDENT INVOLVING Mooney Ovation2 GX, reg. mark N595RJ, in the area of Velika planina, March 10, 2025

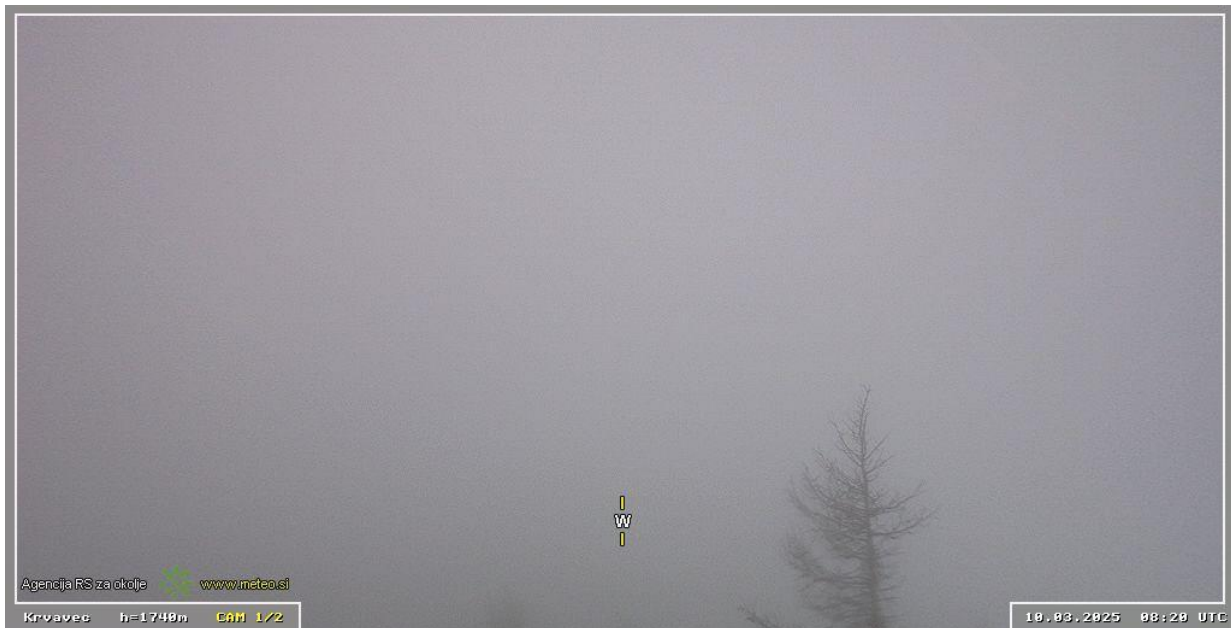
Figure 8: Image from the meteorological camera (altitude approx. 5,700 ft) at the Krvavec meteorological station - west direction, at 09:20 local time

- A cold front was moving eastward across Slovenia. Over the wider Alpine region, the weather was overcast (Figure 6), with mountain tops obscured (Figures 7 and 8), reduced visibility, precipitation, occasional thunderstorms, and conditions conducive to turbulence and icing (Figure 11).

- The forecast indicated that VFR flight was not possible along the intended route (Figure 10).
- The actual weather conditions were also unsuitable for VFR flight (Figures 6, 7, 8).

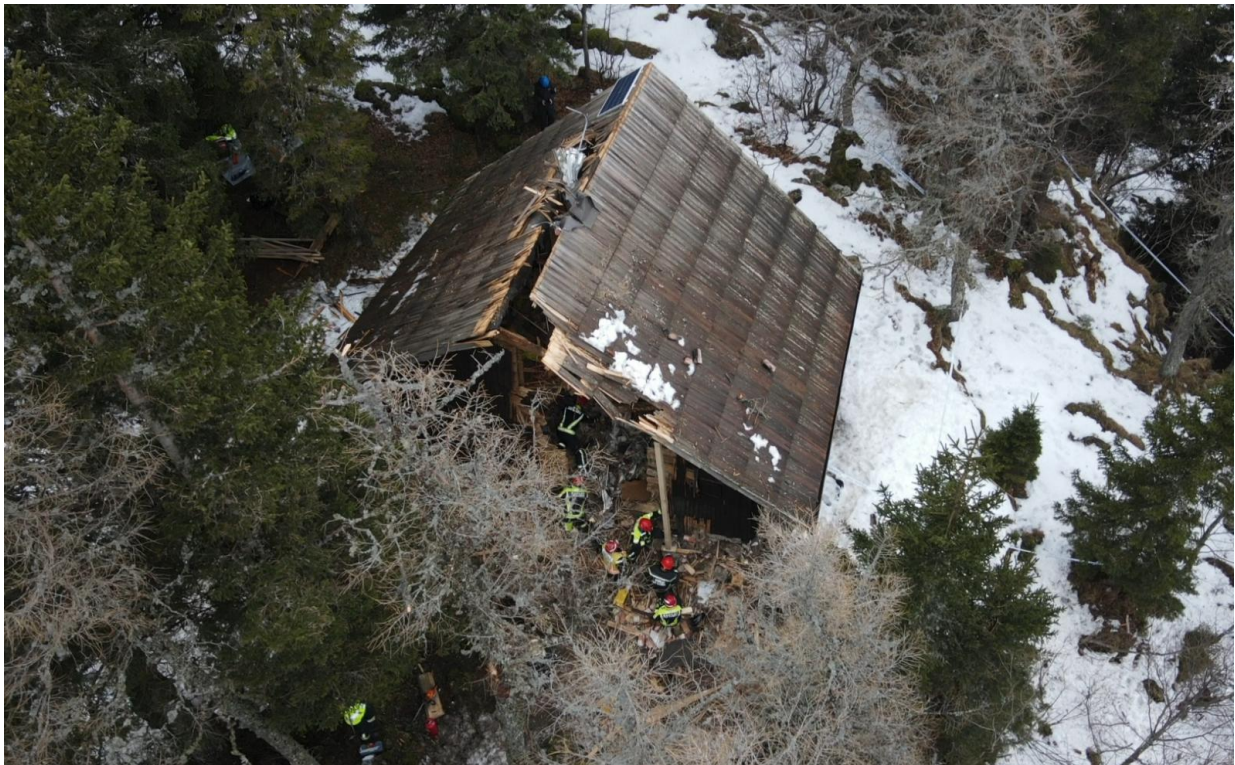
Annex 4: Accident site of aircraft N595RJ
