FINAL REPORT

Aircraft Accident

An-2

Registration mark HA-MKK

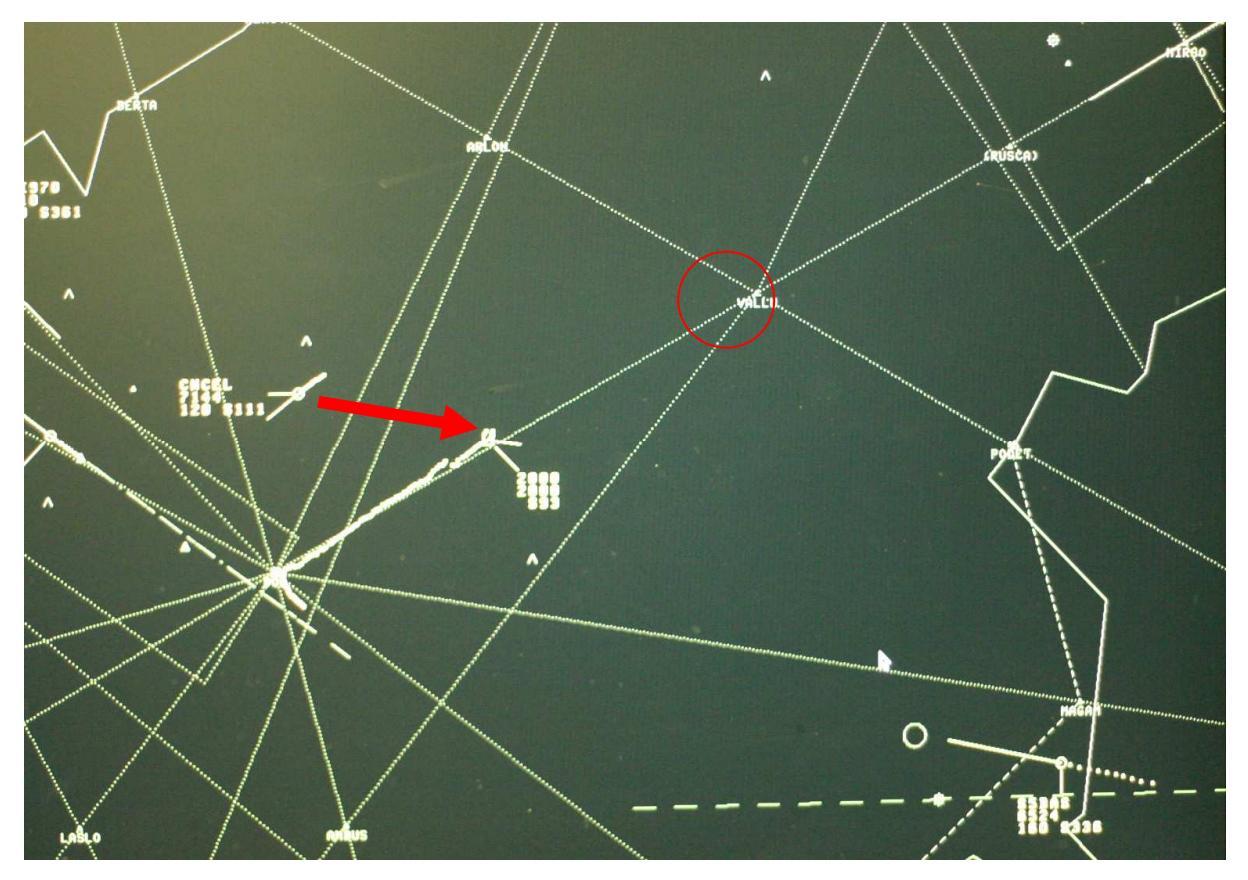
Image 4: Position when aircraft disappeared from the radar screen

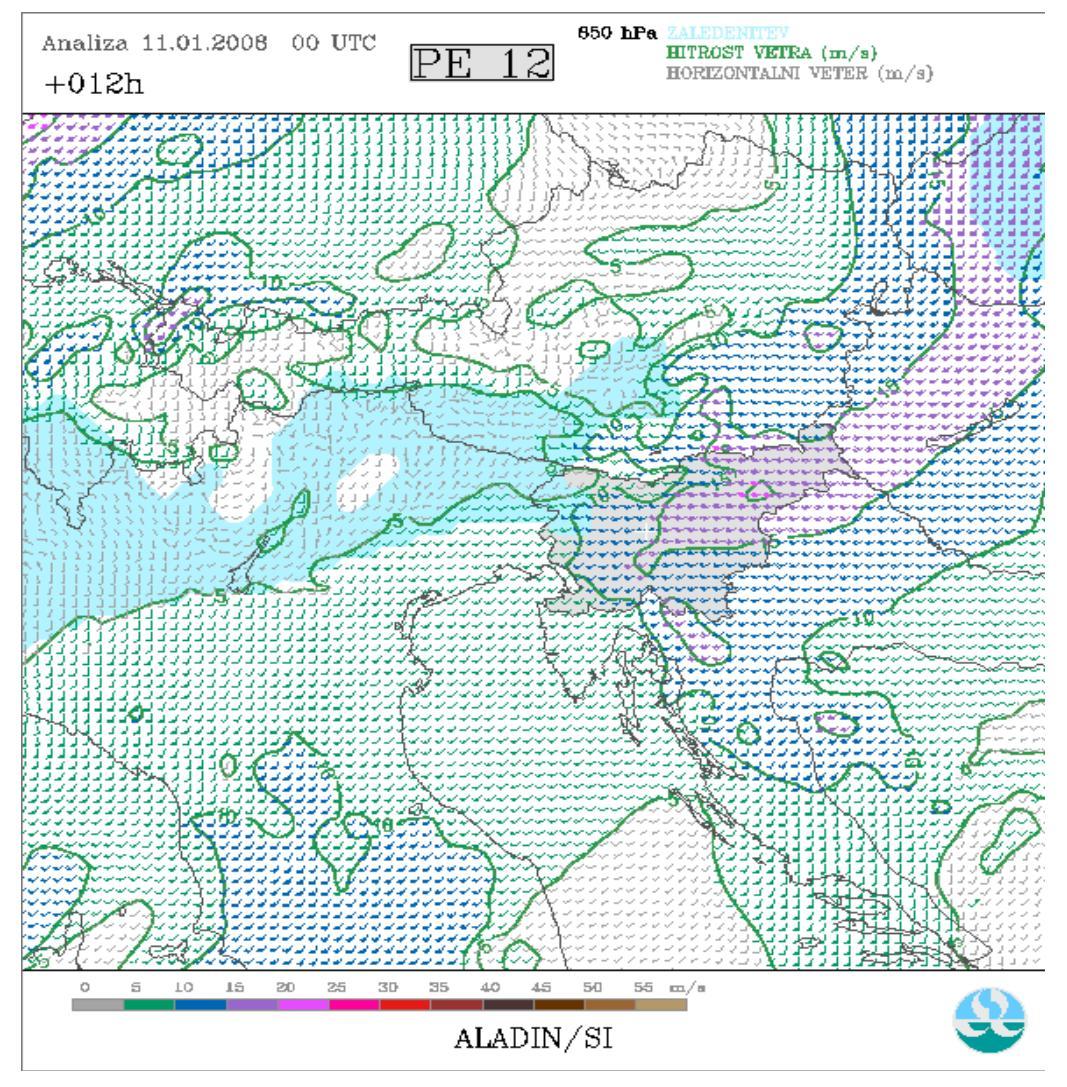
Image 2: ALADIN of 11.01.2008 at 12 UTC(*) - FL050

Over Slovenia, moderate southeasterly winds prevailed. At an altitude of FL050 to FL100, the wind speed calculated according to the ALADIN meteorological model was 25 knots. Over central Slovenia, the wind speed at the altitude around FL050 was approximately 20 knots with gusts of up to 30 knots. At all altitudes, the wind was southwesterly. In the valleys and basins, surface wind blew only in some parts.

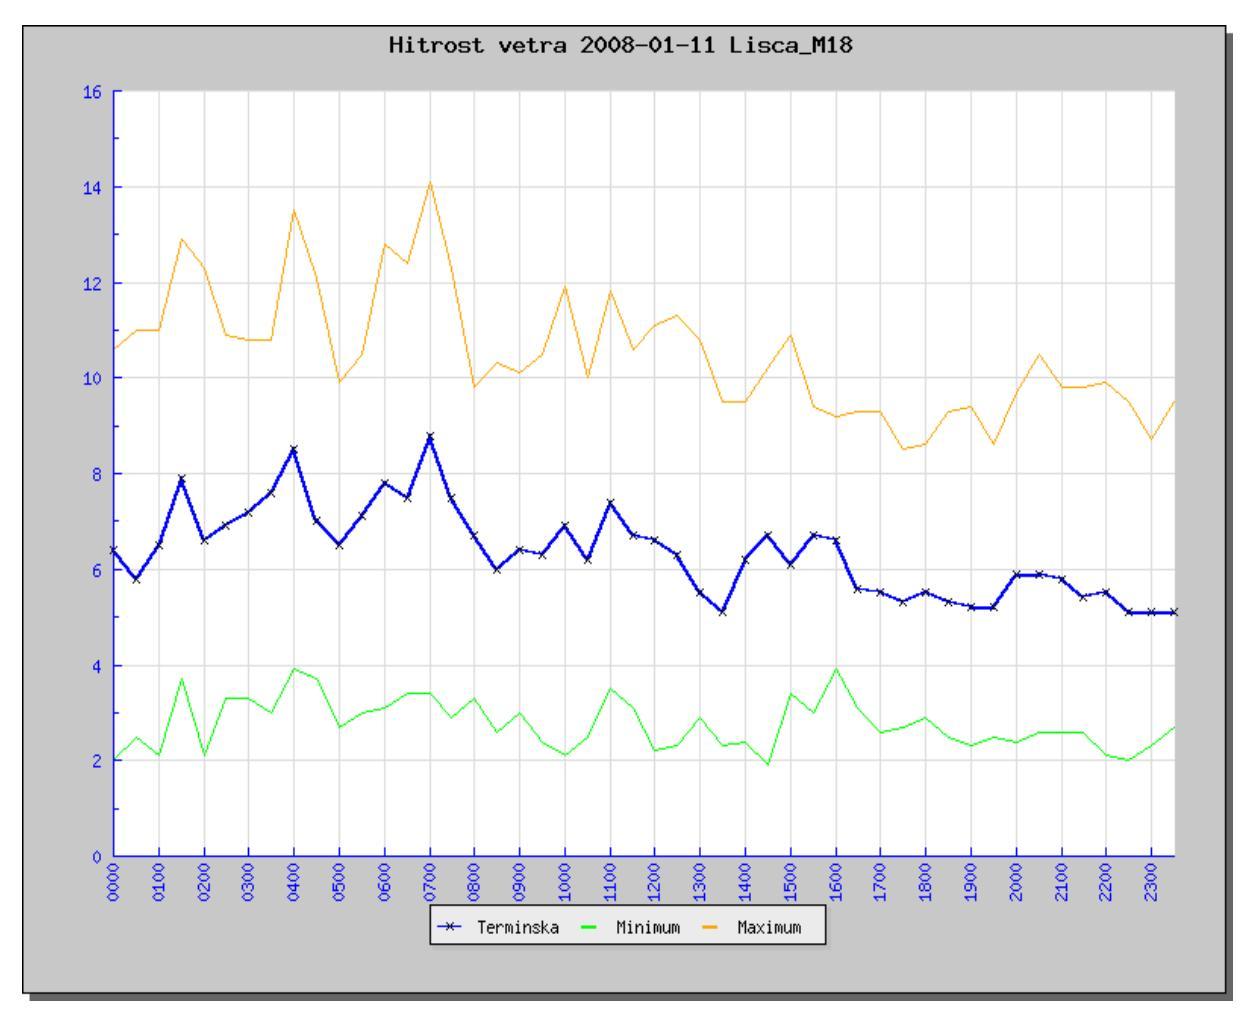
Wind speed 2008-01-11 Lisca_M18

In lower areas, at the altitude of FL030 (Lisca 943 m), wind was 12 knots with gusts to 25 knots.

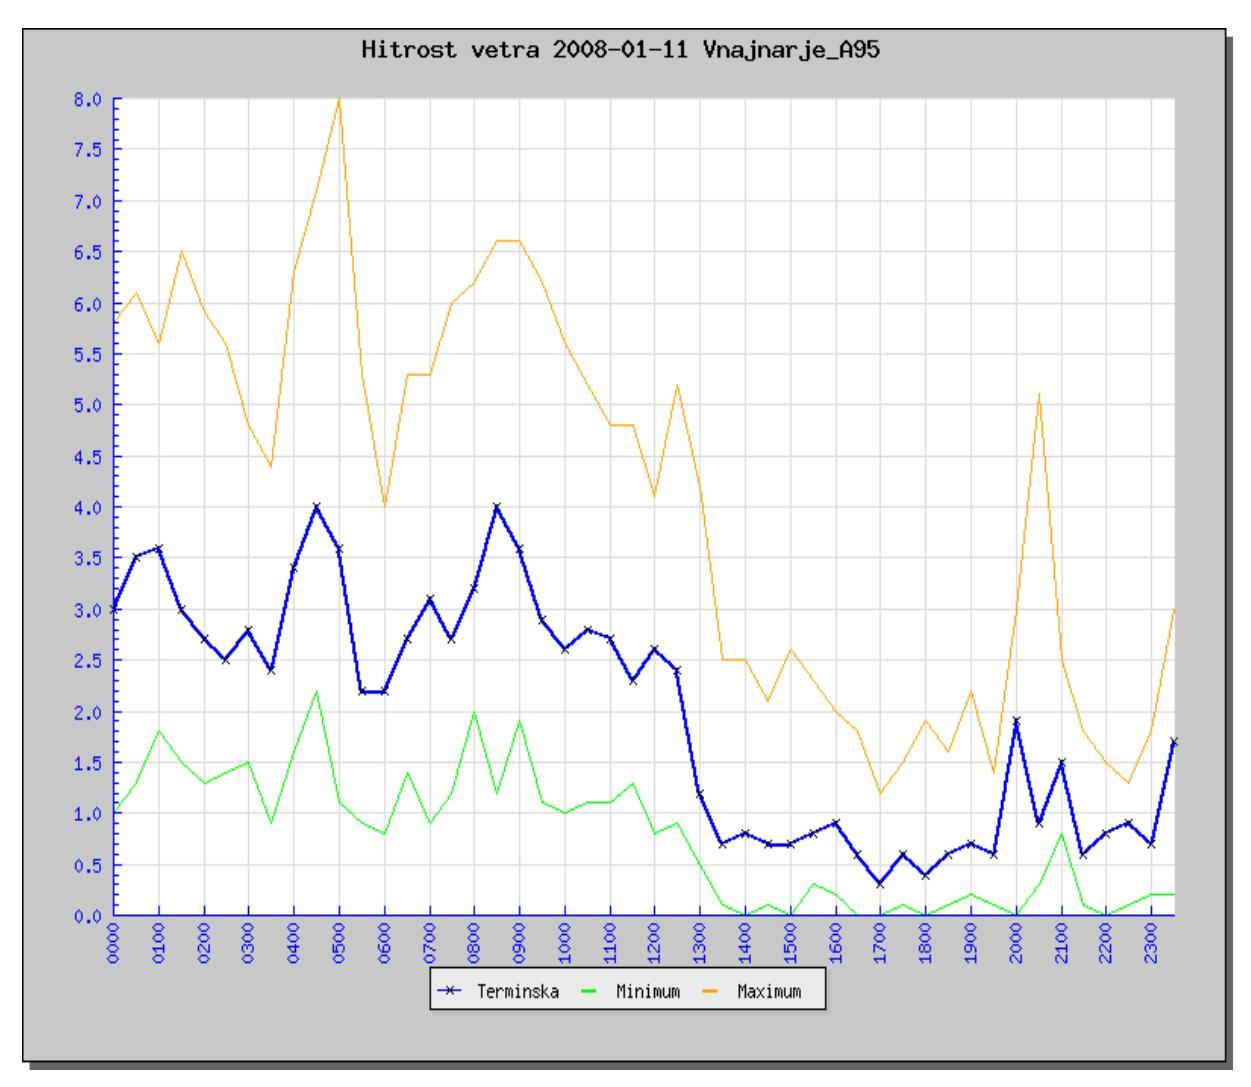
Wind speed 2008-01-11Vnajnarje_A95

On the altitude of FL020 (Vnajnarje 630 m), wind was 5 knots with gusts to 10 knots.
