MINISTRY OF TRANSPORT

AIRCRAFT ACCIDENT AND INCIDENT INVESTIGATION DIVISION www.mzp.gov.si, e: mzp.splni@gov.si Langusova 4, Sl-1535 Ljubljana, t: +386 1 478 8000, f: +386 1 478 81 89

Number: 37200-8/2008/39-0010133 Date: 28 August 2009

# FINAL REPORT OF THE ACCIDENT INVESTIGATION COMMISSION INTO THE ACCIDENT OF ULTRA-LIGHT AIRCRAFT »WILD THING« REGISTERED D-MWTF ON 23 JUNE 2008 NEAR POSTOJNA CITY

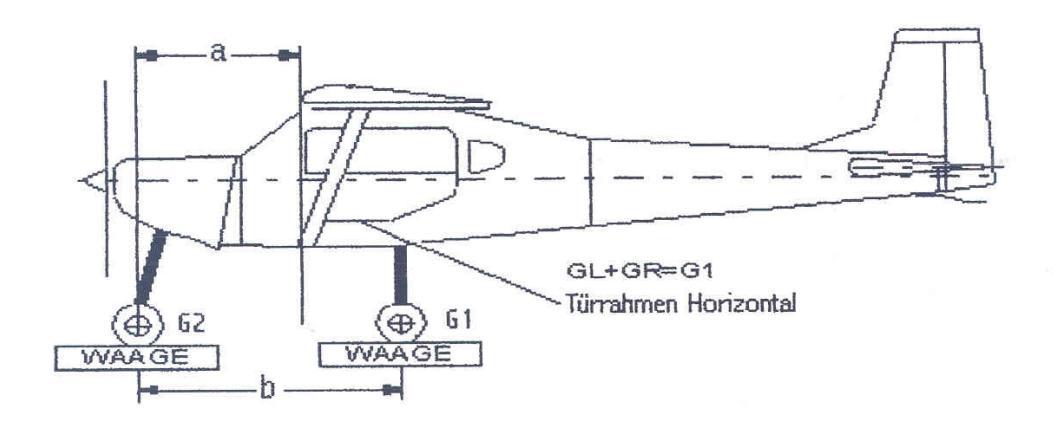
- Commission have got information that the ultra-light aircraft registered D-MWTF was crashed in the year 2001.
- The last maintenance 50 hours inspection was performed by the owner's personnel on 19 June 2008 at aircraft Total Time (TT) **4.852,9 hours.**
- Ultra-light Aircraft D-MWTF was registered for Maximum Take Off Mass (MTOM) up to 450 kg.
- Weight and Balance List was issued on 5 March 2006 (Note: Maximum Load 151,4 kg See List on next page).
- Written visible warning about MTOM and loading was placed on instrument panel ("max. Abflugmasse 450 kg, max. Zuladung 152 kg").

Auftraggeber :		Gewichtübersicht	
		Datum: 05.03.2006	Auftrag :
Muster: Wild Thing 3300 I	Bugrad	Werknummer: 059	D-MWTF
Bezugspunkt BP : Flügelvor	derkante , na	ähe Wurzelrippe

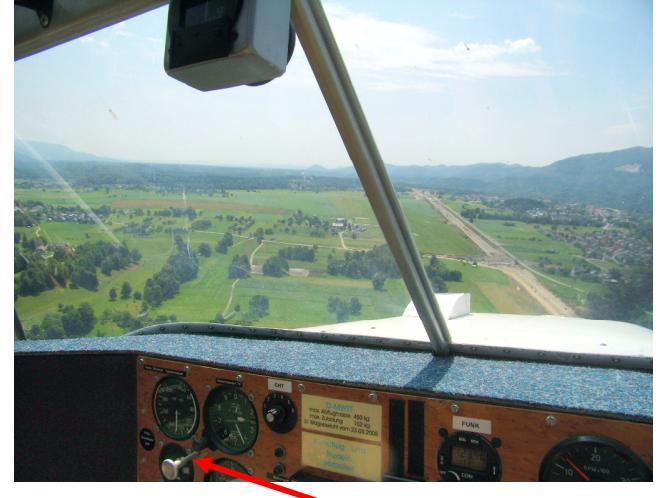
- First information from the member of Aero Light Club (who was shocked) on accident site was that the engine stops because the fuel was closed. He said that the **Emergency Fuel Valve was CLOSED (actually on PULL POSITION).**
- Thrue the examination was found that the Emergency Fuel Valve was OPEN (actually on PUSH POSITION).
- Wrongly interpreting of the Emergency Fuel Valve position was caused because valve was displaced in the past, when owner build in BRS.
- As evidence (that the fuel was open) also see pictures below:

Subject aircraft on approach at Slovenian Airport Lesce-Bled (LJBL) in the year 2007

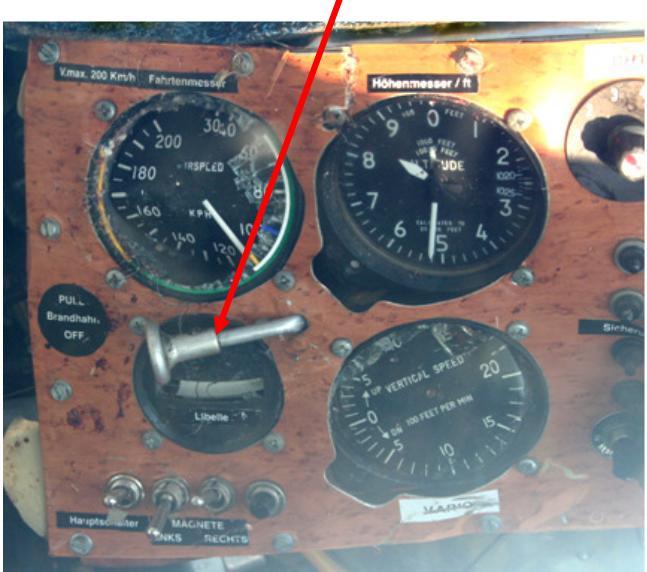
**PUSH POSITION of Emergency Fuel Valve**

Position of Emergency Fuel Valve on accident site

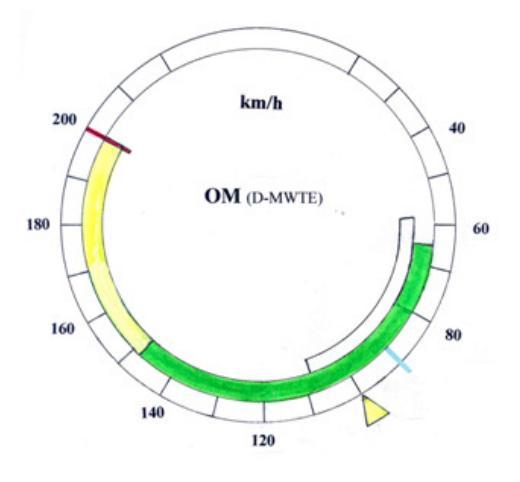
- According to OM (FM) found on board (for ACFT registered D-MWTE) White Arc start at speed of 58km/h and Green Arc start at speed of 65km/h (See illustration below).

- NOTE: According to the German regulations ultra-light aicraft with BRS have MTOM 472,5 kg.
- IMPORTANT:In reality pilot probably think that the Indicated Air Speed (IAS) was<br/>approximately 5 15 km/h higher than stall speed.<br/>Wrong marks on Air Speed Indicator might lead the pilot to<br/>make errors.

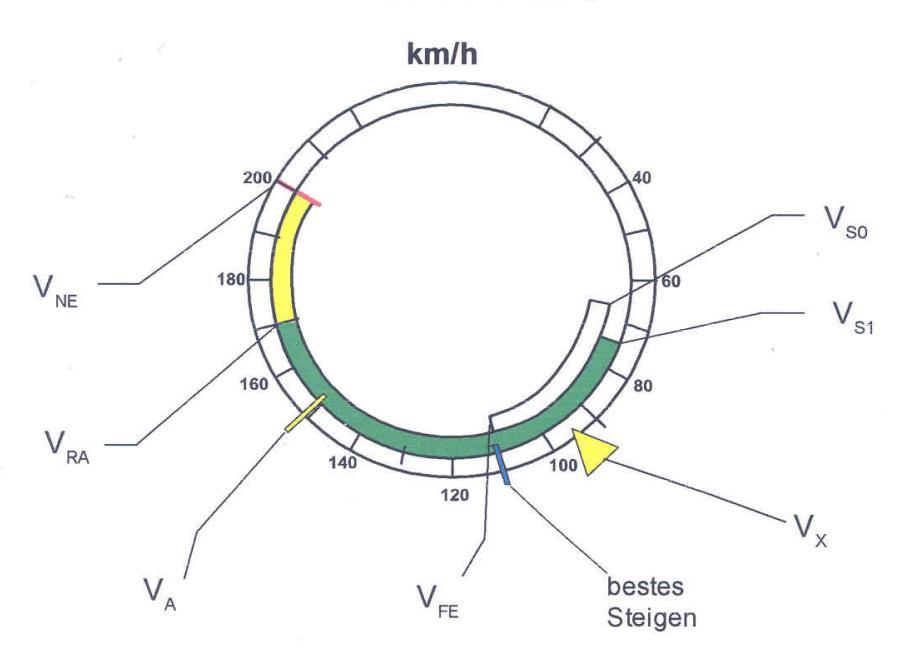
Fahrtmesser und Belastung

- According to »Ultra – Leicht – Bau – International, GmbH« (ULBI) Hassfurt (Germany) OM (FM issued on 5 March 2004) White Arc start at speed of 65 km/h and Green Arc start at speed of 75 km/h (See illustration below).

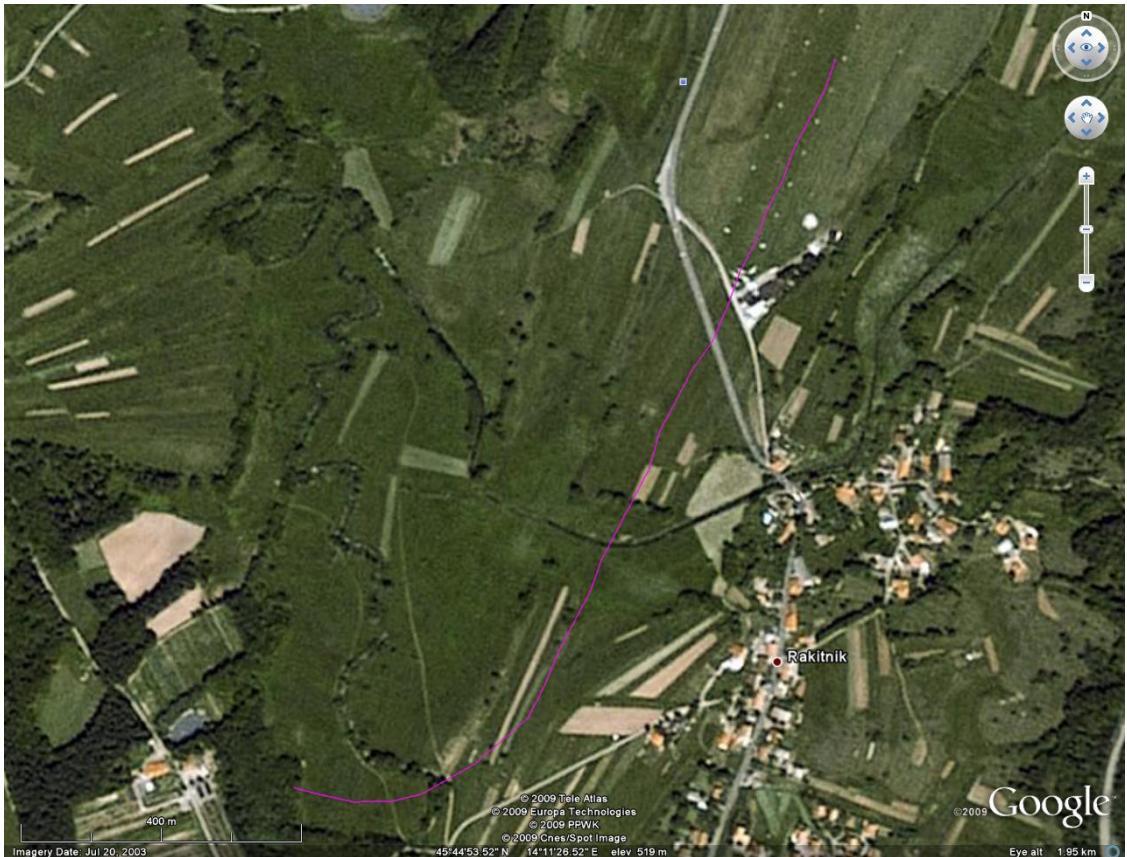
BFU read-out data

After took-off, at 60m above airport level and approximately 700m from the end of RWY pilot probably decided to turn back to the airport. He performed right turn. At approximately 80m above airport level on Right Crosswind Leg aircraft stalled and crashed inside three seconds to the ground (See illustrations on next page).

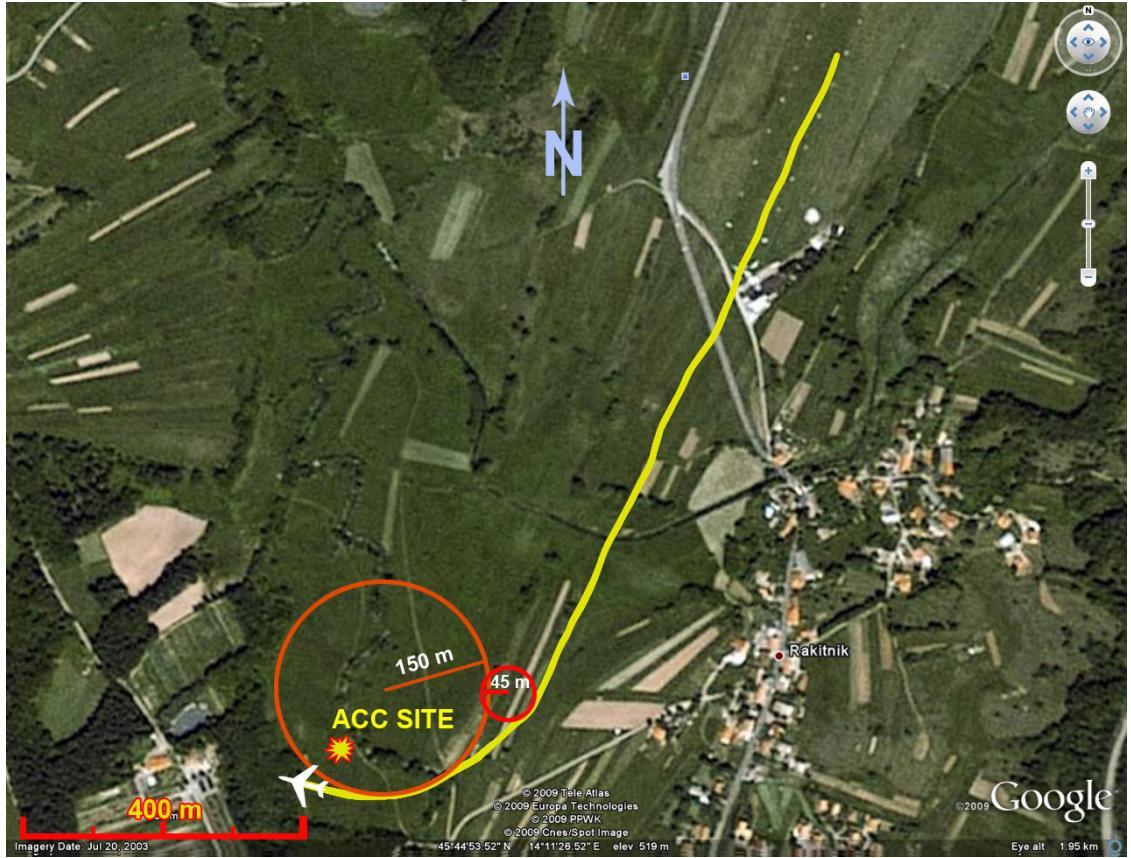
Analysis of data read-out

From illustrations is obvious that the flight track and profile were unstable and changeful. Also Right Turn was unstable with dissimilar bank up to  $23^{0}$ .

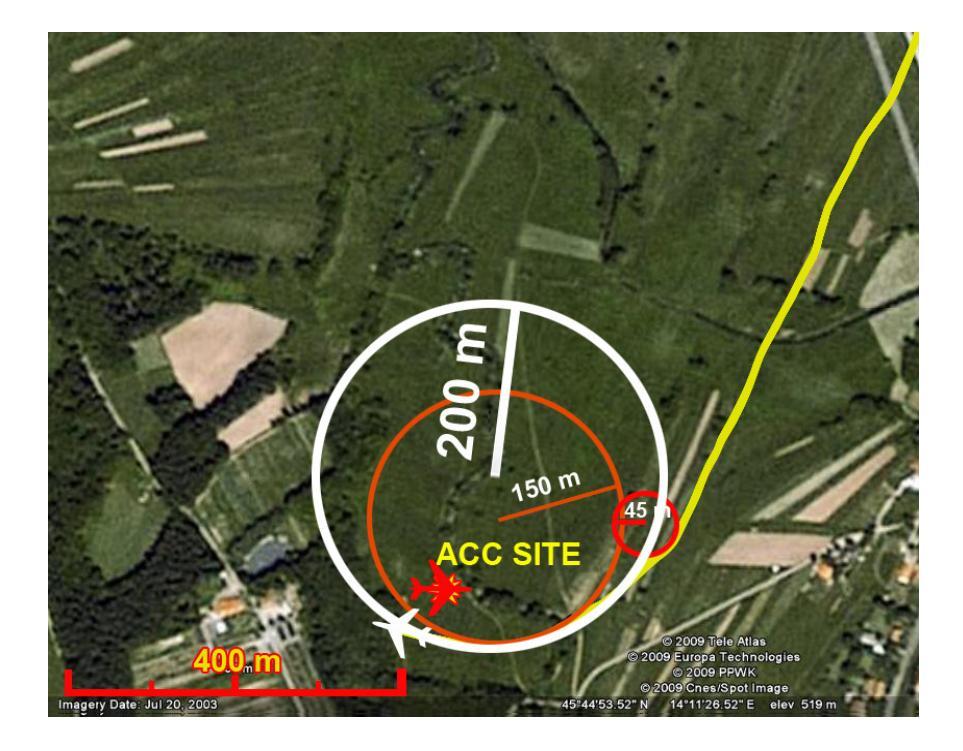
# The right turn middle bank was approximately 18<sup>0</sup>.
