AIRCRAFT ACCIDENT AND INCIDENT INVESTIGATION SERVICE

Number: 37200-3/2012/132-00121171 Date: 23 October 2014

FINAL REPORT

ON THE INVESTIGATION OF THE AIRCRAFT ACCIDENT INVOLVING HOT AIR BALLOON LINDSTRAND LBL 600C REGISTRATION MARK S5-OLO, WHICH OCCURED ON 23 AUGUST 2012 OVER THE LJUBLJANA MARSHES

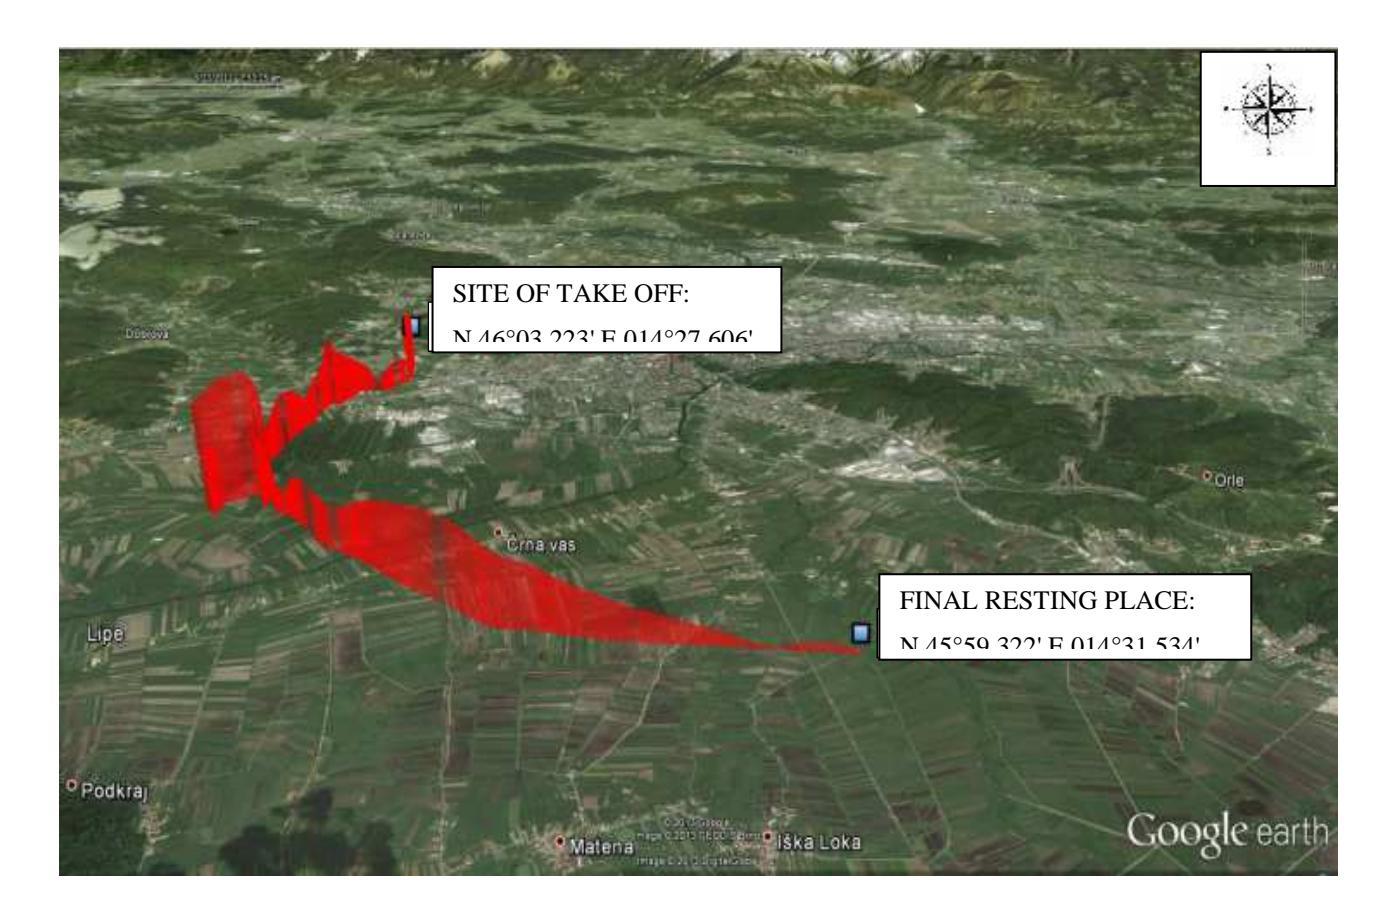
On 22 August 2012, the operator informed the passengers that their balloon flight would take place on 23 August 2012. The meeting place was at Merkur in Ljubljana Rudnik shopping area. On 23 August 2012 at 03:45:00 a.m. UTC, the passengers convened at the meeting place and they were driven by bus to Ljubljana – Brdo. After arrival at Ljubljana – Brdo the operator began preparing the hot air balloon with registration mark S5-OLO for flight. At 04:54:18 a.m. UTC, the hot air balloon pilot took off with 31 passengers in the basket. After take-off, the balloon started moving towards the south, carried by winds with ground speed of less than 20 km/h, which is a light northern wind. After 05:28:36 a.m. UTC, the balloon reached its highest altitude of the day of 1,371 metres above mean sea level (AMSL), followed by a rapid descent. At 05:45:56 a.m. UTC, the balloon began its final ascent, reaching 956 metres AMSL at 05:48:59 a.m. UTC. During the final ascent, wind speeds increased significantly, exceeding 40 km/h for the first time. During the descent after the final ascent, the direction of the wind changed from the north to north-west, followed by a phase of the balloon's rapid descent, all the way to the ground. The average speed of the balloon's descent from 05:49:16 a.m. UTC to 05:52:05 a.m. UTC, when the balloon first struck the ground, was 3.7 m/s. The balloon's average ground speed at this point was 48 km/h. The highest ground speed at this point was recorded at 05:51:17 a.m. UTC, 180 metres above ground, and reached 63 km/h. Ground speeds of more than 50 km/h were measured from a height of 661 metres AMSL or 374 AGL (above ground level) all the way to first contact with the ground, which occurred at 05:52:05 a.m. UTC at N45°59.367' E014°30.960', 320 metres west of the main road from Ljubljana to Ig. The measured speed of the balloon's basket was 43 km/h. From the recorded flight parameters, it was measured that the balloon's basket dragged along the ground for 27 seconds, a total of 240 metres until 05:52:32 a.m. UTC, at an average speed of 32 km/h, which leads to the conclusion that the speed of the wind pushing it was significantly greater. Afterwards, the balloon once again rose, flew over the main road, and was airborne for the next 43 seconds. The balloon reached the highest measured altitude of 41 metres AGL until at 05:53:15 a.m. UTC at N 45°59.330' E 014°31.479' its basket once again struck the ground. At this point, the highest recorded speed was 42 km/h. The basket's second collision with the ground occurred 340 metres east of the main road, at a recorded ground speed of 37 km/h. After the second collision the basket hit the treetops. In this collision, the pipes in the gas equipment in the balloon's basket were damaged, and gas started leaking. The balloon finally came to rest at 05:53:25 a.m. UTC at N 45°59.322' E 014°31.534'. A fire ensued.

Picture 1: Map of the entire flight of S5-OLO hot air balloon on 23 August 2012

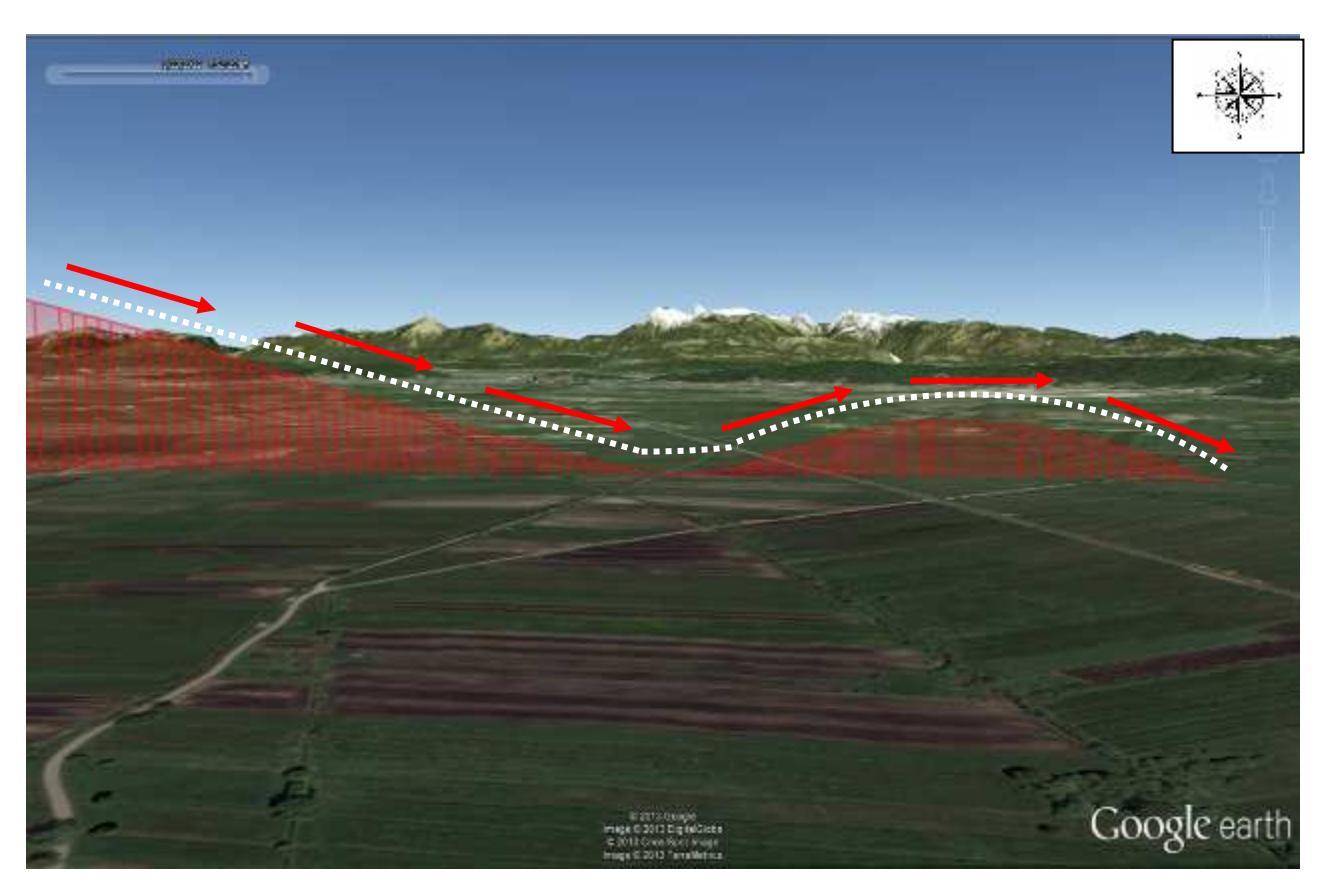
Picture 2: Display of the flight of balloon S5-OLO over the road linking Ljubljana and Ig after the first collision

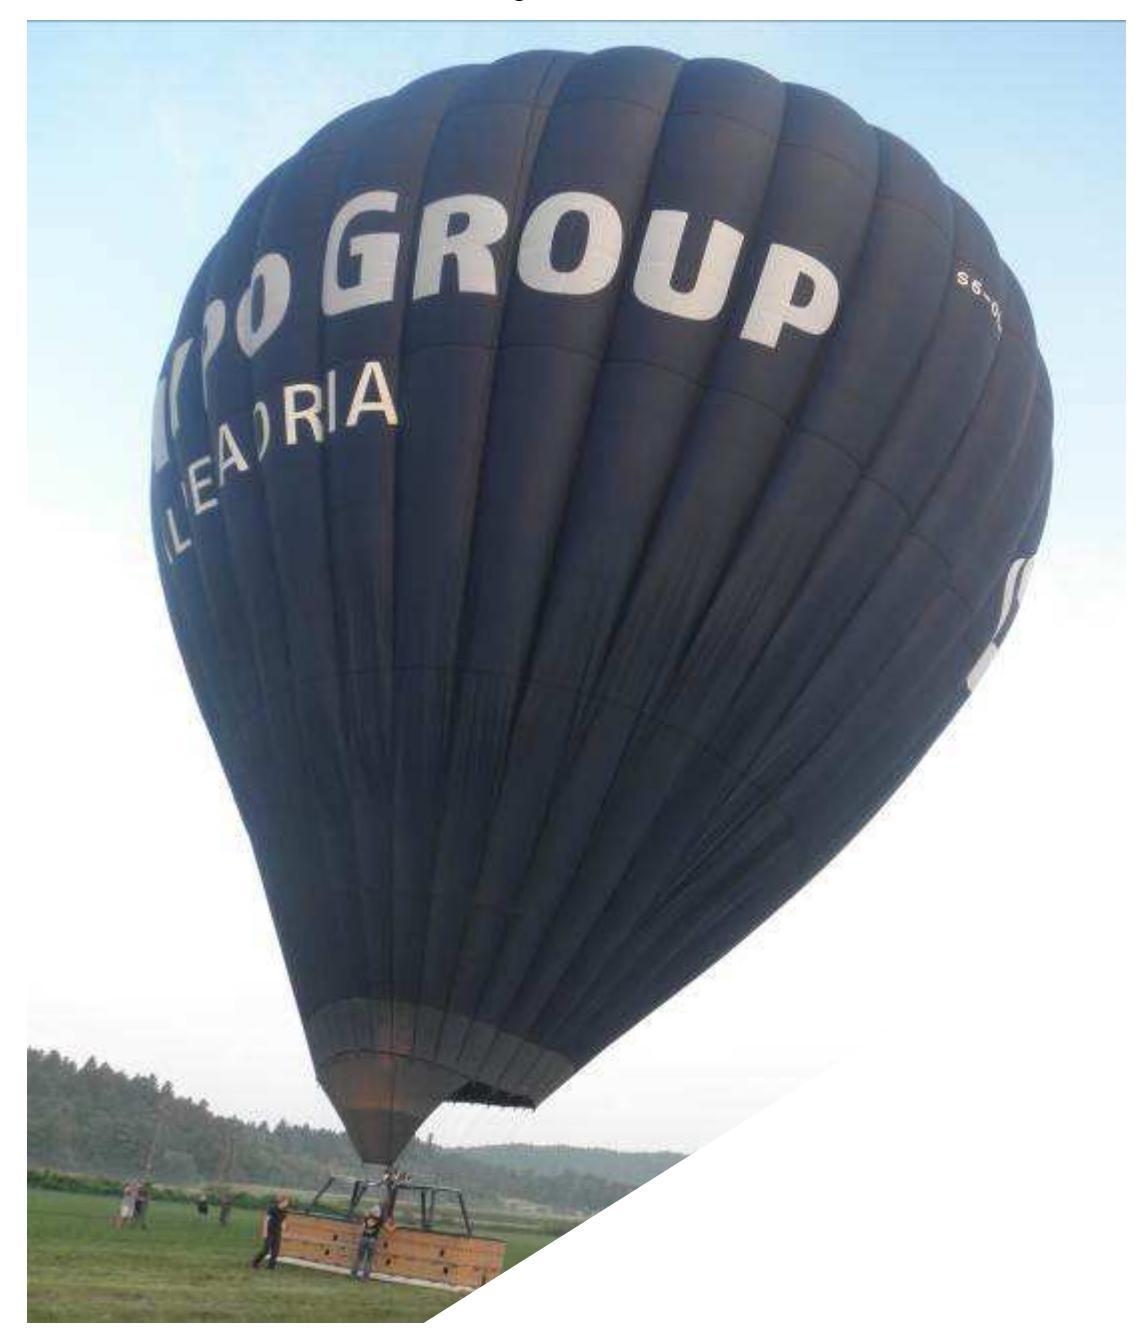
Picture 6: Hot air balloon LBL 600C with registration mark S5-OLO on 23 August 2012

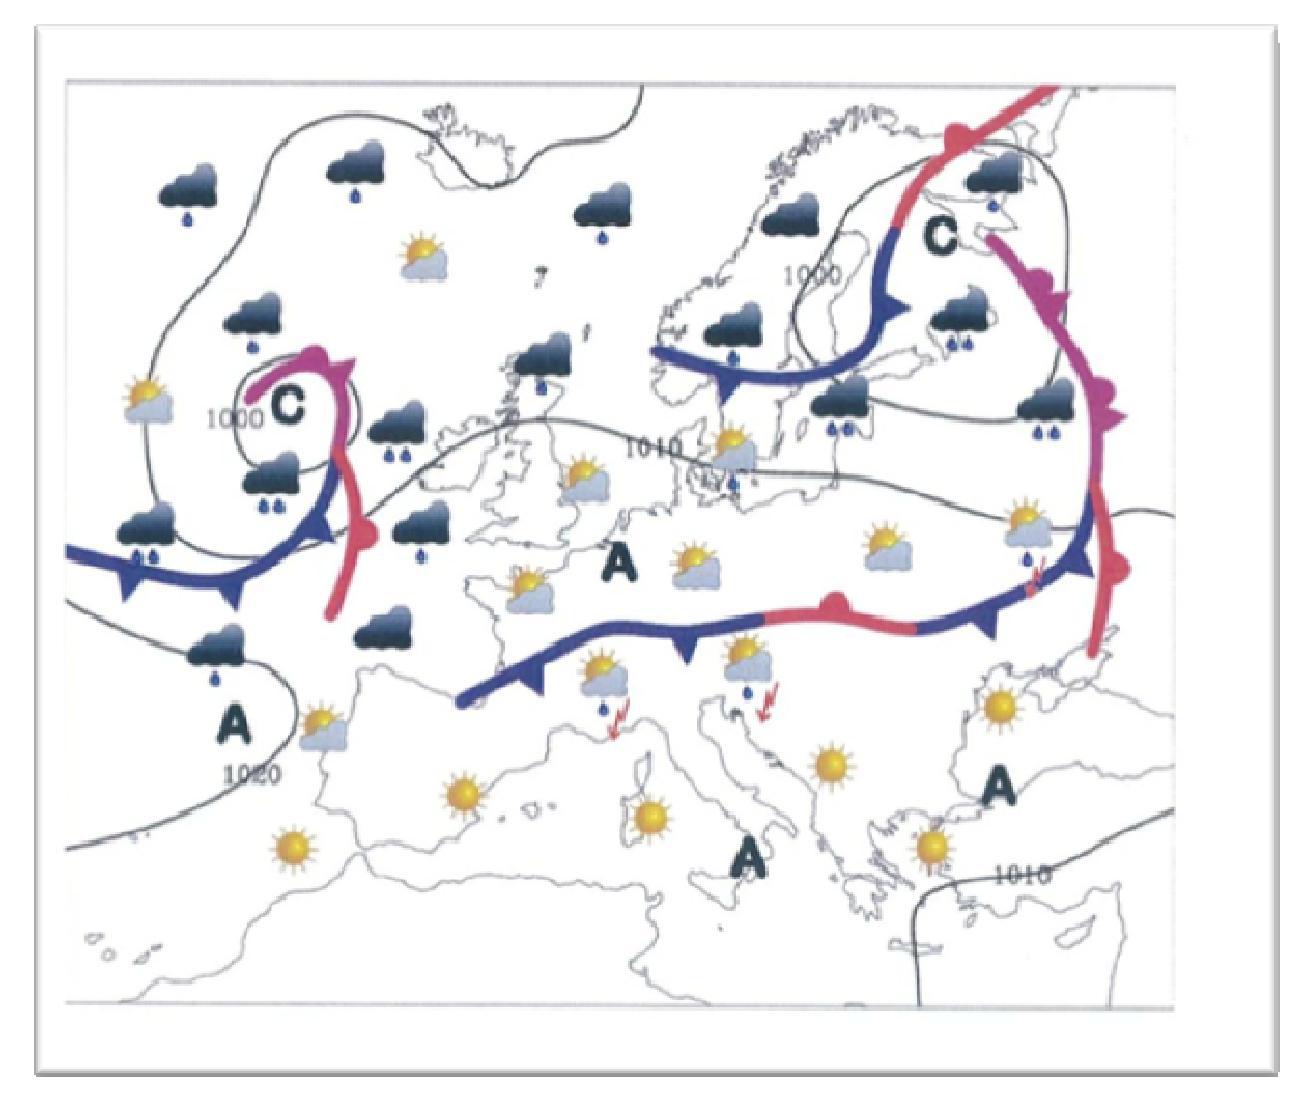
A cold front approached the region of the Alps from the north-west on Wednesday, 22 August 2012, settling in over the Alps on Thursday, 23 August 2012. This cold front caused thunderstorms in Austria, Italy, and northern Slovenia (Picture 10).

Picture 10: A lowlands map made on 22 August 2012 for 23 August 2012

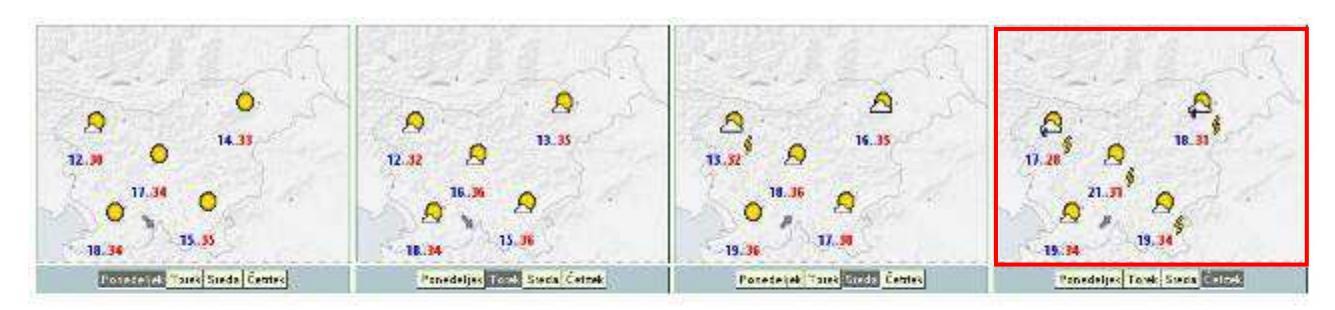
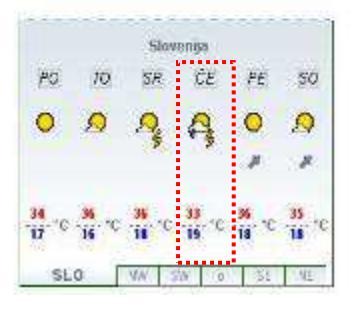
Already several days before Thursday, 23 August 2013, the National Meteorological Service of Slovenia (hereinafter DmetS for *Državna meteorološka služba*) forecast unstable weather conditions with the possibility of thunderstorms on the day of the accident (Pictures 11, 12 and 13).

Picture 11: Forecast for the period from 20 August 2012 to 23 August 2012 – The day of the accident was Thursday, 23 August 2012

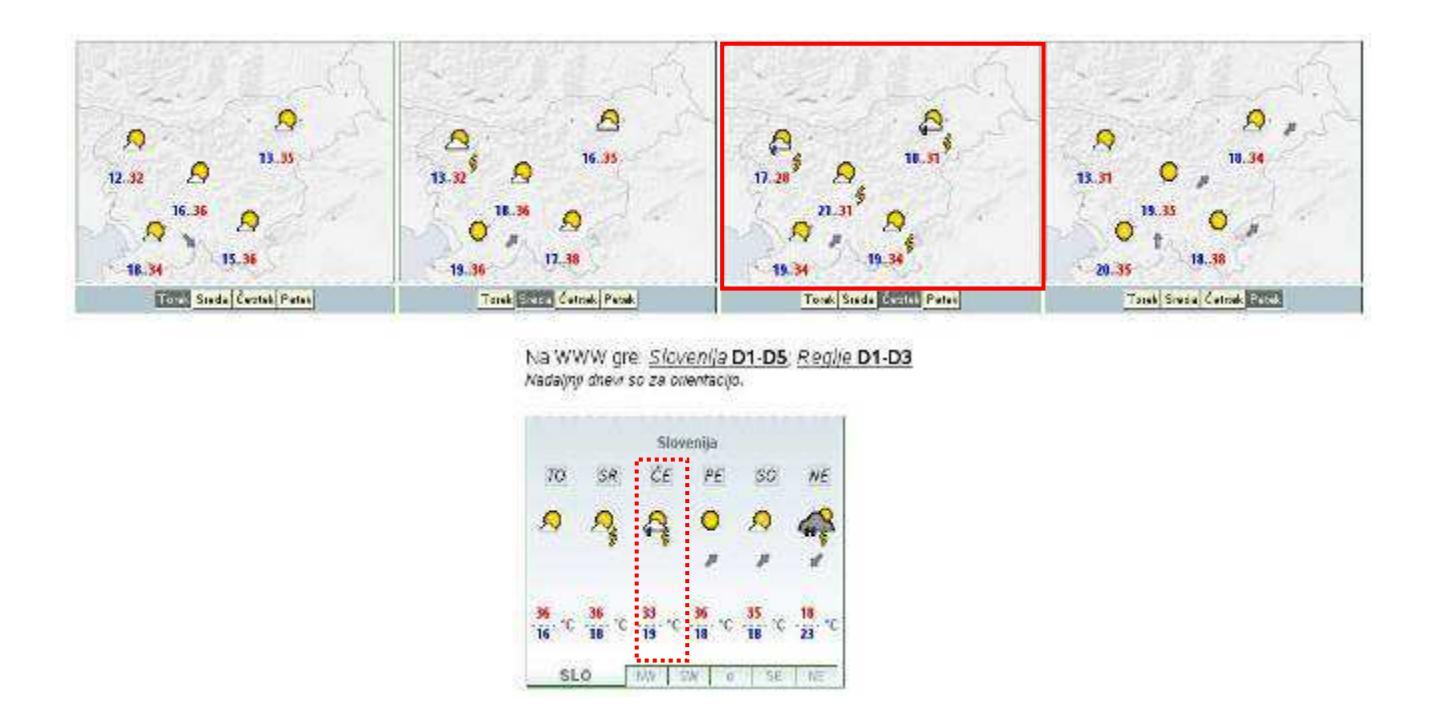
Picture 12: Forecast for the period from 21 August 2012 to 24 August 2012 – The day of the accident was Thursday, 23 August 2012

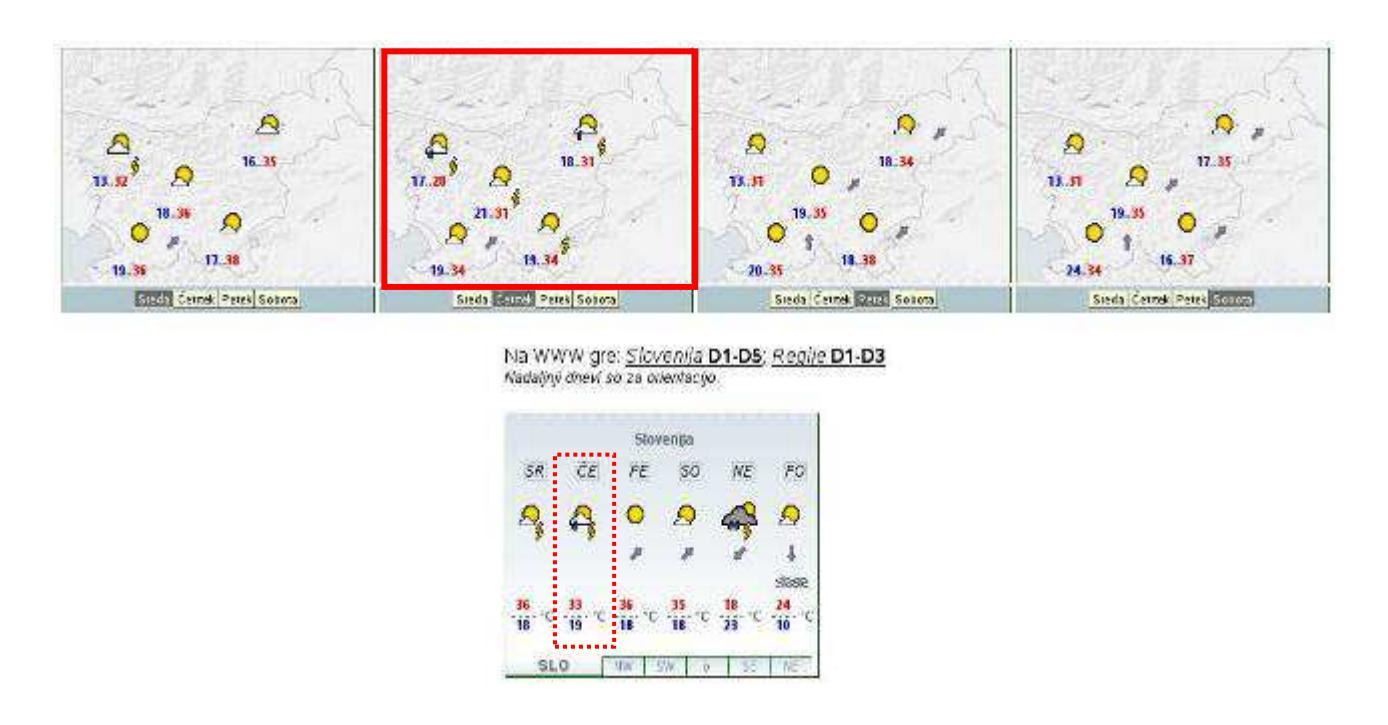
Picture 13: Forecast for the period from 22 August 2012 to 25 August 2012 – The day of the accident was Thursday, 23 August 2012

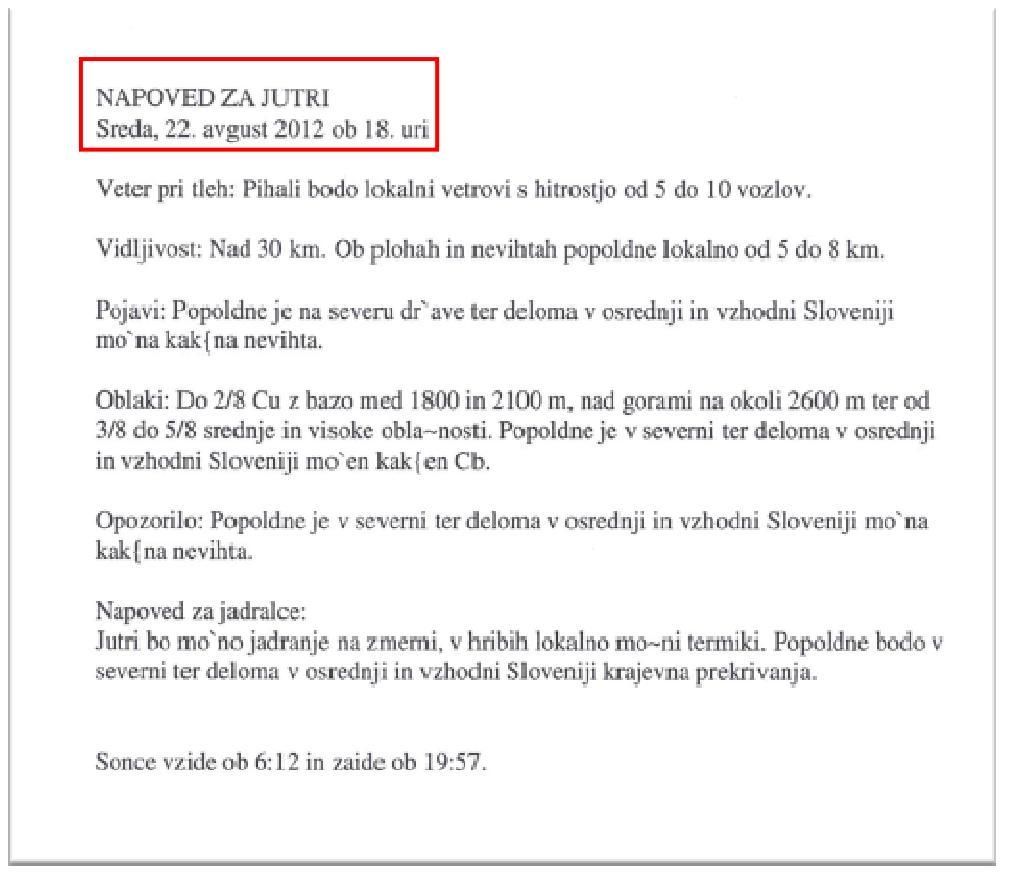
DmetS's forecast, issued on 22 August 2012, included a warning about the predicted occurrence of thunderstorms in the afternoon of 23 August 2013. The air navigation forecast issued on 23 August 2012 included a warning on the predicted occurrence of thunderstorms, without any time limits (Pictures 14 and 15). The forecast also mentioned the formation of storm clouds.

Picture 14: Forecast for Aviation issued on 22 August 2012

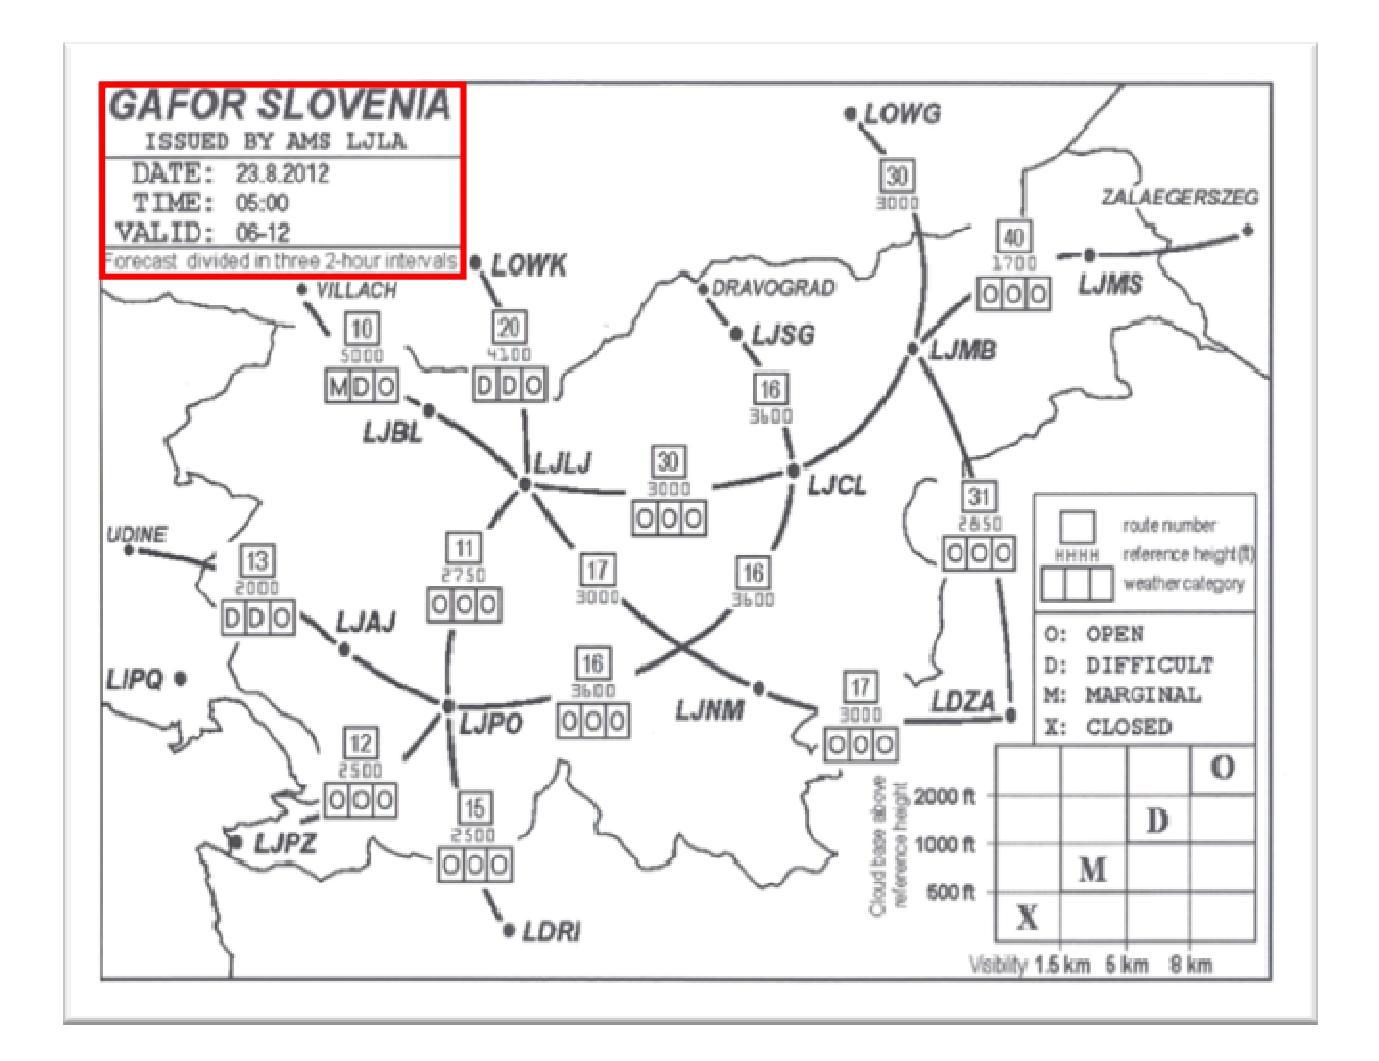
Picture 16: GAFOR forecast issued at 7:00 a.m. local time on 23 August 2012

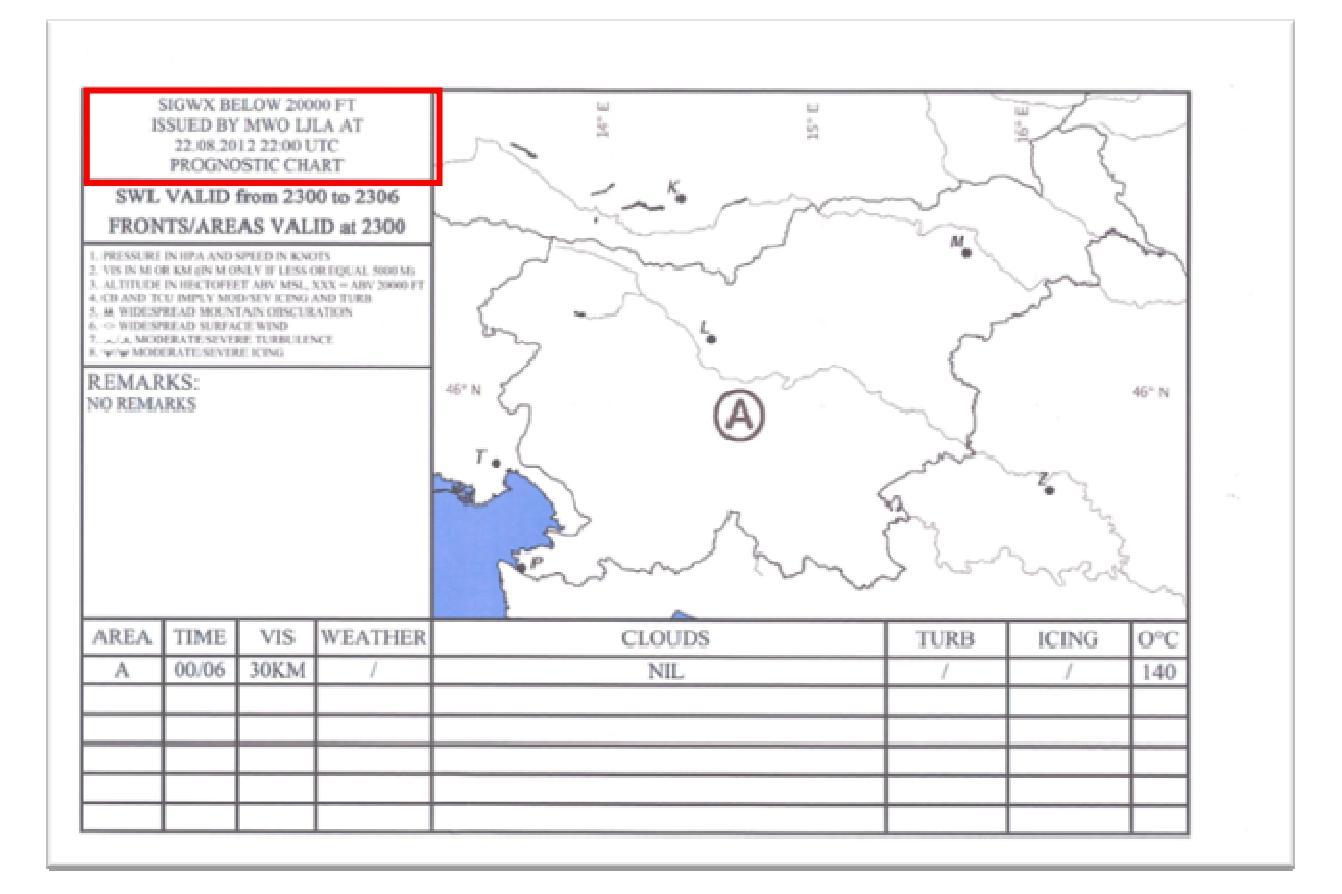
Picture 17: Map of characteristic weather conditions for LJUBLJANA FIR at night on 23 August 2012

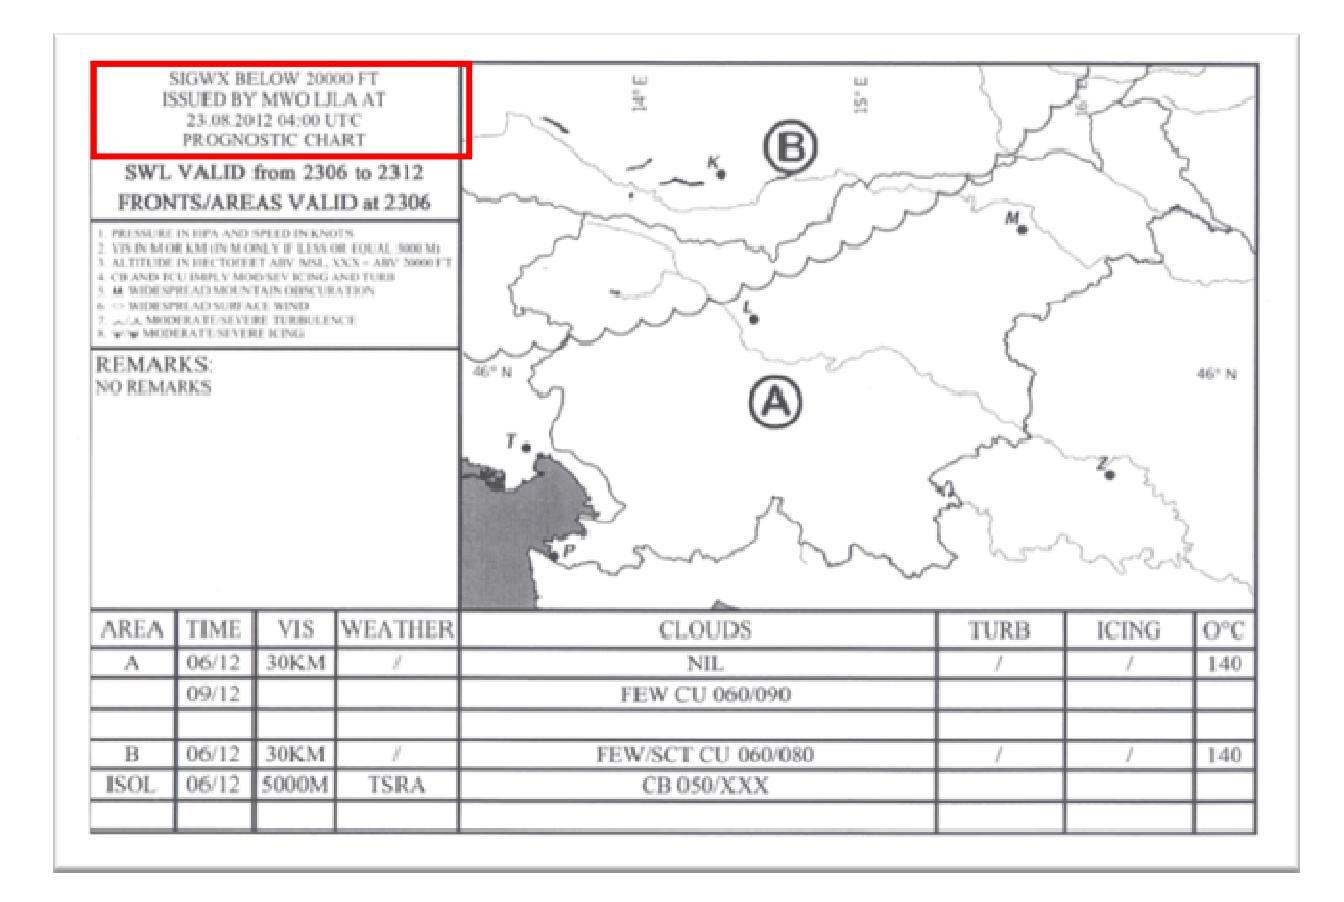
Maps of characteristic weather conditions for the area of LJUBLJANA FIR, valid for the day of the accident (Picture 17, 18 and 19). The first SWL map, on which the area of the forecasted occurrence of thunderstorms in the morning hours on 23 August 2012 is marked, was issued at 06:00 a.m. local time (Picture 18).

Picture 18: Map of characteristic weather conditions for Ljubljana FIR in the morning of 23 August 2012

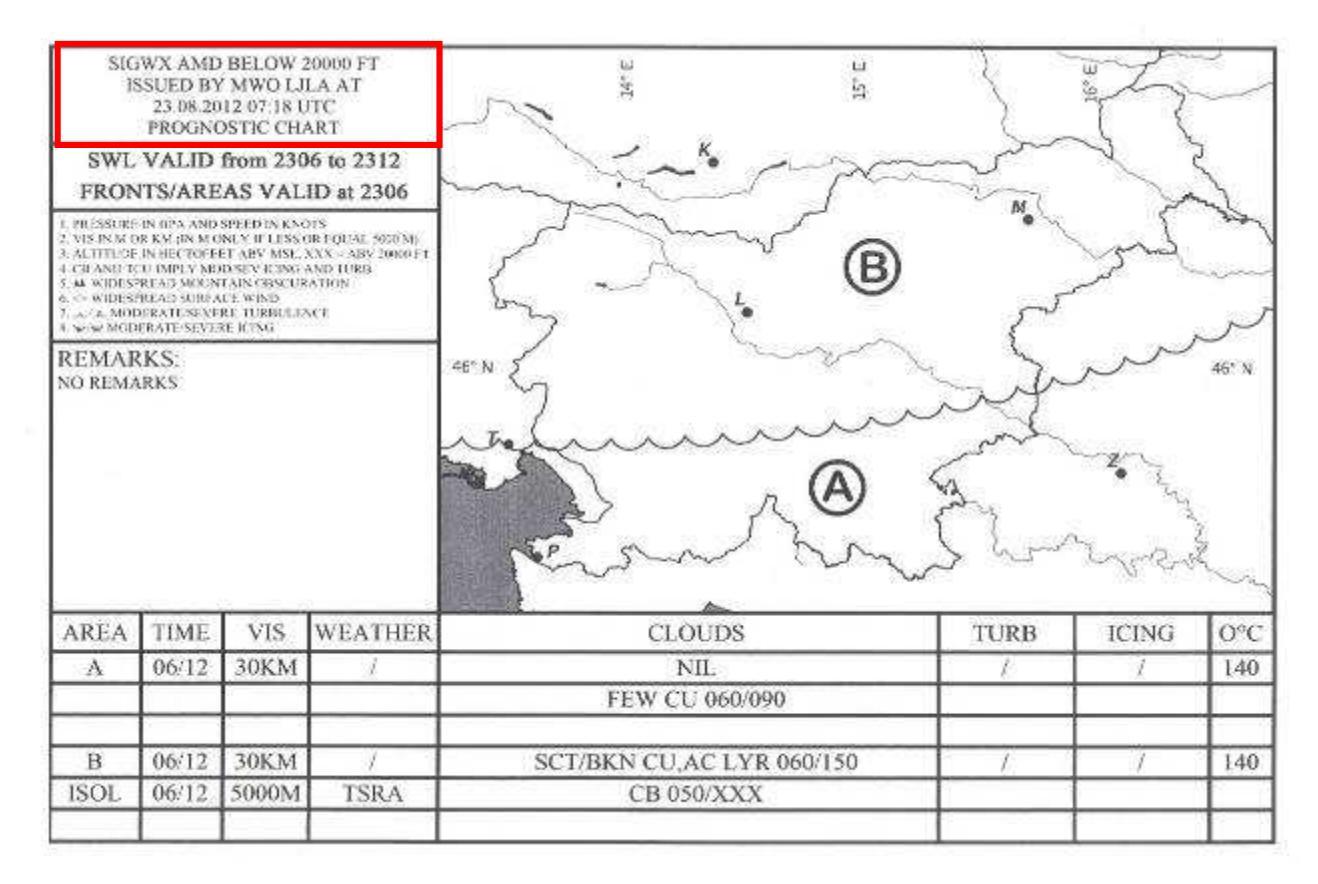
Picture 19: Map of characteristic weather conditions for LJUBLJANA FIR with marked expanded region of expected occurrence of thunderstorms in the morning of

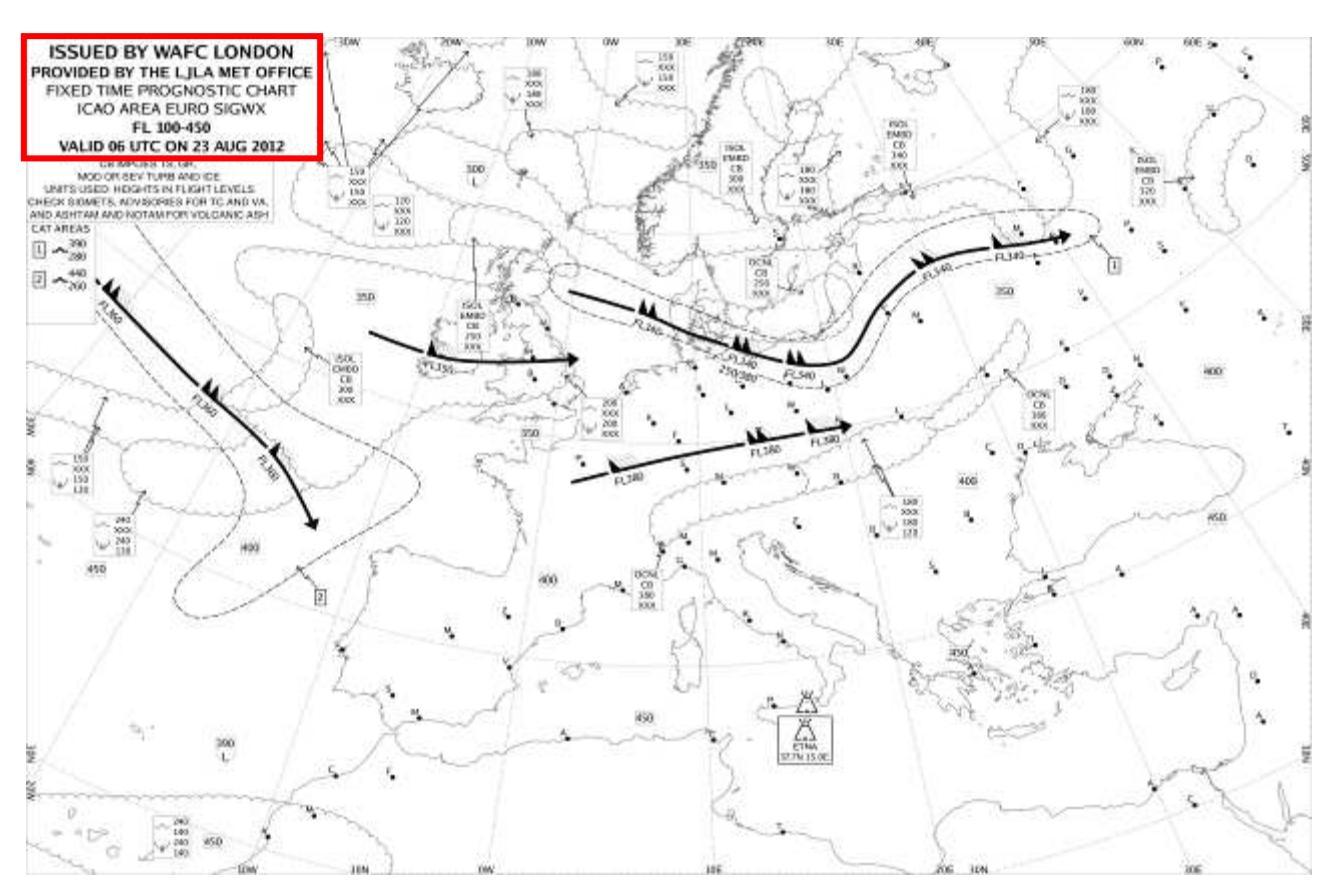
SIGWX forecasts in pictures issued by WAFC London valid for the morning (Picture 20) and late afternoon (Picture 21) hours, predicted the region of the occurrence of thunderstorm clouds somewhat to the north of Slovenia in the morning hours and the occurrence of thunderstorms in Slovenian territory in the afternoon.

Picture 20: SIGWX map valid for 23 August 2012 at 08:00 a.m. local time. Source: WAFC London

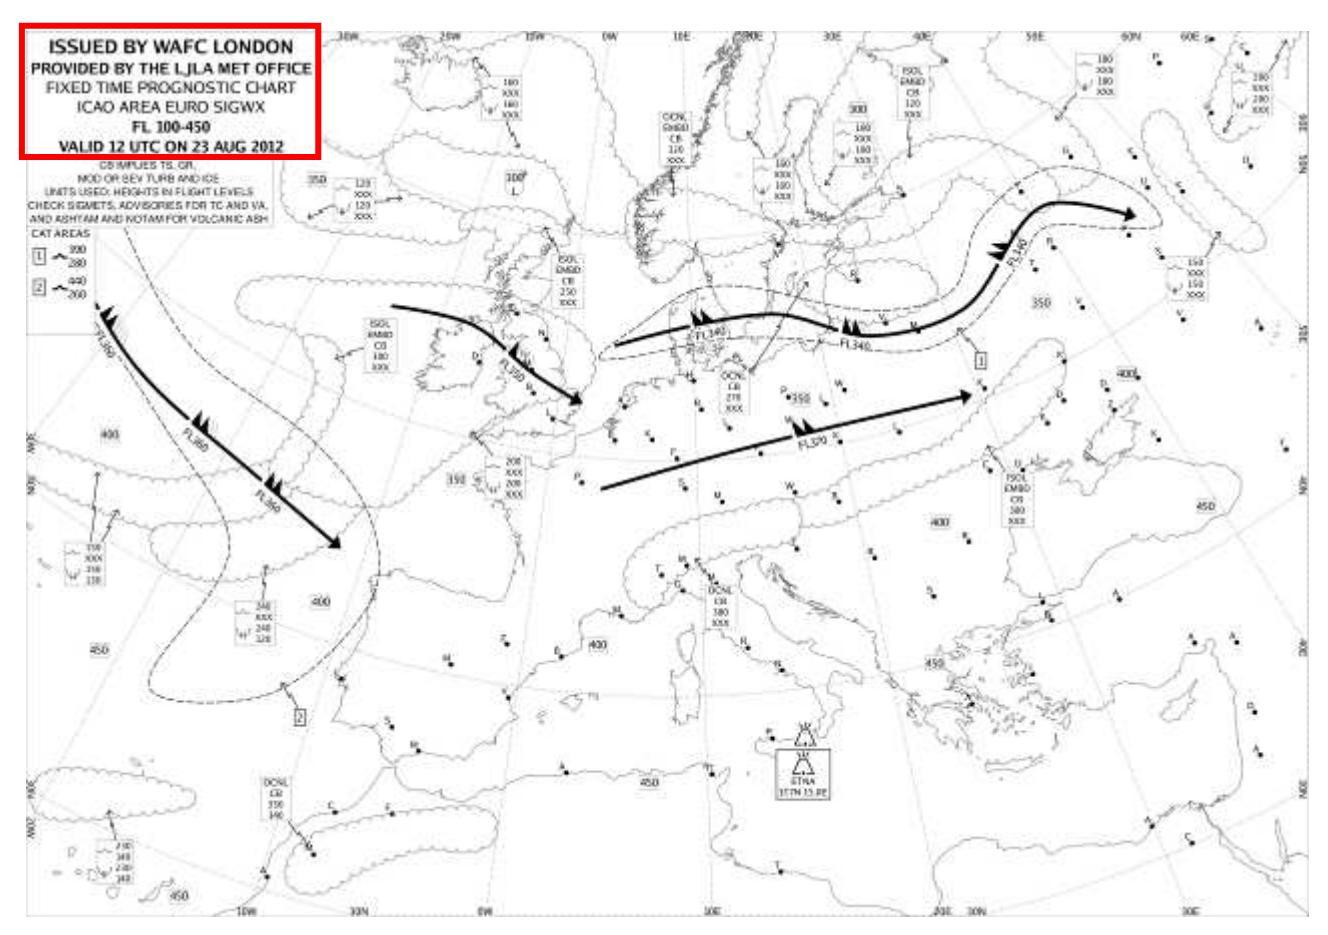
Picture 21: SIGWX map valid for 23 August 2012 at 2:00 p.m. local time. Source: WAFC London

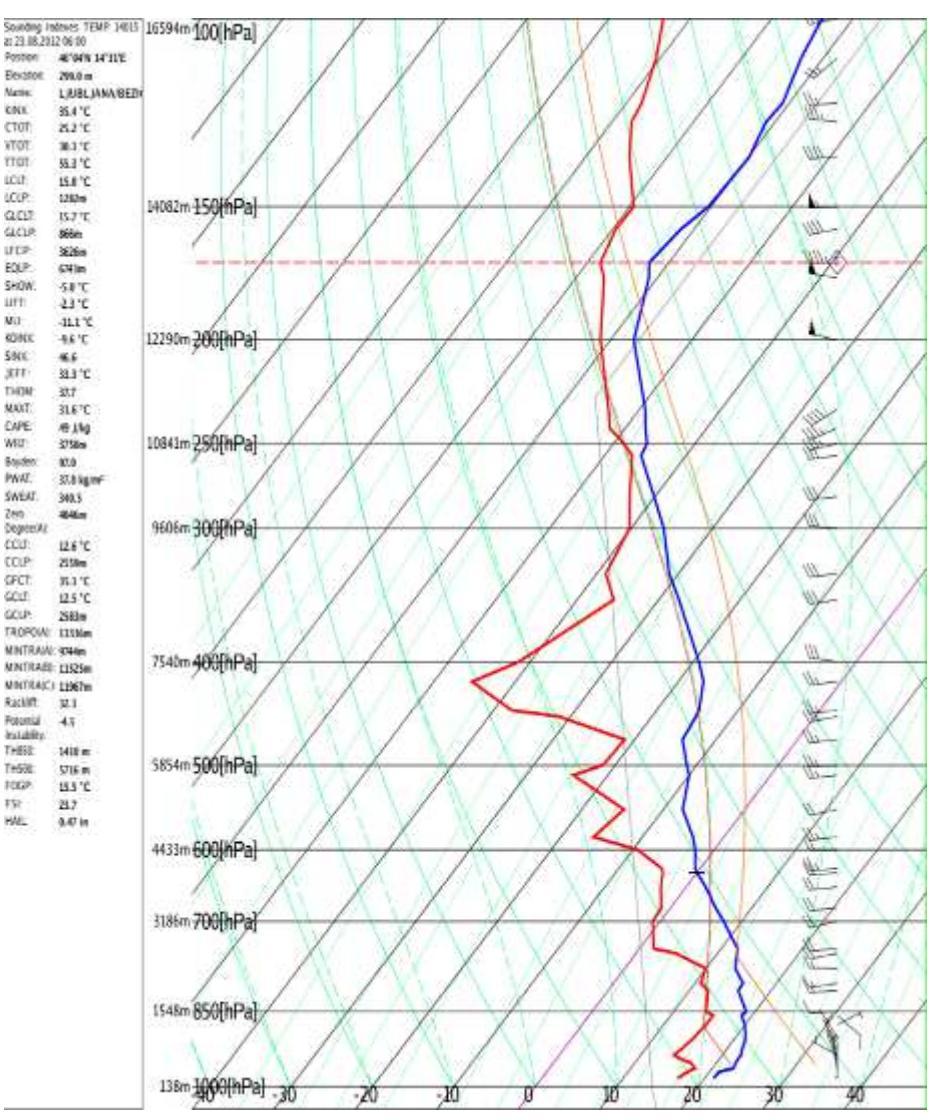
Between 05:00 a.m. and 07:00 a.m. local time, horizontal visibility was estimated in the Ljubljana basin at around 40 km, and there were some mid- and high-altitude clouds with a base at around 2,500 metres above the ground. During this time meteorological stations in this area did not show any precipitation or other meteorological phenomena. At about 05:30 a.m. local time, the staff at DmetS measured the atmosphere at Vojkova 1b, Ljubljana. A meteorological probe measured a temperature of around 20° C to the altitude of around 1,300 metres. In the lower layers of the atmosphere, a north-west wind was blowing up to 10 knots. Above 1,300 metres the measured wind changed orientation to the western direction with a speed of 10 knots, intensifying as it got higher, reaching 15 knots at 1,700 metres, and 20 knots at an altitude of approximately 2,000 metres (Picture 22).

Picture 22: Atmospheric measurements in Ljubljana/Bežigrad on 23 August 2012

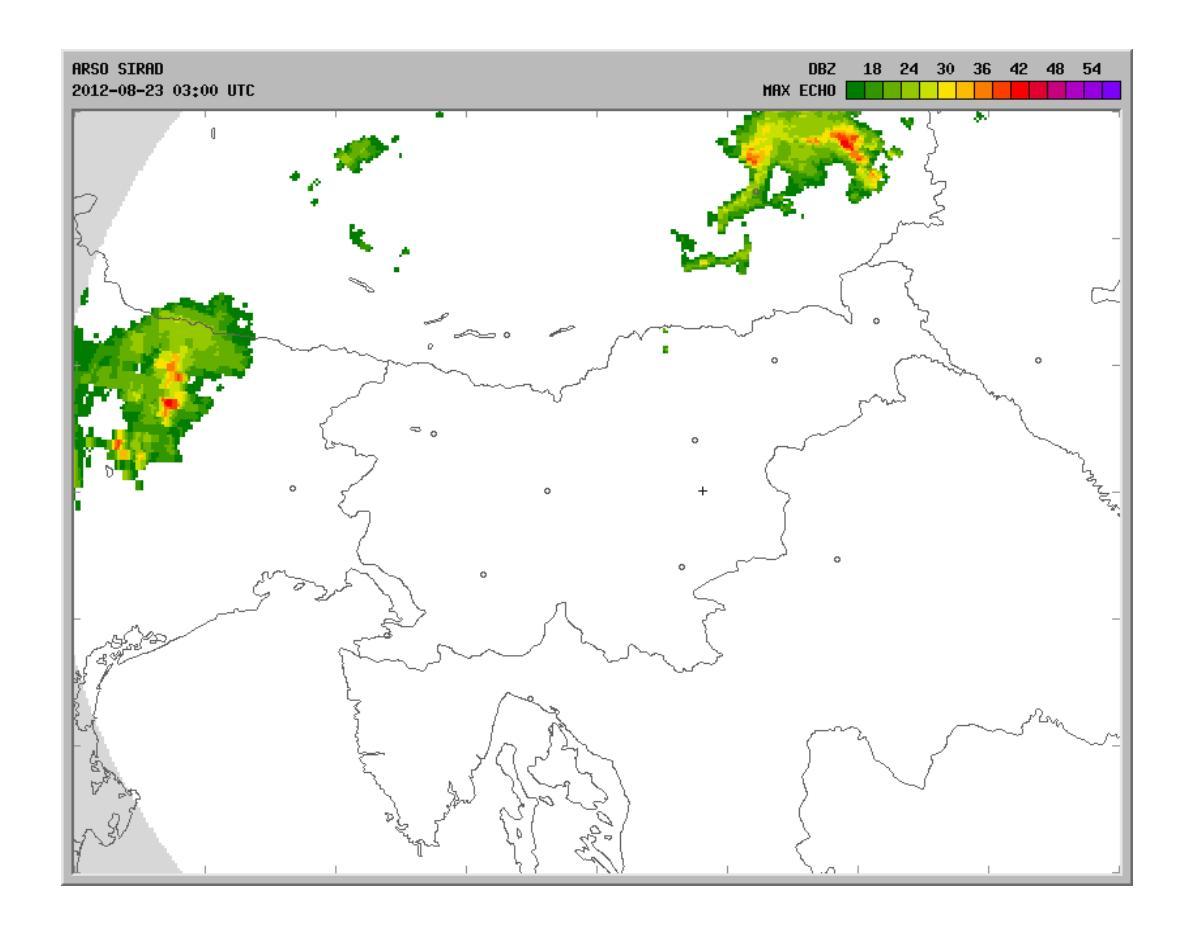
Picture 23: Radar image of maximum radar echoes - measured on 23 August 2012 at 05:00 a.m. local time

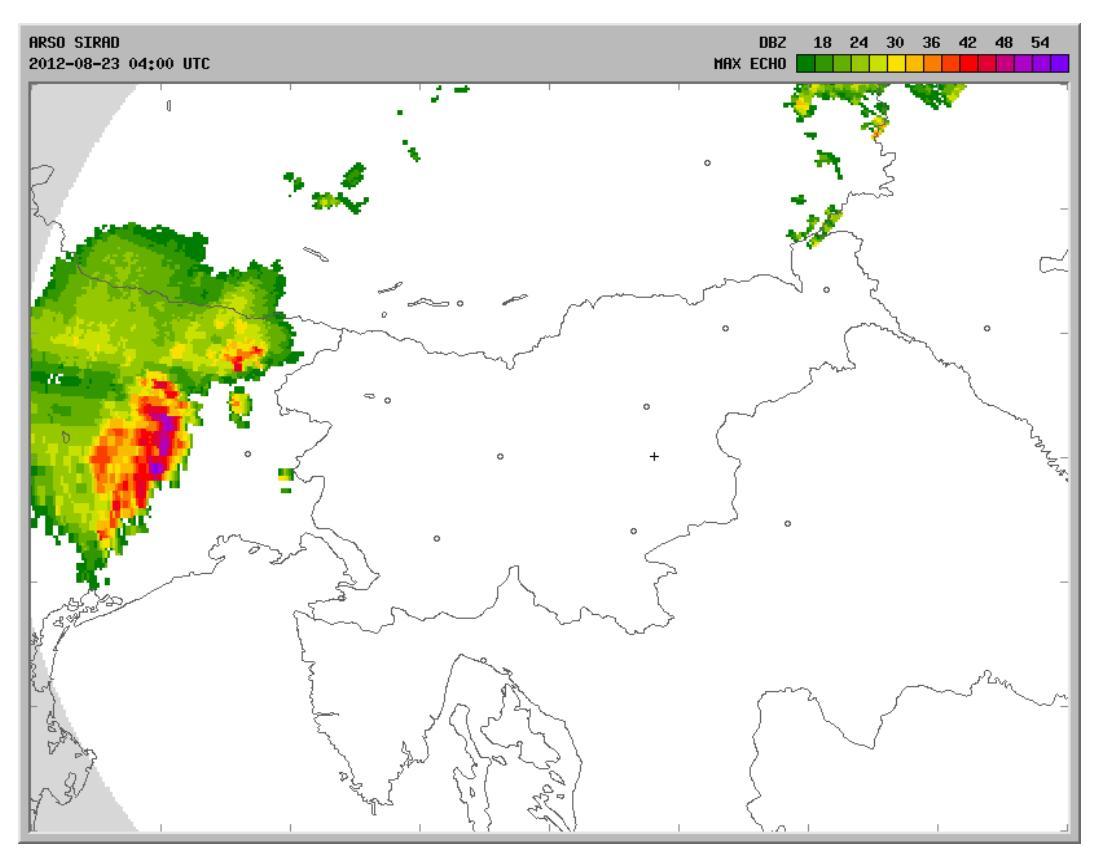
Picture 24: Radar image of maximum radar echoes – measured on 23 August 2012 at 06:00 a.m. local time

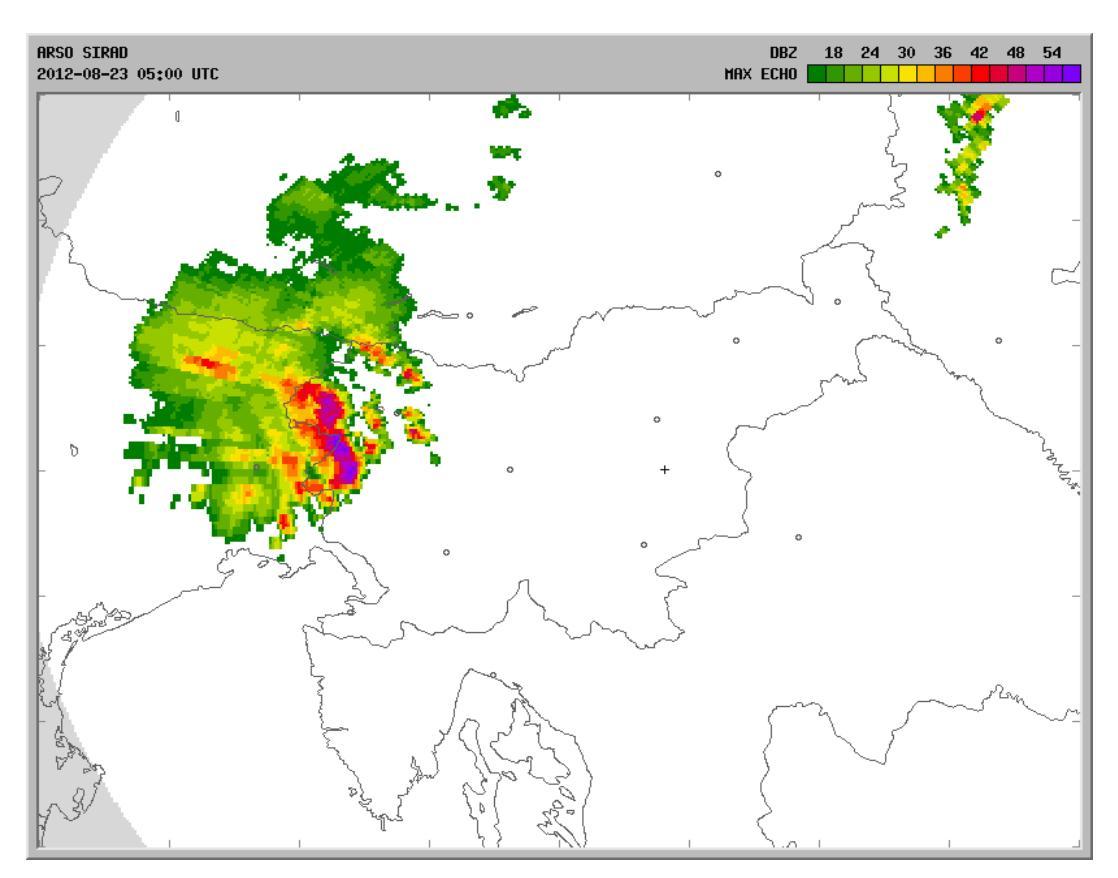
Picture 25: Radar image of maximum radar echoes - measured on 23 August 2012 at 07:00 a.m. local time
