AIRCRAFT ACCIDENT AND INCIDENT INVESTIGATION SERVICE

Number: 37200-3/2012/132-00121171 Date: 23 October 2014

FINAL REPORT

ON THE INVESTIGATION OF THE AIRCRAFT ACCIDENT INVOLVING HOT AIR BALLOON LINDSTRAND LBL 600C REGISTRATION MARK S5-OLO, WHICH OCCURED ON 23 AUGUST 2012 OVER THE LJUBLJANA MARSHES

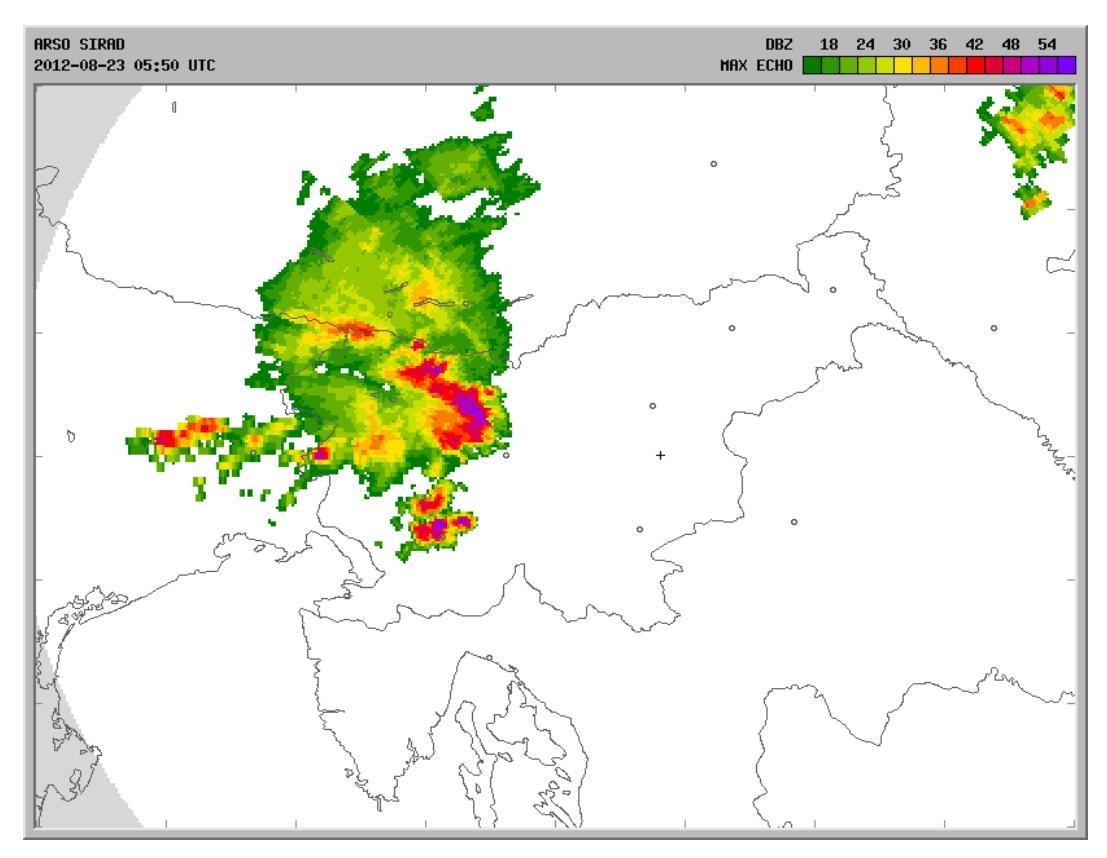
Picture 26: Radar image of maximum radar echoes - measured on 23 August 2012 at 07:50 a.m. local time

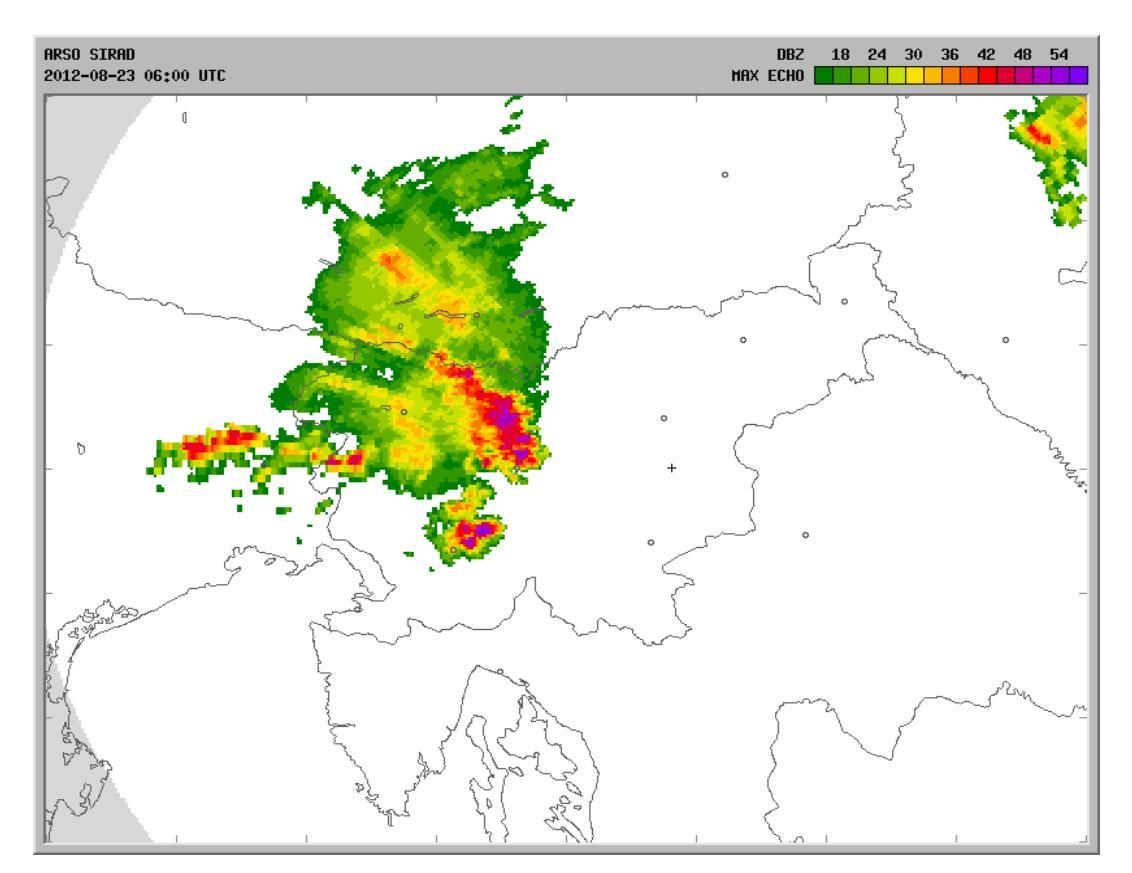
During the night, thunderstorms began to form over the Po plain, which in the morning hours spread from west to east with an estimated speed (on the basis of successive radar images) at between approximately 60 to 70 km/h or approximately 30 to 40 knots. A few minutes before 08:00 a.m. local time thunderstorms reached the area in the direct vicinity of Ljubljana. (Pictures 23, 24, 25, 26 and 27).

Picture 27: Radar image of maximum radar echoes - measured on 23 August 2012 at 08:00 a.m. local time
Weather warnings for air space:

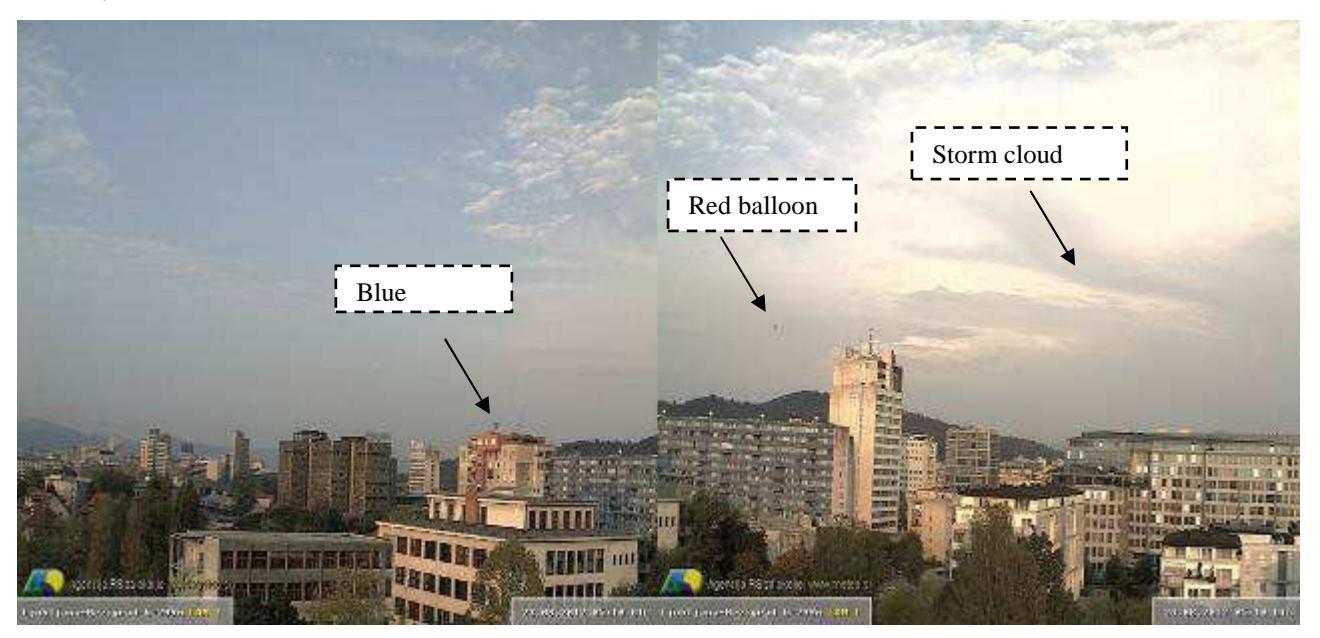
balloons – blue S5-OLO and red S5-OLM – which took off on 23 August 20122, the day of the accident, from Ljubljana - Brdo, and started moving towards the Ljubljana marshes. This footage also clearly shows thunderstorm clouds which are approaching from the west (Pictures 28, 29, 30 and 31).

Picture 28: Photograph from panoramic camera taken at 07:10 a.m. local time

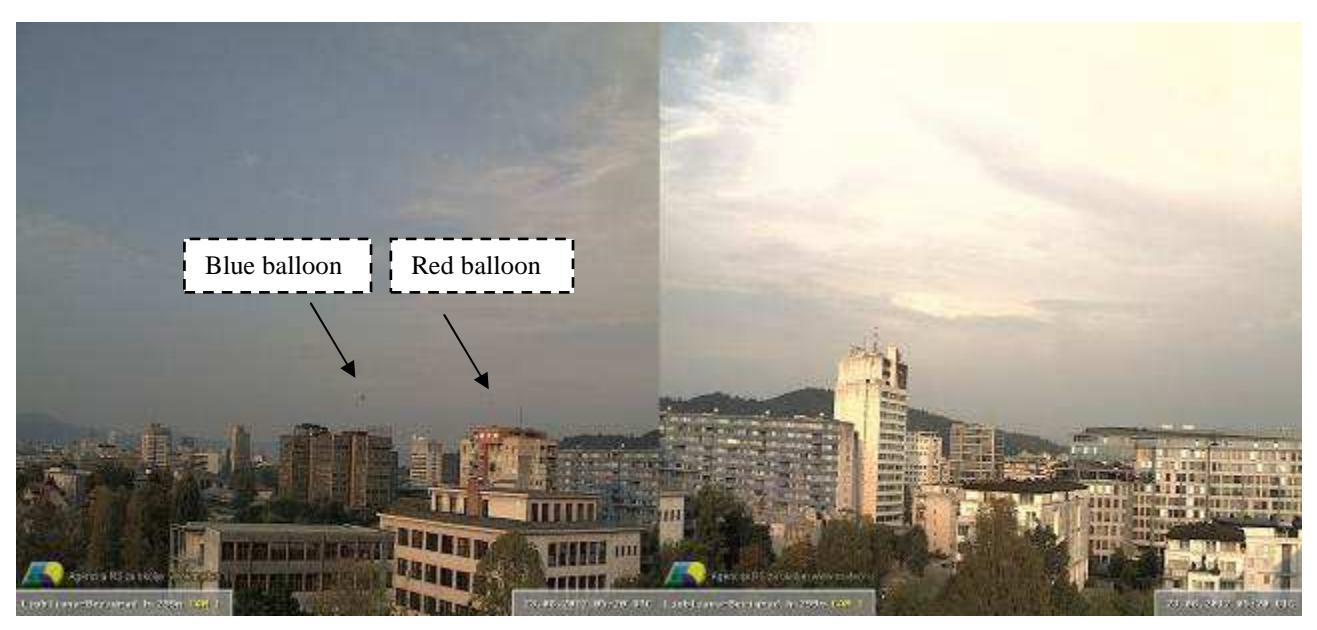
Picture 29: Photograph from panoramic camera taken at 07:20 a.m. local time

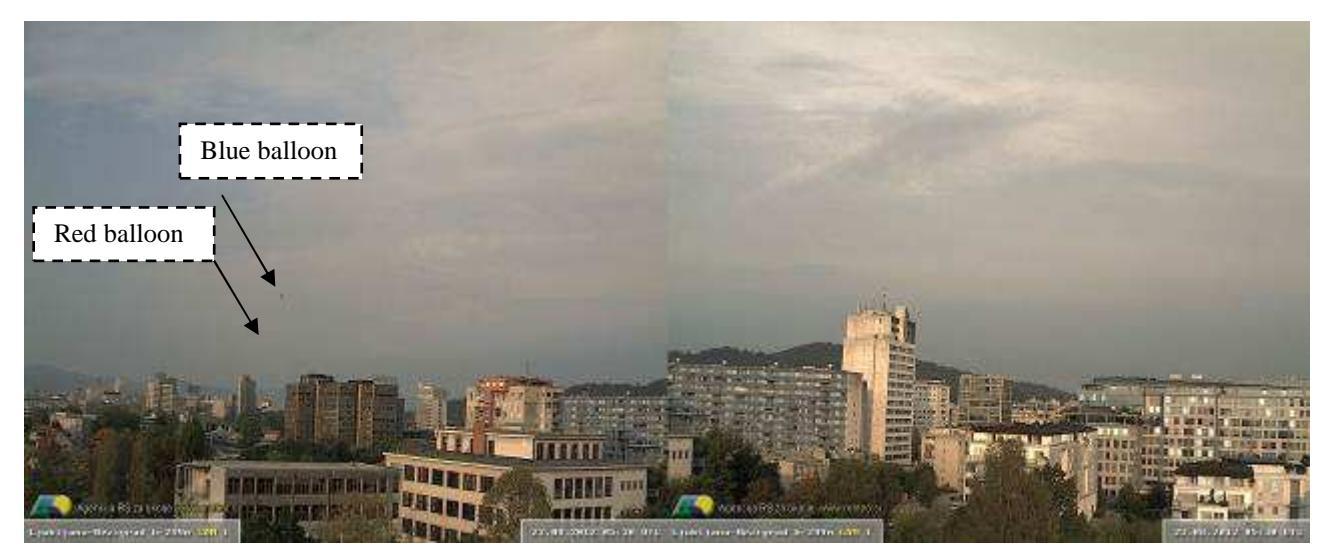
Picture 30: Photograph from panoramic camera taken at 07:30 a.m. local time; the blue balloon has gained altitude.

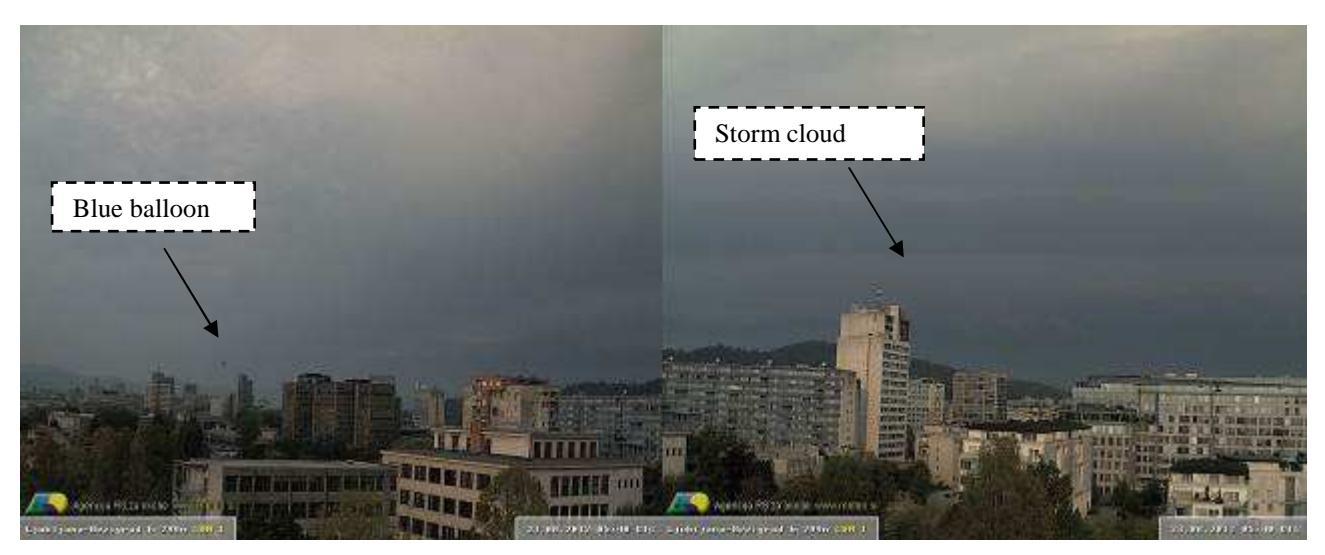
Picture 31: Photograph taken at 07:40 a.m. local time; the storm cloud has reached the western edge of the Ljubljana

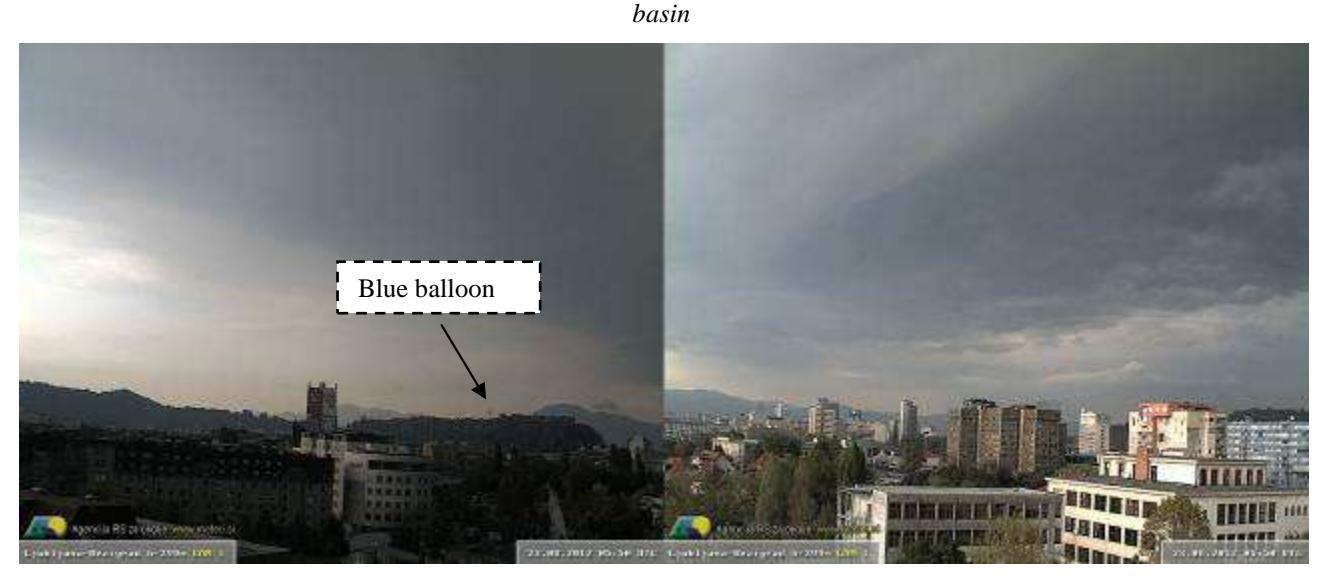
Picture 32: Photograph taken at 07:50 a.m. local time; the storm cloud has reached the Ljubljana basin, the blue balloon is descending in the direction behind the Ljubljana Castle

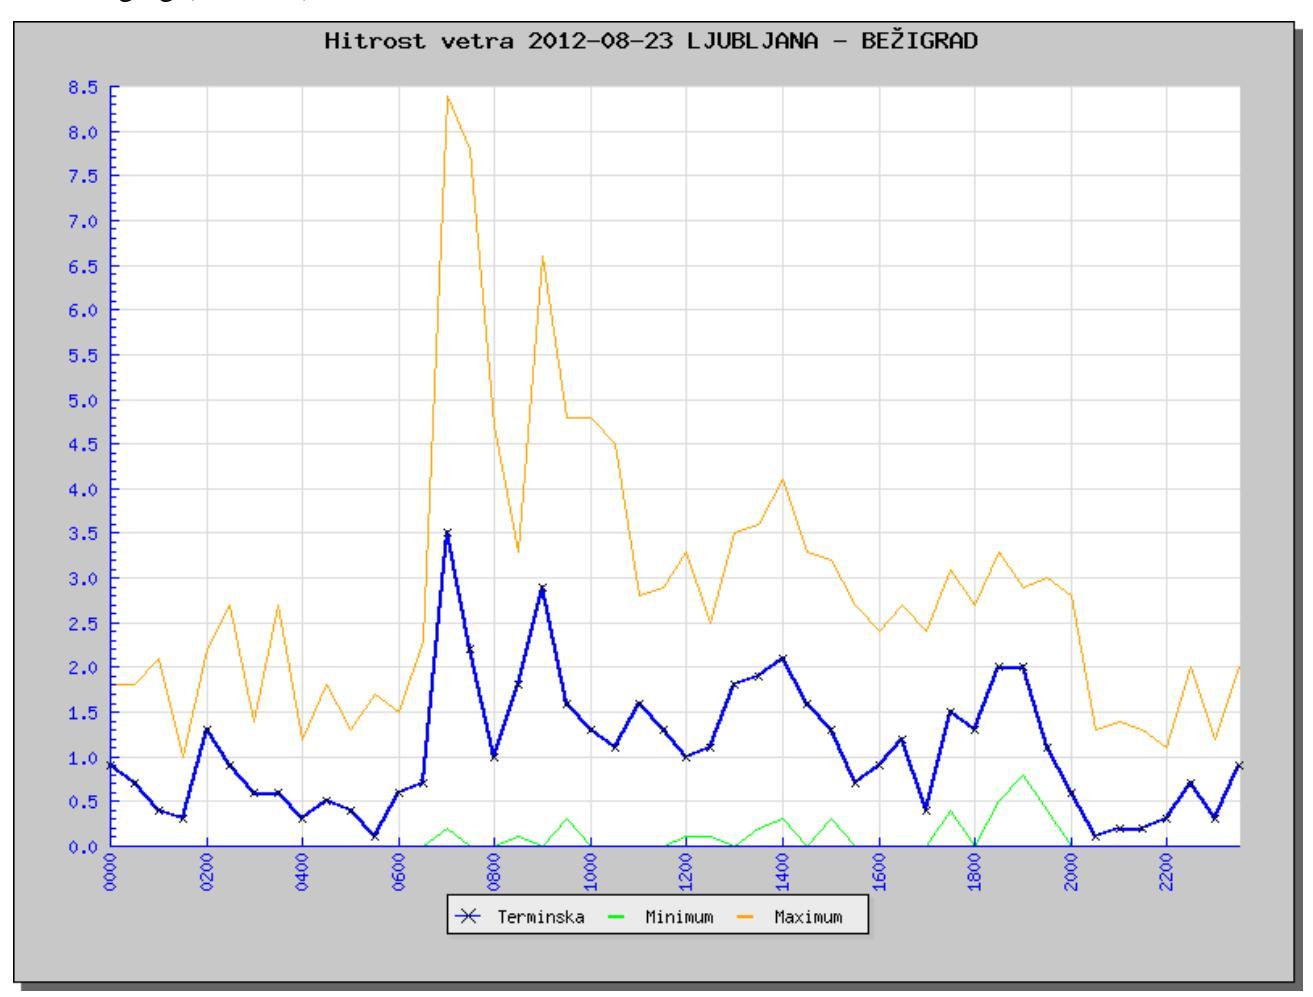
Picture 33: Wind speed measurements (m/s) on 23 August 2012 from Ljubljana, Bežigrad station

Time is expressed in local solar time (UTC+1). Half-hour averages for wind speed values are marked in blue, minimum speed in green, and the strongest gusts within the half-hour interval in orange.

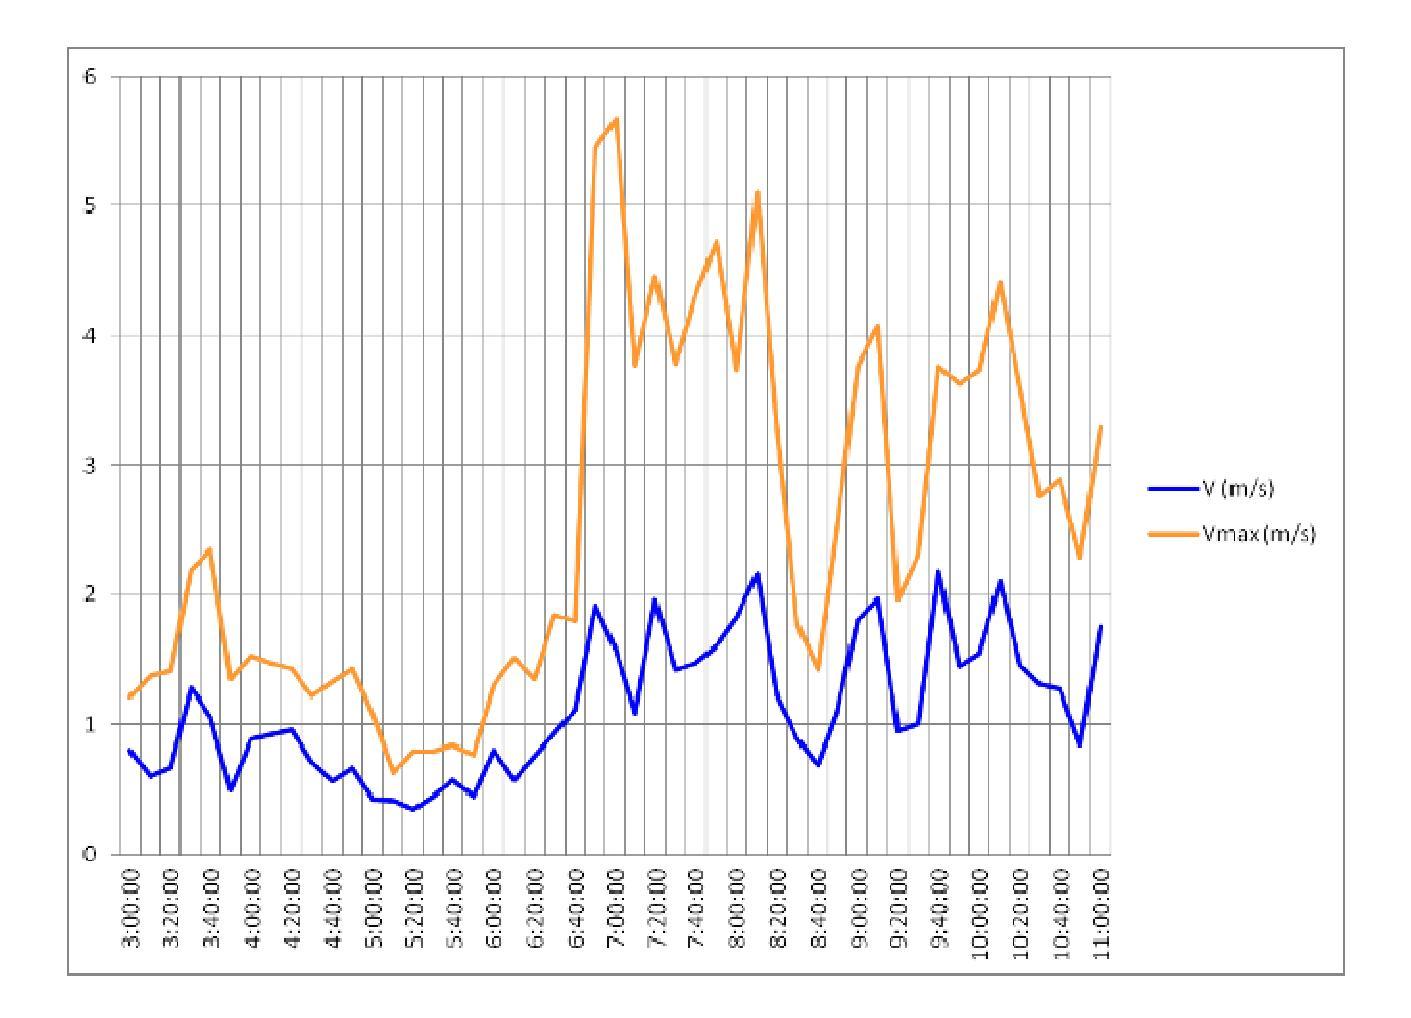
Picture 34: Wind speed measurements (m/s) on 23 August 2012 from Barje landfill station

Time is expressed in local solar time (UTC+1). 10-minute average wind speeds are marked in blue, the strongest gusts within the 10-minute measurement interval are marked in orange. Source: Snaga Javno podjetje, d.o.o..

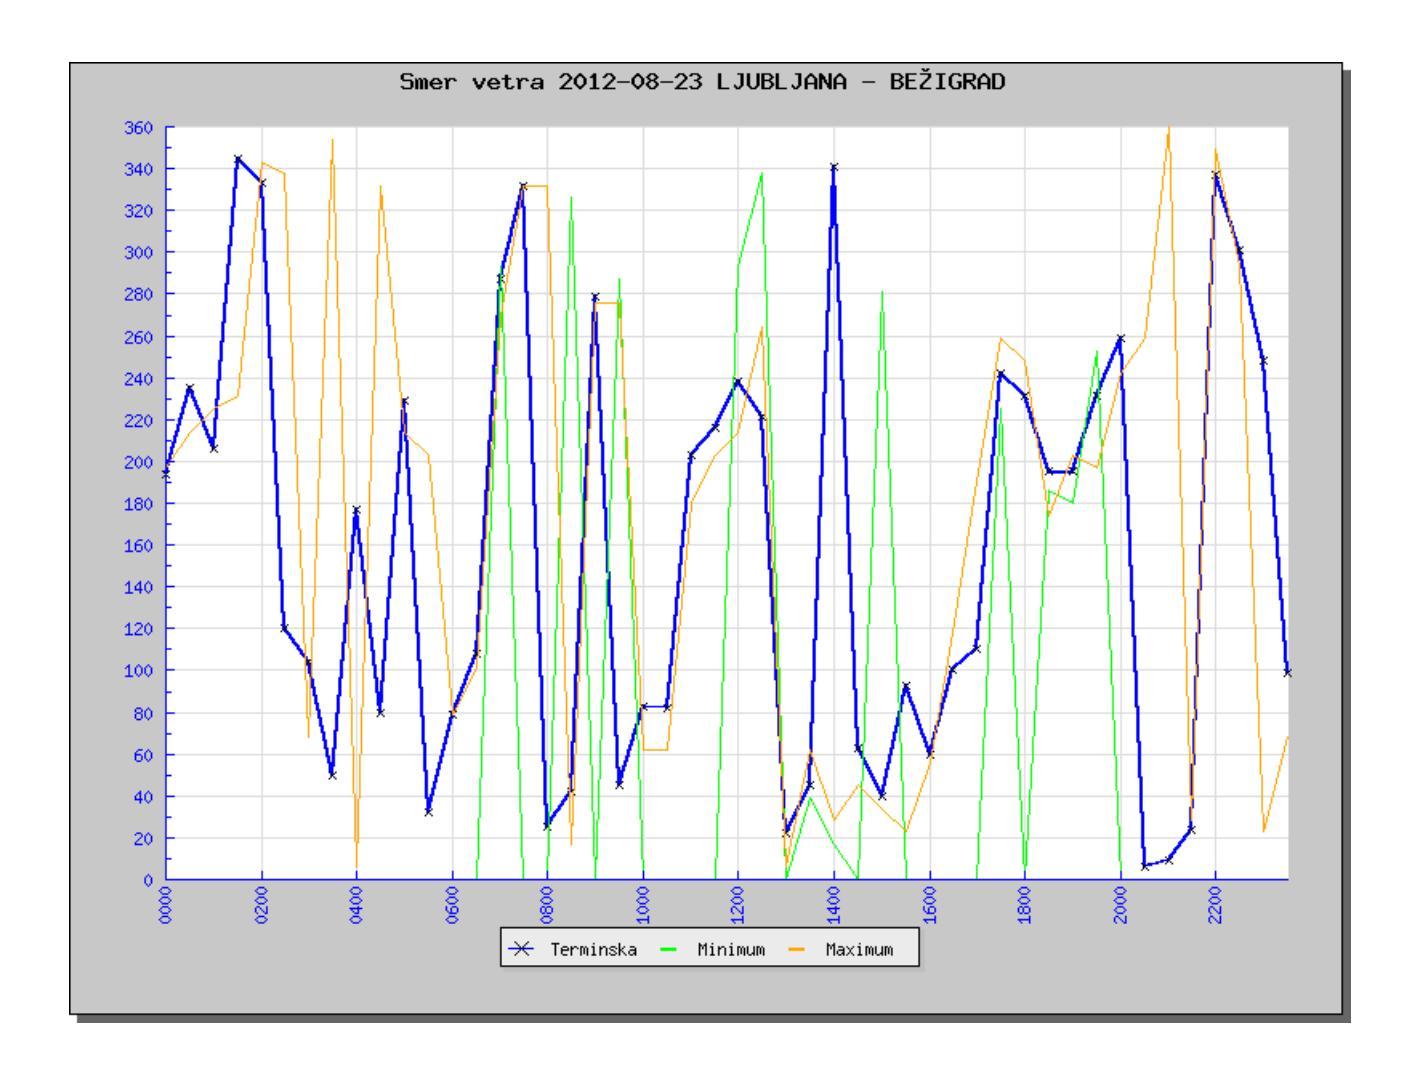
Picture 35: Wind direction measurements on 23 August 2012 from Ljubljana, Bežigrad station

Time is expressed in local solar time (UTC+1). Half-hour average wind directions are marked in blue, minimums are marked in green, and maximum wind directions within the half-hour measurement interval are marked in orange.

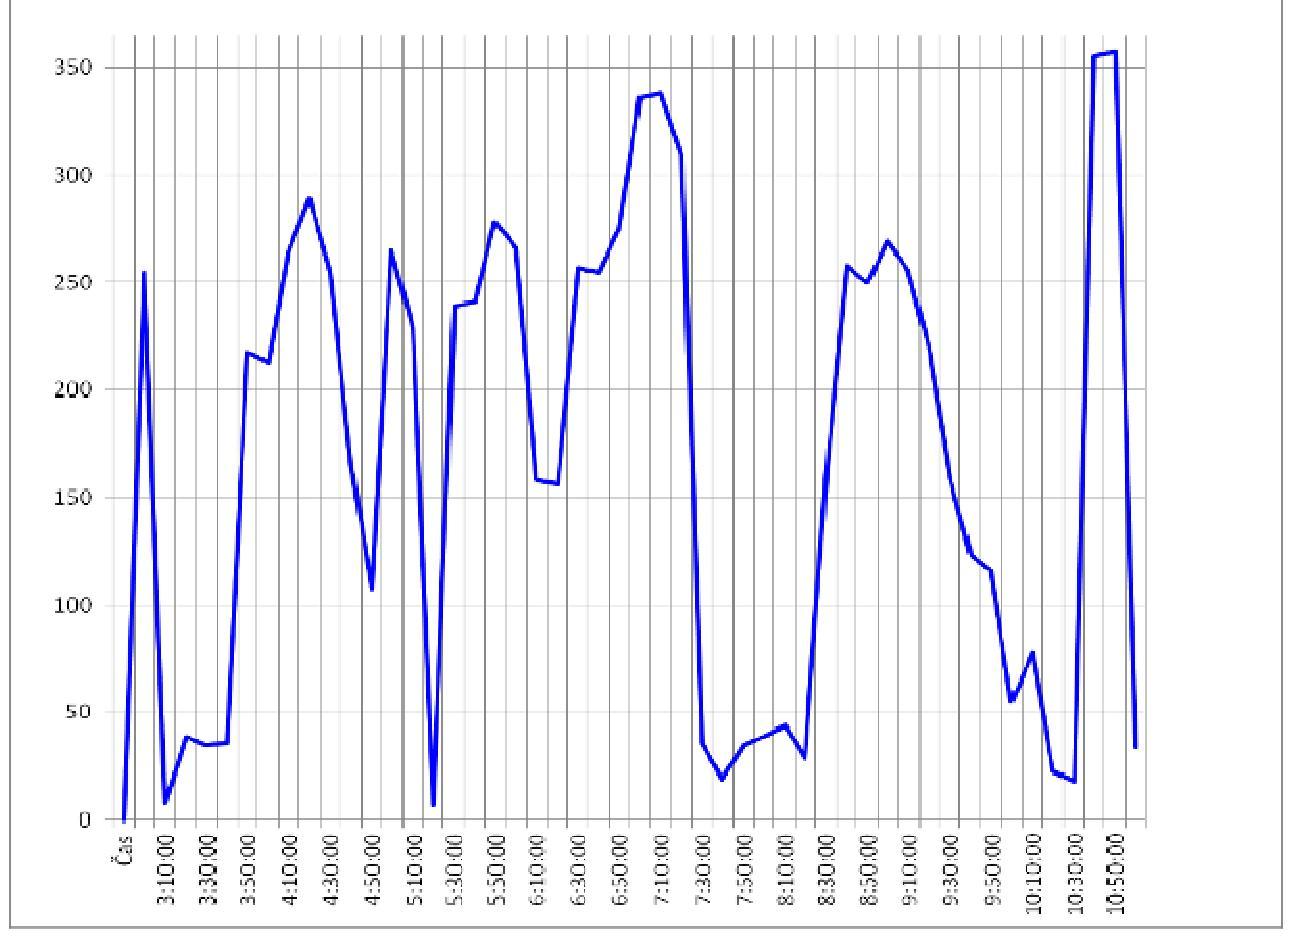
Picture 36: Wind direction measurements on 23 August 2012 from Barje landfill station

Time is expressed in local solar time (UTC+1). 10-minute average wind direction values.

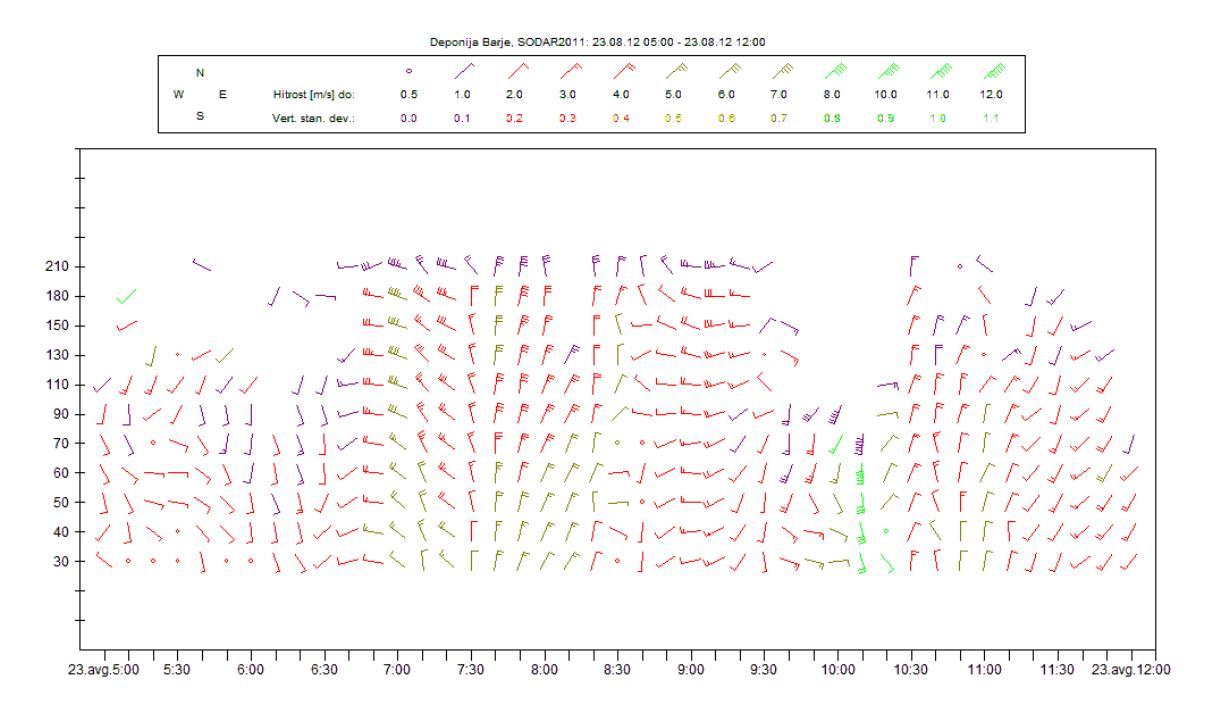
Picture 37: Wind measurements on 23 August 2012 at the Barje landfill measurement station taken with SODAR. Time is expressed in local solar time (UTC+1). 10-minute wind speed and directions up to 200 meters above the measurement point. Source: Snaga Javno podjetje

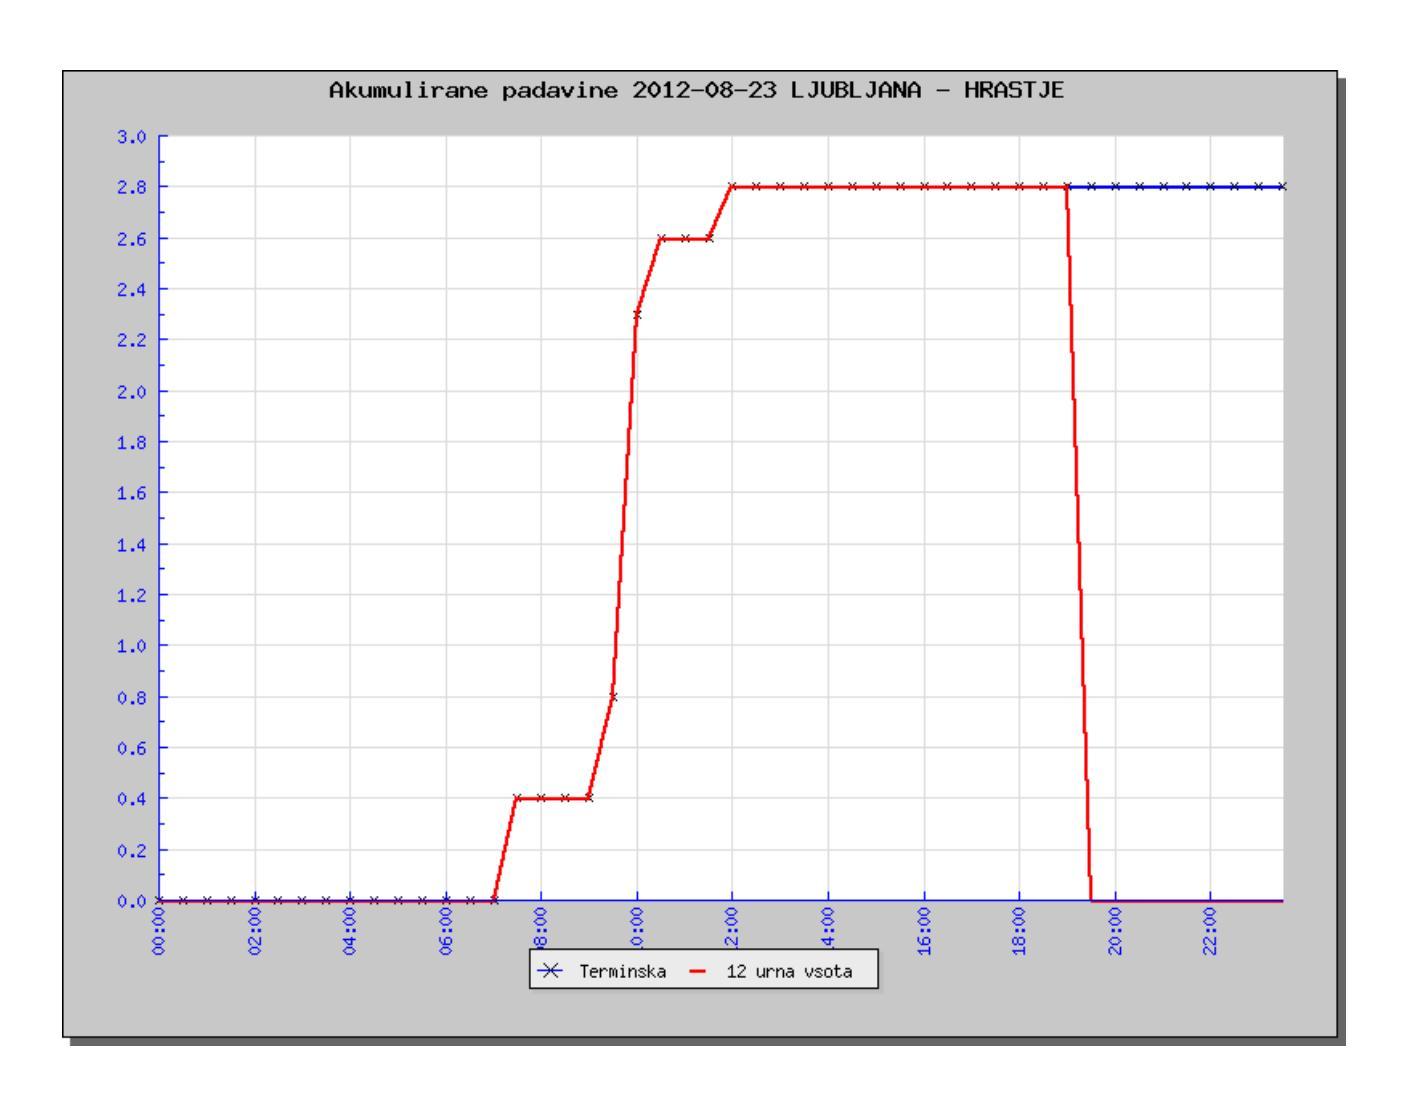
DmetS measures precipitation at several locations in Ljubljana and its surroundings. Precipitation measurements (Pictures 38 and 39) show that precipitation connected to the thunderstorm system passage began after the accident. Precipitation measurements corroborate radar images of precipitation particles (Pictures 23 and 24).

Picture 38: Precipitation measurements on 23 August 2012 at Ljubljana, Hrastje measurement point.

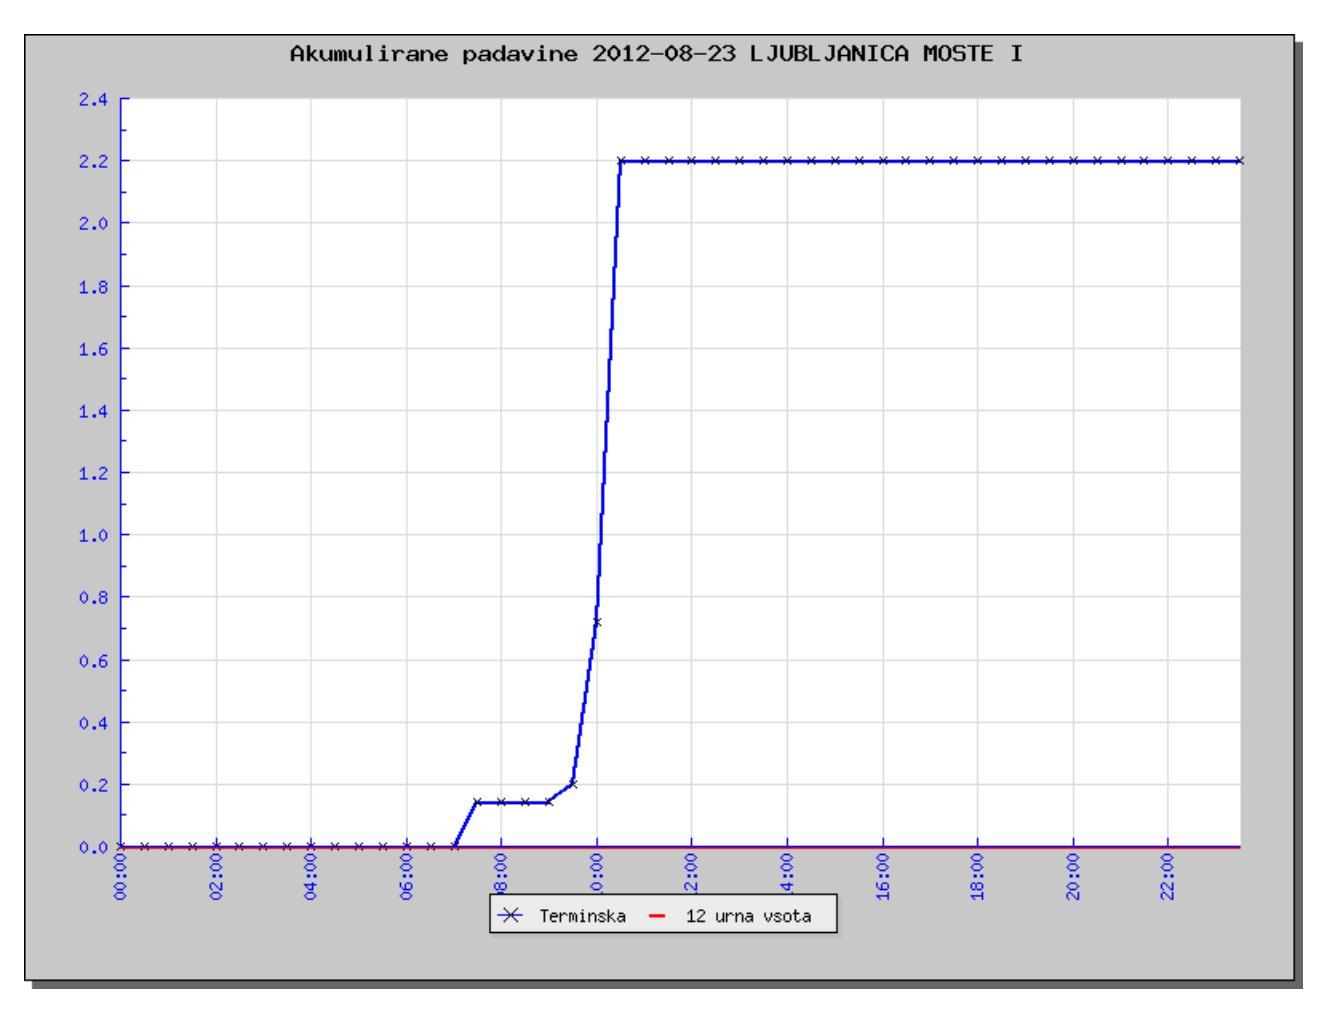
Picture 39: Precipitation measurements on 23 August 2012 at Ljubljana, Moste measurement point. Time is expressed in local solar time (UTC+1).

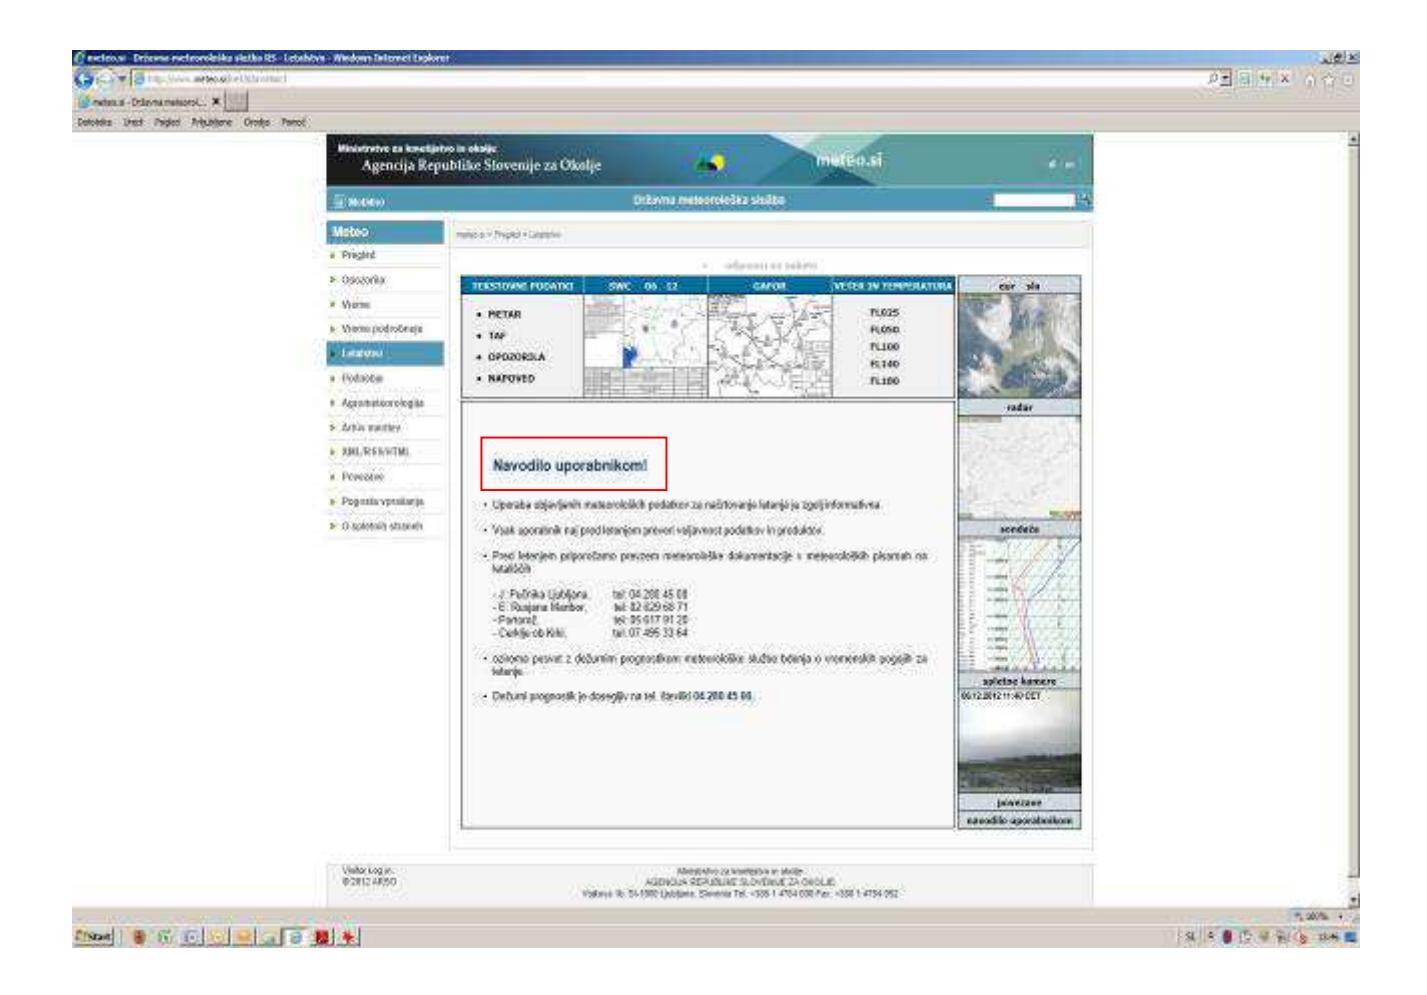
Picture 40: www.meteo.si - instructions for using meteorological information

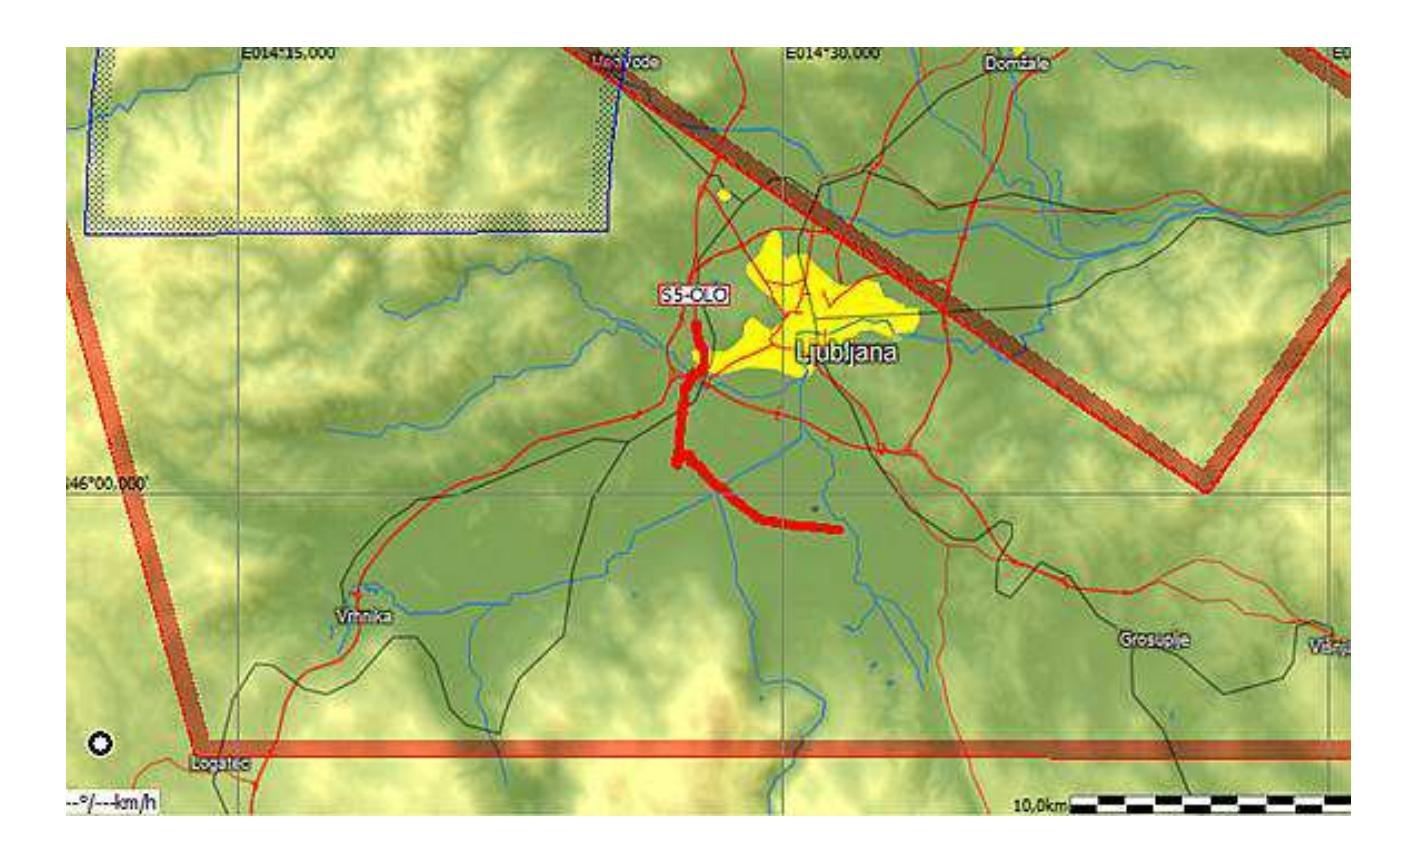
Picture 42: A description of the path of balloon S5-OLO (red) within TMA Ljubljana 1 (bordered red, border is shaded) and south of CTR Ljubljana (shaded red and surrounded with a thick red line).

From the flight recorded on balloon S5-OLO on 23 August 2012 it is evident that 28 minutes and 38 seconds of the flight was carried out within the controlled class C airspace of TMA Ljubljana 1. That is exactly 50% of the duration of the entire flight. Balloon S5-OLO entered and exited the controlled class C airspace TMA Ljubljana 1 at the following times and altitudes:

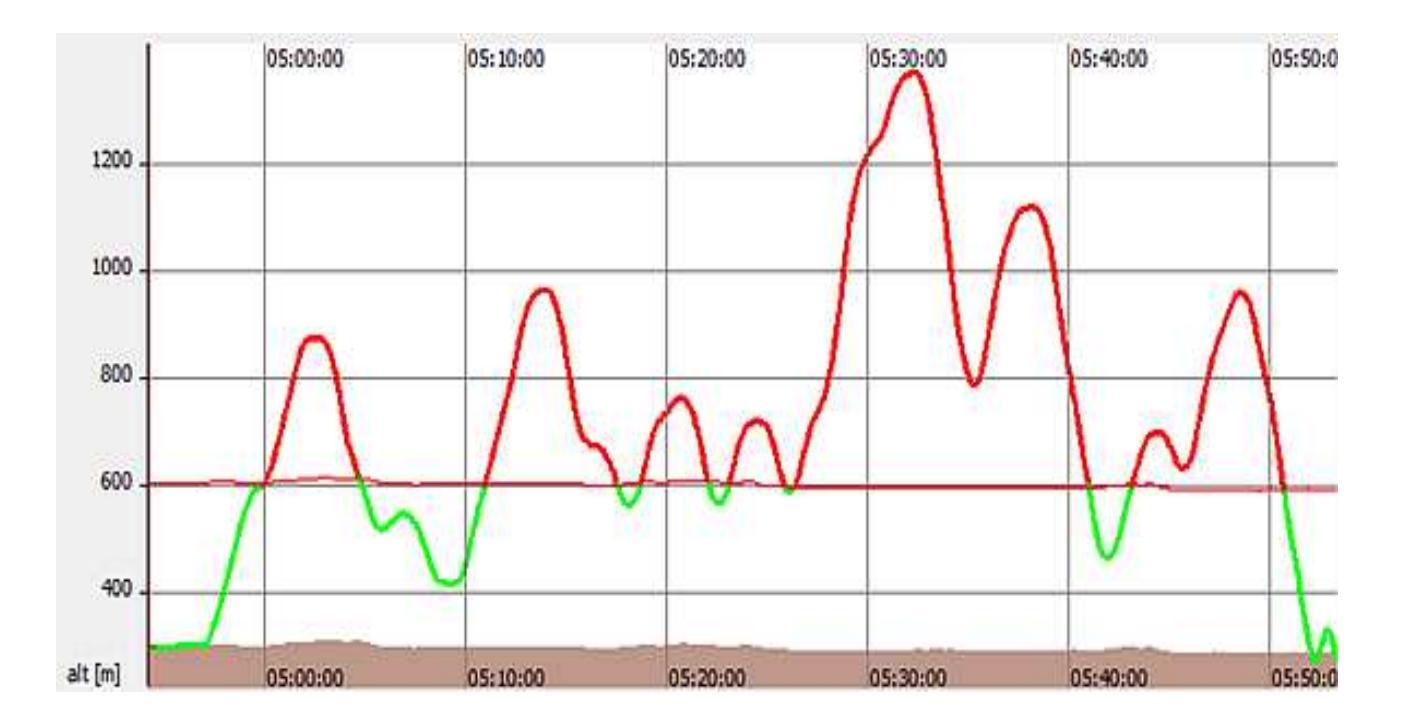
Picture 43: Barogrom of S5-OLO's flight. The green part of the path shows the flight below 1,000 feet AGL, the red part shows the flight above 1,000 feet AGL, i.e. within the TMA Ljubljana 1 air space.

The flight of S5-OLO went normally until 05:28:36 a.m. UTC. The balloon moved towards the south, as winds carried it with a ground speed lower than 20 km/h, which is a light northern wind. At 05:28:36 a.m. UTC balloon S5-OLO achieved its highest altitude of the day (1,371 m AMSL), followed by a rapid descent. During the descent, the wind direction changed from north to northwest. Later, after 05:49:39 a.m. UTC, during the final descent the wind changed to westerly, and wind speed increased to above 50 km/h, which continued up to the first contact with the ground at 05:52:05 a.m.UTC, at N45°59.367' E014°30.960' halfway between Ljubljana-Rudnik and Ig.2.1.4

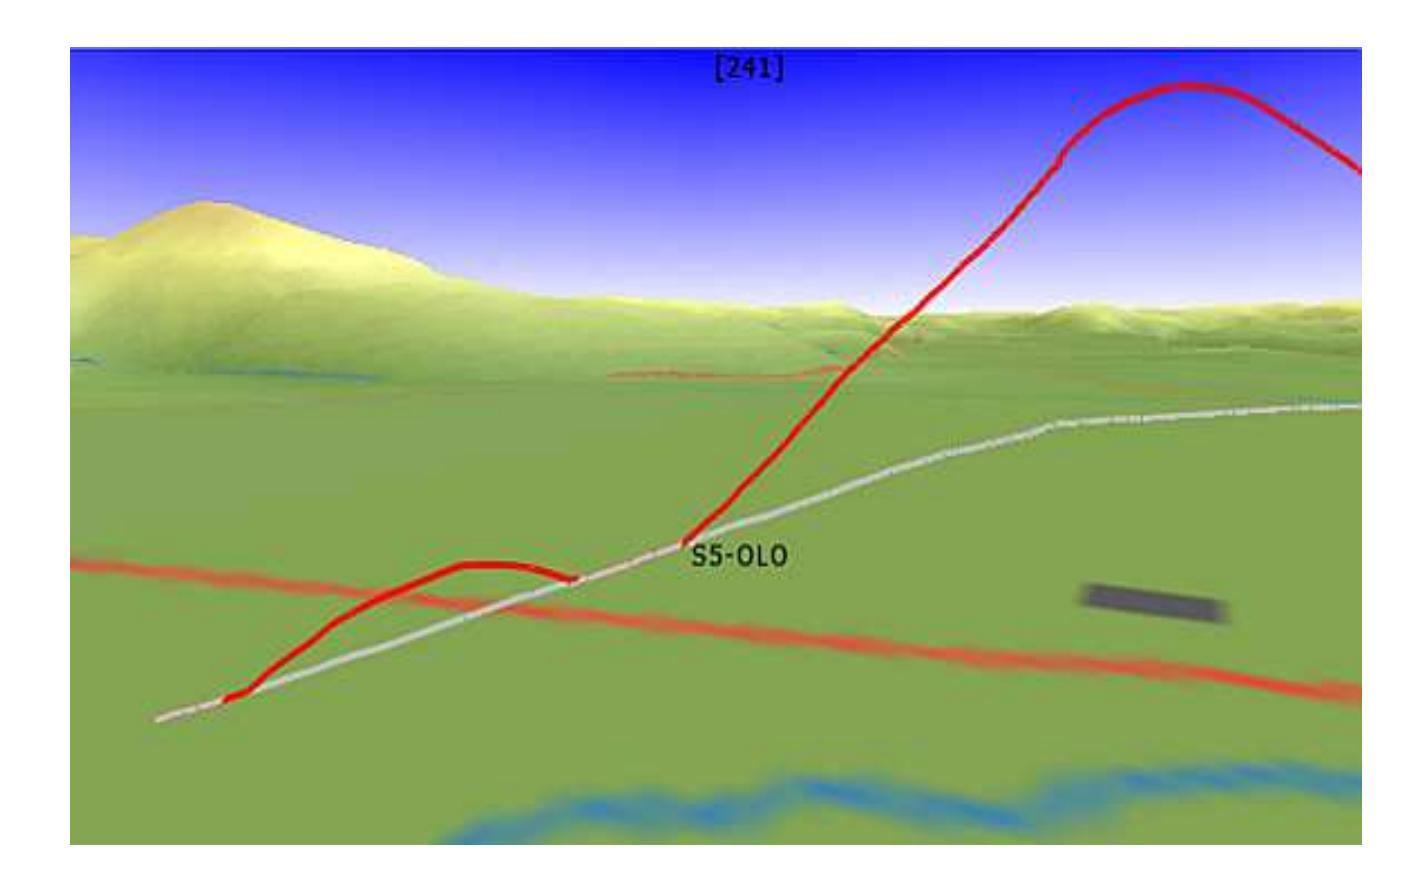
The final ascent was followed by a rapid descent all the way to the ground. The average speed of descent between 05:49:16 a.m. UTC and 05:52:05 a.m., when the balloon first hit the ground, was - 3.7 m/s. The average ground speed at this point was 48 km/h. The highest recorded ground speed at this point was recorded at 05:51:17 a.m. UTC, 180 metres above the ground at 63 km/h. Ground speeds of more than 50 km/h were recorded from the altitude of 661 m AMSL (374 AGL) all the way to the first contact with the ground at 05:52:05 a.m. UTC.

Picture 44: 3D view of the last part of the flight of balloon S5-OLO (moving from right to the left). The figure clearly shows how the balloon hit the ground, how it dragged along the ground, how it flew over the road, and how it came to a stop.

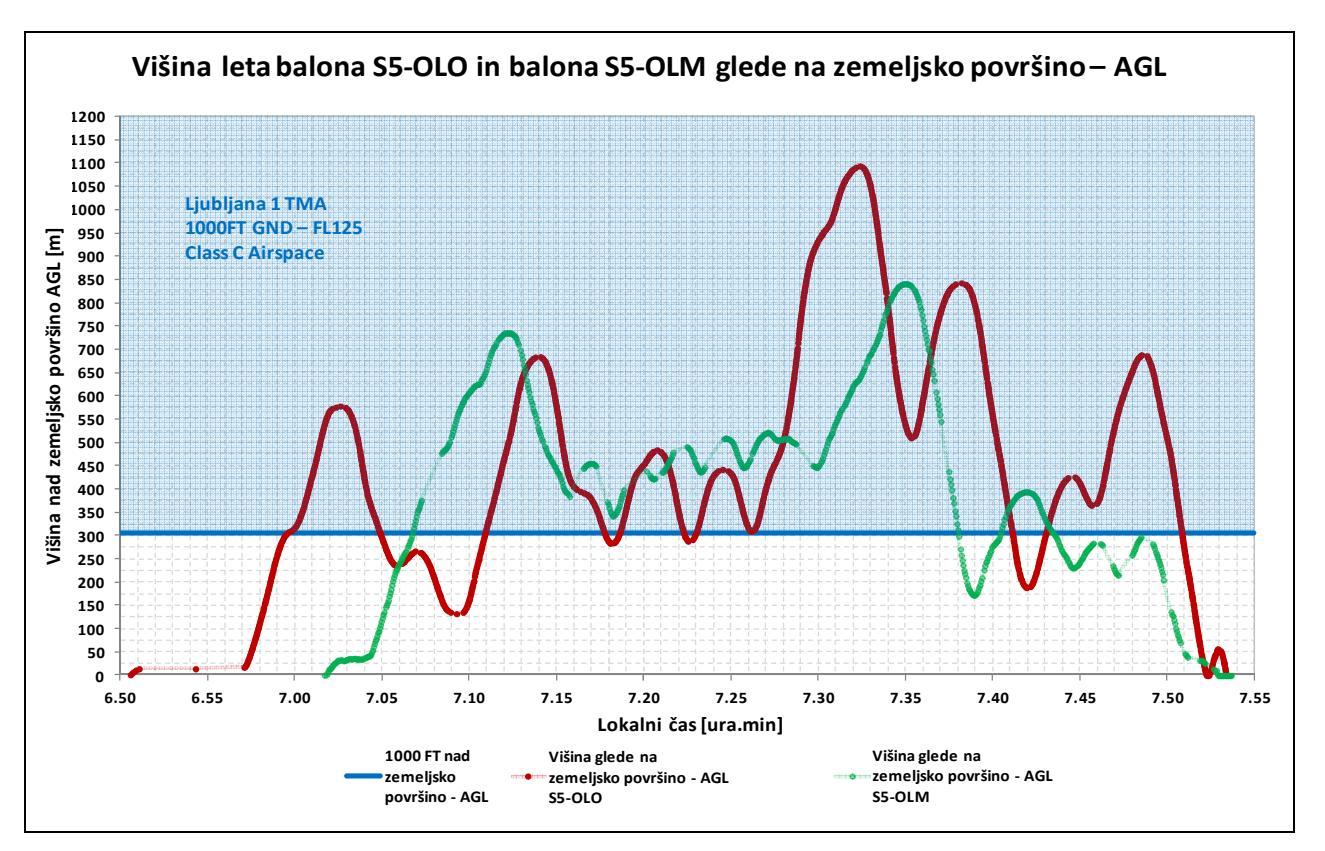
Picture 48: Altitudes of balloons S5-OLO and S5-OLM on 23 August 2012
