AIRCRAFT ACCIDENT AND INCIDENT INVESTIGATION SERVICE

Number: 37200-3/2012/132-00121171 Date: 23 October 2014

FINAL REPORT

ON THE INVESTIGATION OF THE AIRCRAFT ACCIDENT INVOLVING HOT AIR BALLOON LINDSTRAND LBL 600C REGISTRATION MARK S5-OLO, WHICH OCCURED ON 23 AUGUST 2012 OVER THE LJUBLJANA MARSHES

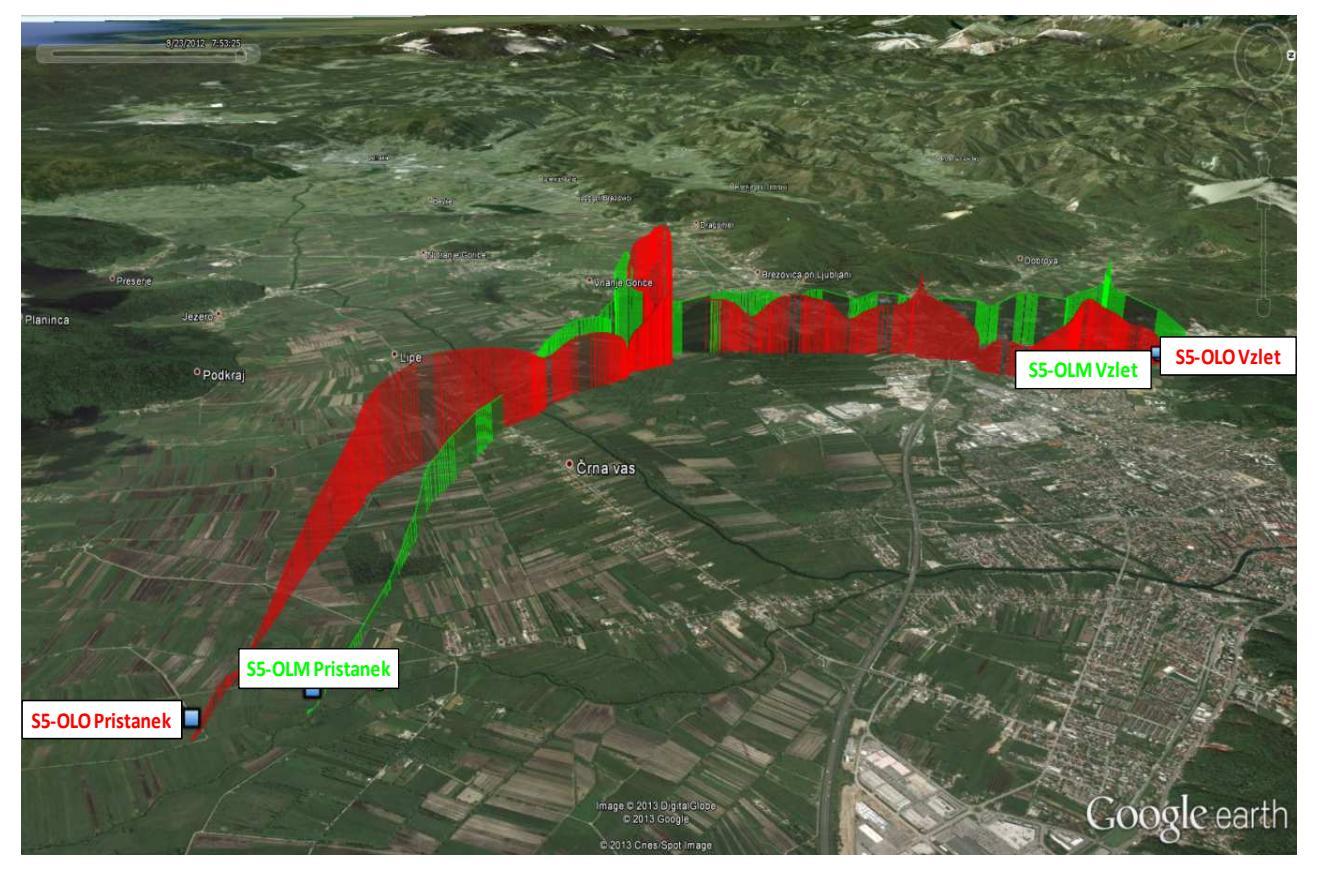
Picture 49: Display of the flights of balloon S5-OLO and S5-OLM on 23 August 2012

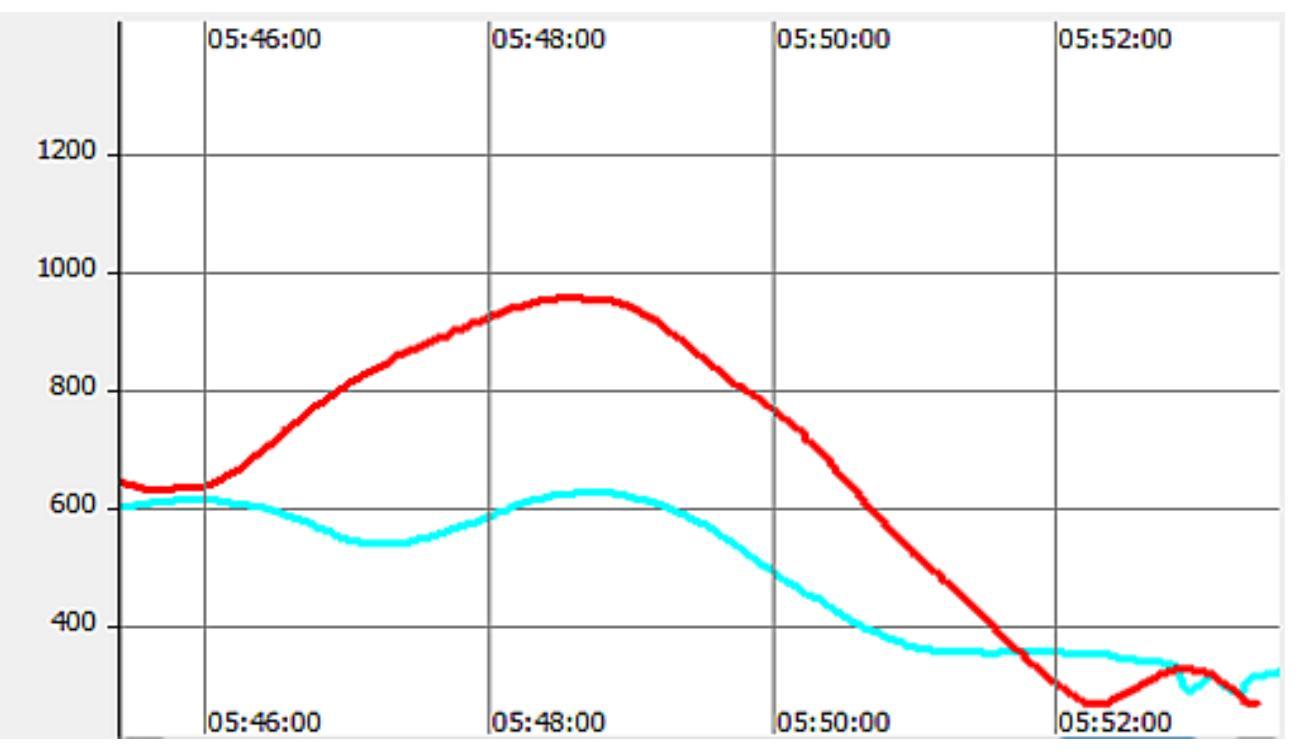
S5-OLO	S5-OLM
Maximum descent speed	-5 m/s	-3,2 m/s
Minimum descent speed	-2,8 m/s	0,0 m/s (altitude hold)
Average (wind) speed	55,2 km/h	38,2 km/h
Time from reaching 200 m AGL until	55 sec	2 min 55 sec
landing

Picture 50: Barogram of the final part of the flight of balloon S5-OLO (red) and S5-OLM (blue)

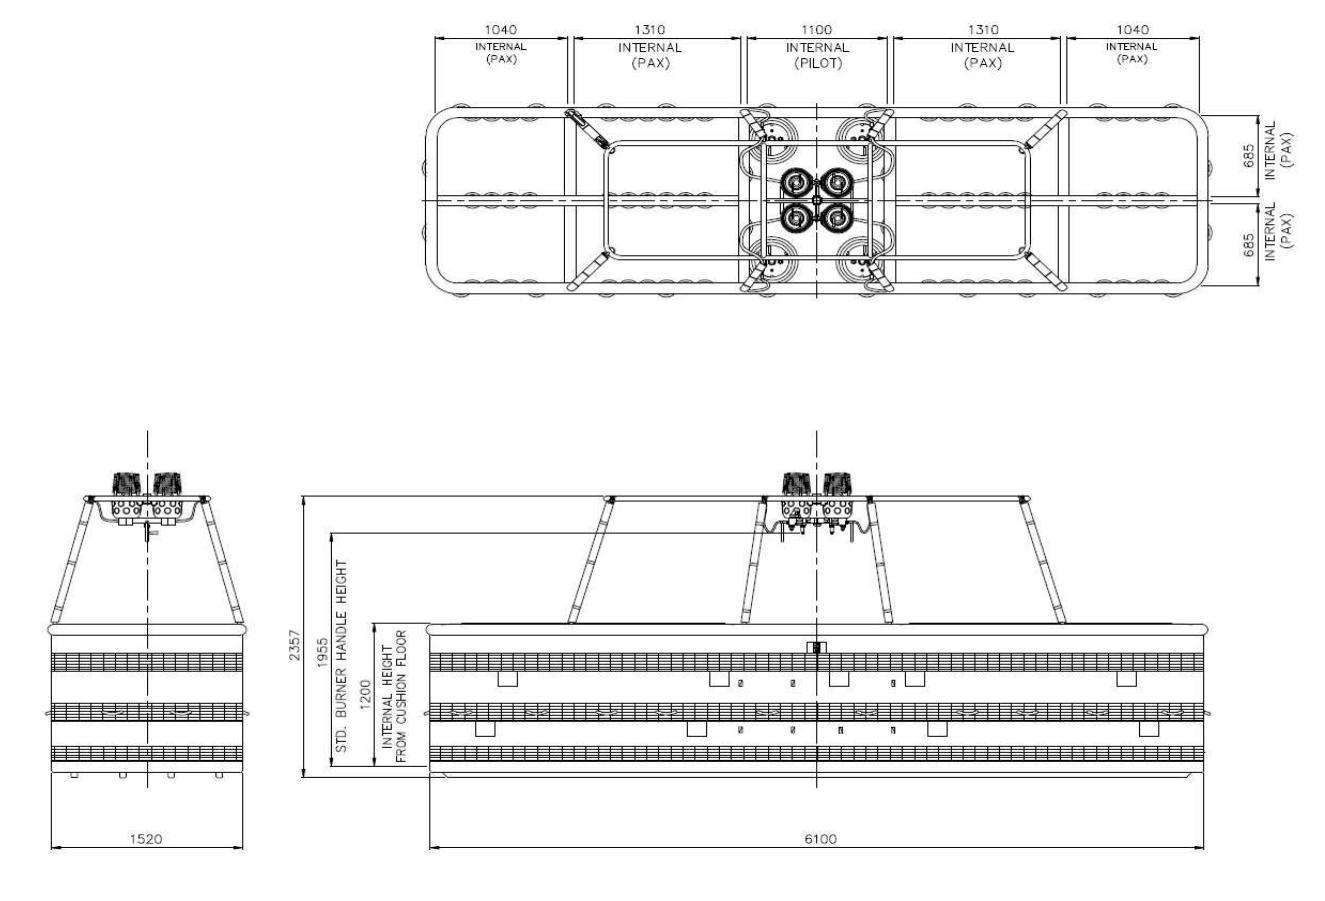
It was determined when analyzing the cause of the fire that when the balloon's basket hit the canopy the pipes in the gas rigging in the basket were damaged and as a result there was a gas leak from 7 tanks, which had their valves open, all the way until the balloon came to a complete halt. The immediate cause of the fire were pipes damaged in the impact with the canopy, the indirect cause was the open shut-off valves on the tanks, which were not closed by the pilot before the impact.

Picture 56: The basket of Lindstrand tip BA 050-A-001 with gas rigging, tanks, and burner

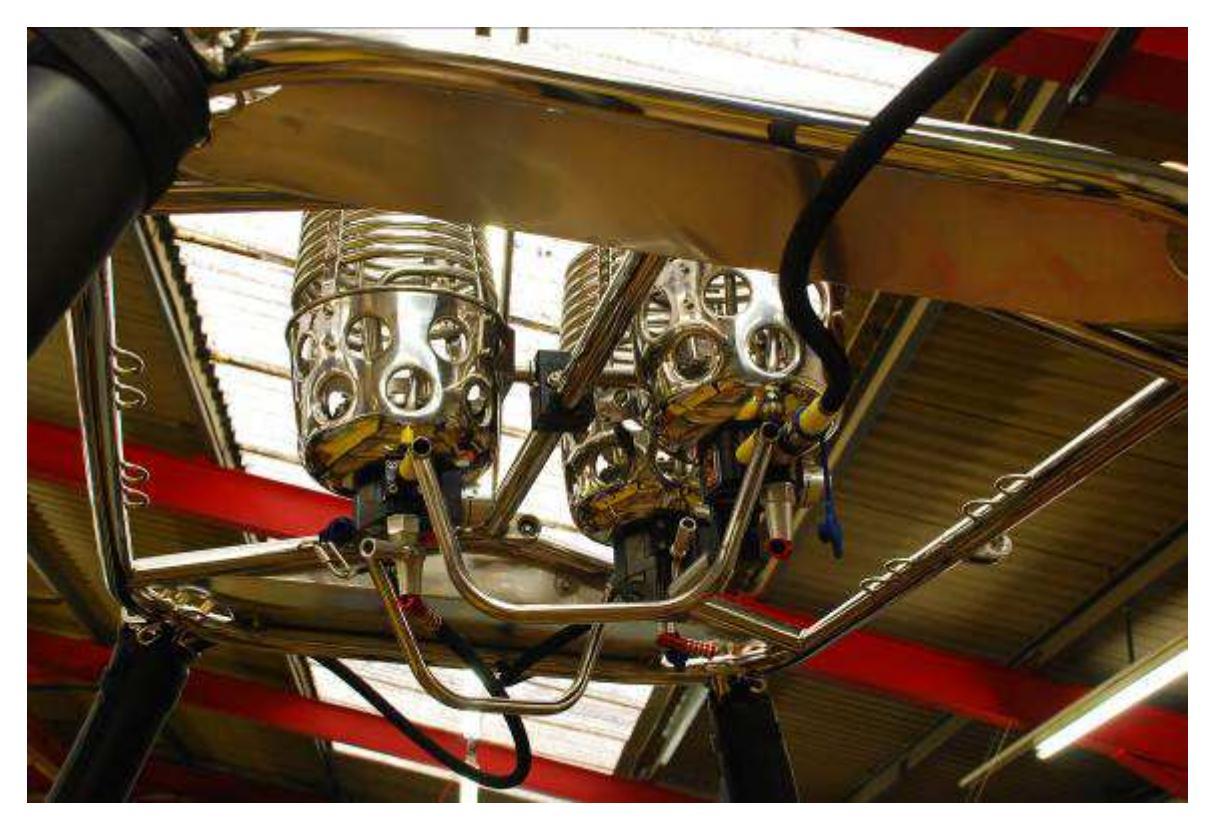
Picture 57: View of the gas rigging up to the burner in the basket – Source: Manufacturer
