FINAL REPORT

ON THE INVESTIGATION OF THE AIRCRAFT ACCIDENT

INVOLVING THE AIRCRAFT PIPER PA-34-200T, SENECA II,

REGISTRATION S5-DGL, ON 26 OCTOBER 2012

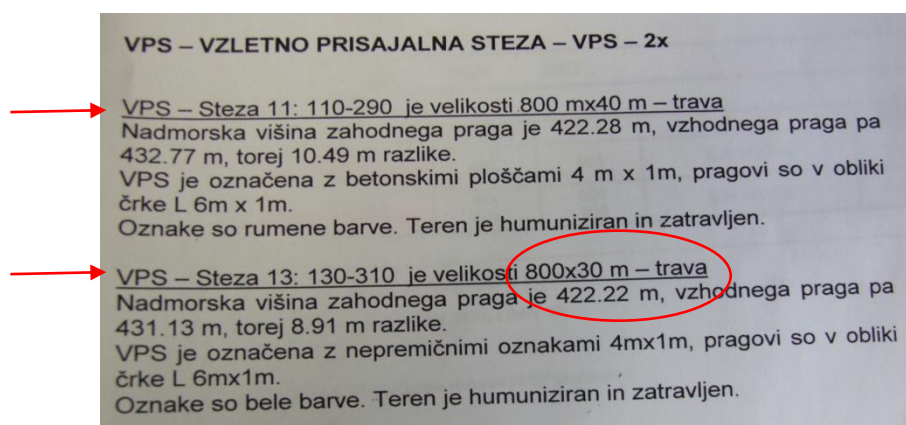
Figure 8 Formally valid data from the Divača Airport Aviation Guide rev. No. 2

According to the operating licence issued by the CAA on 21 February 2012, the operator was not allowed to operate runway 13-31. Pursuant to the decision issued, the airport operator was obliged to obtain an operating permit and provide for the proper marking of the closed runway 13-31.

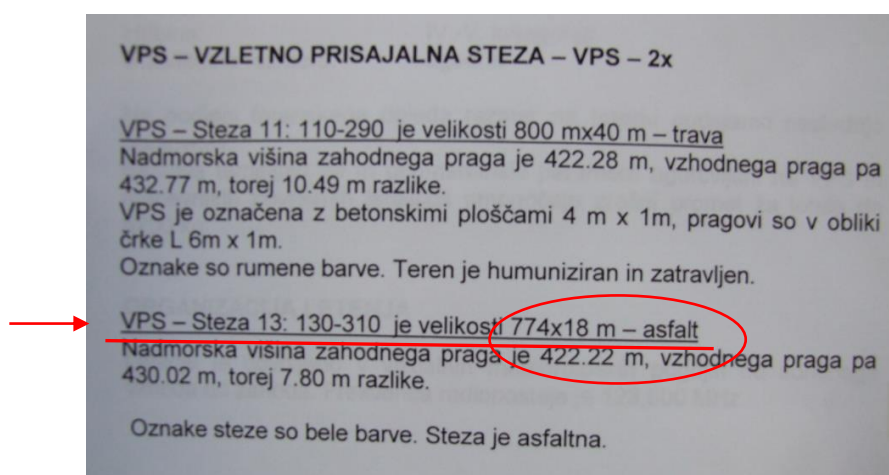
Figure 9 Data from the Divača Airport Aviation Guide rev. No. 4

Figure No. 9 (data from the Airport Guide revision no. 4) shows that the asphalt surface of the runway 13 measures 774m x 18m. Data on the basis of measurements that were carried out after the event are also the actual data on the day of the accident, which were implemented after the event in revision no. 4 of the Airport Guide of 7 November 2012.

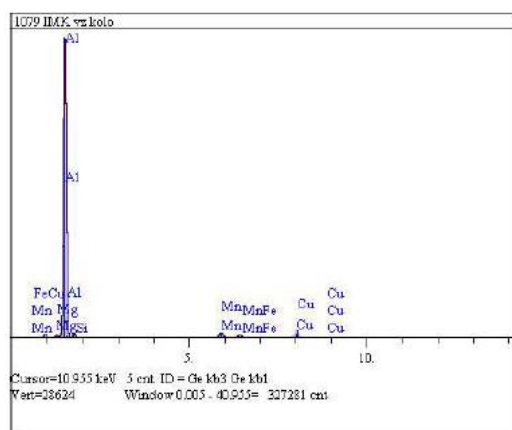
Slika 5. AES analiza in spekter kateri je viden na sliki 4

From the investigations carried out with an AES analysis on the two samples (Support Fitting and Fixation Retainer Tube), it can be concluded that both test samples are made of aluminium alloy. Based on the appearance and the type of damage it can be concluded that the fracture occurred due to a sudden overload of the support fitting. Our conclusion is based on the fact that on the fracture surface itself no so-called rest lines were observed from which it could be concluded that this is the case of a stress fracture (Figure 9). The main cause for the fracture is the previously mentioned sudden overload of the support fitting.

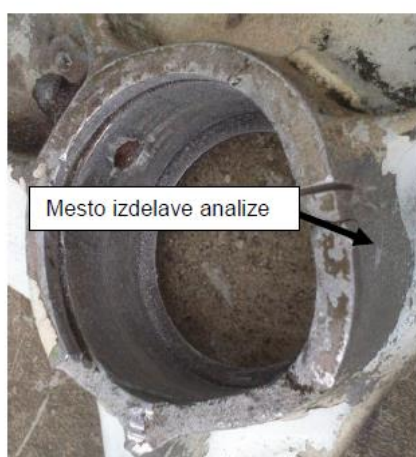
Slika 6. Mesto izdelave AES analize

Na sliki 6 in 7 je prikazano mesto izdelave AES analize, na sliki 8 pa pripadajoči spekter in analiza.
