**FINAL REPORT**

**ON THE INVESTIGATION OF AN AIR ACCIDENT**

**INVOLVING THE ROBIN DR 400/180 AIRCRAFT WITH**

**REGISTRATION NUMBER S5-DKL 14 SEPTEMBER 2014 AT**

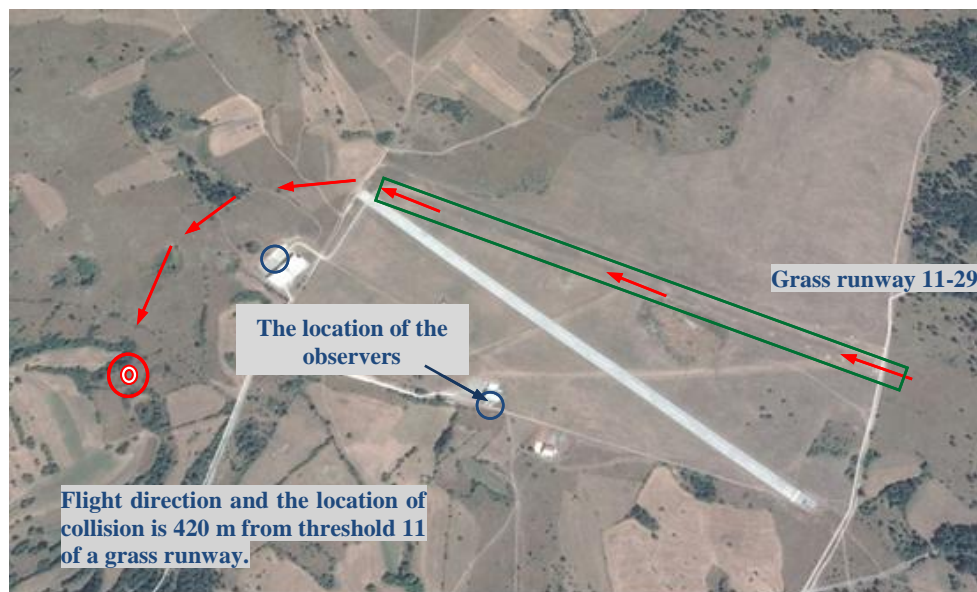
Figure 1 1: Divača Airport – take-off route and the site of the collision

After receiving confirmation from the head of flying, the aircraft took off at 12:54 p.m. in direction 29 from the runway. After take-off, the aircraft turned west and then, in a left roll, collided with the terrain that was 420 m away from threshold 11 of a grass runway. Upon collision with the terrain, the aircraft caught fire. Upon the crash, the pilot and two passengers died at the scene of the accident and one passenger sustained serious bodily injuries.

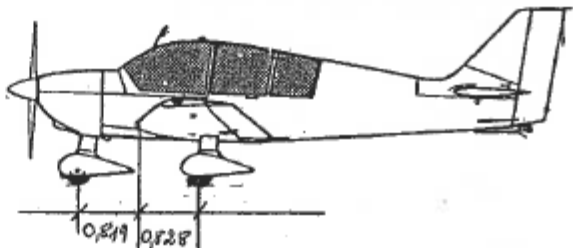
It is evident from the aircraft's type certificate and the manufacturer's operational manual that the maximum take-off weight (MTOW) is 1100 kg, which should not exceed this value in conditions without any loads. It is evident from the report of the confirmed maintenance organisation on the weighting of the aircraft (the last measurement was performed on 12 March 2014) that the mass of the empty aircraft was 659 kg. The sum of the quantity of fuel, the mass of the crew, and the mass of the empty aircraft should not exceed the MTOW – 1100 kg. The Commission finds that the MTOW value was on the limit of the permitted MTOW or on the limit of the aircraft's capability in the category "normal," prescribed by the aircraft manufacturer in the operational manual.

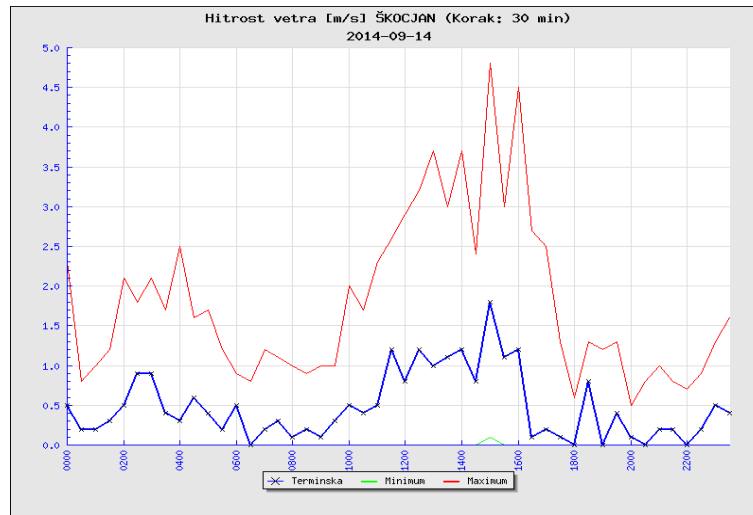
During the day, there was weak wind with changeable direction and speeds of up to 2 KTS and gusts of up to 5 KTS, and in the late afternoon there was wind with gusts of up to 9 KTS. At higher altitudes, there was a north-eastern wind with speeds of up to 10 KTS.

Figure 1 12: Wind speed at the Škocjan automatic weather station. The speed is in m/s, time is UTC+1

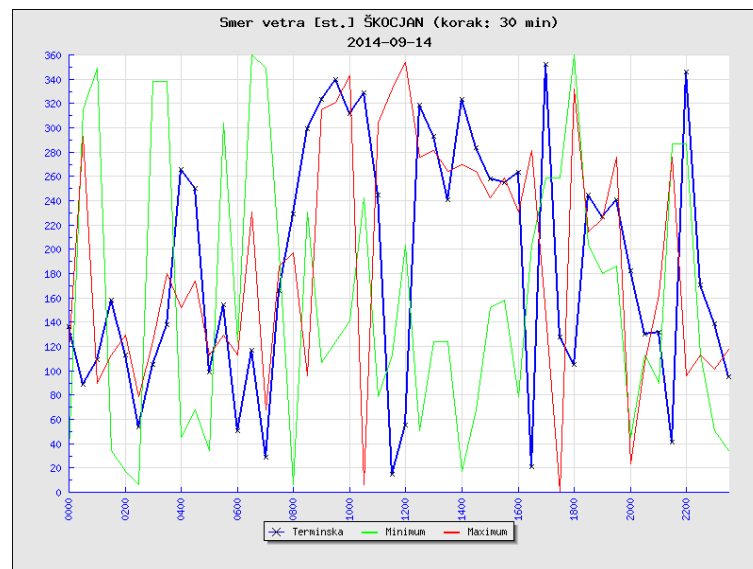
The wind direction was changeable, the prevailing wind directions on the ground could not be determined.

Figure 1 13: Wind direction at the Škocjan automatic station. The time is UTC+1

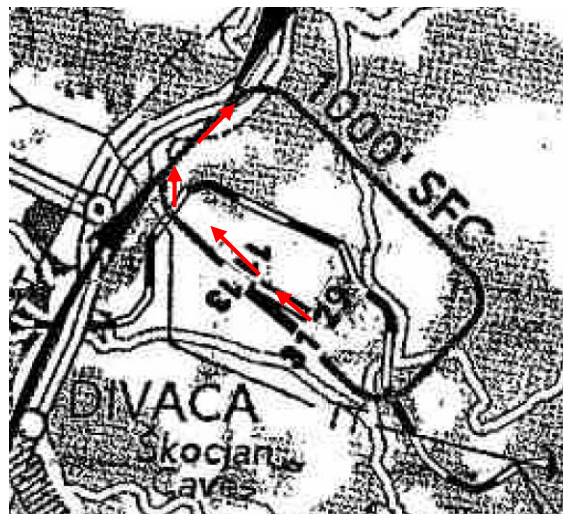
Figure 1 16: A sketch of the traffic patterns determined by the Airport Manual

In Appendix no. 1 of the Divača Airport Manual (reviewed version no. 5 of 15 August 2013, confirmed by the CAA), the operator determined the instructions for approach and departure procedures. Among other things, the instructions stated that “*the zone and the traffic pattern are north of the airport above the railway.*” This means that the traffic pattern for take-off and landing is “right-hand” in the direction north or “left-hand” in the direction south.
