MINISTRY OF INFRASTRUCTURE

SAFETY INVESTIGATION AGENCY

FINAL REPORT
ON
ACCIDENT INVESTIGATION OF
PIPER PA28R-201
OE-DYM
near Mengeš,
3rd December 2015

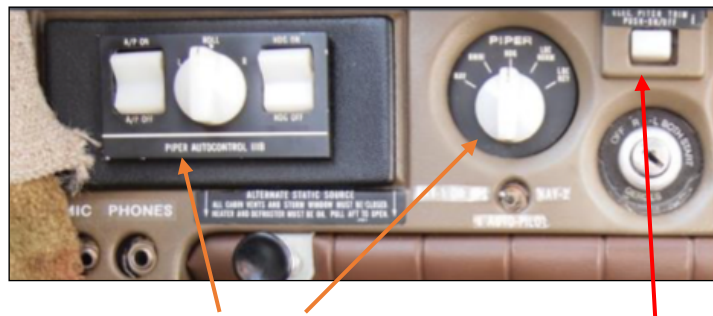
Image 8 – Position of autopilot control switches and main Electric pitch trim switch

This brings up the question whether the electric pitch trim was also engaged (which is not part of the autopilot). Electric pitch trim is controlled by the means of a two-position switch on the yoke, main electric pitch trim which is located on the instrument panel under the yoke, near autopilot control switches and an Electric pitch trim circuit breaker. Operation of Electric pitch trim is described in the AFM Supplement.

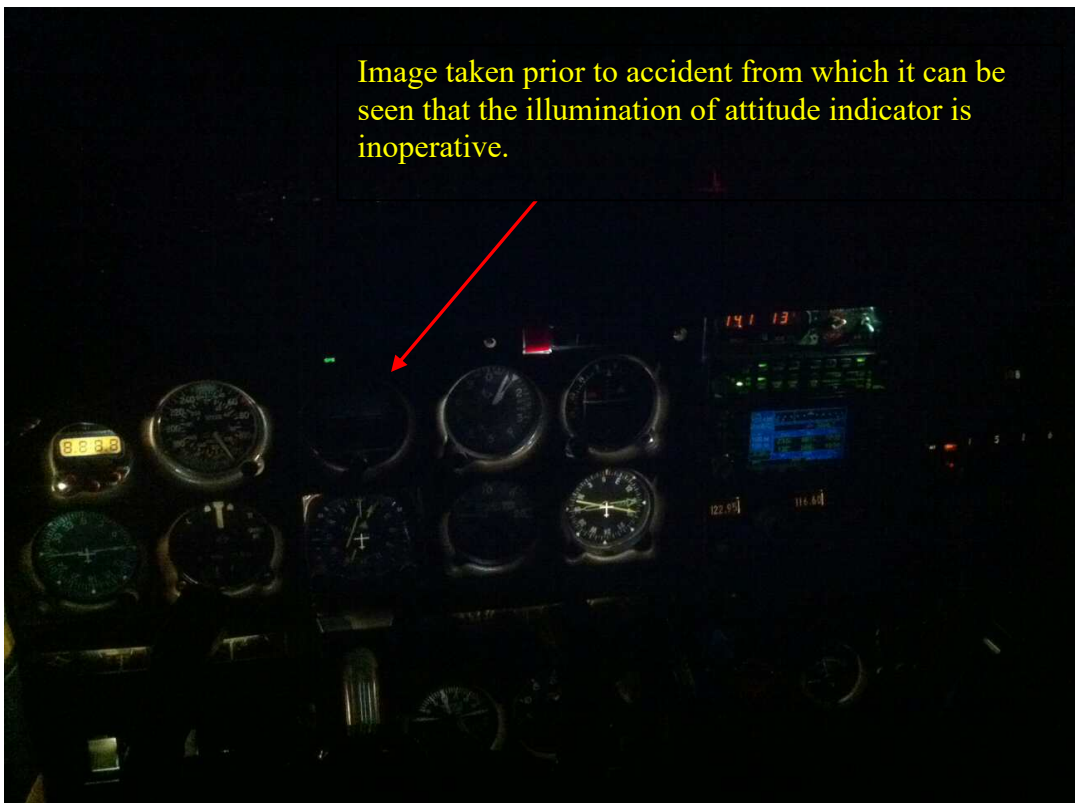
- Insufficient pilot experience in instrument flight in IMC conditions has contributed to the accident;
- An improperly illuminated instrument panel, especially attitude indicator illumination affected the control of the position of the aircraft in the approach path and thus contributed to the accident;
- The long interruption in exercising qualifications for instrument flight and flight on aircraft type has contributed to the accident;
- In the final phase of the ILS approach, the pilot decided for a missed approach procedure, but combination of turn and climb was followed by illusion which induced a pilot error that resulted in a spiral dive.

Image taken prior to accident from which it can be seen that the illumination of attitude indicator is inoperative.
