SLOVENIA SAFETY INVESTIGATION AUTHORITY

FINAL REPORT ON ACCIDENT INVESTIGATION OF AIRPLANE PIPER PA32-301T N710CC at Predmeja – near Ajdovščina, 14th July 2016

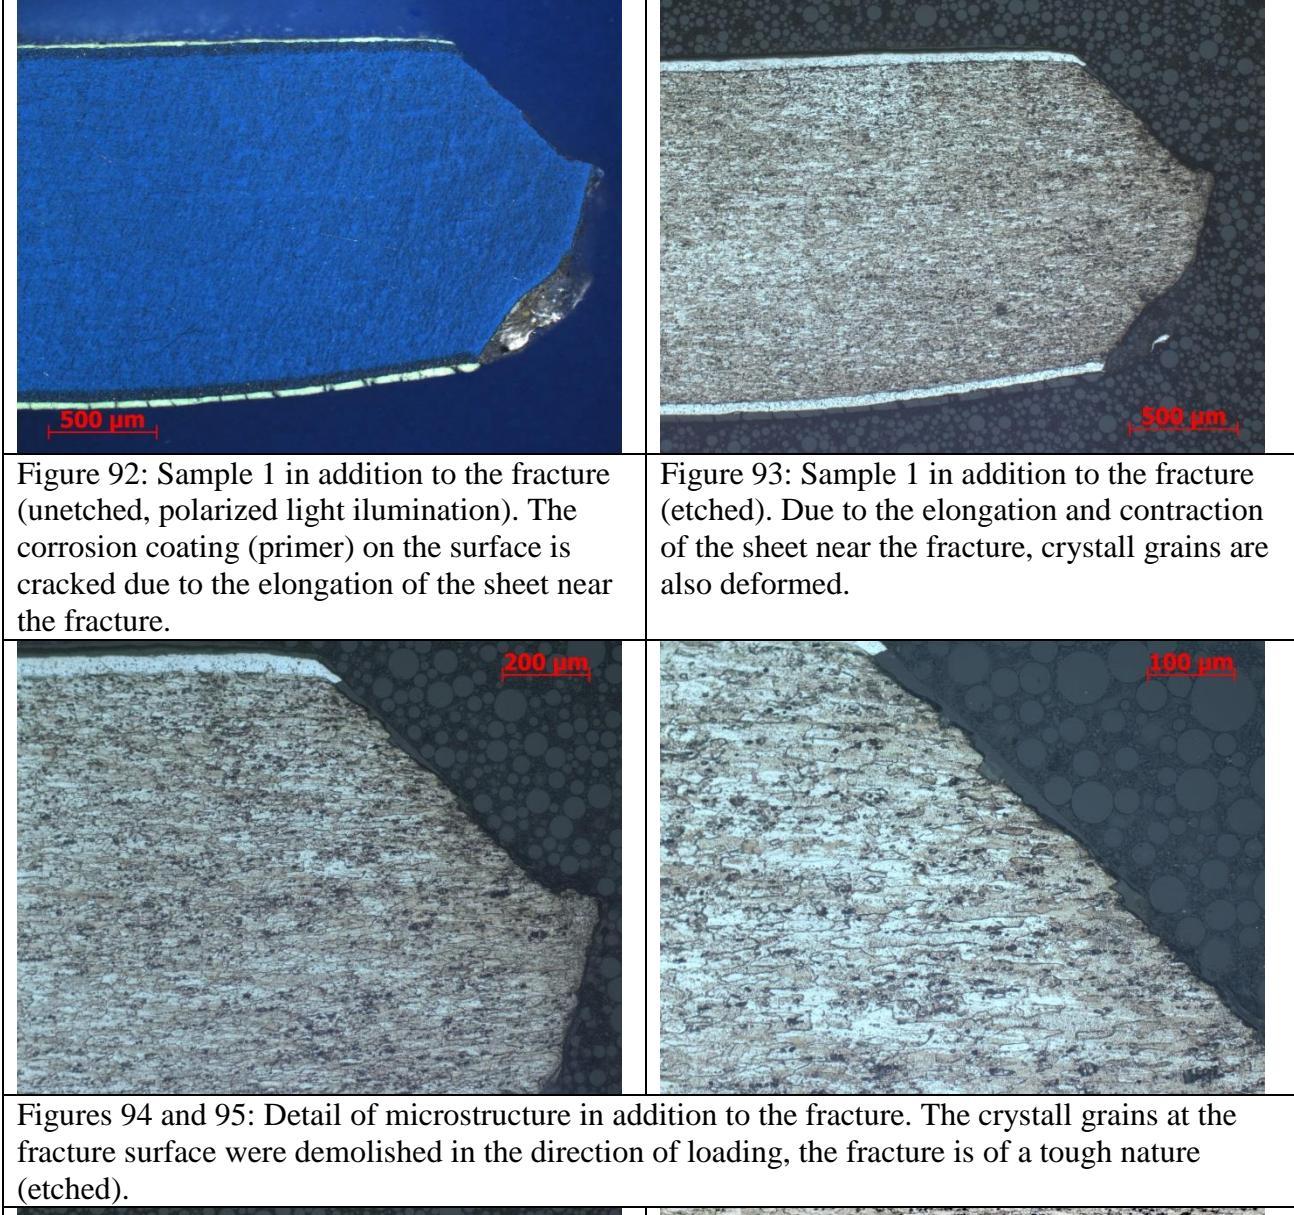
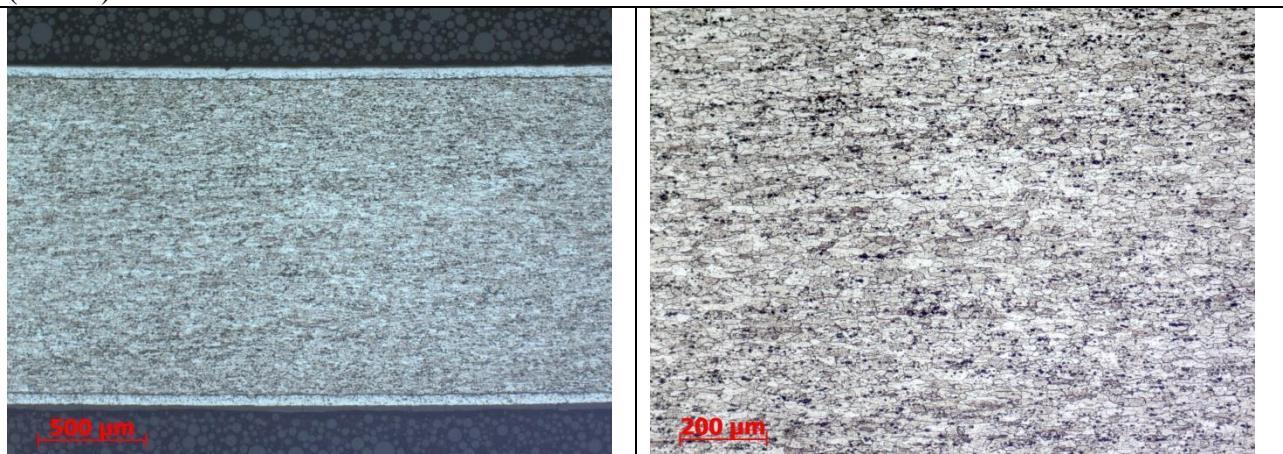
Figures 96 and 97: Sample 1 - the longitudinal cross-section of the profile plate in approximately 20 mm from the fracture. A thin layer of alloy (probably alloys AW-1230 or pure Al high purity, i.e., "Alclad") is deposited on the surface of the sheet - etched.

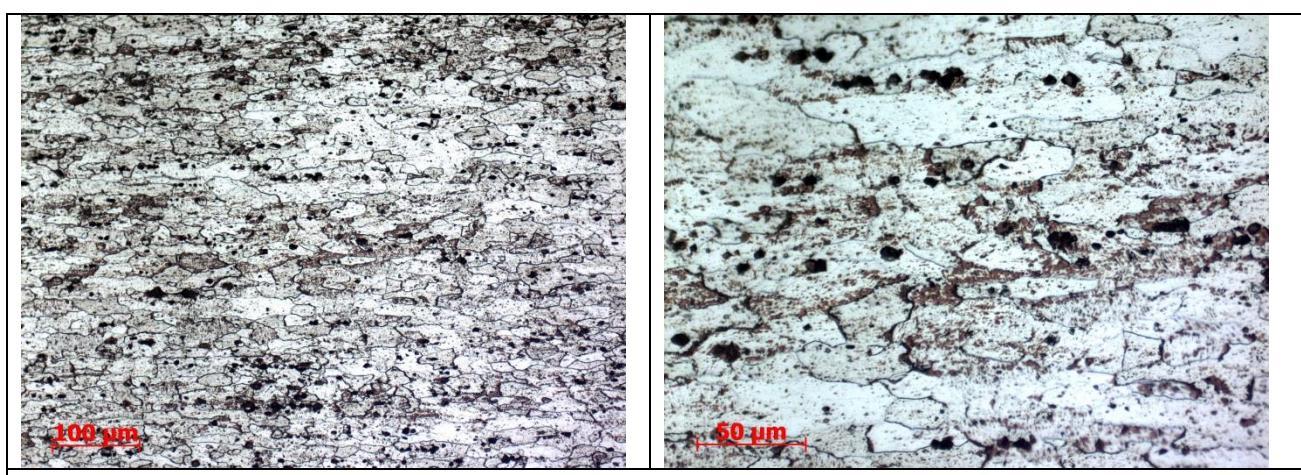
Figures 98 and 99: Sample 1 - the longitudinal section of the sheet of the profile at a distance of about 20 mm from the fracture. Details of the microstructure of the sheet of alloy 2024: various precipitates of intermetallic compounds are dispersed over crystalline grains α : insoluble particles (Cu, Fe, Mn) Al₇, fine particles are CuMgAl₂, Cu₂Mn₃Al₂₀ and Cu₂FeAl₇. In particular, the presence of the CuMgAl₂ (S-phase) and CuAl₂ (θ ') phases indicated precipitation strengthening of the aluminum alloy (solution heat treatment of the aluminum alloy) - etched.

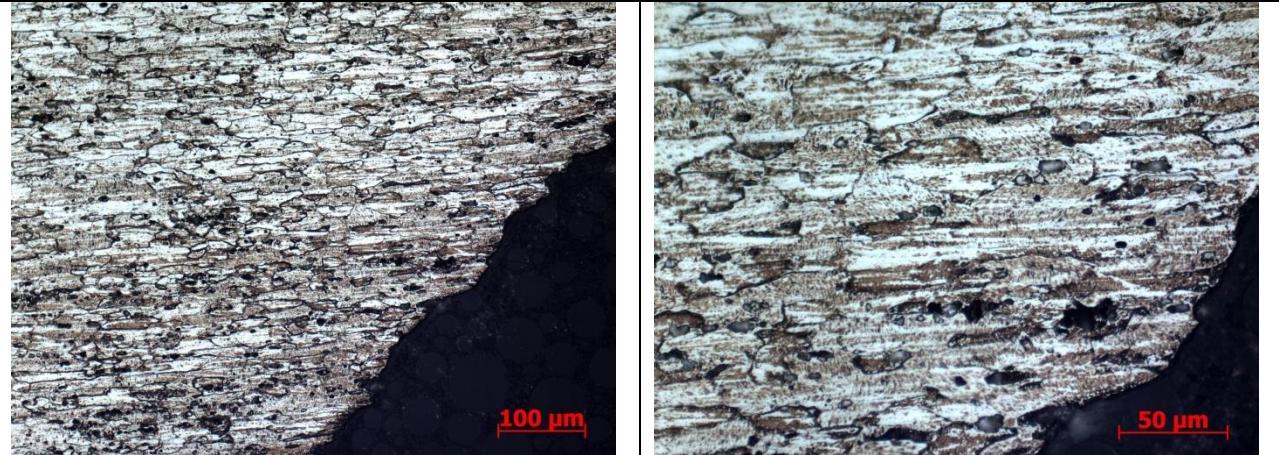
Figures 106 and 107: the longitudinal cross-section of the sheet of the longitudinal profile. Sample 2 in addition to the fracture - a detail of the microstructure (etched).

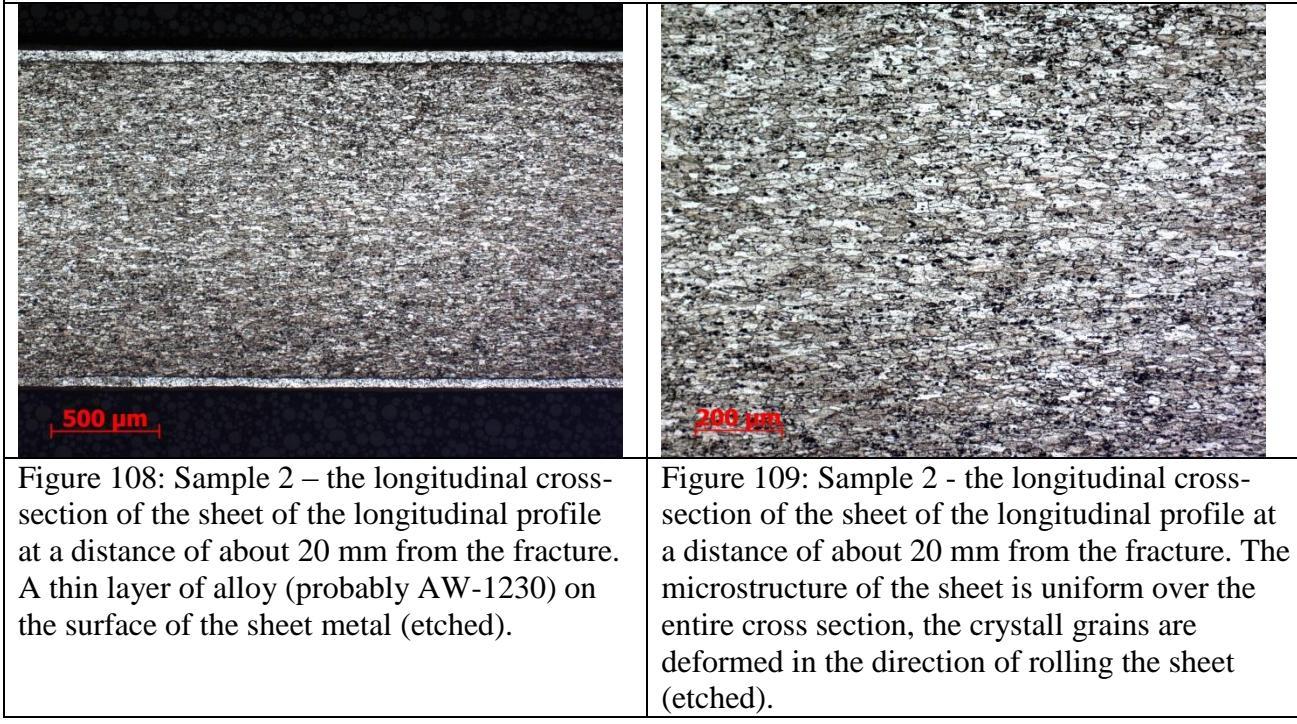
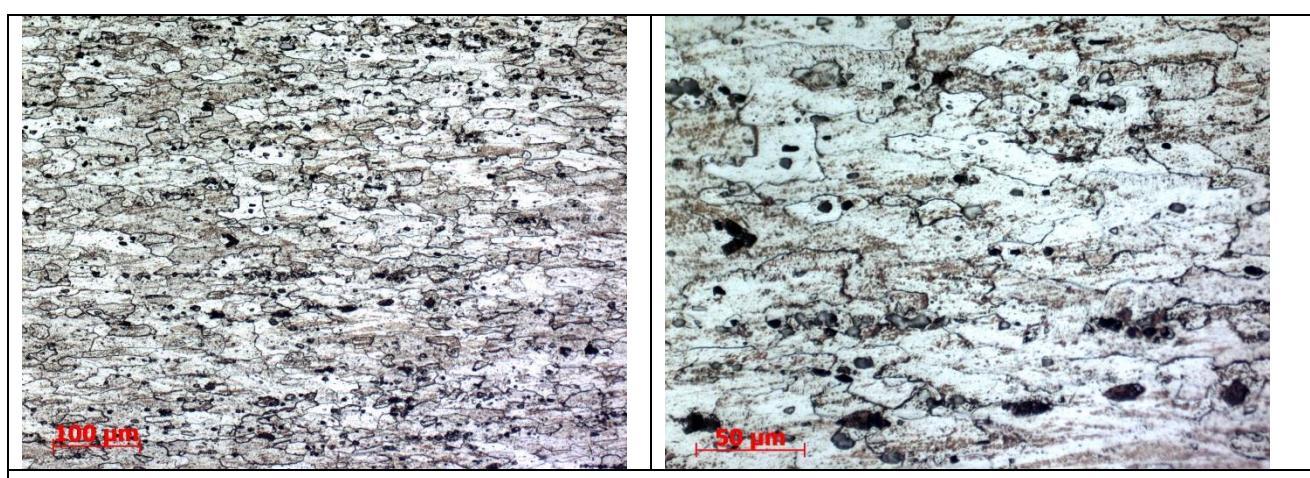
Figures 110 and 111: Microstructure details of aluminium alloy 2024 sheet: various precipitates of intermetallic compounds are dispersed over crystall grains α (etched).

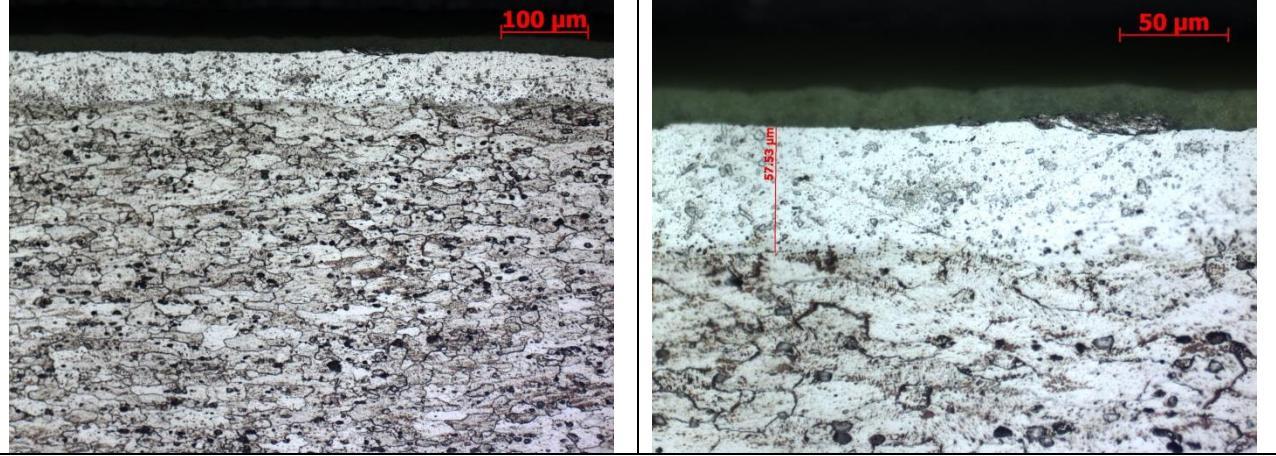
Figures 112 and 113: Sample 2 - the longitudinal cross-section of the sheet of the longitudinal profile at a distance of about 20 mm from the fracture - the detail of the cross-section at the surface. A thin layer of alloy (probably alloy AW-1230 or pure Al high purity, i.e., "Alclad"), a thickness of about 60 μ m, is deposited on the surface of the sheet metal. On the surface there is also a thin layer of basic anti-corrosion coating (etched).

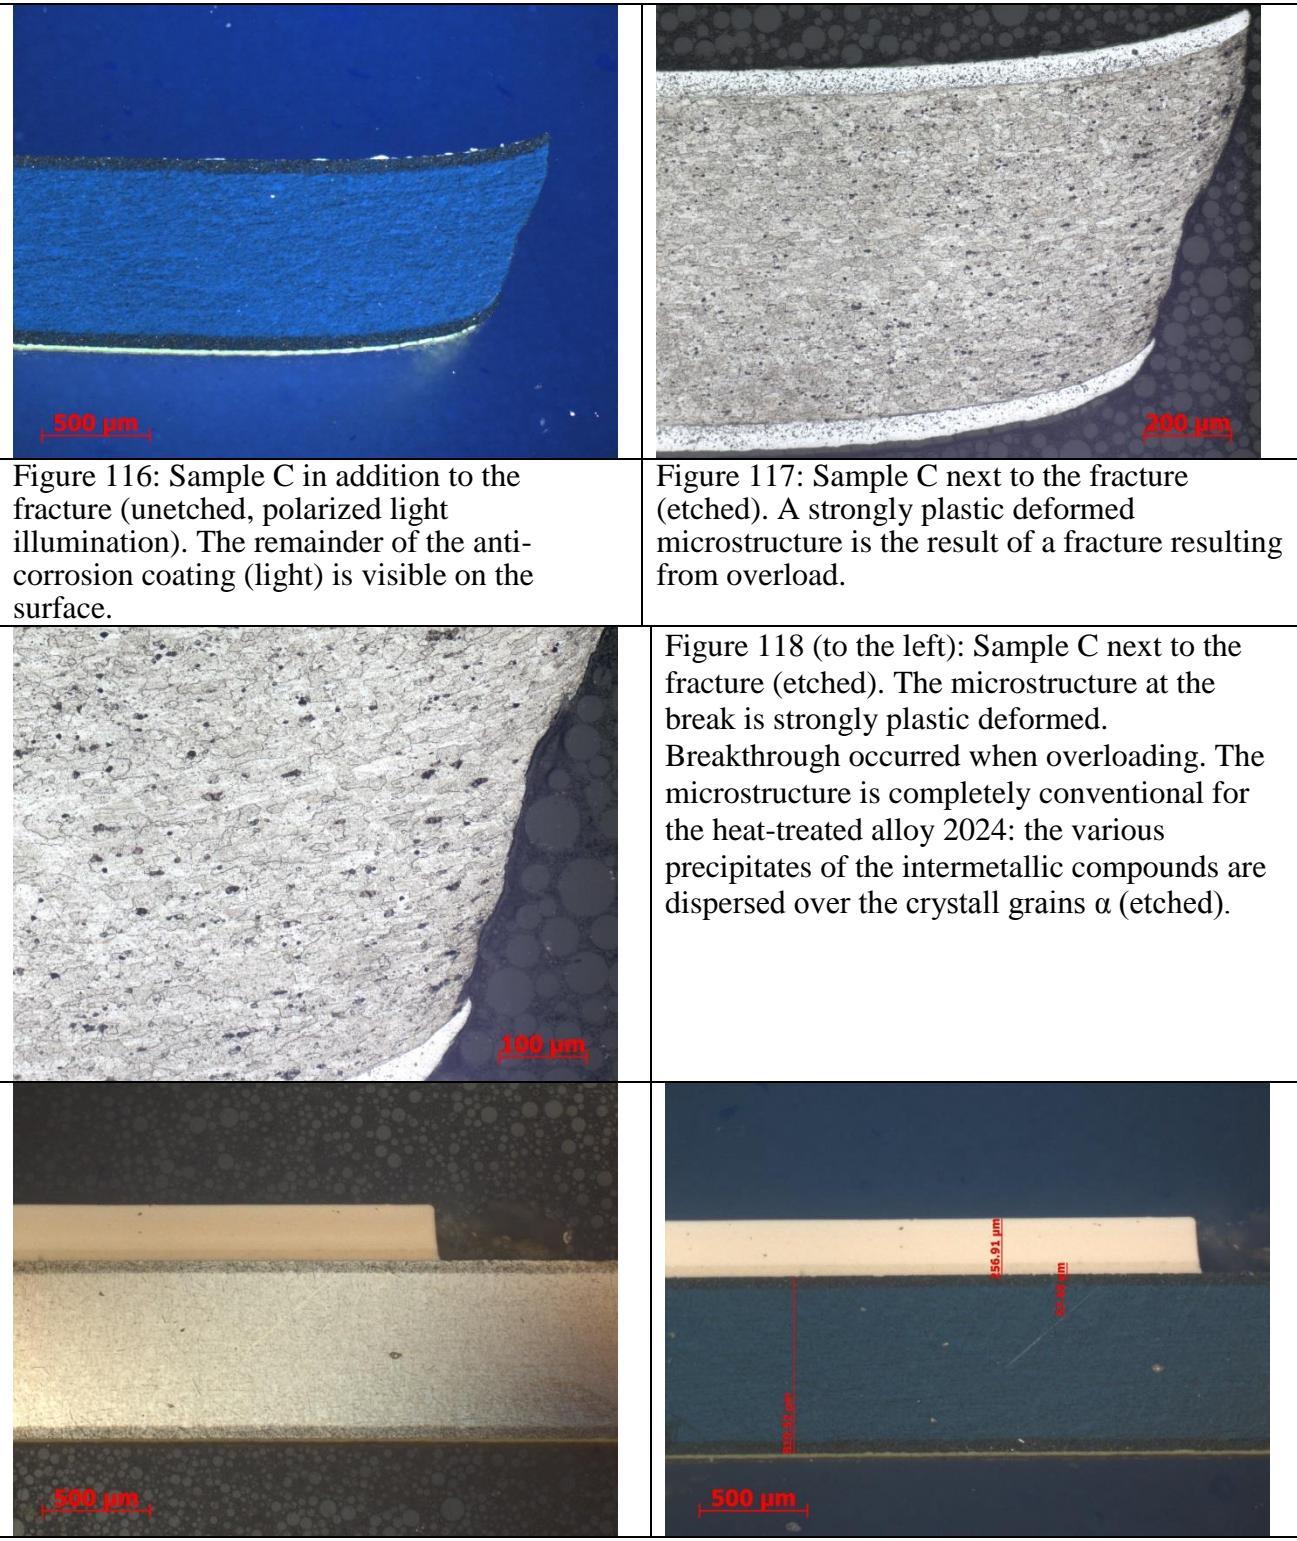
Figures 119 and 120: Sample C - sheet cross-section at a distance of about 20 mm from the fracture (unetched, white and polarized illumination). A thin layer of alloy is deposited on the surface of the sheet (probably AW-1230). On the outer side (in the figures above, two layers of anti-corrosion coating in a total thickness of about 260 μ m. The thickness of the front sheet is 0.82 mm.

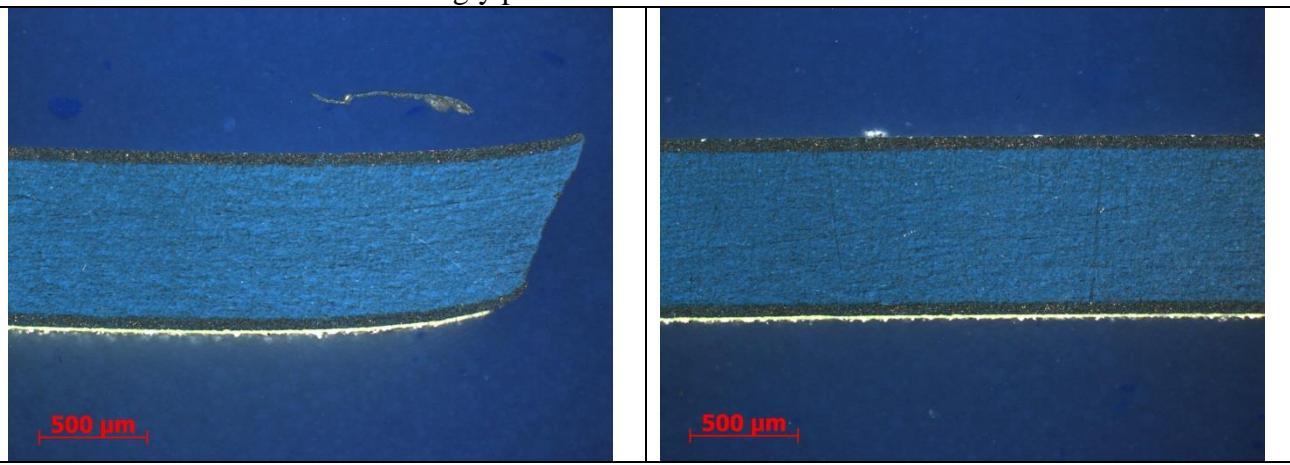
Figures 125 and 126: Sample D - cross-section of the sheet in addition to the fracture and at a distance of about 20 mm from the fracture (polarized light illumination). On the outer side, the anti-corrosion coating was delaminated, on the inside the basic anti-corrosion coating remained on the surface (light – on the bottom).

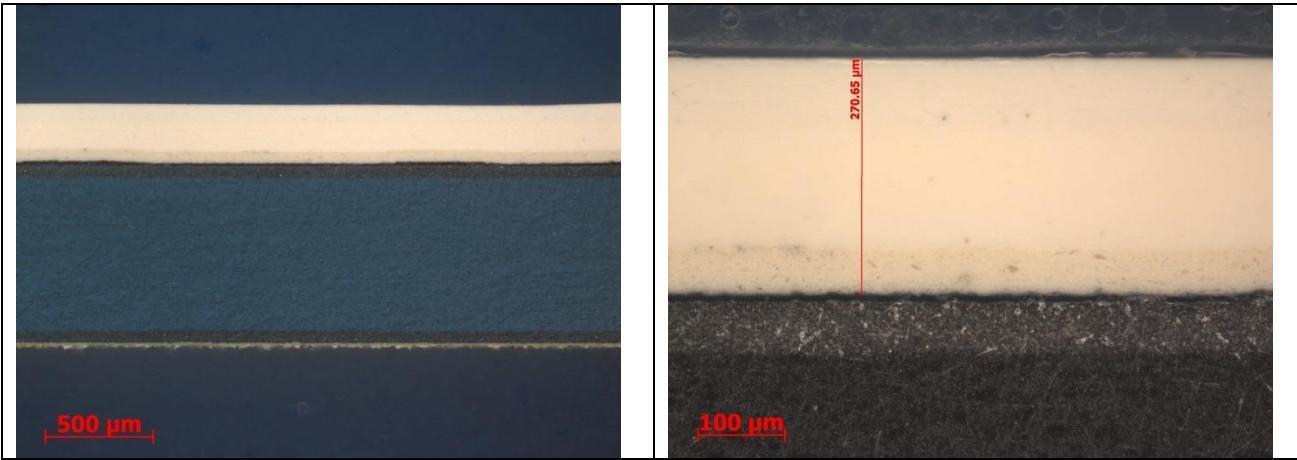
Figures 127 and 128: Sample D - approximately 20 mm from fracture (polarized light illumination). On the plate are layers of white anti-corrosion coating in the total thickness of 270 μ m remained on the outside.

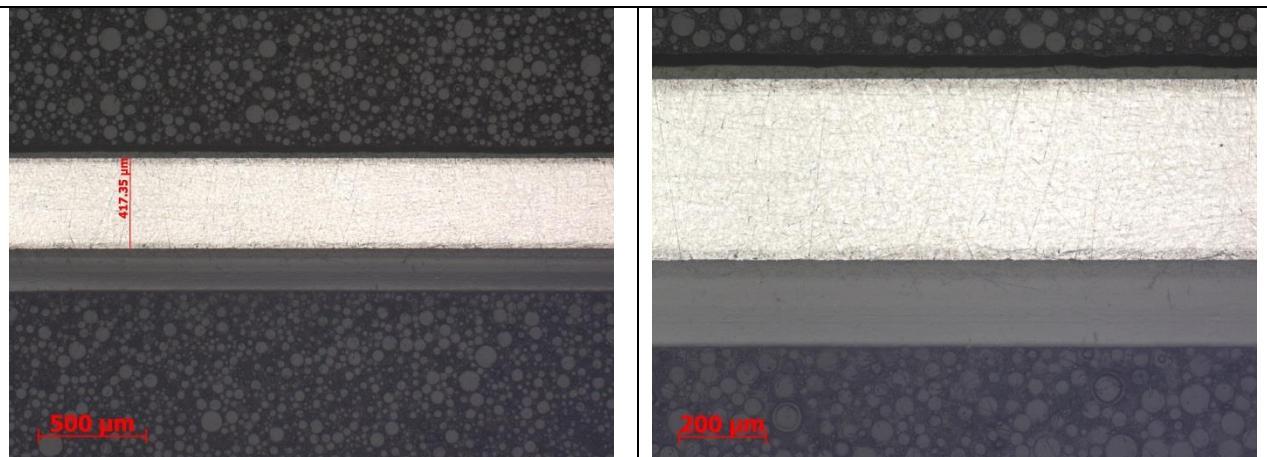
Figures 133 and 134: Sample B 1 - cross-section of the middle sheet at a distance of 20 mm from the fracture (unetched). The thickness on the undamaged part is between 412 and 417 μ m. On the underside there is an anti-corrosion coating of about 250 μ m thickness.

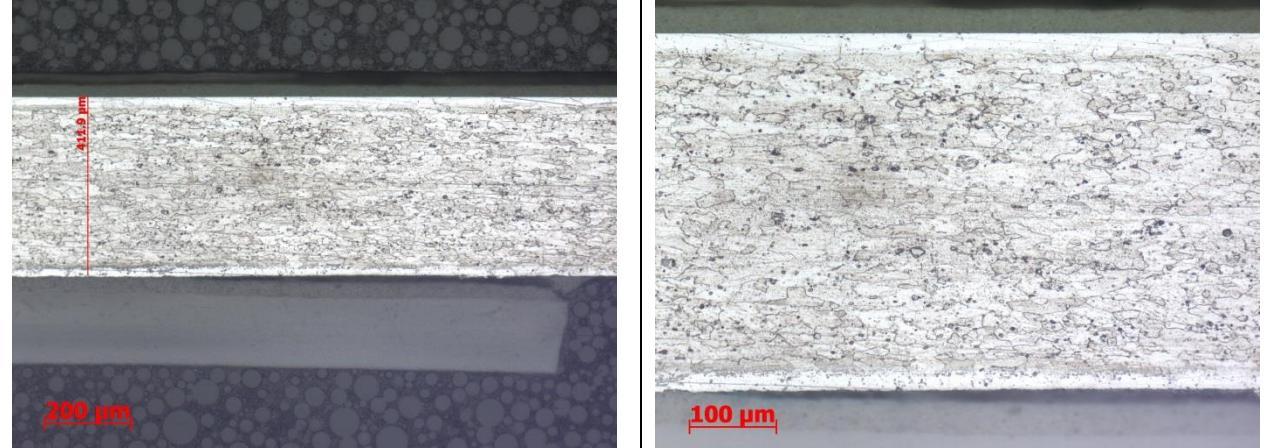
Figures 135 and 136: Sample B 1 - cross-section of the middle sheet at a distance of about 10 mm from the fracture. Microstructure of metal sheet 2024: various precipitates of intermetallic compounds are dispersed over crystall grains α , which are slightly extended in the direction of rolling sheet metal (etched).

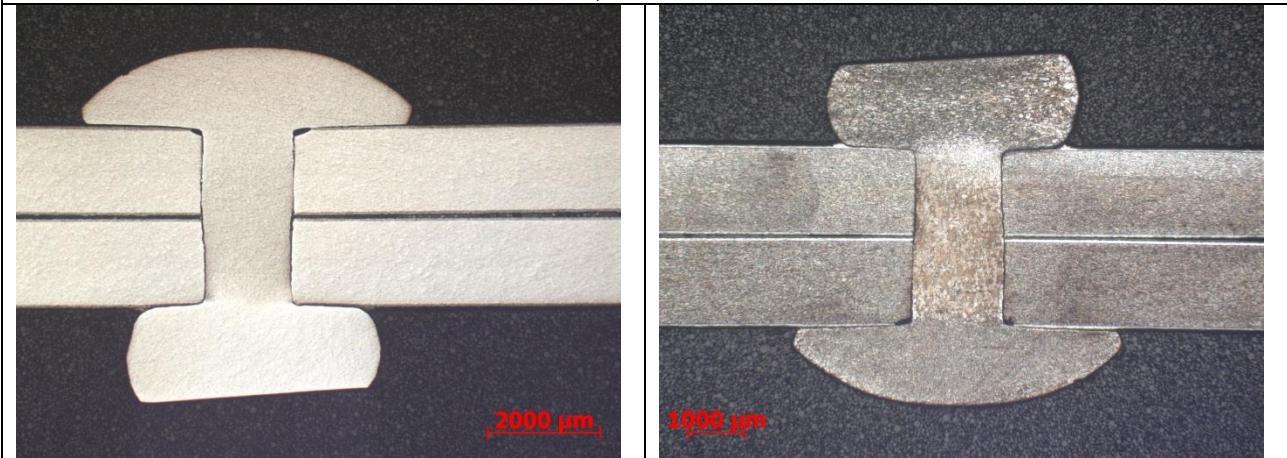
Figures 143 and 144: Riveting joint between the longitudinal profile and the reinforcing profile (unetched and etched). Both elements are made of the same sheet (1.57 mm thickness). There are no corrosion damages in the contacts (crevices) between the various elements.

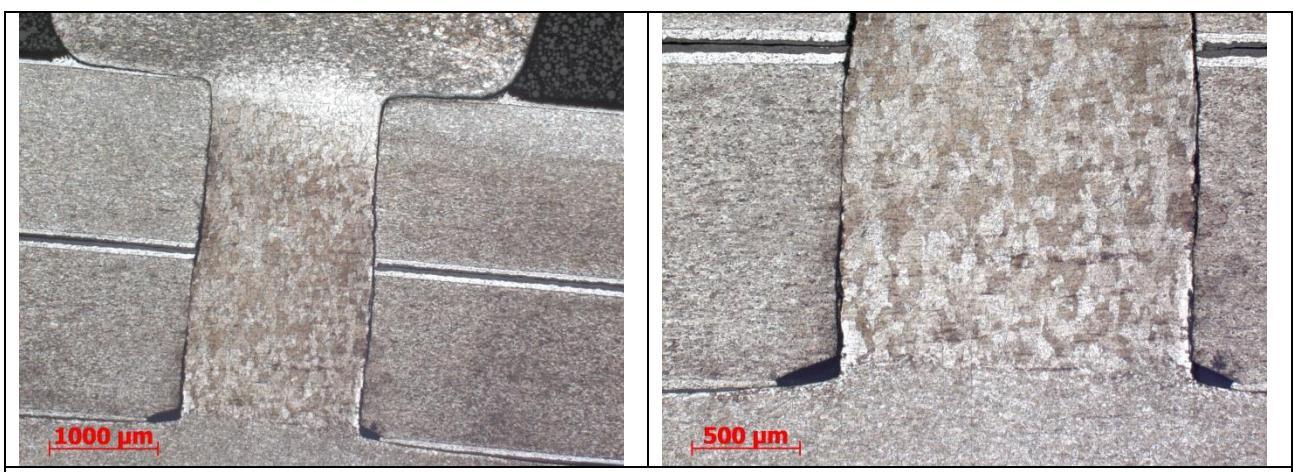
Figures 145 and 146: Riveting joint between the longitudinal profile and the reinforcing profile (etched) - detail. The rivet stem fits nicely in the hole. The rivet is forged with cold forging. On the rivet head in the deformed part, the microstructure is cold hardened, and the crystall grains are smaller.

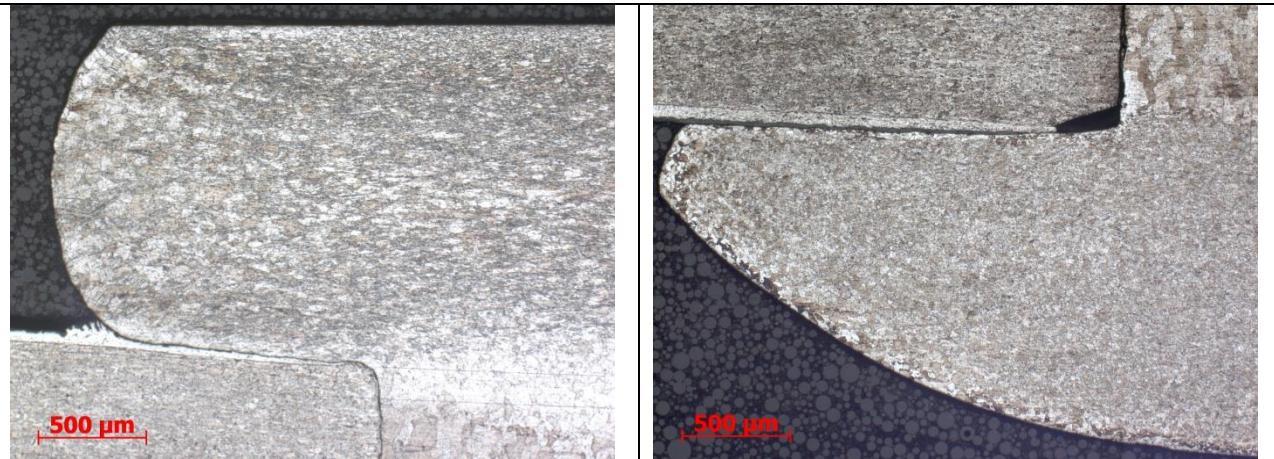
Figures 147 and 148: Riveting joint between the longitudinal profile and the reinforcing profile (etched) - details between the riveted part and the sheet metal, rivet head and sheet metal.

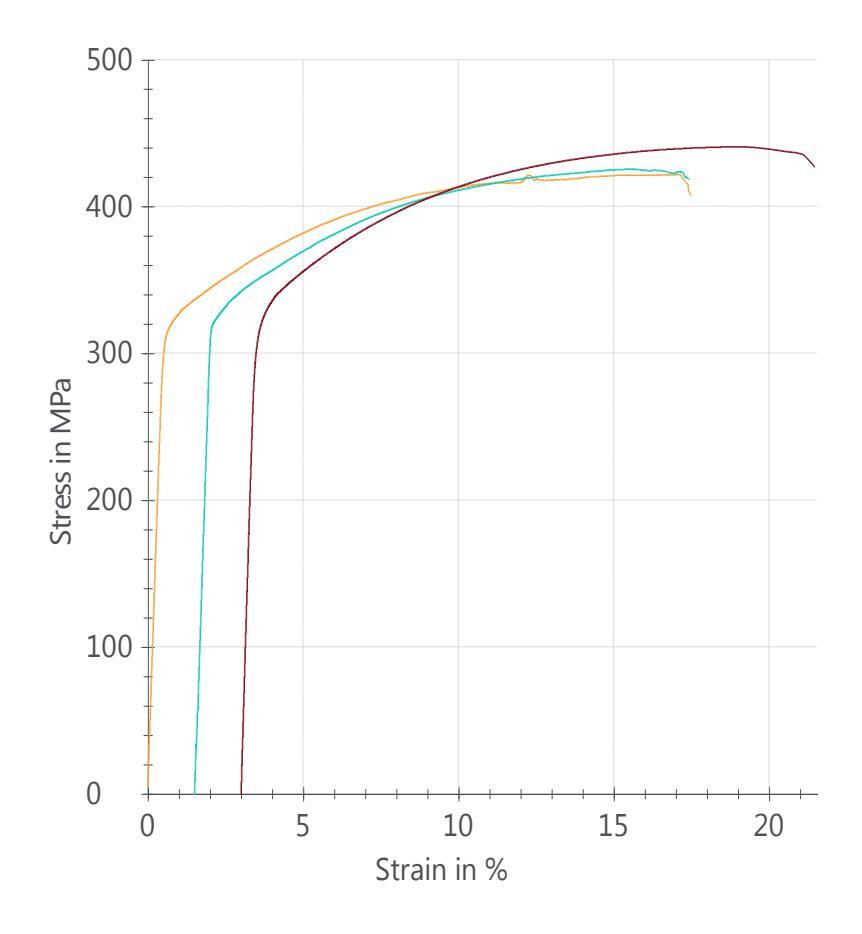
The mechanical properties of the 0.815 mm thick sheets (the front plate of the wing) correspond to the prescribed properties for the quality EN-AW-2024 T4, and the mechanical properties of the of the longitudinal profile (thickness 1.57 mm) also correspond to the properties with the T3 and T351 treatments. The ratio $Rp_{0.2} / R_m$ is appropriate, there is no increase in the yield strength ($Rp_{0.2}$) and a reduction in elongation (A_{50}), which could result from the classical dynamic fatigue of the material.

Figure 155: Serial graphs strees/elongation (from left to right samples: Z/1886-1/17, Z/1886-1/17).

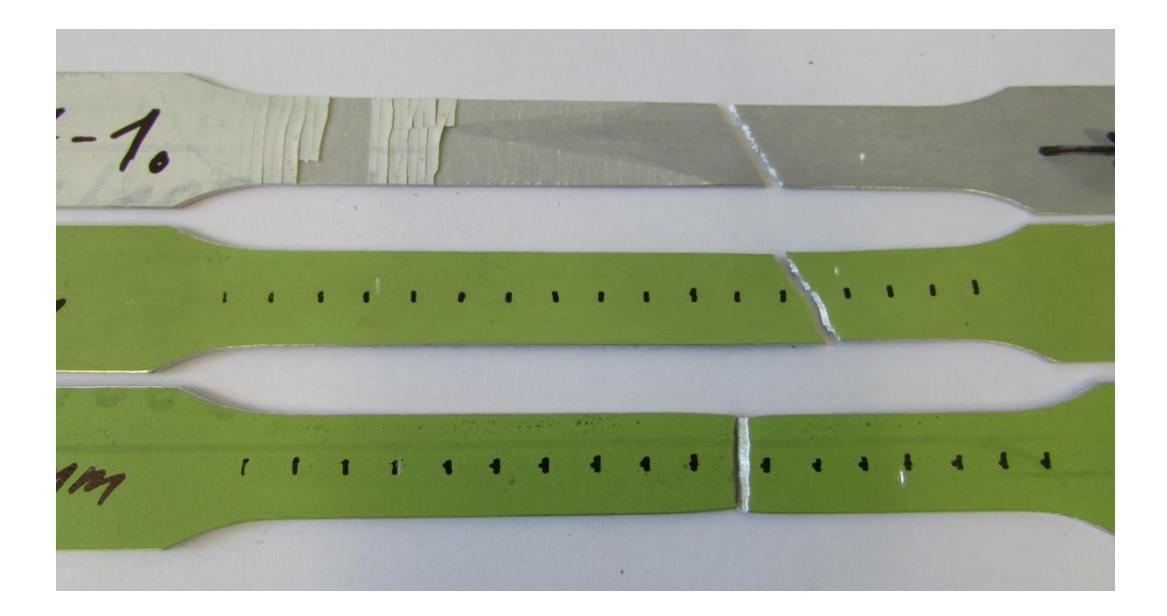
Figure 156: Tensile test pieces after tensile test. IMG-5667

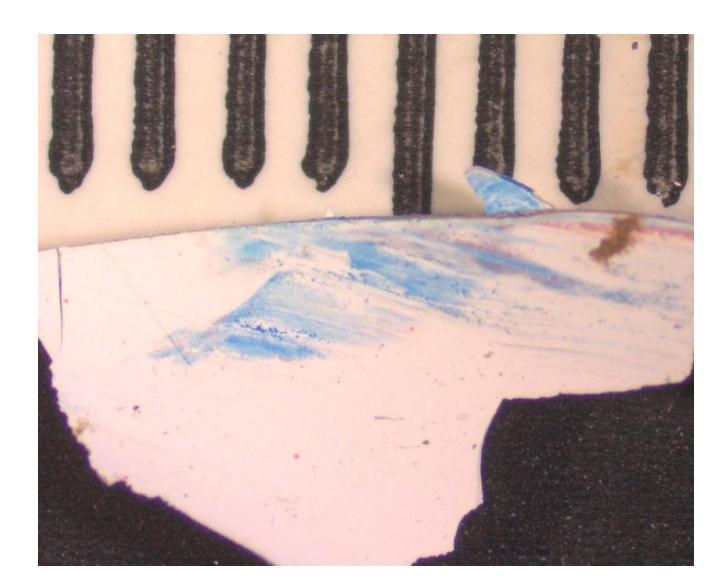
Slika 7: Vzorec št. 1

NFL ozn. vz.	orig. ozn. vz.	opis zavarovanega materiala	embalaža zavarovan ja	kraj odvzema ali ime osebe, ki ji je bil vzorec odvzet
1	1	 delci bele barve, na njih mikrozdrsnine modre barve in rdeče barve kovinski delček, prebarvan s svetlo zeleno barvo, na njem bela barva in mikrozdrsnine modre barve (Slika 5 in Slika 6) 	plastična škatlica	levo višinsko krmilo
2	2	 delci bele barve, na njih 	plastična	levo višinsko krmilo

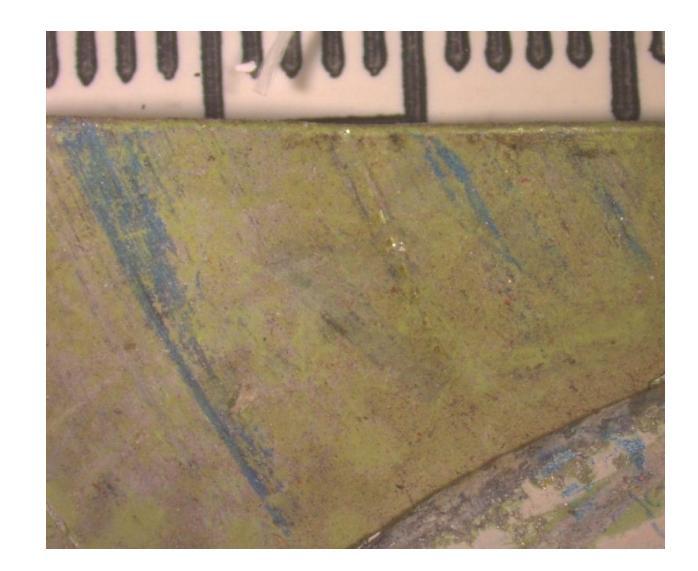
Slika 8: Vzorec št. 1

mikrozdrsnine rdeče in temne barve (Slika 7)	škatlica	
3	3	 delci bele barve, na njih mikrozdrsnine rdeče barve (Slika 8) 	plastična škatlica	levo višinsko krmilo
6	6	 kovinski delčki, na njih mikrozdsnine modre in sive barve (Slika 9) 	plastična škatlica	desno višinsko krmilo
7	7	 delci bele barve, na njih mikrozdrsnine rdeče in sive barve (Slika 10) 	plastična posodica	leva stran letala ob identifikacijski ploščici
