**AIR, MARITIME AND RAILWAY ACCIDENT AND INCIDENT
INVESTIGATION UNIT**

Number: 37200-2/2022/35

FINAL REPORT
ON THE ACCIDENT INVESTIGATION
Of the Jonker JS MD-3 Rapture glider,
reg. marks D-KXBL,
in Hudi kot, Ribnica na Pohorju,
February 26, 2022

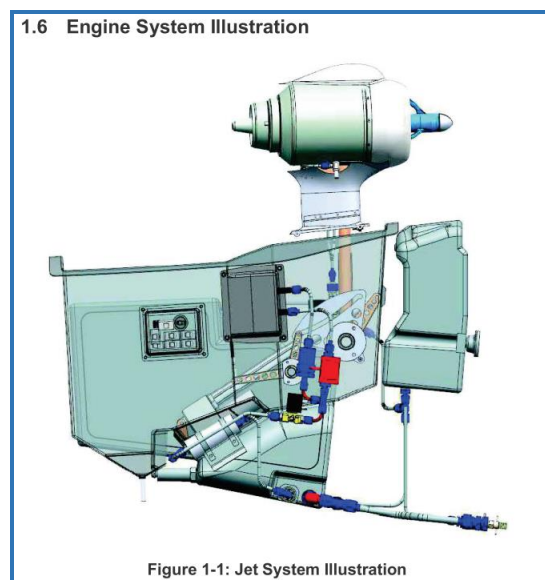
Figure 3: Jet Sustainer System

When the pilot realised that the altitude did not guarantee a safe return to the take-off airport, he decided to start the engine. During the first attempt, the display for engine operation in the cockpit, the JDU (Jet Display Unit), went out. The pilot suspected a battery failure and switched the engine ignition to another (spare) battery. On the second attempt, the engine did not start, and the JDU instrument displayed an error:

Possible cause of the fault (according to the flight manual): Mechanical failure in the area of the jet engine.

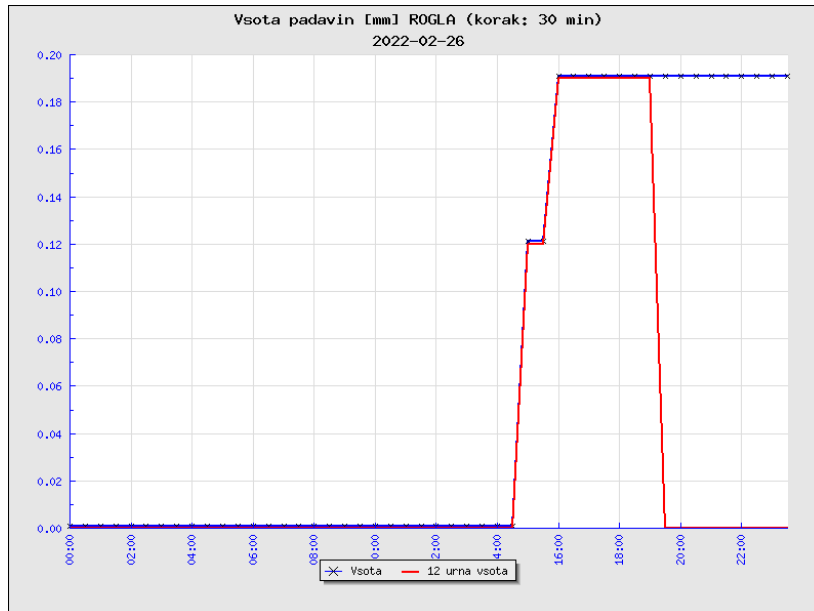
Figure 8: Total rainfall on Rogla

Due to the rainfall in this area, precipitation was quite locally distributed, which is why it was only measured at two automatic stations, namely in Rogla and Uršlja gora.

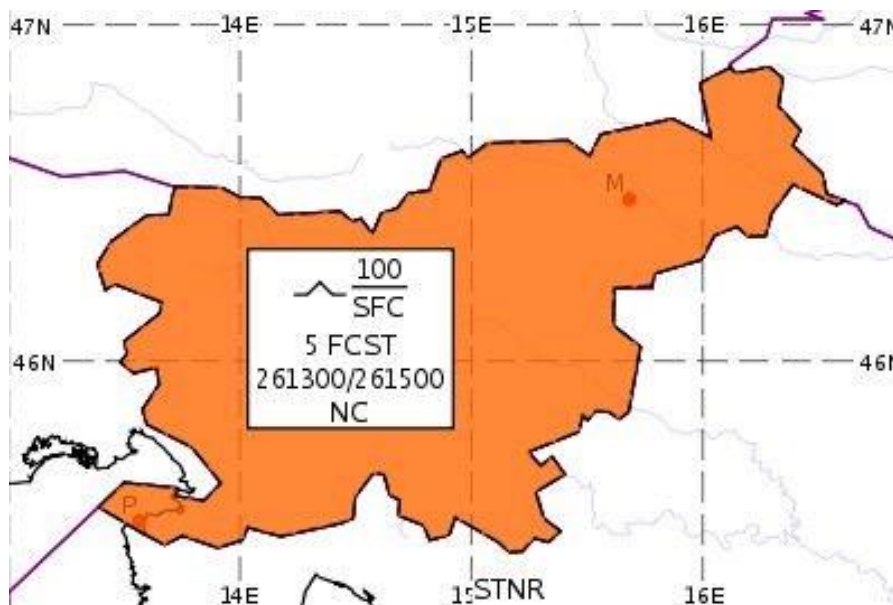
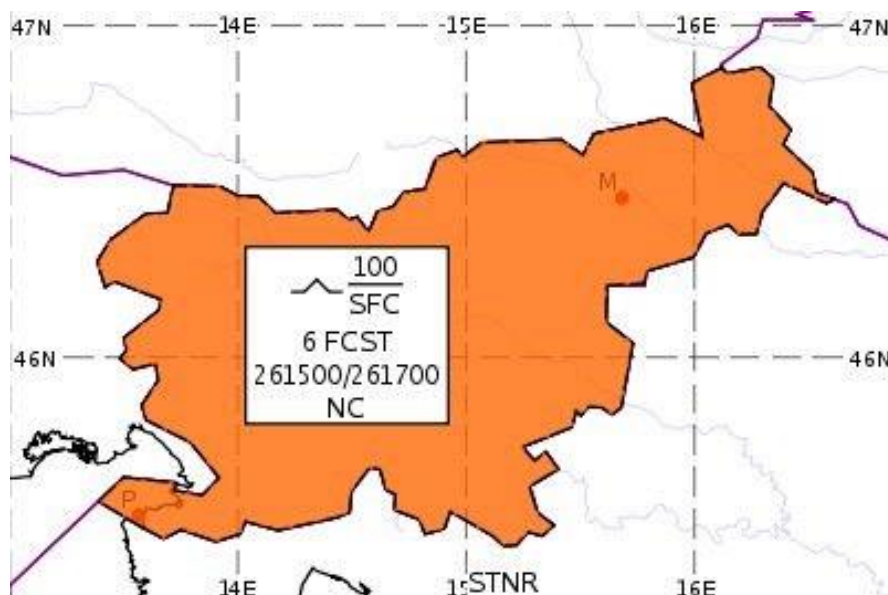
According to modelled forecasts and measurements of wind speed and direction, moderate turbulence occurred between the ground and FL100 between 15:00 and 17:00, for which an AIRMET warning was also issued (Figures 10 and 11). The METAR data from Edvard Rusjan Maribor Airport, the radar images, and the images from the station cameras around the accident area show that cumulus congestus (TCu), which occur during showers, were present. There were no thunderclouds. The icing was limited to the area of the showers, so no special warnings were issued.

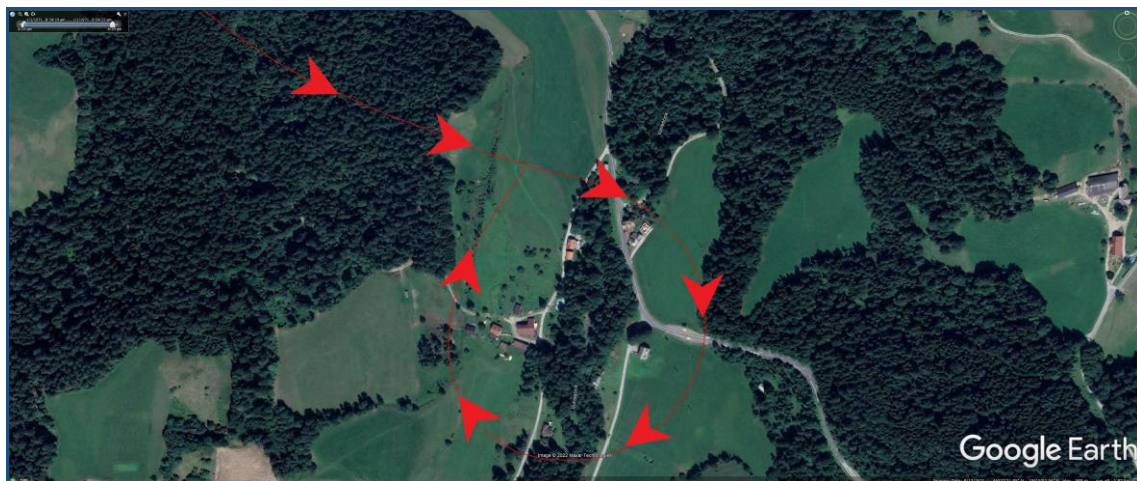
**ATTACHMENT 4 – Off-airport landing maneuver**

After the third failed engine start, the aircraft lost so much altitude that the pilot was forced to land outside the airport.
