REPUBLIC OF SLOVENIA MINISTRY OF INFRASTRUCTURE

FINAL REPORT ON THE ACCIDENT INVESTIGATION of the AQUILA AT01 motor aircraft, reg. mark OE-CYY, near Lesce airport (LJBL),

August 5, 2022

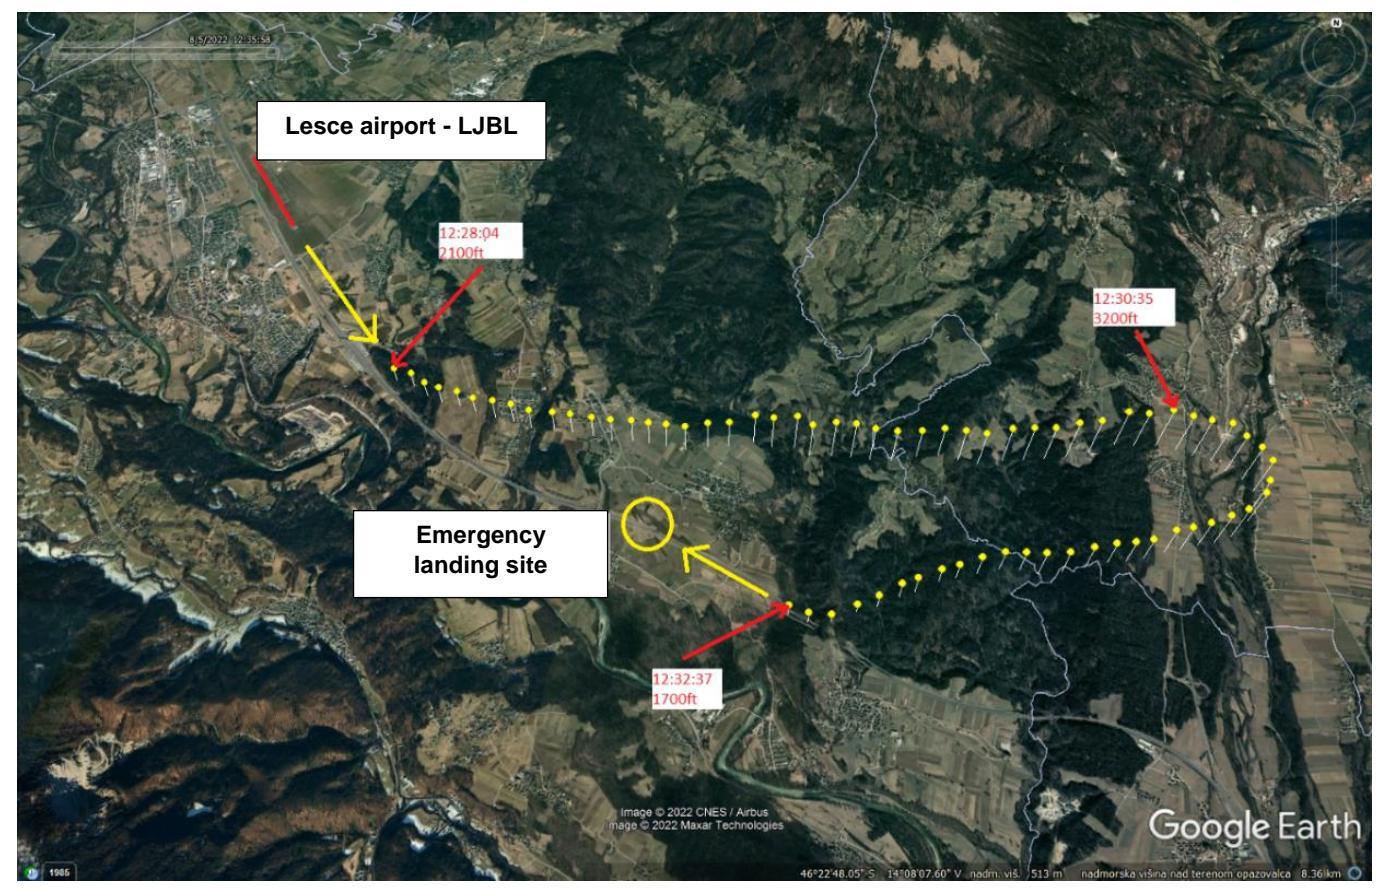
Figure 1: Flight line (OE-CYY) and place of emergency landing

On August 5, 2022, the pilot took over the aircraft at Lesce Airport (LJBL) from the aircraft maintenance organisation for the purpose of a technical flight (ferry flight) to the home base at the airport in Graz, Austria. A "Certificate of Release³" was issued by the maintenance organisation. After the pre-flight inspection, the pilot took off with the passenger at 14:20 local time. After take-off, he performed a school circuit and a touch-and-go landing to check the operation of the engine and then continued the flight according to the flight plan he had previously submitted to the Slovenia control. During the climb, a sudden engine failure occurred at an altitude of 3,200 feet. The pilot steered the aircraft back towards the airport of departure and informed the air traffic controller that they would have to return to LJBL due to an engine problem. Shortly afterwards, the pilot announced that he would make an emergency landing on the part of the aircraft skidded with its right wing about 40 m along the embankment until it came to a standstill. The nose leg of the landing gear was damaged, the right wing was damaged, and the structure of the rear part of the fuselage was torn. The pilot and the passenger left the aircraft unharmed.

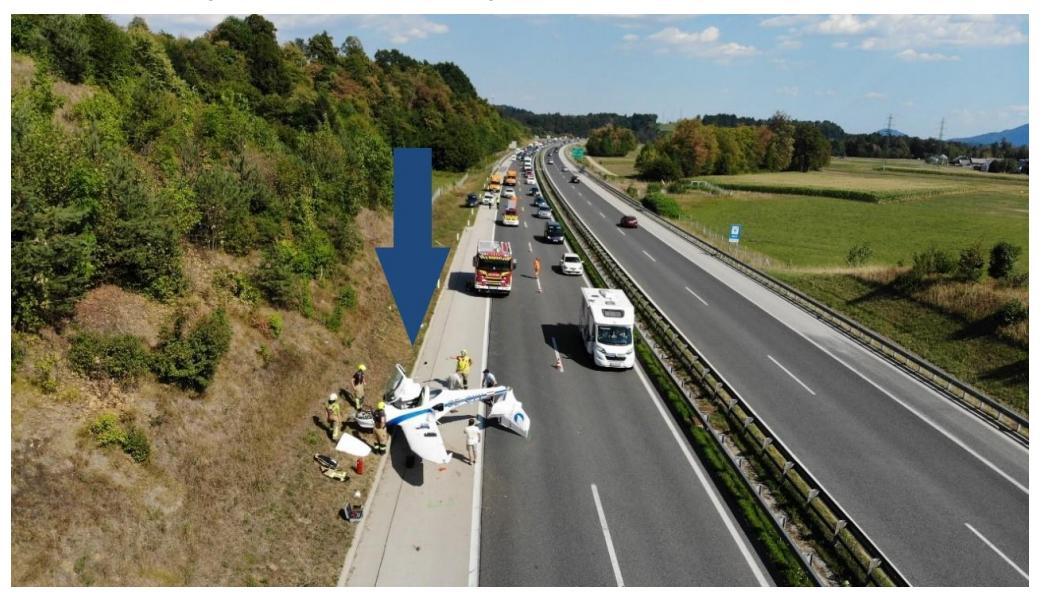
Figure 3: Landing direction and position of OE-CYY after landing on the highway section

The aircraft landed on the Gorenjska highway in the direction of Jesenice. During the landing on the highway, the aircraft was not damaged until the moment when the pilot steered the aircraft to the far right of the runway to avoid a collision with vehicles, causing the right wing of the aircraft to slide along the embankment at the edge of the highway. During heavy braking and sliding of the right wing against the terrain, the nose leg of the landing gear was damaged (aerodynamic covers of the landing gear wheels, tyres), part of the right wing, right flap, and aileron of the aircraft were broken off and fell off, and the tail of the aircraft was damaged (broken off). Surface cracks were visible on part of the left wing. The propeller also showed surface damage. A small amount of fuel leaked from the fuel drain valve, which was pushed by the edge of the cracked abutment onto the concrete curb next to the damaged nose leg.

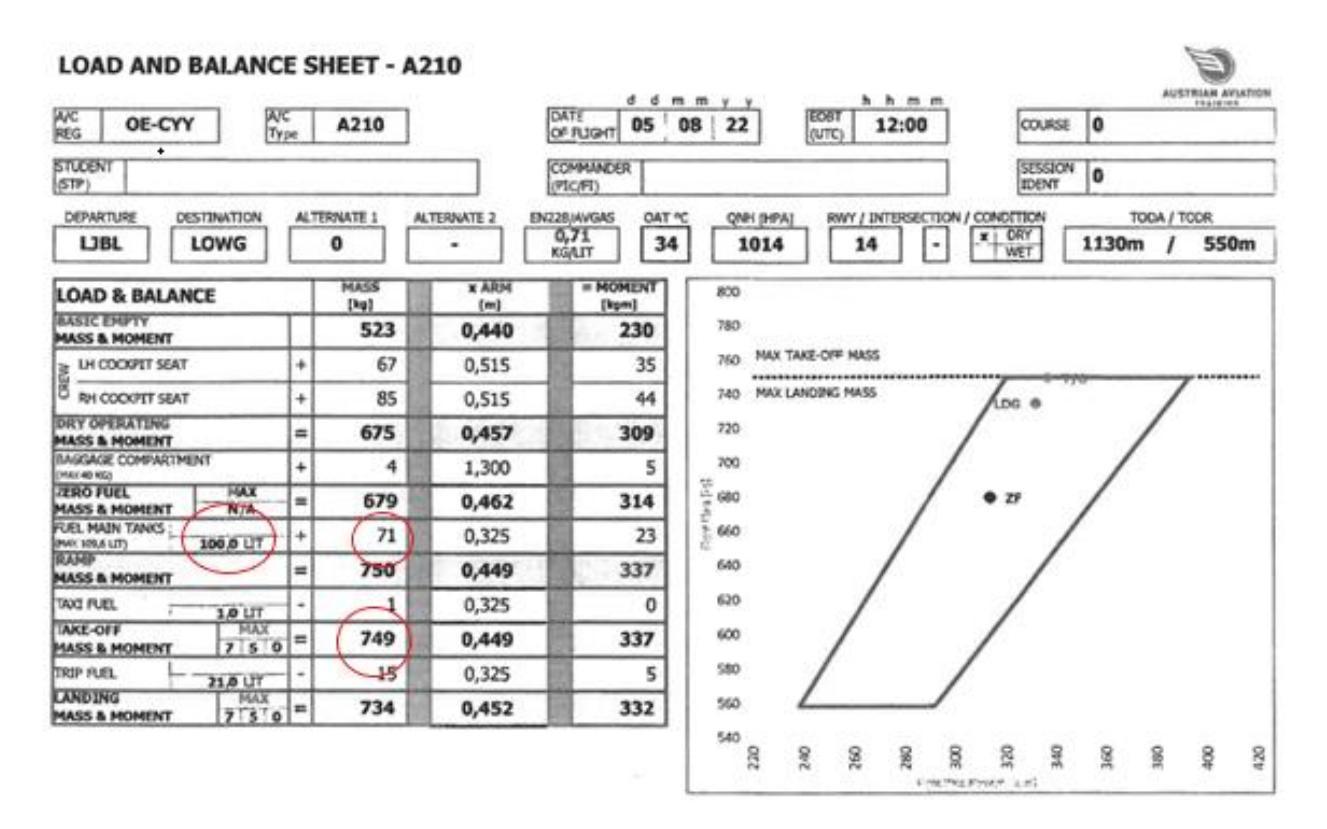
Figure 5: Calculation of the weight of the aircraft in preparation for the flight on August 5, 2022: "Load and Balance" form

Analysis of the data obtained (data from the aircraft manufacturer and data from the operational manual) shows that the maximum take-off weight (MTOW) of the aircraft is 750 kg, while the weight of the empty aircraft is 523 kg. The sum of the values for the fuel quantity, the mass of the crew, and the mass of the empty aircraft should not exceed the value of the MTOW - 750 kg. The Commission notes that the maximum permissible take-off weight of the aircraft was not exceeded at the time of the occurrence, as evidenced by the report on the latest measurements. The calculation of the permissible weight and the position of the aircraft's centre of gravity (Load & Balance Sheet form), which the pilot submitted as proof of flight preparation, shows that with a fuel mass of 71 kg (100 litres), it would not exceed the MTOW - 750 kg. The actual amount of fuel before take-off was less than the value given by the pilot when calculating the permissible weight and determining the position of the centre of gravity during flight preparation. The analysis of the fuel quantity shows that the take-off weight of the aircraft at take-off was 699 kg. The pilot's pre-

flight calculation is 749 kg, taking into account the amount of fuel in the tanks of 100 litres (71 kg), which differs by 50 litres from the actual amount of fuel found during the investigation of the accident.

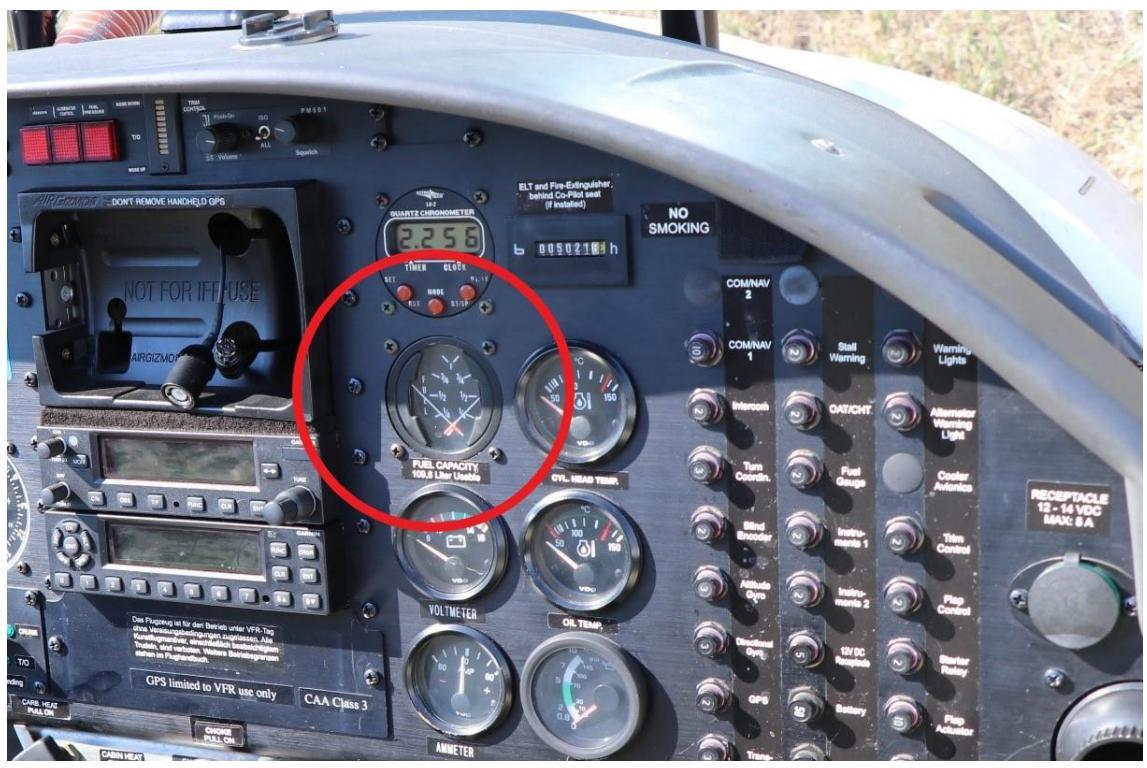
Figure 7: OE-CYY fuel gauge on the instrument panel in the aircraft cabin

A fuel sensor is installed in each tank, which generates an electrical signal depending on the amount of fuel in the tanks and sends it to the fuel quantity displays on the instrument panel in the cockpit. The fuel quantity display shows the following values: FULL, 3/4, 1/2, 1/4, and EMPTY.

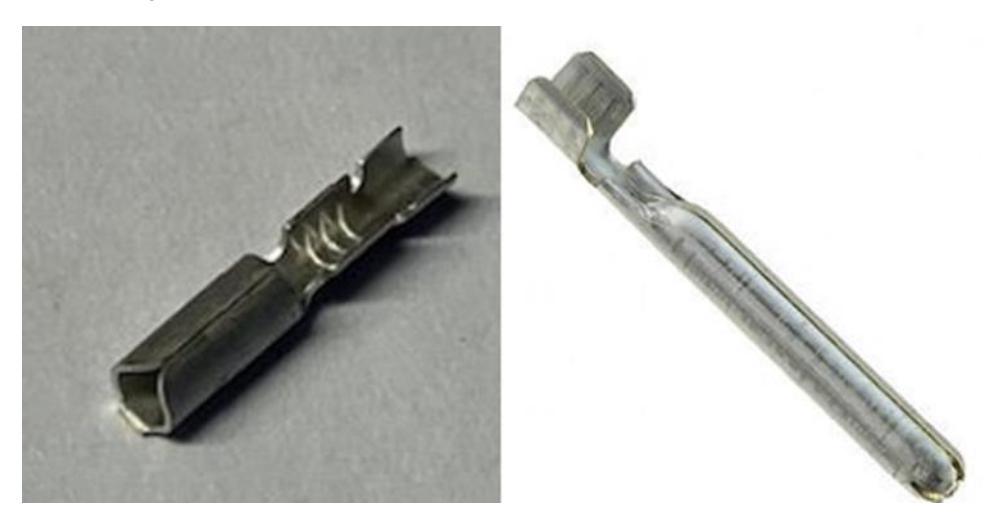
Figure 18: Male and female connectors

When draining the fuel from both tanks, the amount of fuel in the left tank was measured at 0.16 litres. The amount of fuel measured in the right tank was 31 litres. No water was found in the fuel. The water drainage system and the entire fuel installation system were checked to detect possible leaks. When checking the function of the fuel gauge on the cockpit instrument panel, it was found that one of the connection contacts on the back of the instrument was loose. The female part of the contact was approximately 2/3 outside the length of the male contact and in the non-contact position.

The display of the manufacturer's device ⁵was compared with the position of the GND wire (GND is the abbreviation for "ground"). It turned out that the fuel quantity display is correct if the contact of the ground wire is correctly fitted (Figure 14). If the ground wire contact is loose or protruding (Figure 15), both fuel quantity instrument displays are completely off in the top position. **Such an instrument display can be identified as full of fuel.**

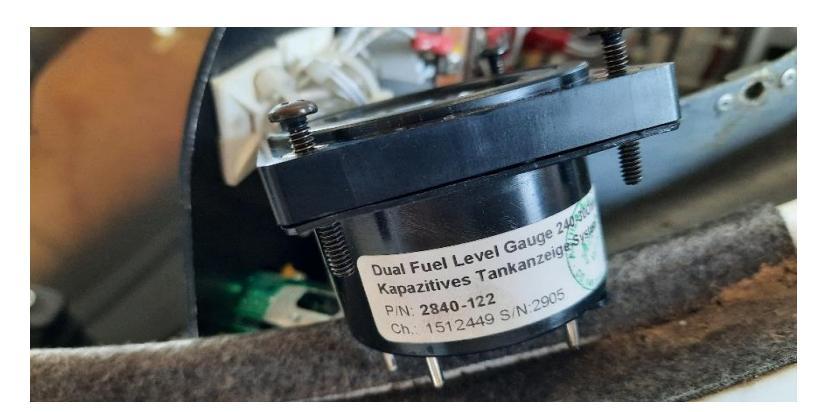
Figure 19: Westach Fuel Gauge, P/N: 2840-122

The manufacturer of the device has indicated on its website how the non-matching contacts of the device are to be connected to the electrical installation.
