AIR, MARITIME AND RAILWAY ACCIDENT AND INCIDENT INVESTIGATION UNIT Tržaška cesta 19, 1000 Ljubljana T: 01 4

Številka: 37200-1/2022/71 Datum: 23. 07. 2024 unofficial translation

# FINAL REPORT ON THE ACCIDENT INVESTIGATION Of a hot air balloon Lindstrand LBL 150A, reg. mark OO-BDI, near Ig – Ljubljansko barje ,

# January 22, 2022

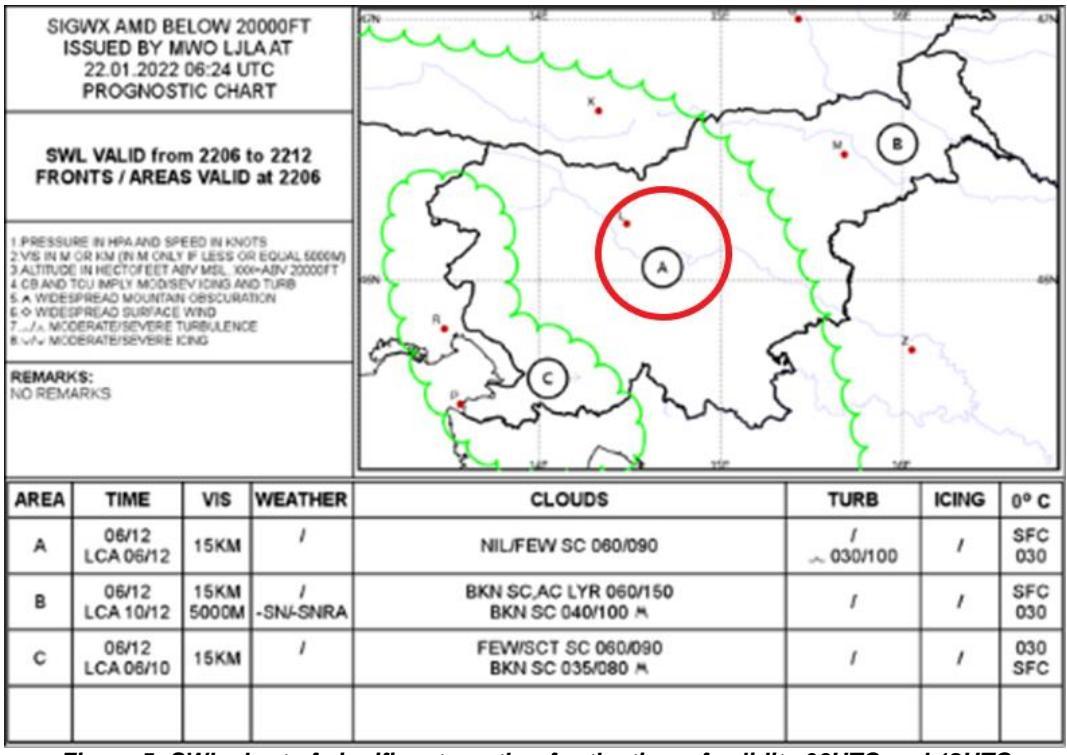
The Ljubljana Marshes fall within the area labelled A, for which some stratocumulus clouds with a base at 6000 FT AMSL and locally moderate turbulence above 3000 FT AMSL due to increased winds have been forecast.

Figure 5: SWL chart of significant weather for the time of validity 06UTC and 12UTC

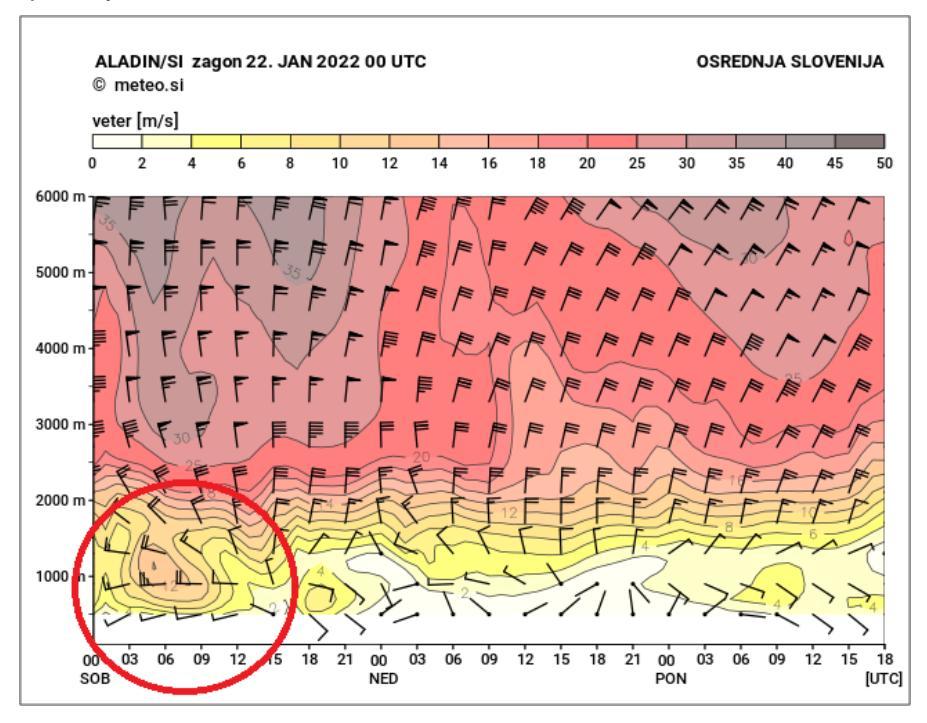
Figure 6: Model wind forecast according to the height of the ALADIN model for the area of central Slovenia: the figure shows a forecast of stronger wind, even in the lower layers

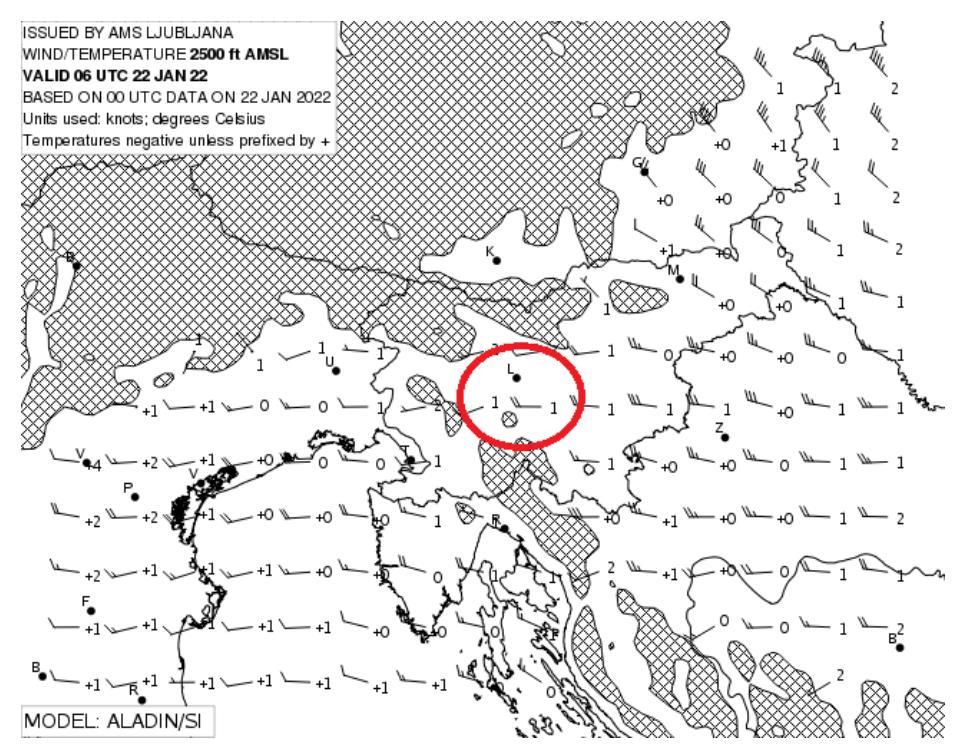
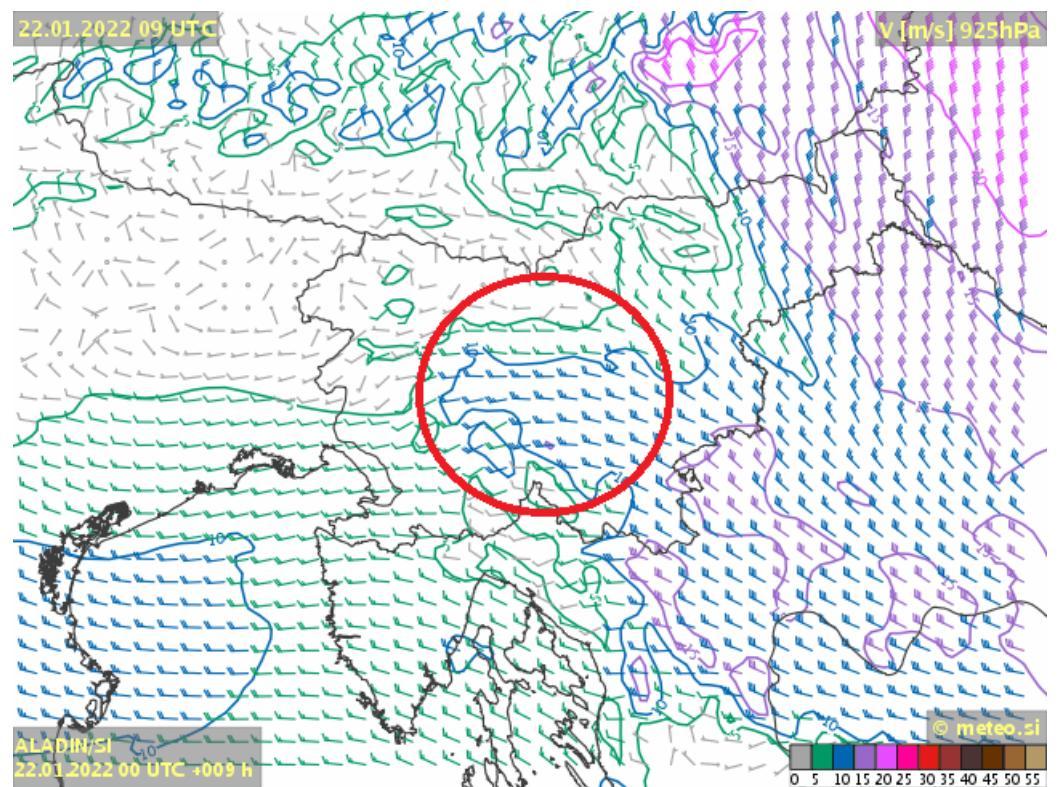
Figure 7: ICAO standard wind and temperature chart of the ALADIN model at 2500 FT AMSL for 06UTC

- suitable conditions for flying under VFR rules;
- the presence of individual stratocumulus clouds with a base at 6000 FT AMSL;
- local presence of moderate turbulence above 3000 FT AMSL;
- increased wind in the central part of Slovenia with an average speed between 36 km/h and 50 km/h at an altitude of about 2500 FT AMSL (Figures 7 and 8).

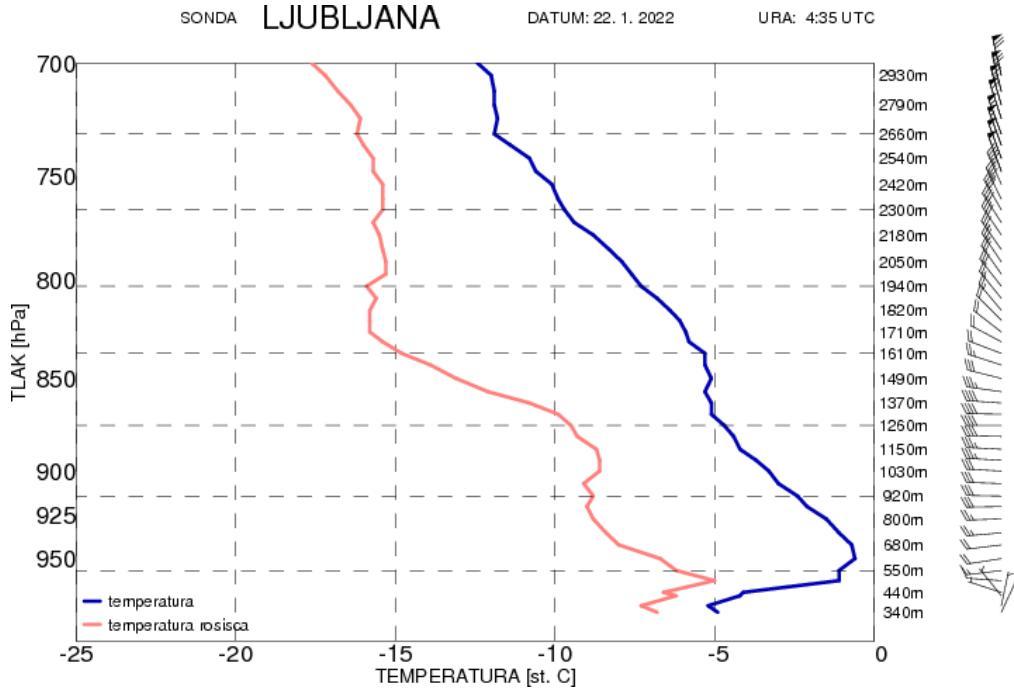
Figure 13: The result of a radiosonde measurement at the Bežigrad site. The measurement started at 4:35 UTC, so the morning temperature inversion, which is typical for the colder season, is clearly visible. Above the inversion, the probe measured an increased westerly wind

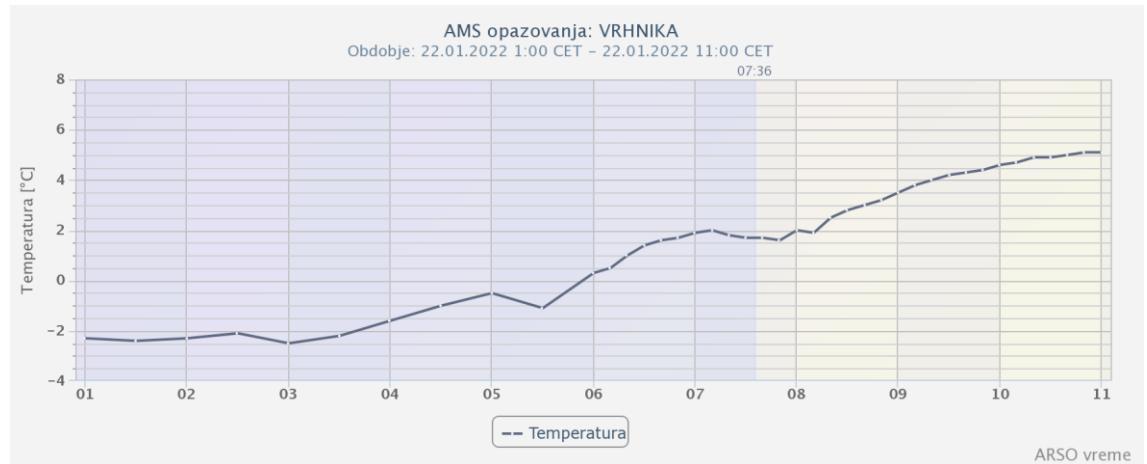
Figure 14: The temperature at Vrhnika station on January 22, 2022. The time is local time (UTC+1). The air temperature began to rise in the second half of the night
