FINAL REPORT

ON THE INVESTIGATION OF THE AIRCRAFT

Cessna 172,

reg. mark S5-DLM,

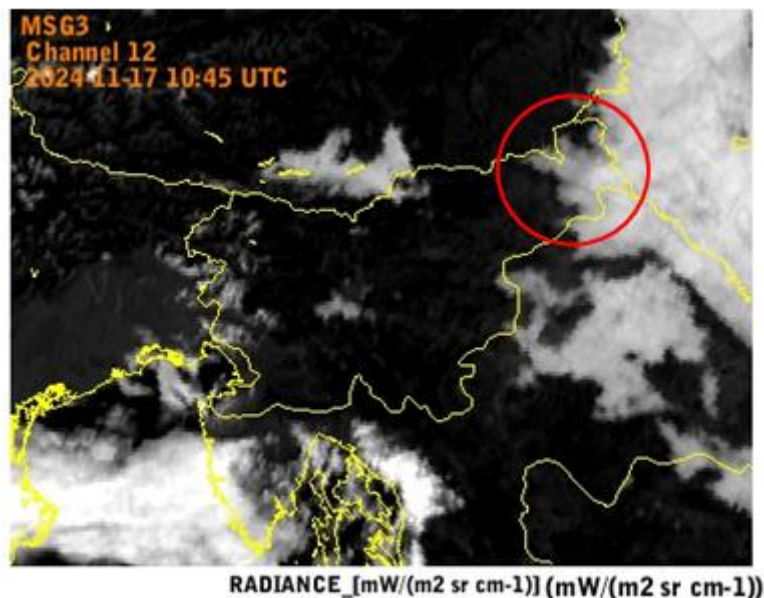
East of the approximate line Mureck (Austria) – Ormož, fog was present, which did not extend fully to the far northeast of Slovenia, while west of this imaginary line conditions were mostly clear with good visibility. Based on imagery from nearby cameras and meteorological model calculations, the fog layer was estimated to extend up to approximately 1,000 ft AGL (about 300 m above ground level).

Figure 5: Satellite image (EUMETSAT) in the visible spectrum at 11:45 LT

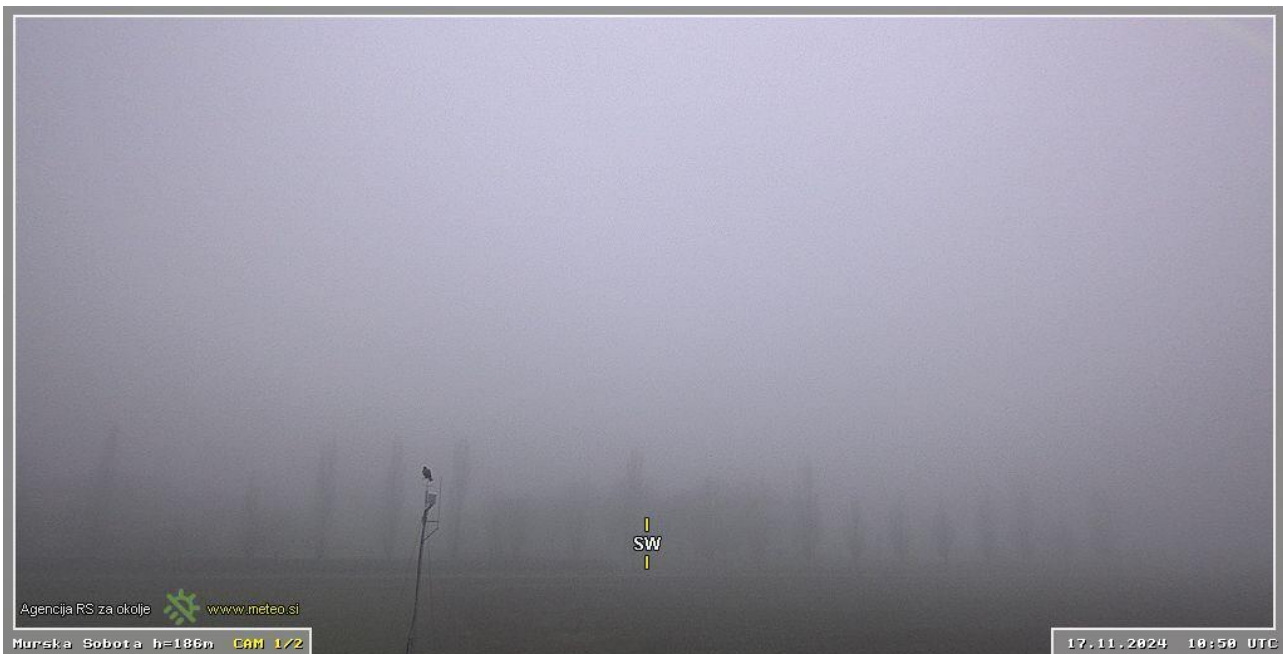
Based on data from the automatic weather station Murska Sobota (microlocation Rakičan), the horizontal visibility was estimated at approximately 300 m, and the vertical visibility at approximately 200 ft AGL (about 60 m above ground level). The surface temperature was $-0.2\text{ }^{\circ}\text{C}$. Surface wind was variable in direction with a speed of 3 to 5 kt.

Figure 6: View from the Murska Sobota meteorological station (Rakičan) towards the southwest at 11:50 local time

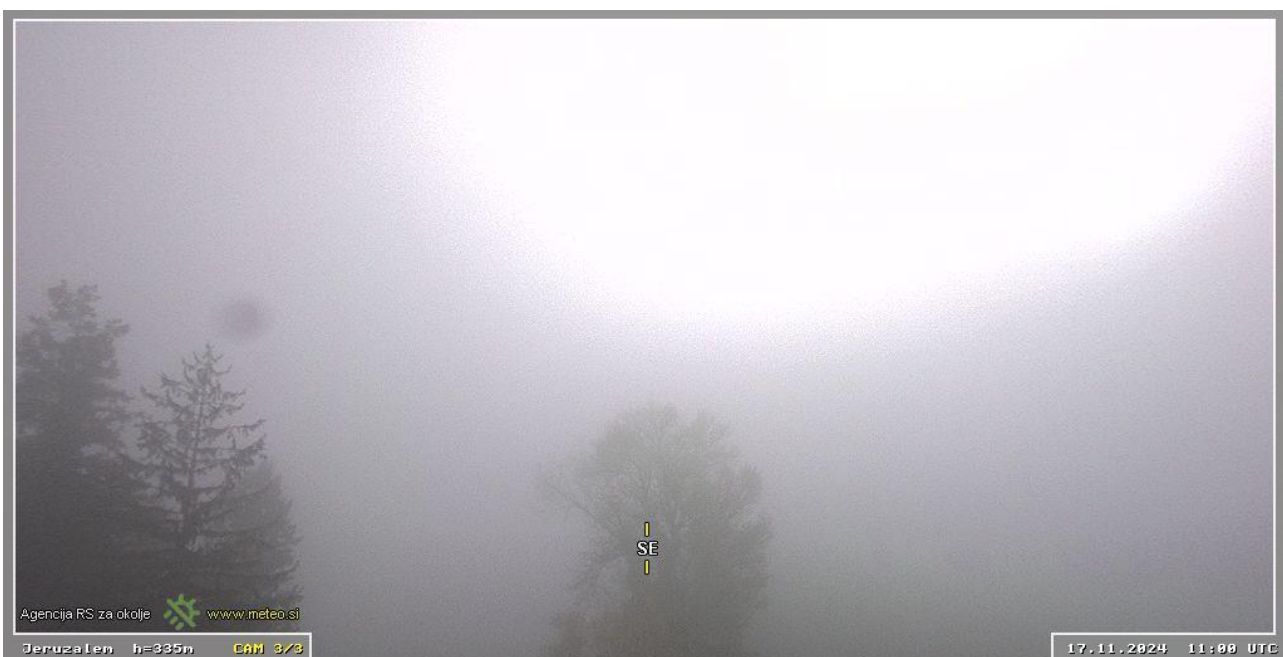
Figure 7: View from the Jeruzalem meteorological station (elevation 335 m AMSL) towards the southeast. It can be seen that the top of the fog layer is only slightly above the location

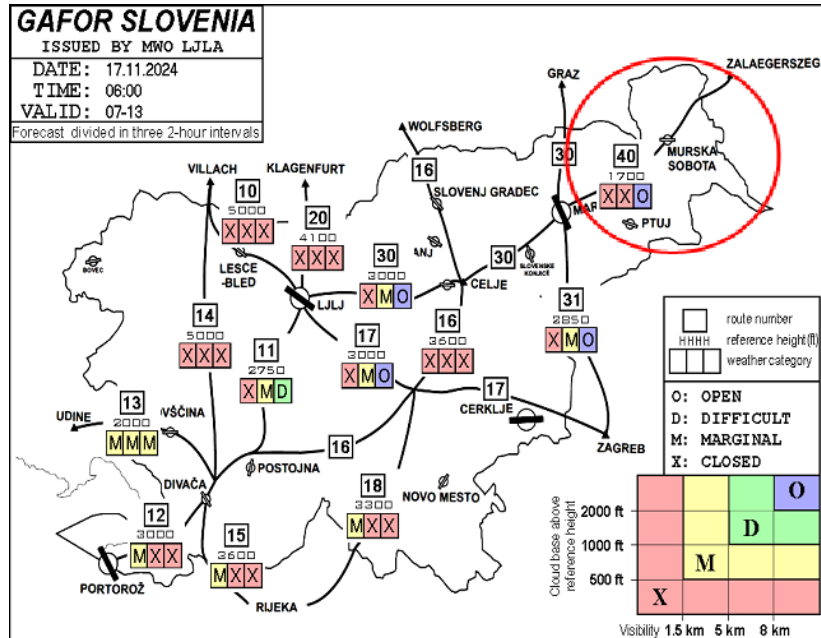
The GAFOR forecast, issued at 06:00 UTC¹³, indicated poor expected conditions for VFR flight on route 40 across Prekmurje, with an expected improvement in the afternoon. In the time window from 10:00 to 12:00 local time, the forecast conditions for VFR flight were marked as X.

Figure 8: GAFOR forecast issued at 07:00 local time: in the time window from 10:00 to 12:00 local time, the forecast conditions for VFR flight on route 40 were marked as X

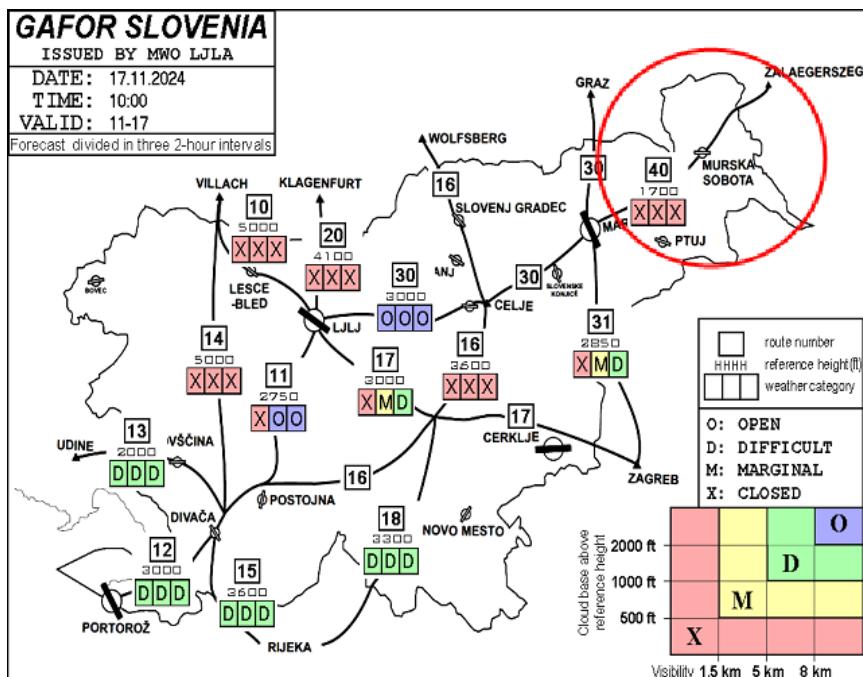
The forecast issued at 10:00 UTC no longer indicated improvement, but rather poor conditions for the entire day. In both forecasts, the expected weather conditions at the time of the accident were unfavourable.

Figure 9: GAFOR forecast issued at 11:00 local time. In all time windows, the forecast conditions for VFR flight on route 40 were marked as X
