AIR, MARINE AND RAILWAY ACCIDENT AND INCIDENT INVESTIGATION UNIT

### **NOTICE OF COMPLETION OF INVESTIGATION**

#### **Serious incident involving WT9 600 FG Dynamic, Reg. D-MSHU, 1 May 2025, Mangart near LJBL**

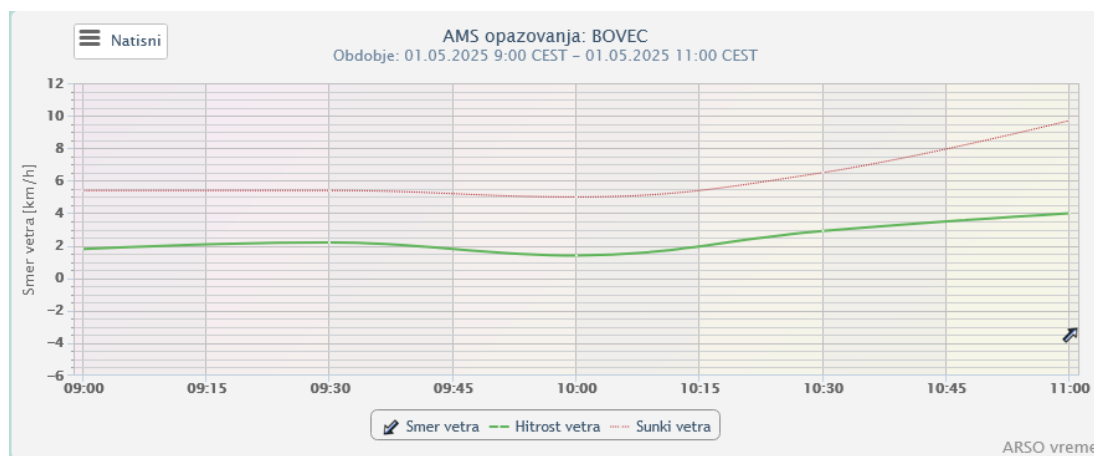
Figure 4: Wind speed measured at the automatic station at Bovec Airfield

Near the surface, light local winds were observed, while light northeasterly winds prevailed at altitude. In the Bovec area, a valley wind was present, with an average speed of up to 3 knots and gusts up to 5 knots. Over the Kanin area, a southerly wind was observed with speeds up to 3 knots.

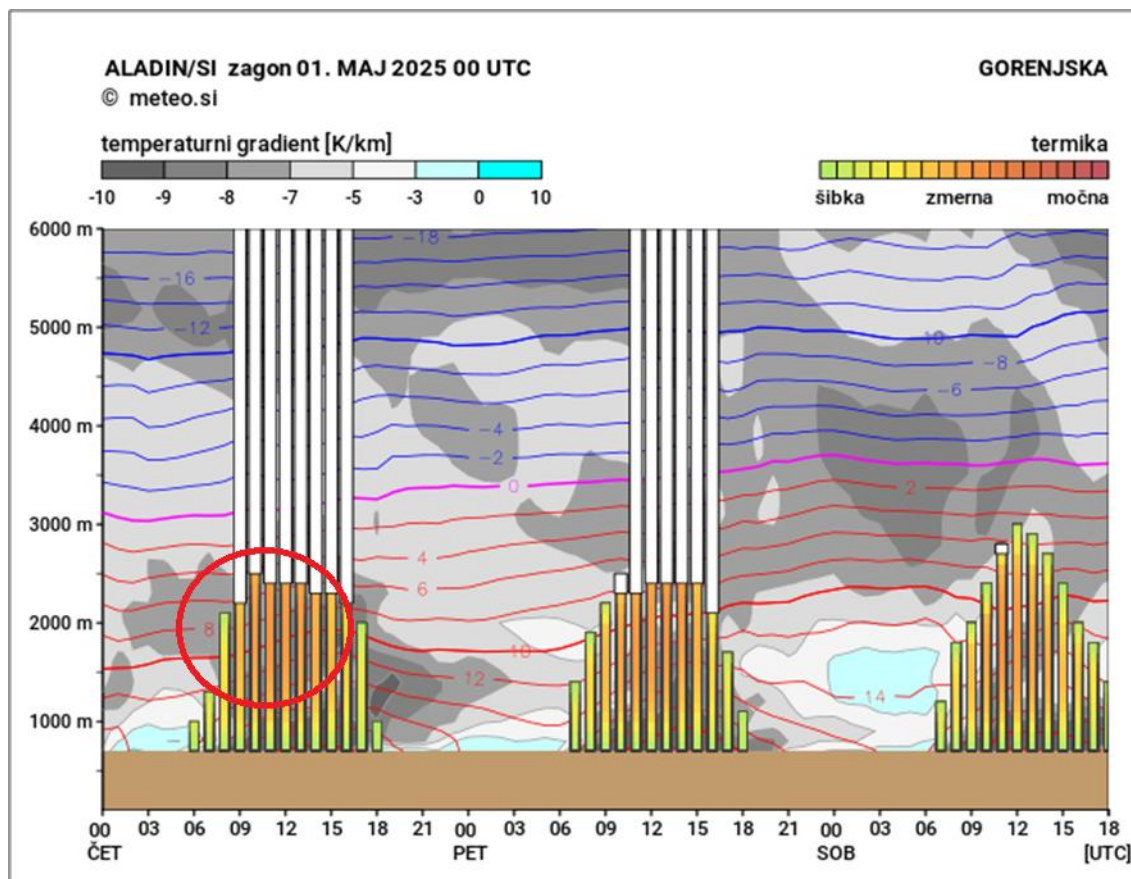
Figure 6: Thermal activity forecast for the Gorenjska region

Moderate thermal activity was forecast for the day (see Figure 6). At the time of the occurrence, thermals were not yet fully developed.

At the edges of thermal updrafts, weak turbulence could occur due to differences in vertical air movement.
