REPORT ON INVESTIGATION FOR SERIOUS CASUALTY BY THE M/V MAERSK HOUSTON

breakaway from pier, bottom touching, contacts with
shore infrastructure and moored tugboat
in the Port of Koper
19. 07. 2023

AIR, MARITIME AND RAILWAY
ACCIDENT AND INCIDENT
INVESTIGATION UNIT YYY

Final Report

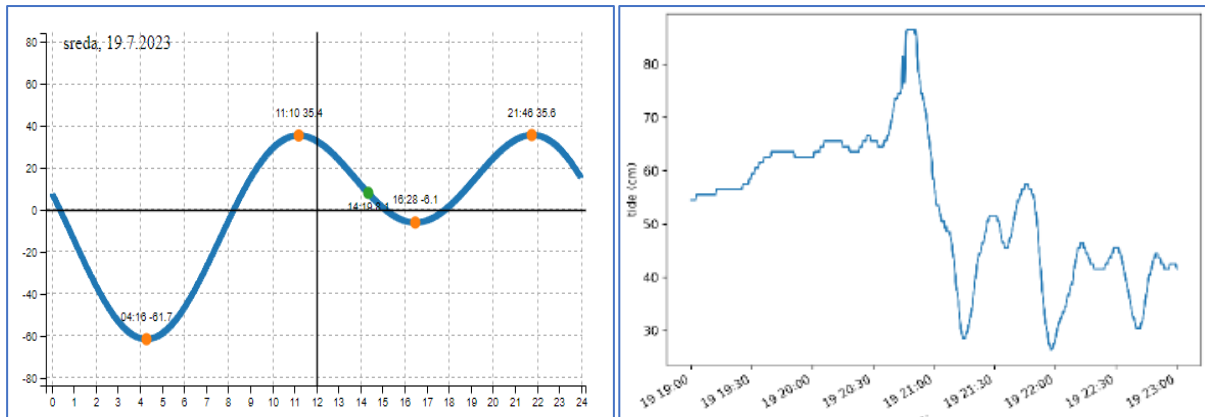
Figure 20. shows the sea height where the measured sea level is higher than the predicted sea level. The storm additionally caused a sea level rise in the bay, which caused the sea level at the mooring to rise by approximately 25 cm. This phenomenon had some effect on the ship, pushing it towards the interior of the basin, i.e., to the east.

Figure20: Sea heights (left predicted 35 cm, right measurements at sea, 87 cm in front of the second pier.)

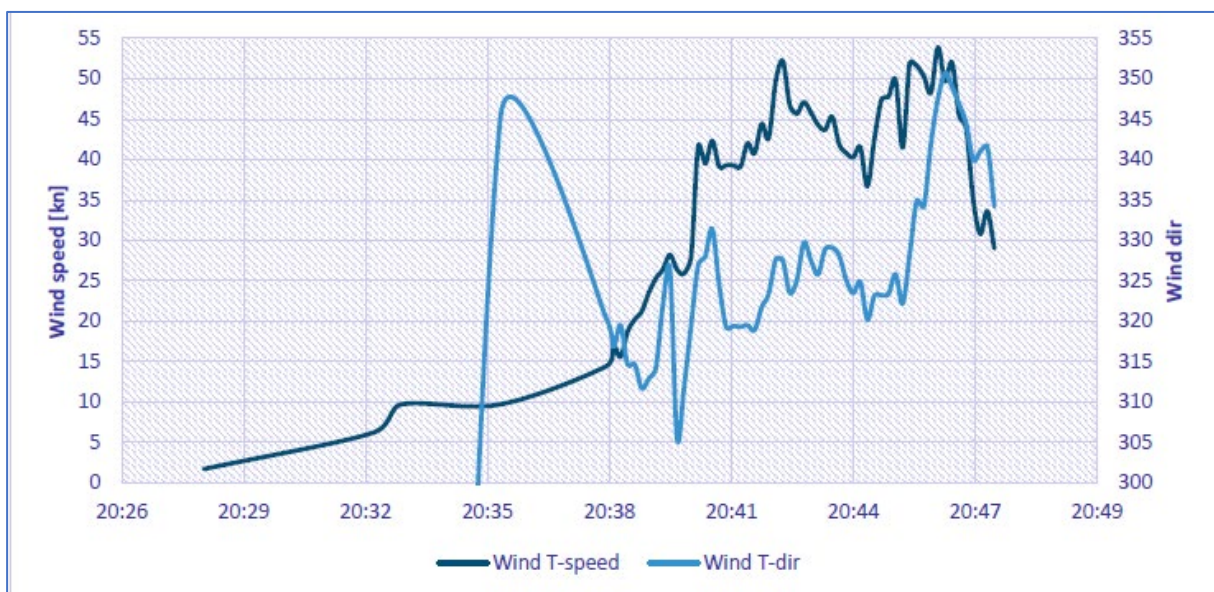
Figure21: True wind measurements on Maersk Houston, maximum measured speed 27.7 m/s (53.9 kt)

From the analysis of the meteorological records, it can be concluded that strong winds have occurred, but this is not a meteorological emergency as the measurements do not differ significantly from the archived wind measurements given in the ADMIRALTY Sailing Directions - NP47 Mediterranean Pilot Vol. 3, available on board the ship. The wind evolution and the analysis of the accident scenario are given in Chapter 2 - Analysis of the event.

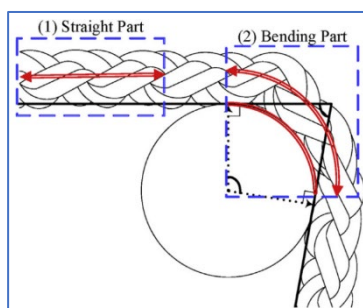
Figure 24: Rope bending load

In addition to the tension of the mooring rope during mooring, when it does not exceed the safety load threshold, over time the repetitive forces damage the ropes through heat generation due to the build-up of frictional energy. In addition, ropes are also affected by bending fatigue. Because of friction and bending fatigue, the temperature rise is higher when using synthetic fiber ropes, which can lead to rope breakage more quickly (Figure 24).

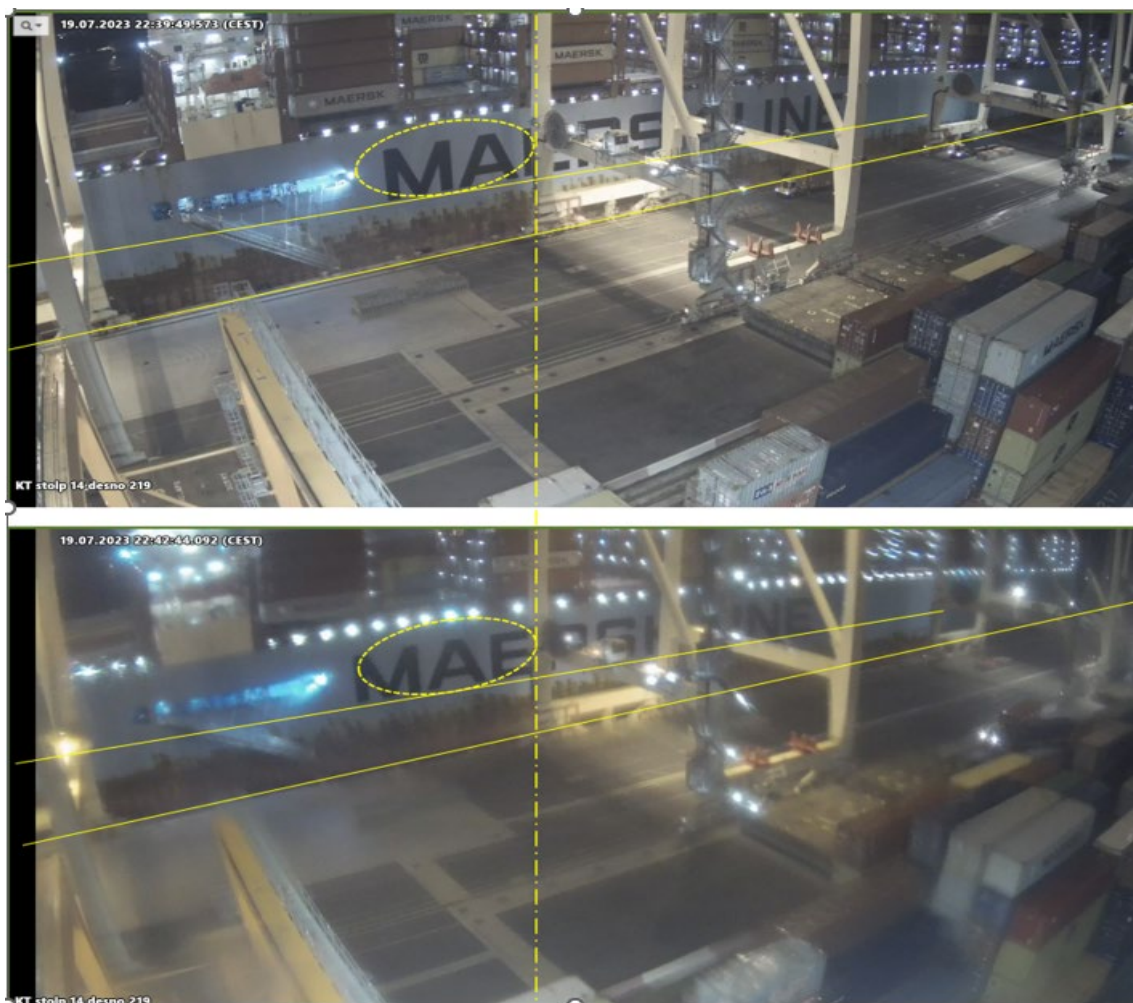
Figure 28: Observed mid-ship longitudinal movement (source: VNC Luka Koper)

An overview of the forward motion of the center section of the ship, as well as the drift away from the pier, is shown below in two sequences (Figure 28). The upper part of the figure shows the position of the ship at 22:39:50 hours, when the wind was blowing from 326.2° at 28.2 knots (14.5 m/s).

At 22:42:44, a longitudinal shift and a slight drift of the stern away from the shoreline are observed. The wind speed is 46,7 knots (24 m/s) bearing 323,5°; at this time, the stern mooring winch drum brakes may have failed. To facilitate the estimation of longitudinal and transverse movement, lines are drawn on the figures.

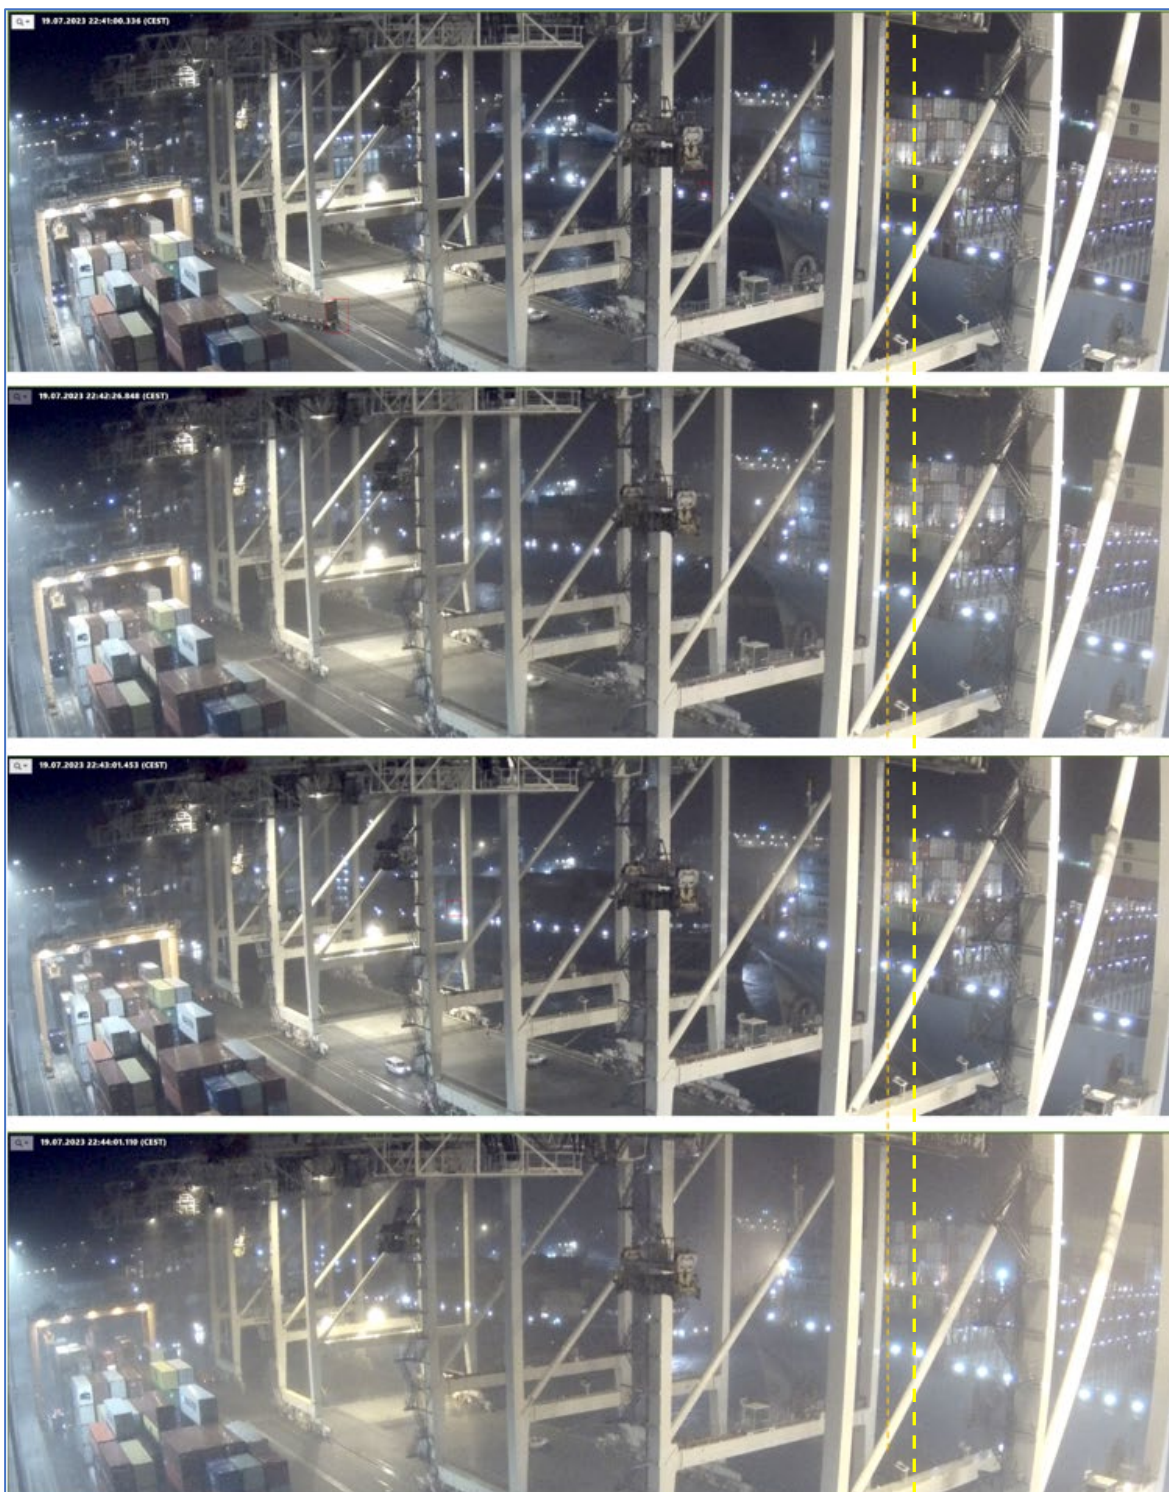
Figure 30: Sequences of longitudinal and transverse movement at the bow (source: VNC Luka Koper)

To analyze the ship's bow movement, a control line is drawn on the time sequences (Figure 30) to make it easier to observe the slipping of the ship. In the second sequence at 22:42:27, showing the longitudinal movement of the ship, all the headlines are still visible. At 22:44:00 in the last sequence, the forward springs are missing. A larger longitudinal movement of the ship is observed. It is assumed that the forward springs, which were short and had a large angle of action, were the first lines to be slackened and parted, followed by the stern springs. The linesmen reported that the forward lines were snapping at that time.

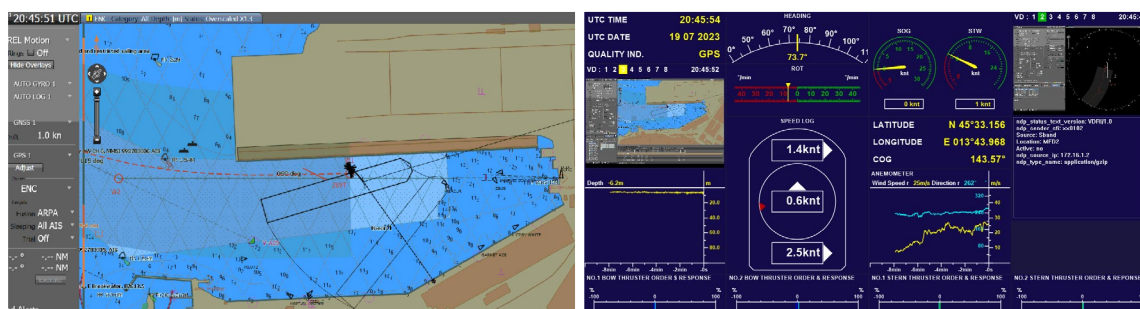
Figure 31: Situation at 22:45:54 after contact, ship movement (source: VDR)

At 22:45:31 - due to the forward motion of the Maersk Houston caused by high winds and parted ship's lines, especially parted forward springs, Maersk Houston made contact with the lowered arm of container crane STS 59. Between 22:45:31 and 22:45:54, the ship's VDR recorded the sound of the contact and falling of the damaged signal masts on the compass deck. Winds from bearing 347⁰, at 54 knots (27.8 m/s), continued to push the ship off the pier. The ship's bearing was 074⁰, COG is 144⁰.

The stern began to drift towards the south side of Basin I and Berth 1 on the passenger terminal.

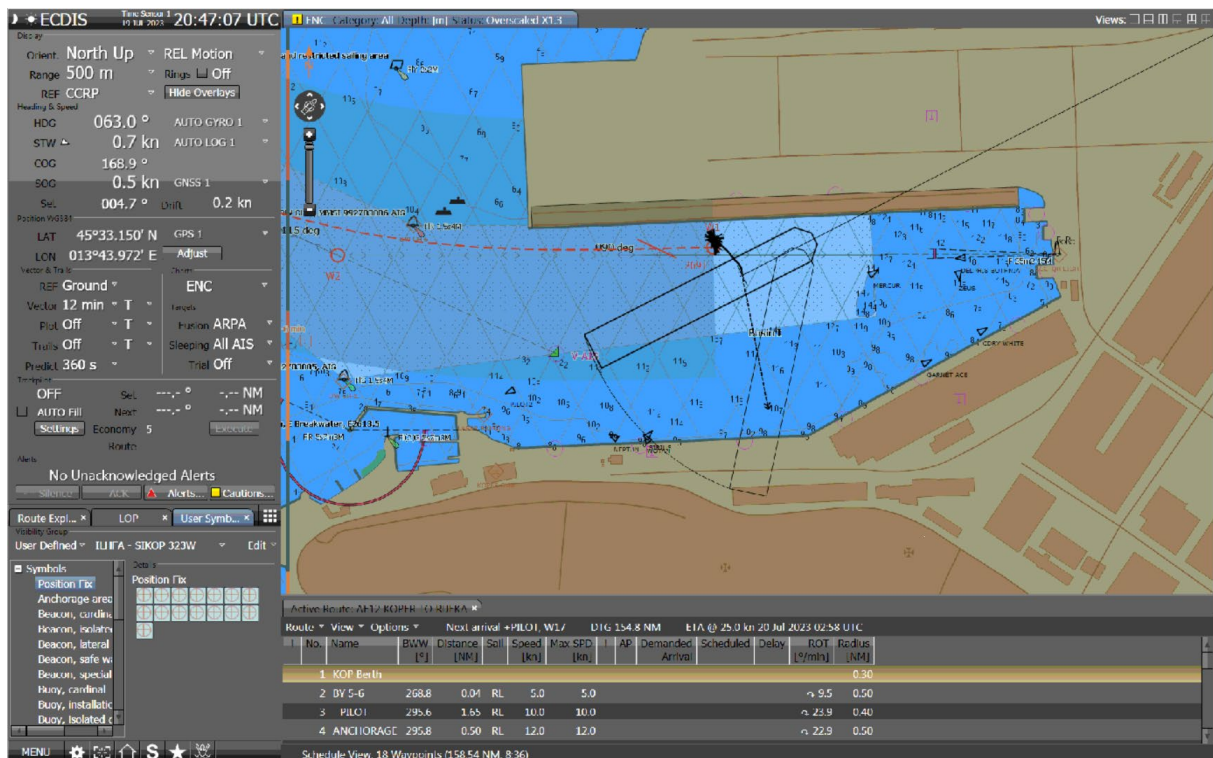
Figure 32: Situation at 22:47 LT (source: VDR)

At 22:47, the ship is turning towards 063⁰, COG is 169⁰ with a speed of 0.5 knots astern (Figure 32). The speed astern is as high as 1.9 knots. The bow thrusters (BT) operate at 50% power to port, pushing the bow to port. The wind is from direction 107⁰, and the wind speed is 15 knots (7,8 m/s).

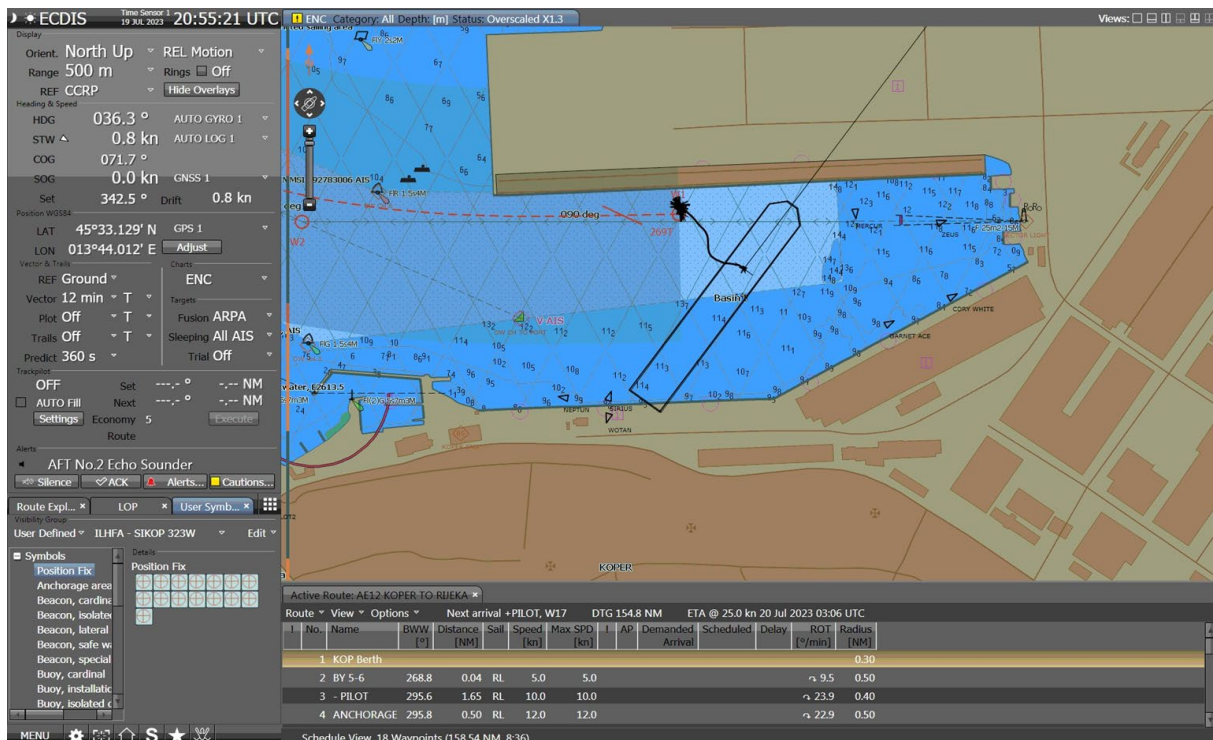
Figure 33: Situation at 22:55 LT (source: VDR)

At 22:55 (estimated), the ship touched the soft bottom and contacted the pier wall between bollards #15 and #17 at least three times (Figures 33 and 34).

The ship's heading is 036°, COG is 072°, and 0,3 knots astern. Bow thrusters (BT) are operating at 80% power to port, and the stern thrusters (ST) are also at 80% power to port. The main engine is not used due to the given position of the ship and the proximity of the bow to the pier, berth #7A. The wind is from direction 129°, speed 15 knots (6,5 m/s).

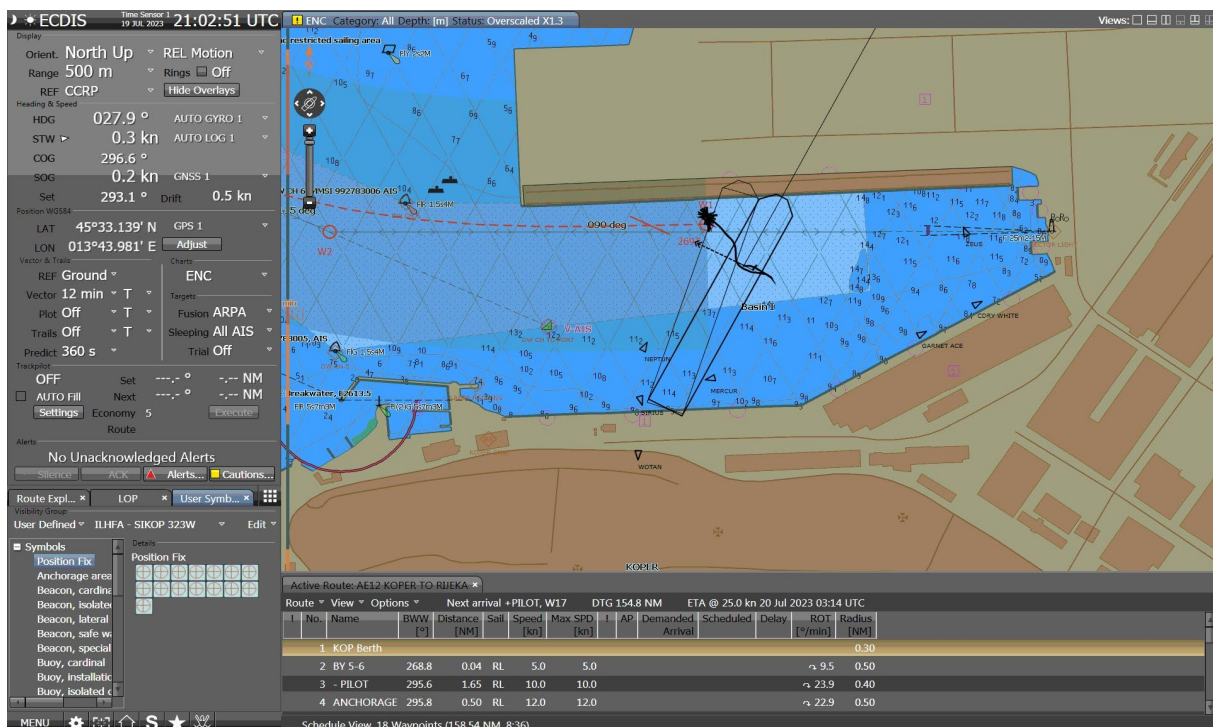
Figure35: Situation at 23:02 LT (source: VDR)

At 23:02, tugboat Mercur started assisting (boxing) on the starboard quarter. Bow thrusters (BT) are not operating, and stern thrusters (ST) are operating at 80% power to port. The ship's heading is 028⁰, and the COG is 297⁰. The ship is moving toward moored tugboats due to stern thrusters operating to port and the tugboat pushing from the starboard quarter. The main engine is not used due to the given position of the ship and the proximity between the bow and Pier 1, berth #7A (Figure 35).

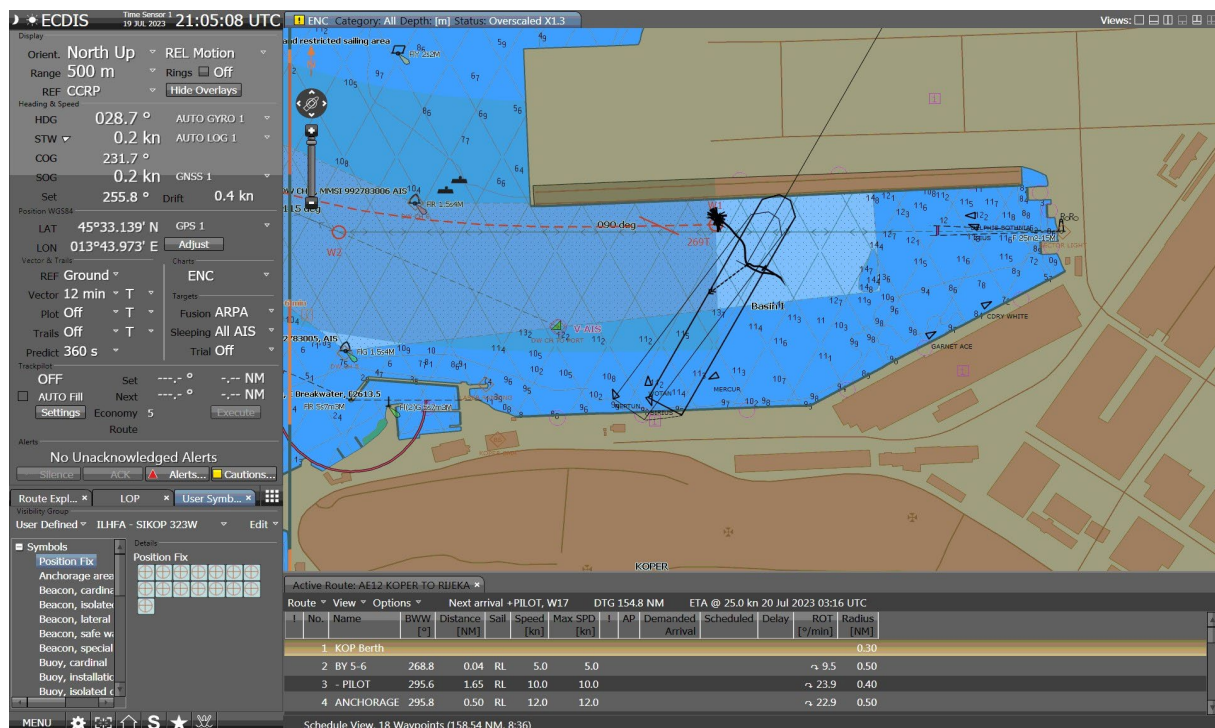
Figure36: Situation at 23.05 LT - after shore contact, (source: VDR)

At 23:04:39, the ship's bow made contact with the Pier 1 fenders and the pier's vertical wall. Bow thrusters are stopped while stern thrusters are operating at 80% power to port. Tugboat Mercur is assisting on the starboard quarter and pushing the stern to port, the main engine is not running (Figure 36).

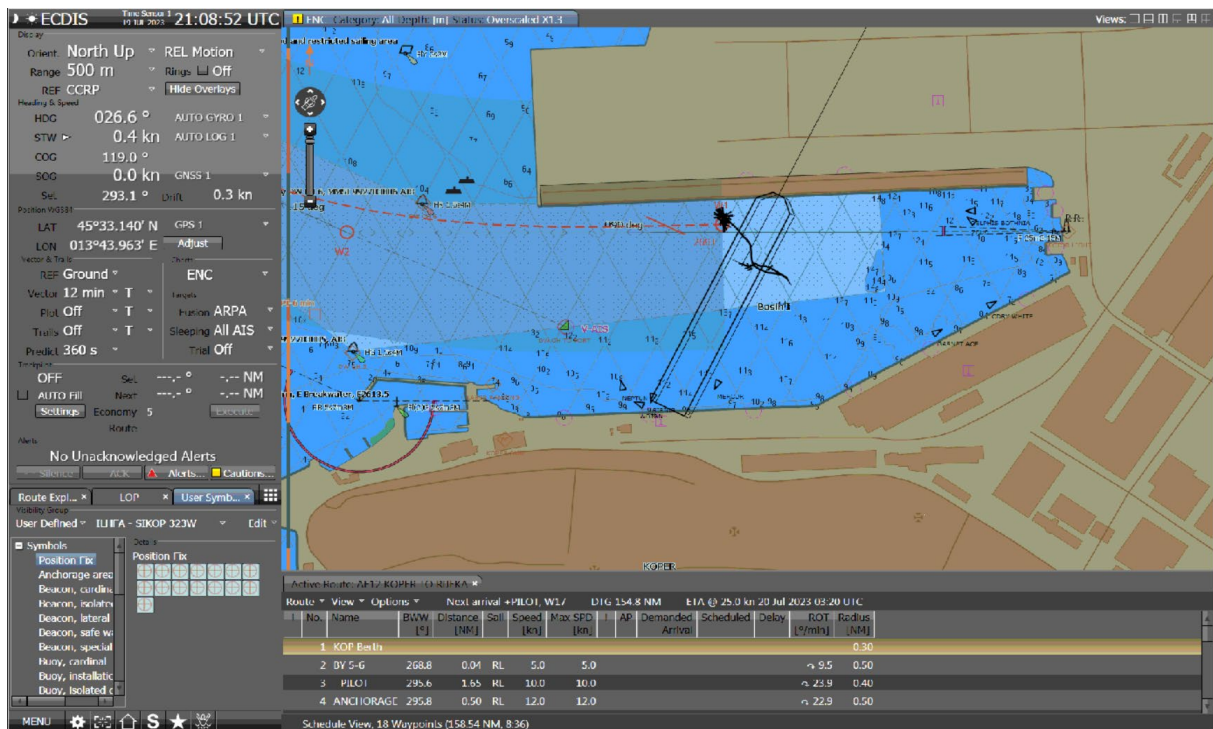
Figure37: Situation at 23:08:50 LT - contact with the tugboat Sirius, (source: VDR)

The ship's heading is 027°, COG is 119°. Bow thrusters are stopped, and stern thrusters are operating at 60% to port. At starboard quarter, the tugboat Mercur is pushing stern to port, main engine is not running (Figure 37). The wind direction is 056°, 23,7 knots (12,2 m/s). At 23:08, the ship's stern (port quarter) made contact with the tugboat Sirius, abeam tugboat Wotan, moored on Berth 1 (Figures 37 and 38).

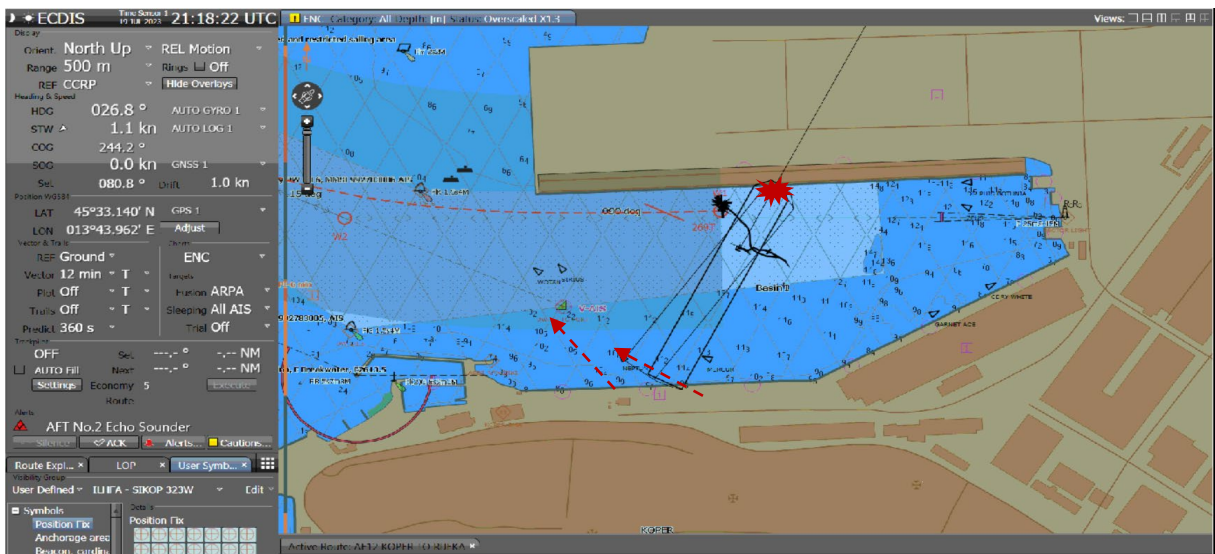
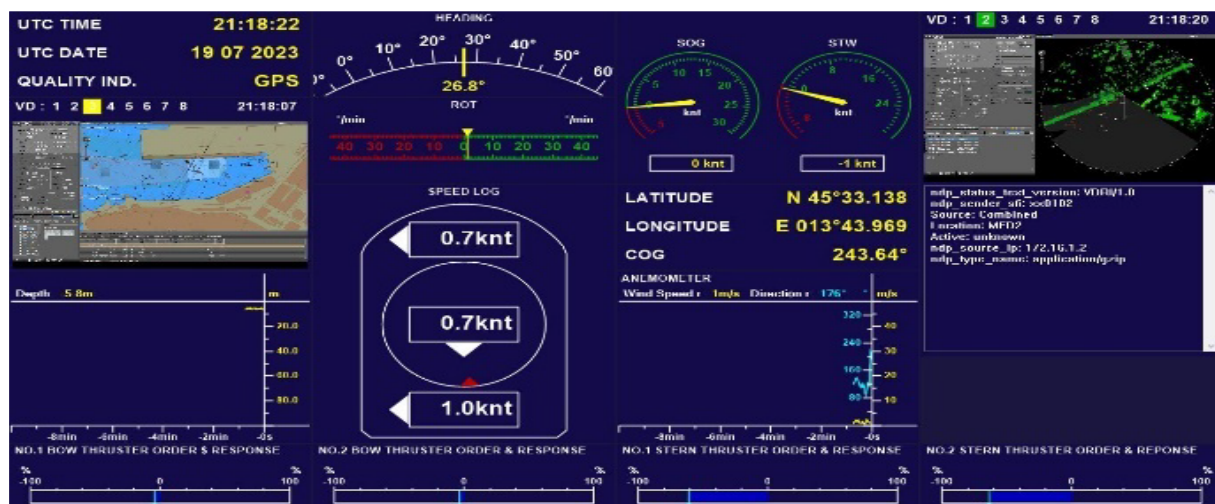
Figure40: Situation at 23.18.22 LT - contact with shore lift #58 (source: VDR)

at the stern is pushing the ship to port, the other is pulling her to port (Figure 39). The wind direction is 081° , speed of 19 knots (9.6 m/s). At 23:18:22, with her upper left part of the bow plating (bulwark), the ship made contact with the vertical seaside leg 1 of STS 58.

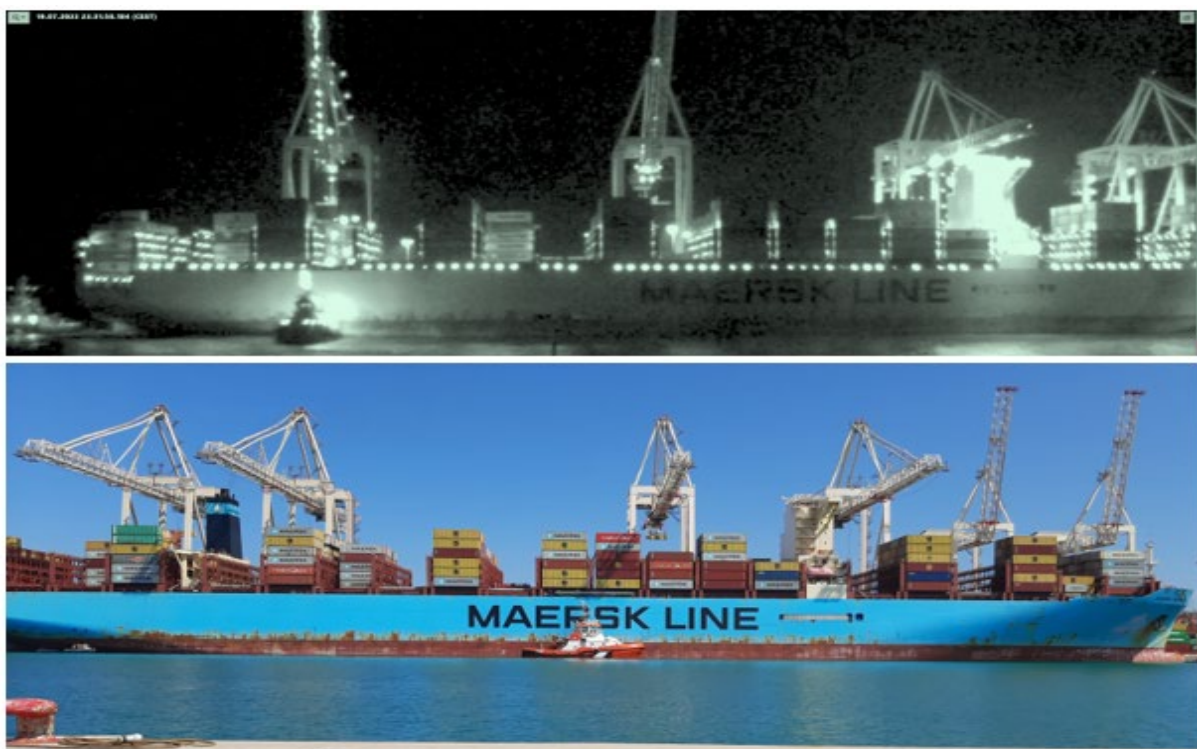
Figure41: Overview of the cargo distribution on board

At the time of the incident, not all the cargo bays on board were filled with containers. It is estimated that this doubled the total surface area and, consequently, the impact of the wind from the north-west direction. This caused a very high torque, which particularly put strain on the stern mooring lines and the forward springs.
